PROJECT No	ES347
PROJECT TITLE	THE OLD VICARAGE, HORTON
CLIENT	MR ROBERT STANLEY

DISCIPLINE	STRUCTURAL
DOCUMENT TITLE	STRUCTURAL SURVEY OF PART GROUND FLOOR INFILL EXTENSION
AUTHOR	KARL JERVIS

DATE	15th APRIL 2015
CHECKED BY	DOUGLAS CROFT
DOCUMENT NUMBER	SS01
REVISION	A

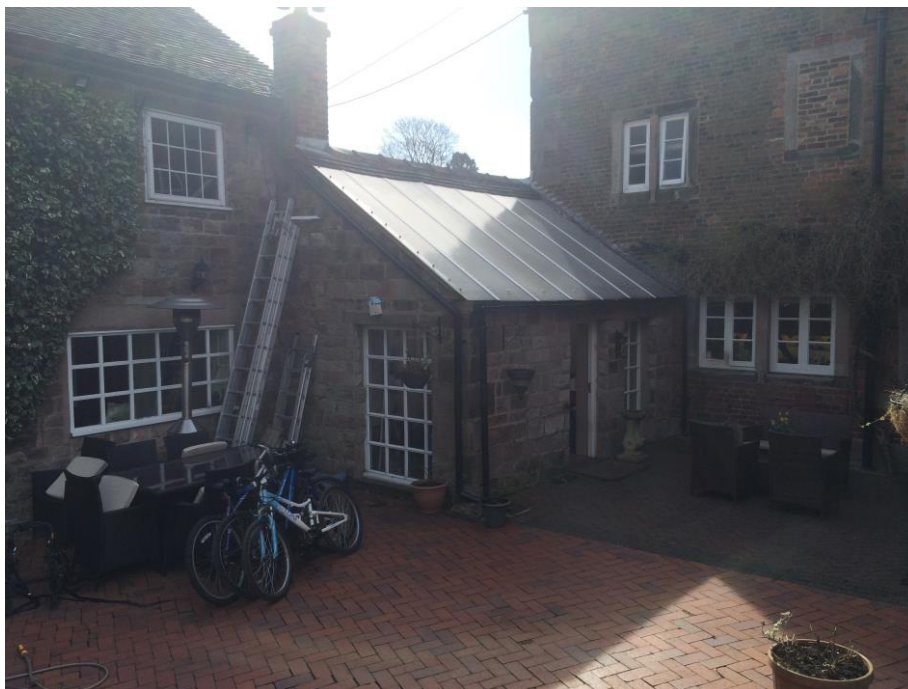
- 5.1 The infill building between the main building and the outbuildings (the focus of this report), is a single storey masonry building with timber pitched roof supporting tiles to the eastern pitch and transparent lightweight polycarbonate sheeting to the western pitch (photo 1).
- 5.2 The roof structure is formed with cut timber rafters (approx. 70mm deep x 40mm wide) supported on timber purlins and external walls (photo 2). There is an exposed external rafter at the northern gable wall which is supported on the timber wall plate which projects out past the face of the gable wall (photo 3)

Photograph 1 – View of infill from Northwest

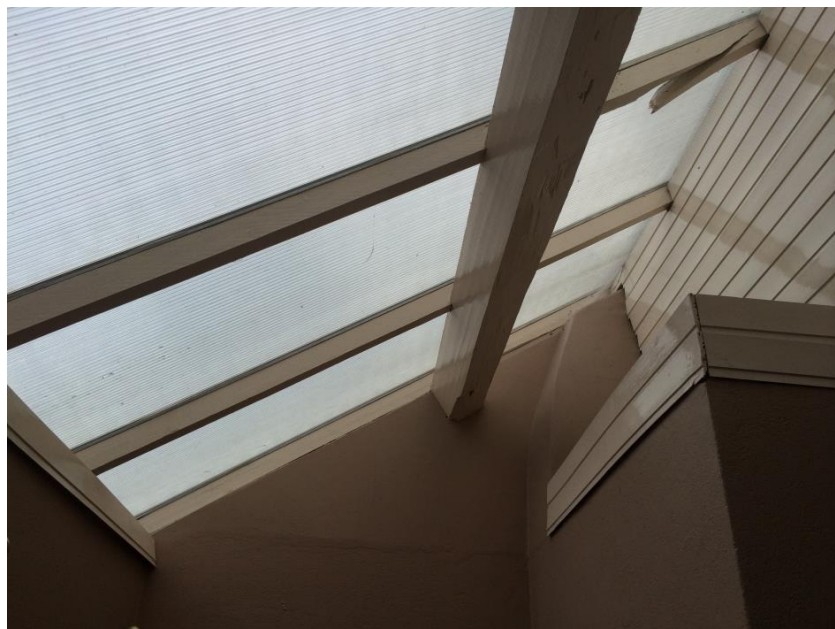
Photograph 2 – Roof structure from inside on western pitch

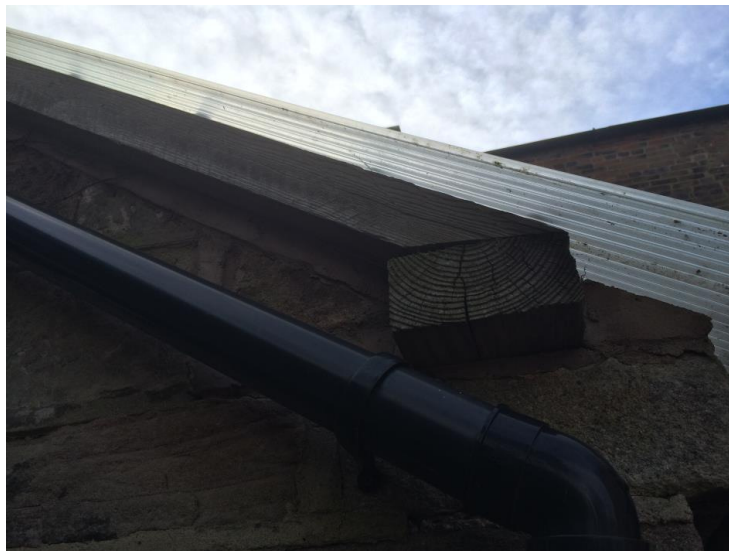
- 6.2 The stonework to the northern gable is becoming weathered in locations, also mortar is becoming loose and perished (photo 8).
- 6.3 The exposed end rafter and timber wall plate at the northern gable end are exposed to the elements and are starting to suffer from wet rot (photo 3).
- 6.4 The floor appears to be slightly undulating although this may be a consequence of poor workmanship during construction.
- 6.5 Loss of mortar around gutter support brackets leading to loose gutter supports (photo 9)

Photograph 3 – Exposed timber roof structure at Northern gable

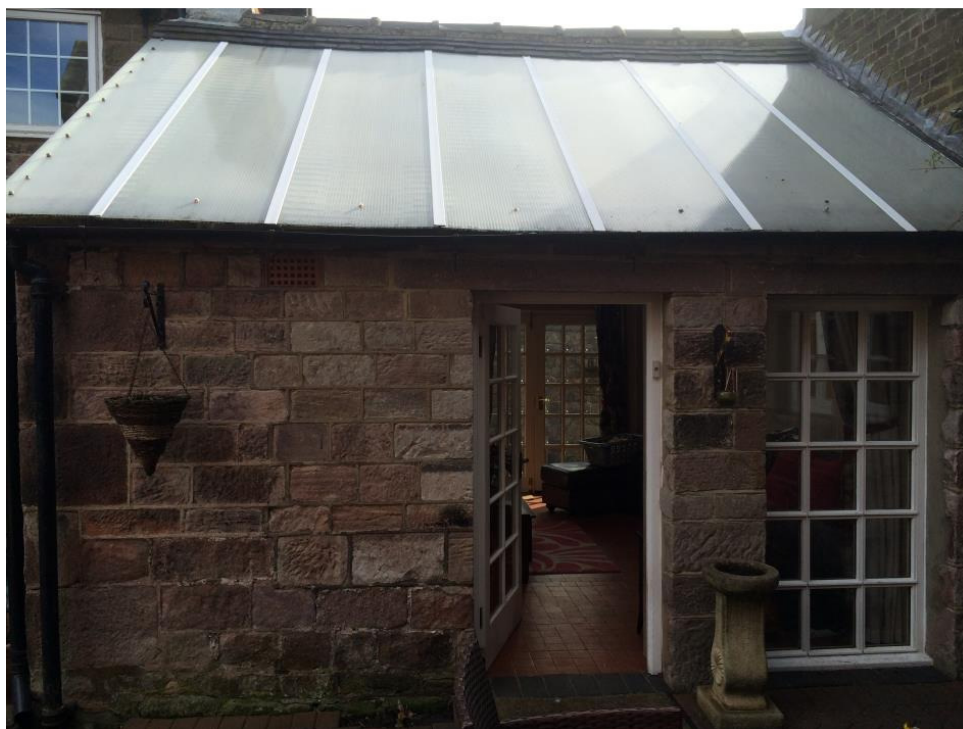
- 5.5 The masonry walls are approximately 450mm thick solid walls faced with sandstone to the exterior.
- 5.6 Lintels over the openings are precast concrete (photo 4).

- 5.7 There is ceramic 'air brick' vent in the western wall (photo 4).
- 5.8 There is a corbelled sandstone projecting eaves detail to the eastern and western walls (photo 3).

Photograph 4 – Western Elevation

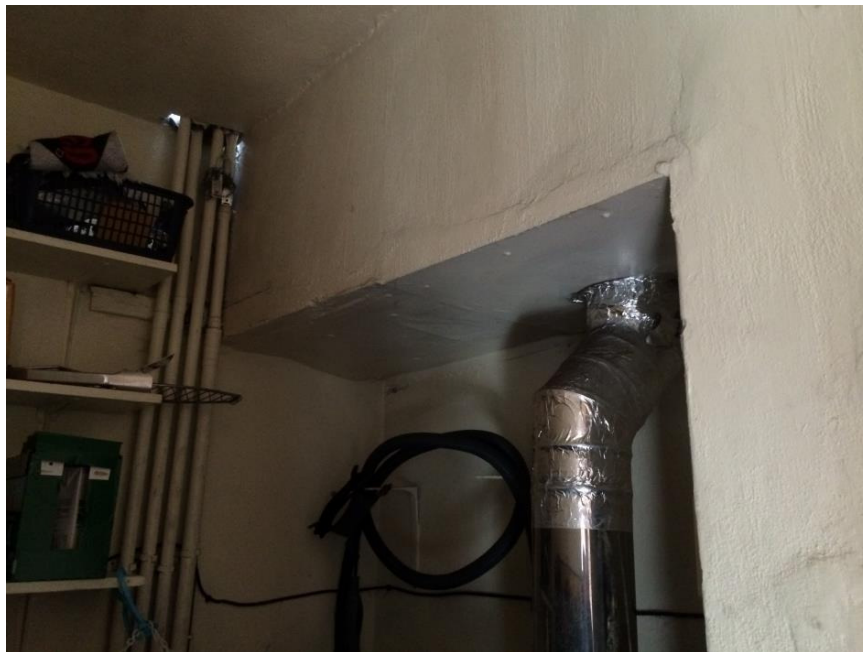
- 5.9 The stone faced walls are butt jointed up to the external walls of the main building and the outbuildings, the joint filled with mortar.
- 5.10 There is a chimney stack near the ridge line on the northern gable wall which tightly abuts the outbuildings (photo 1). The chimney stack contains the flue from the boiler. The chimney breast is open at ground floor and is presumed to corbel in towards the ridgeline (photo 5).

Photograph 5 – Open Chimney breast at ground floor

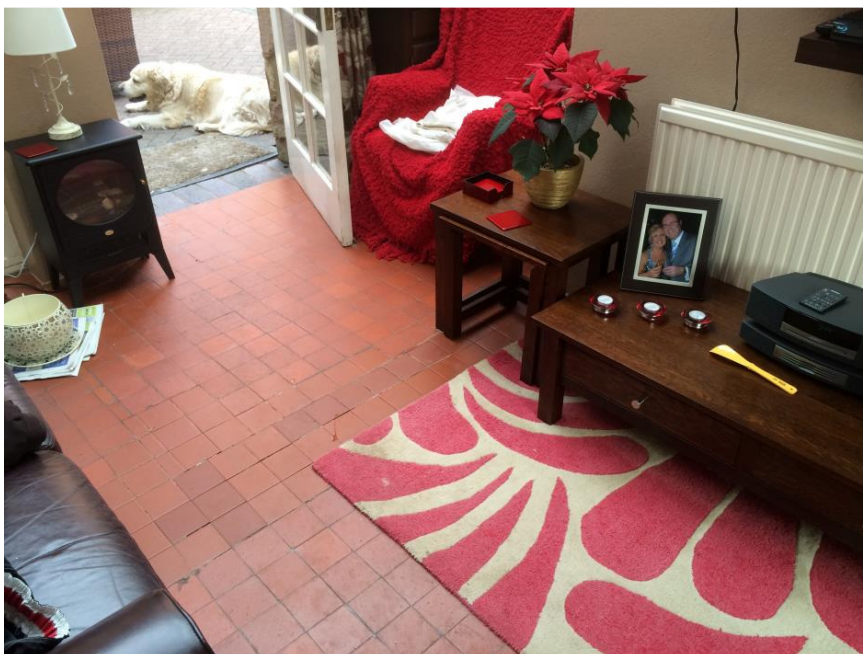
- 5.11 The internal faces of the walls have been directly rough plastered/rendered and painted.
- 5.12 The ground floor is constructed in solid concrete or brickwork supported by the ground and finished in quarry tiles (photo 6). Door thresholds are engineering brickwork.

Photograph 6 – Floor construction

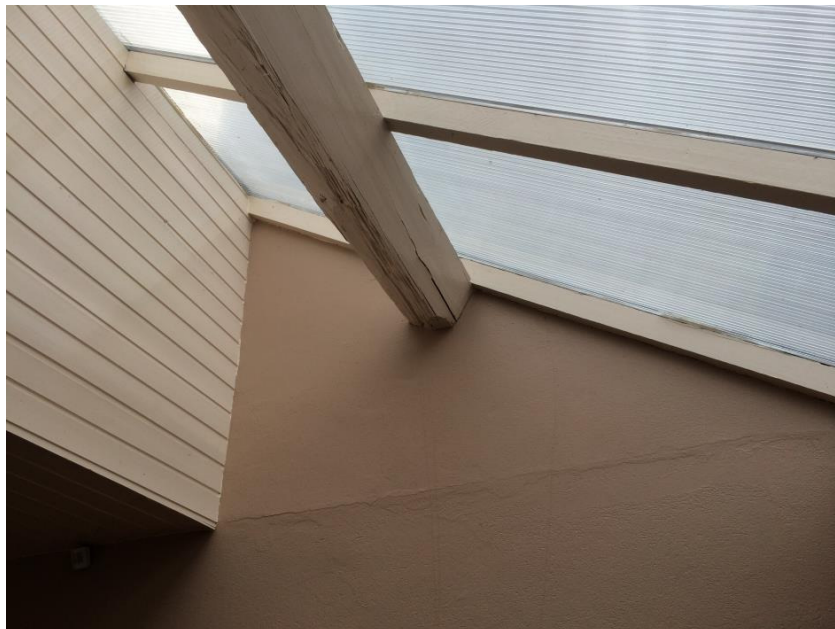
- 6.1 The western purlin is splitting along its length and starting to 'flake' at its southern bearing on the main building northern external wall (photo 7). It is

likely that some moisture is entering the purlin from the brickwork above causing moisture content variations and wet rot.

Photograph 7 – Splitting of timber purlin

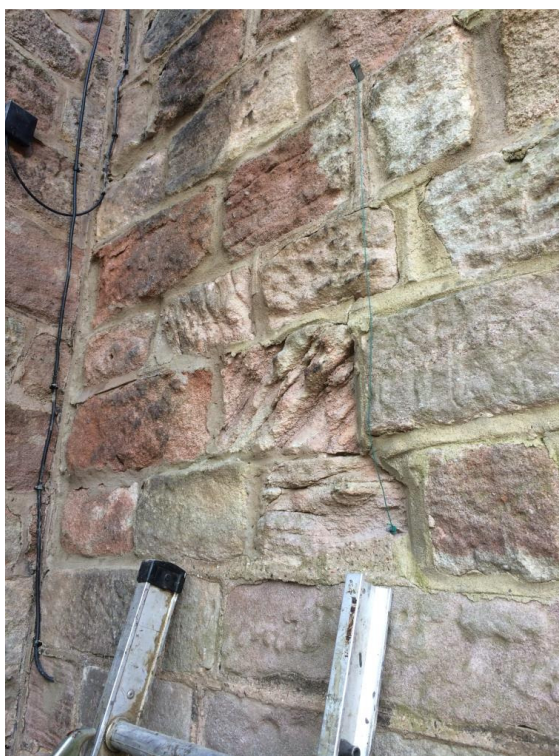
Photograph 8 – weathered stonework to northern gable

- 7.1 Generally the walls of the infill building are of sound construction requiring some level of maintenance to ensure weather-tightness and ongoing serviceability.
- 7.2 Weathered stones should be replaced and loose and perished mortar should be raked out and re-pointed with a natural hydraulic lime mortar.
- 7.3 The timber roof structure is generally adequate, although measures should be taken to protect the exposed timbers from further deterioration due to wetting and rot.
- 7.4 Exposed rafters and wall plates should be enclosed in weather proof boarding.
- 7.5 Timber purlins built into external brickwork walls should be protected by wrapping in waterproof membrane at the bearing or similar.
- 7.6 The undulations to the floor are likely to be long standing and are likely not causing a problem to the occupants, therefore no action is recommended.

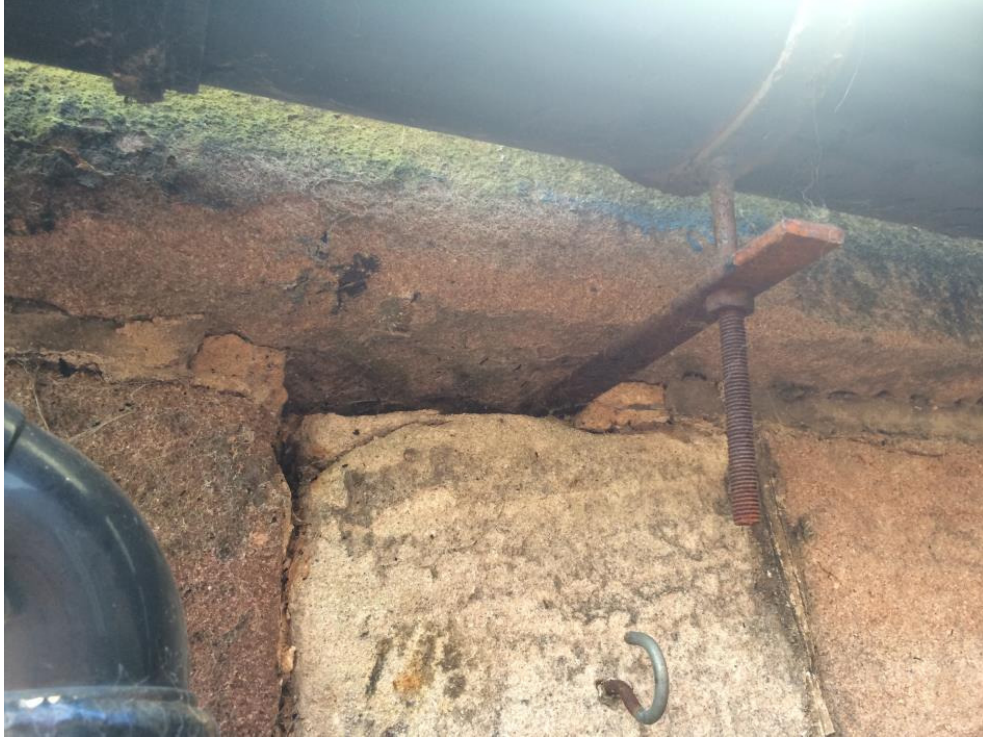
Photograph 9 – Loose gutter brackets
