Middle Hulme Grange - Barn

Meerbrook, Leek

Structural Condition Report

Project 1554

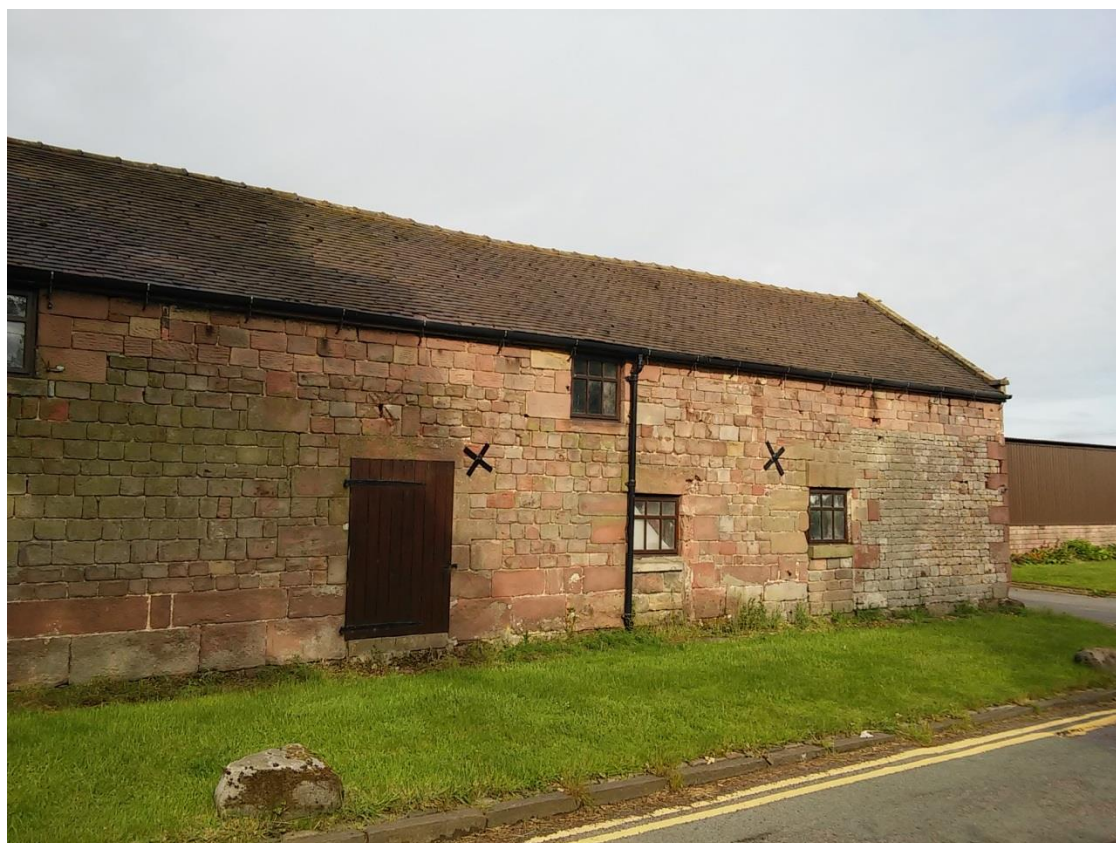
Partial View of Main East Wall – note coursing appears quite regular without excessive vertical distortions

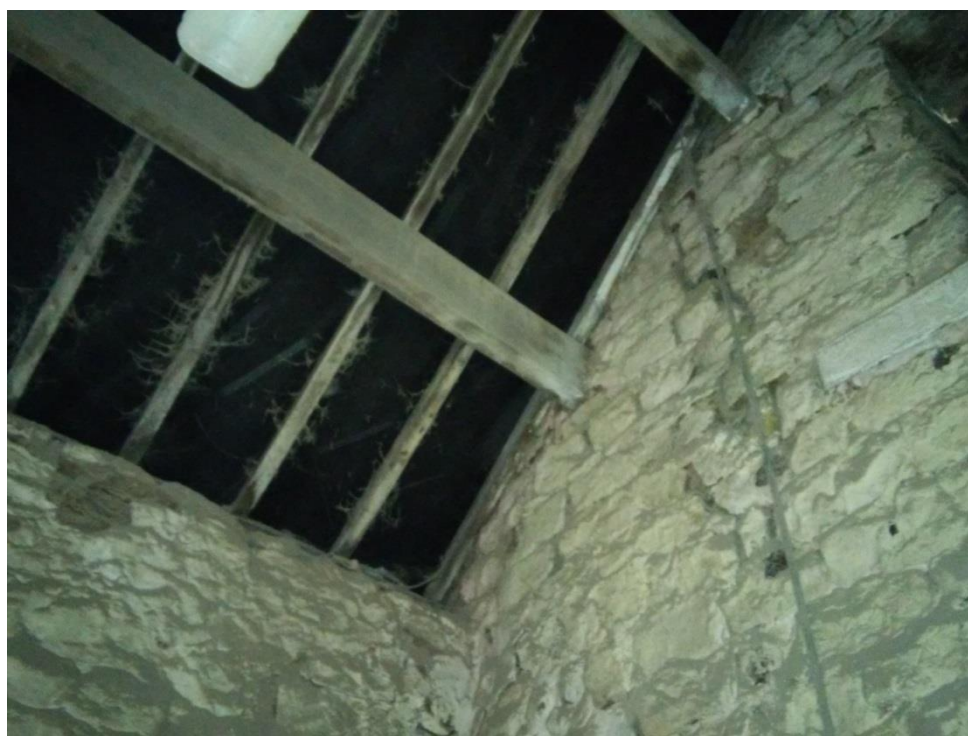
Evidence of splitting of the end gable wall at the southeast corner at high level between the purlins

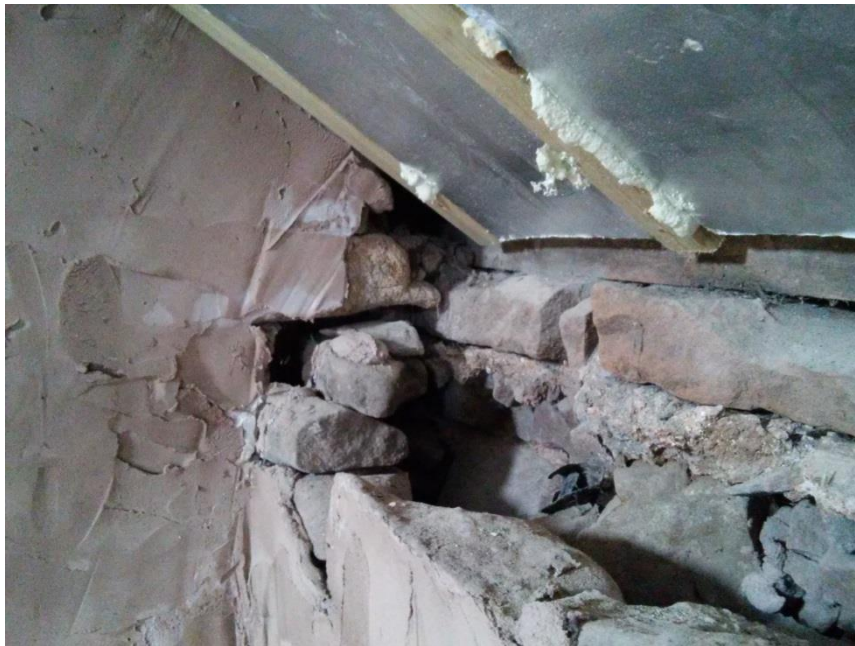
Typical cross wall to main side wall junction at roof eaves. Where exposed, the rubble fill within the main side wall cavities appears loose, and may have contributed to the lack of verticality of the external faces by settling within the void and causing relative spreading of the inner and outer leaves.

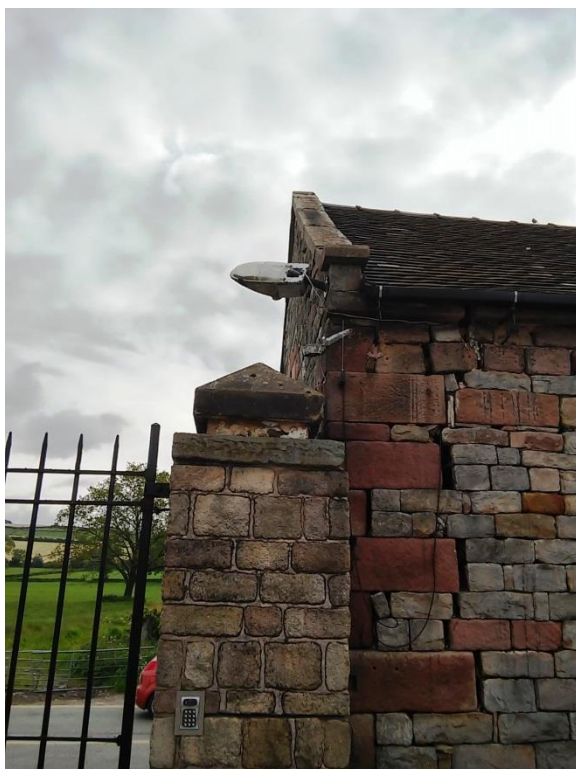
At the northwest corner of the barn, the gable wall appears to have been pushed northwards by the west side wall. This could have been caused by multiple effects such as solar thermal on a long expanse of tight jointed wall and / or cyclical freeze thaw acting on a build-up of snow and ice at the roof corner. Internally the walls have been rendered (advised about 10 years ago). There is no recent evidence, such as cracking of the render, to suggest that this movement is ongoing. The building owner also advises that the corner has been buttressed when the site entrance was remodelled.

View of the open joints indicative of the north gable wall having been pushed away from the west side wall more at the top than towards the base. This now buttressed by the adjacent recent substantial gatepost.

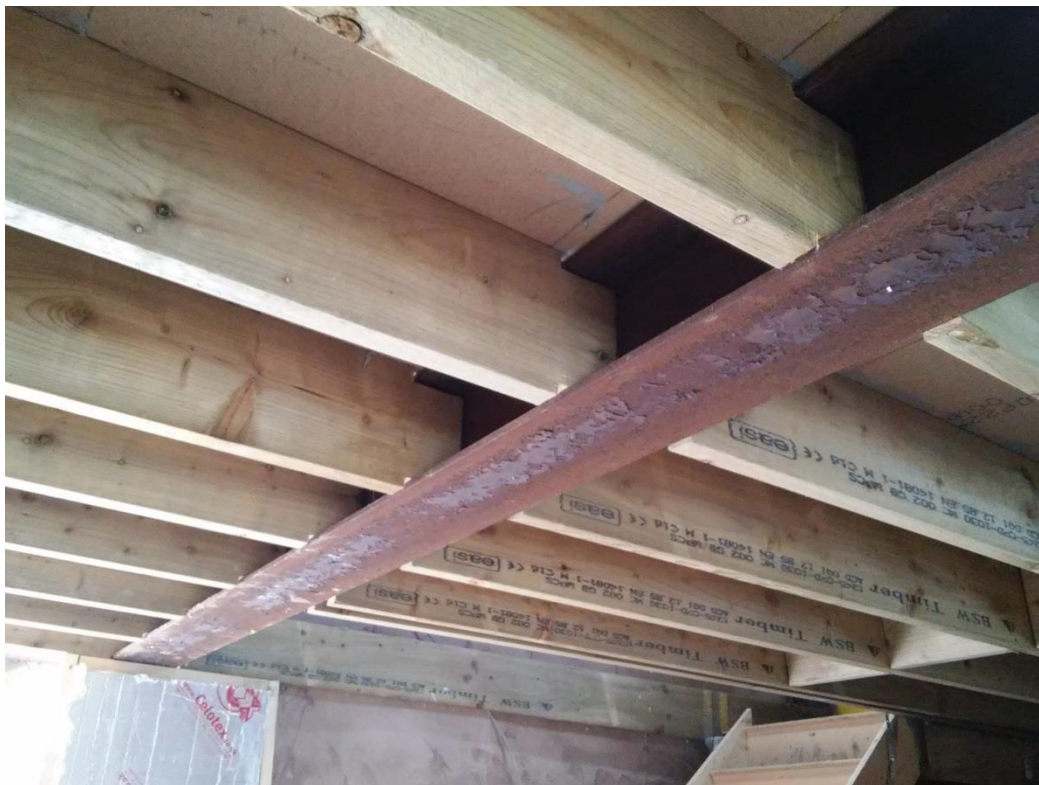
Typical soffit view of the recent mezzanine deck – some lines of support noggins and all of the fire protection are yet to be installed

5. There is no evidence to suggest that the new concrete ground floor slab will not be adequate for the intended new use.
6. Fire protection of the mezzanine floor is absent and therefore needs to be fitted.

7. There are various locations where timber noggins should be fitted to the mezzanine floor timbers in order to comply with Building Regulations.
8. The re-roofing works appear to perform satisfactorily. The degree of longitudinal tying of the main timber purlins appears minimal and it is recommended that additional "BAT" type 30x 5 section galvanised ties are added across each of these joints.

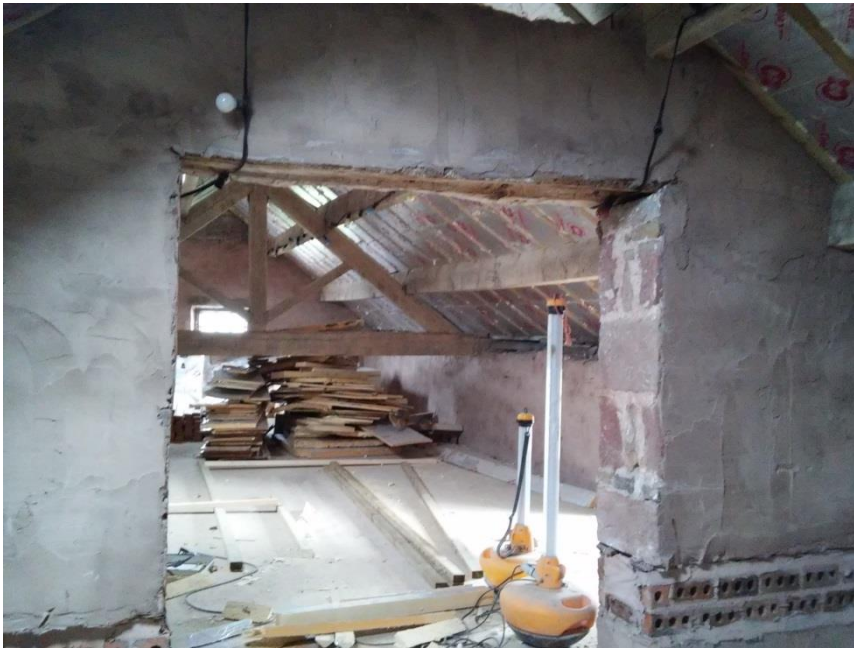
It is believed that the main purlins and kingpost trusses are original and have been retained. The purlins appear to be in good condition, although the 2 bays towards the north end are longer spans than typical, and there are quite obvious creep deflections present. The ridge line of this portion of the barn is also noticeably deformed. There is evidence of insect attack in several of the main timbers, but this does not appear serious or ongoing. The proportions of the sections used, and jointing of the kingpost trusses appear sensible and normal.

Internal view looking to the northeast corner, showing the 2 long span bays at this end of the barn.

The foreground internal crosswall is a new insertion on the line of a pair of steel tie beams which have since been cut and incorporated into the wall.

9. A structural assessment of the two long span end bay roof purlins is advised, and strengthening effected as the calculations might prove necessary.

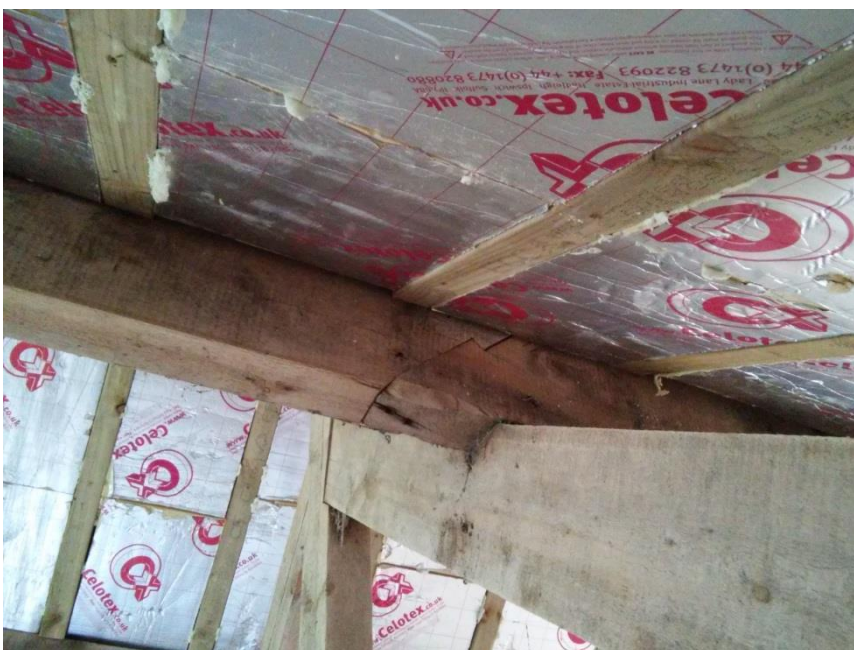
Typical scarf joint between purlins over truss lines. Butt joints have been utilised over cross walls.

The tying action which can be achieved with these joint details is limited. However, since new upgraded tiling battens have been used, and if it is assumed that the butt joints between these are well staggered then the longitudinal tying of the roof can be considered adequate.

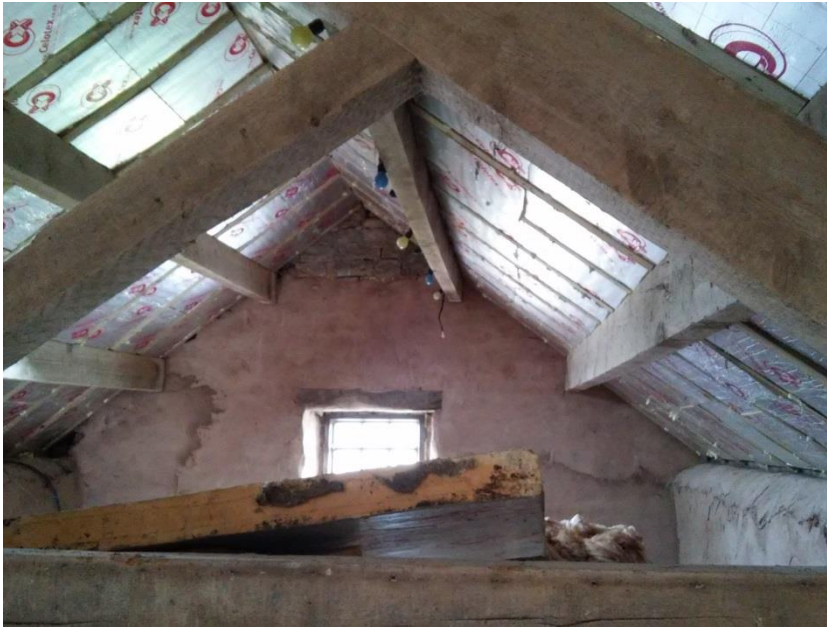
The re-roofing works retained the use of a central ridgeboard. The purlins are orientated with their main structural axes set vertical. The bases of the new spars are fixed to a traditional wallplate aligned with the outside face of each main side wall. With this structural arrangement the vertical gravity loads applied to the roof continue to exert lateral thrust onto the walls. This thrust derives from arch action at the apex ridgeboard, as the ridgeboard is insufficiently rigid to act as a vertical support on its own. Ideally there should be eaves level cross tie timbers which transfer this thrust internally across the barn, such that there is no need for reliance on the side walls for lateral support.

Typical roof arrangement which is very traditional but does result in outward thrusts being applied to the tops of the main sidewalls

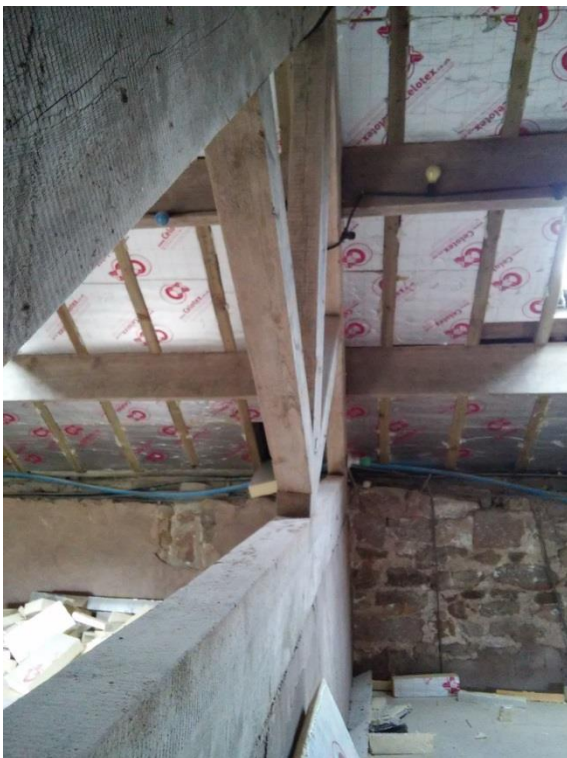
Two of the main kingpost trusses have distorted out of plane. This probably occurred during a period when the roof was in a poor state of repair such that the degree of lateral restraint was inadequate, and the moisture content of the timbers was high due to ingress of rainwater. This is not of serious structural concern.
