## MAP REGRESSION

## PHOTOGRAPHS

### Stableblocks

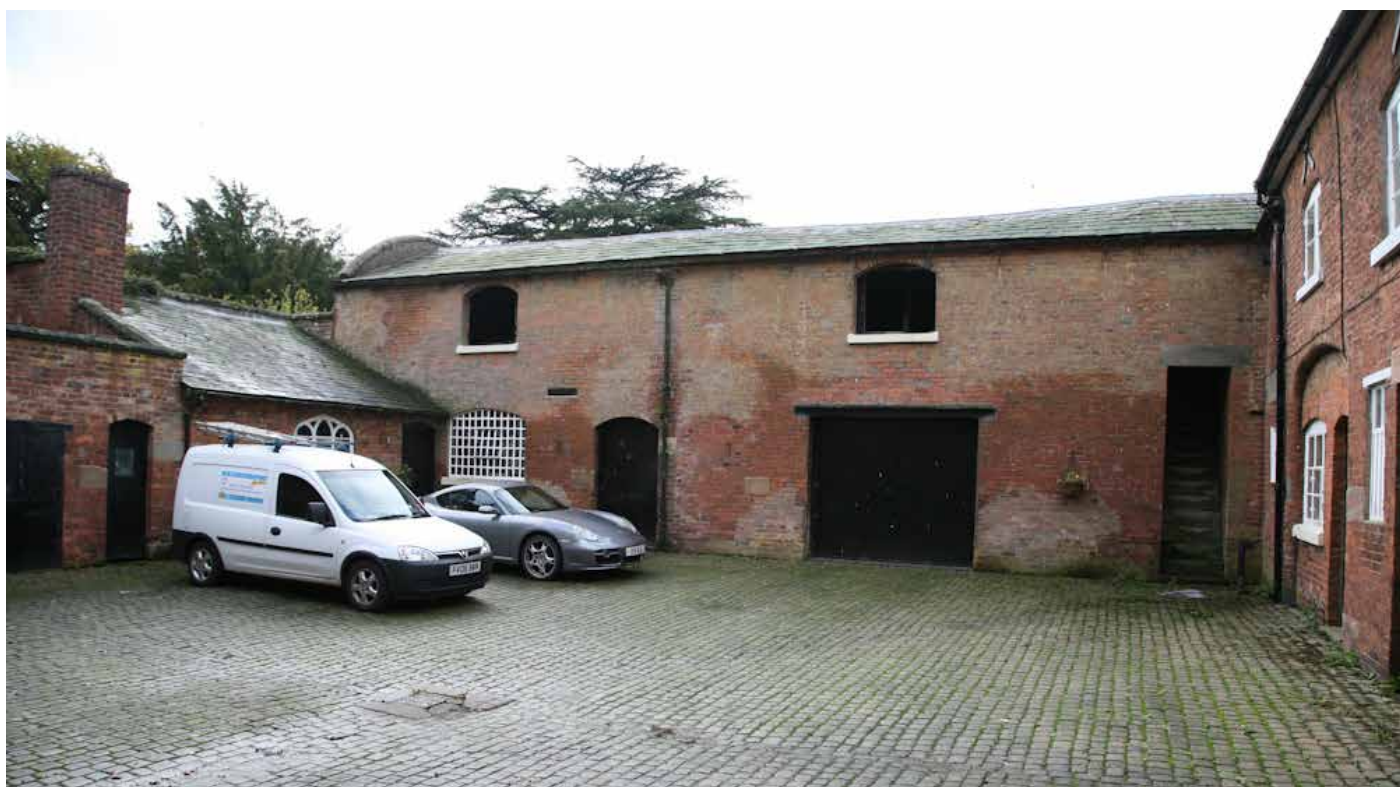
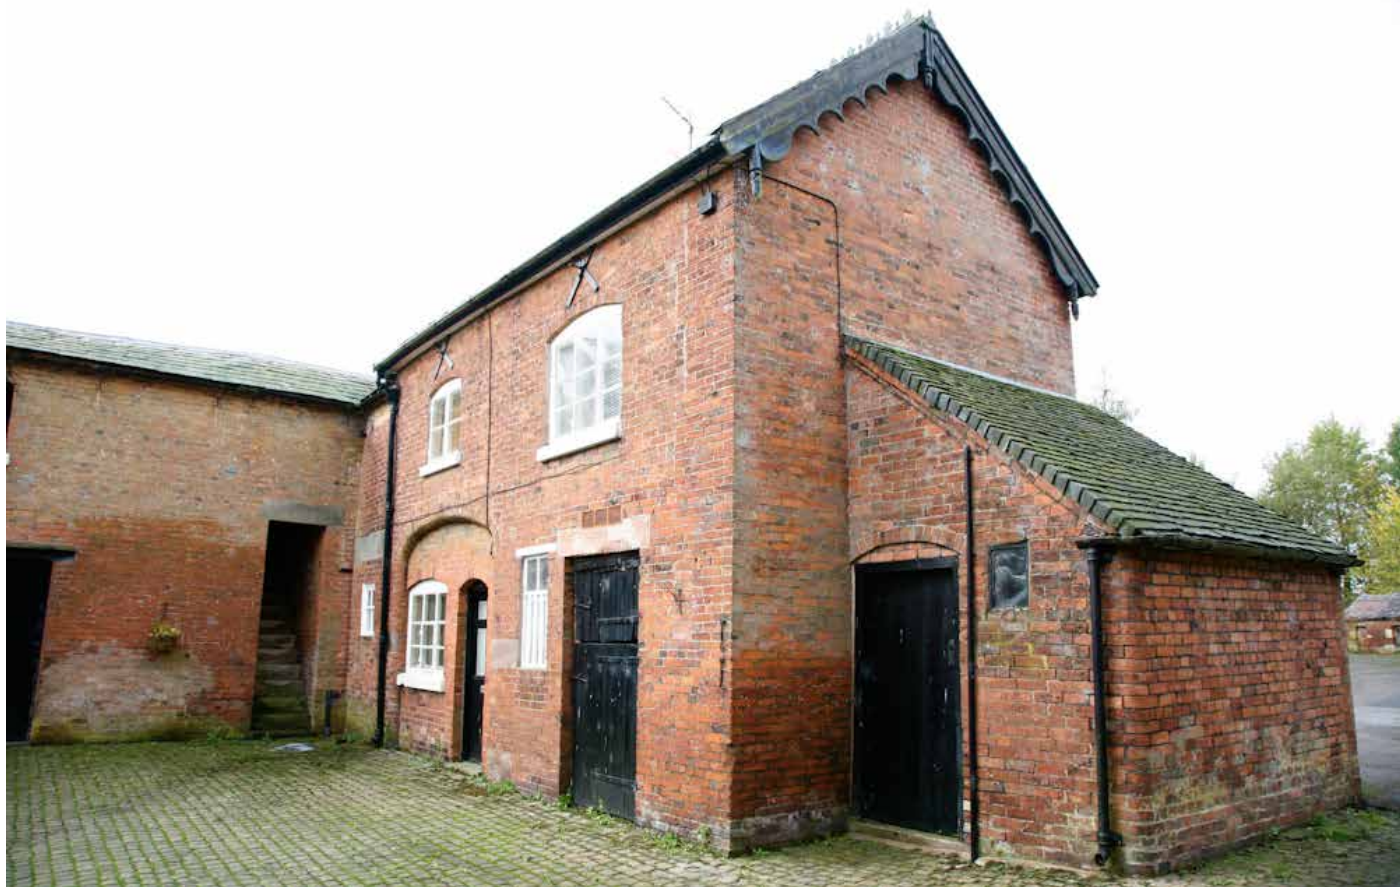
The block to the west (above) was originally built as a sister stables to the block to the east. The late Georgian symmetry of the design is clear from this elevation of the eastern block but has been spoilt by the inserted window at first floor level, C20 (of no interest). Cast iron windows were inserted at first floor level to replace the original horizontal sliding timber shutters when the building was adapted as a laundry and ancillary storage.

The block to the east (below) was designed with an integral staircase to the attic floor, in-situ. The symmetry of the original design has been severely damaged by a twentieth century garage. Some time before this was inserted, the stable door to the left was blocked up. Limewashed at one time, this has slowly eroded.

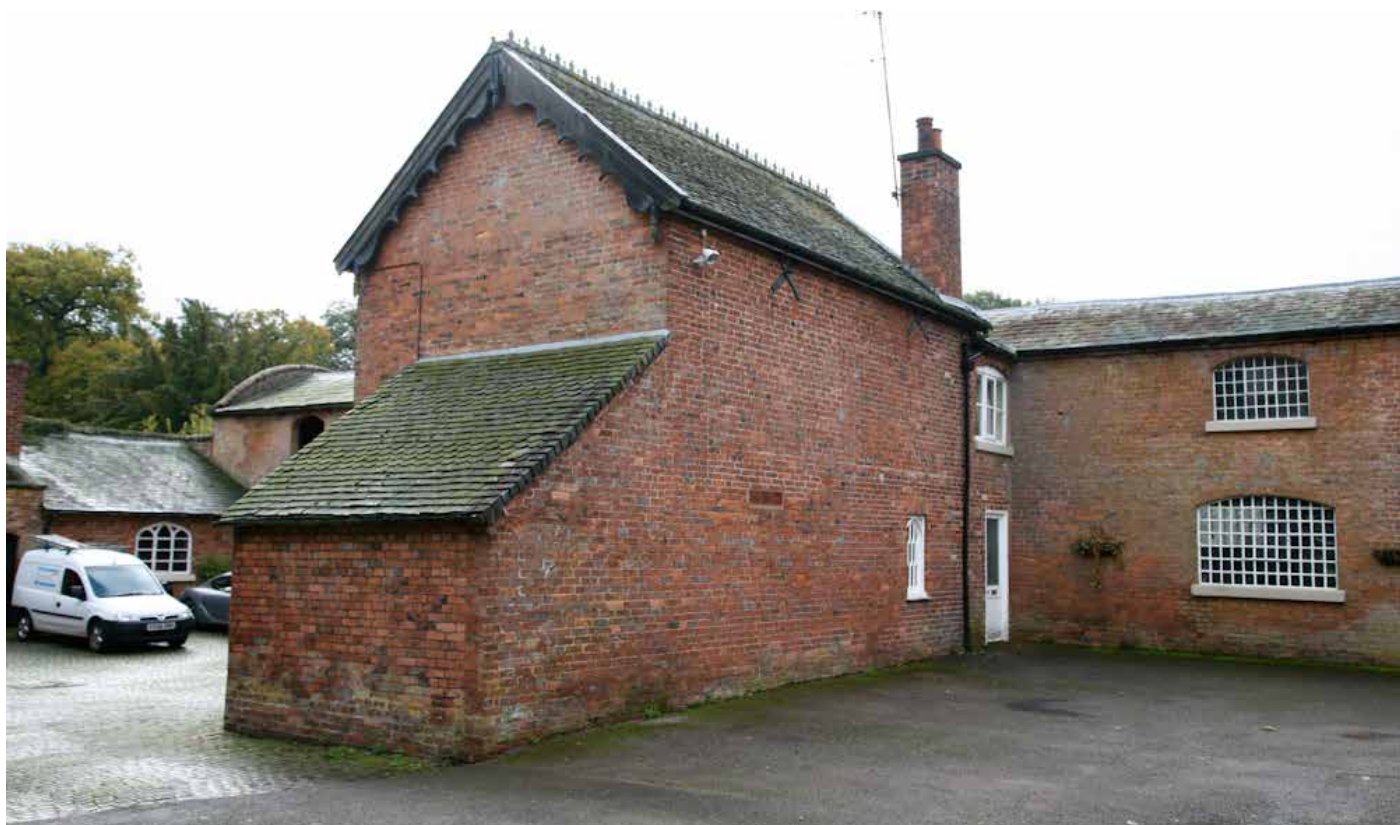
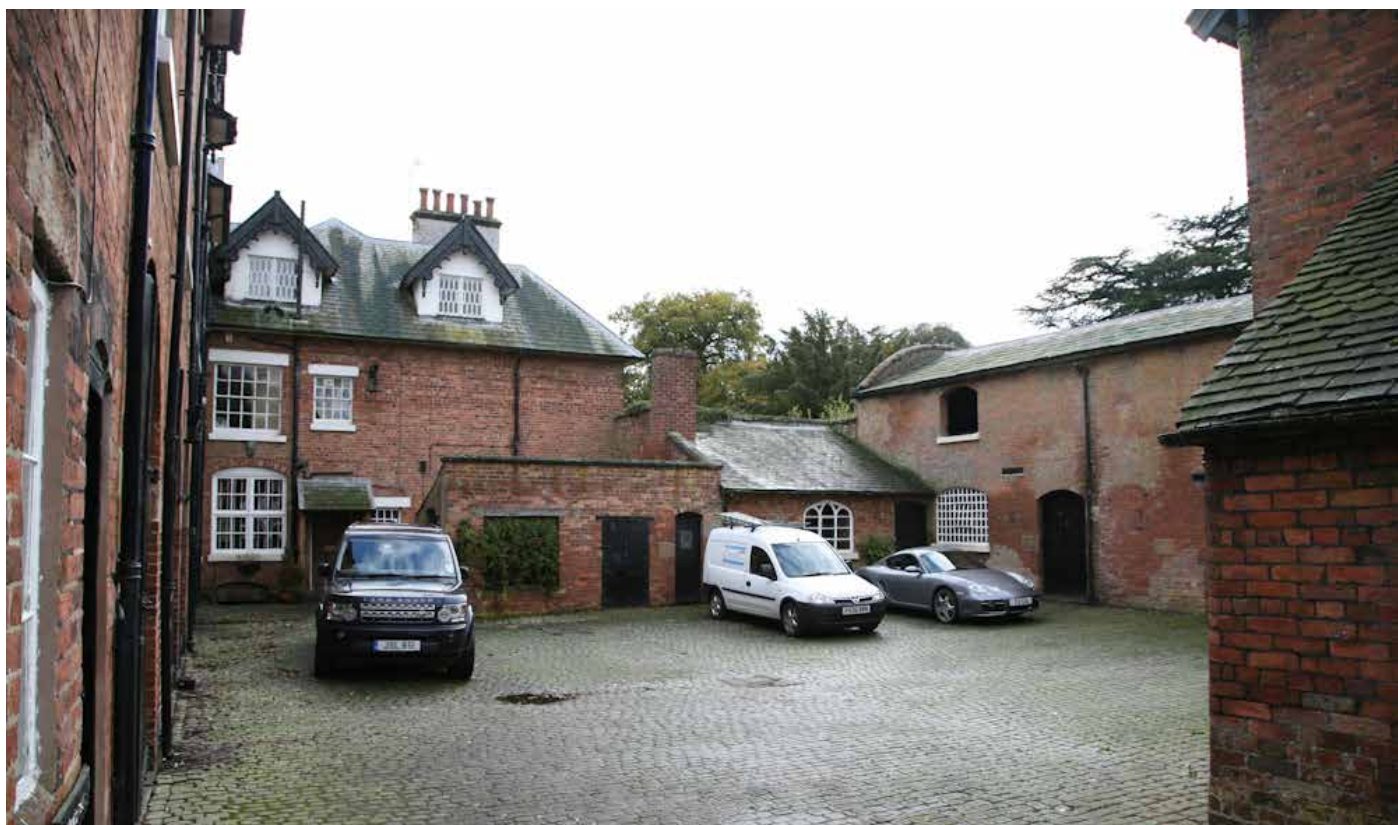
### **The "Bothy" or Groom's Cottage**

The brickwork in the gable end of this building and a short section of the return brickwork reveals an 18th century sized brick, with narrow 2" x 9" bricks. The narrow gauge brickwork finishes at eaves level, perhaps indicating an original hipped roof. The building also contains a cross wall in stone, with carefully and precisely tooled stone masonry, which appears to be a former outer wall. Later modifications to this building include the reconstruction of the first floor, which incorporates keyed brickwork, hence the staggered straight joints, the infilling of the gap between this and the Stableblock, and the adaptation of part of the ground floor cart / gig bay into a dwelling. The building has had at least 4 phases of significant changes. Below - rear elevation with large area of 18th century brickwork, rebuilt using original 2" bricks.

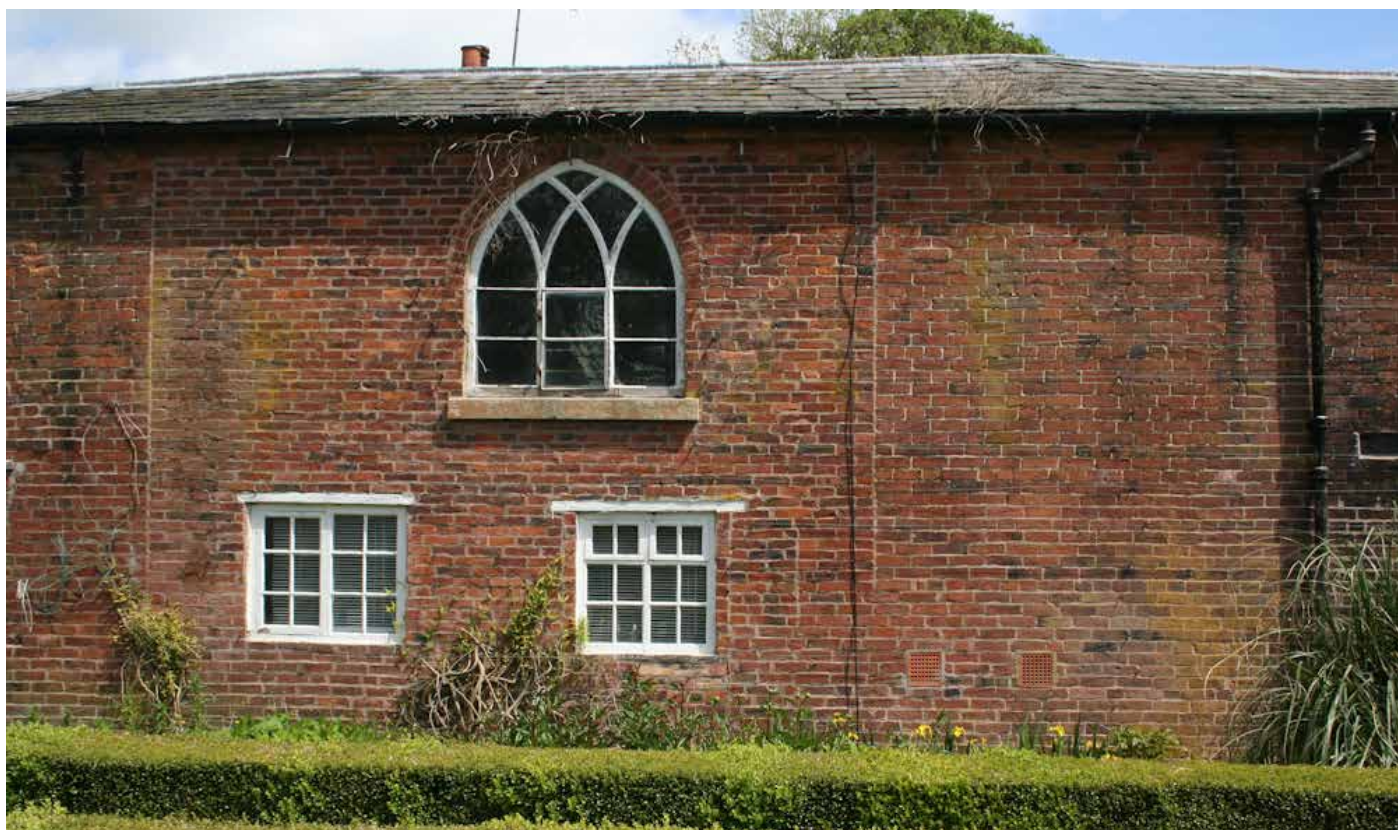
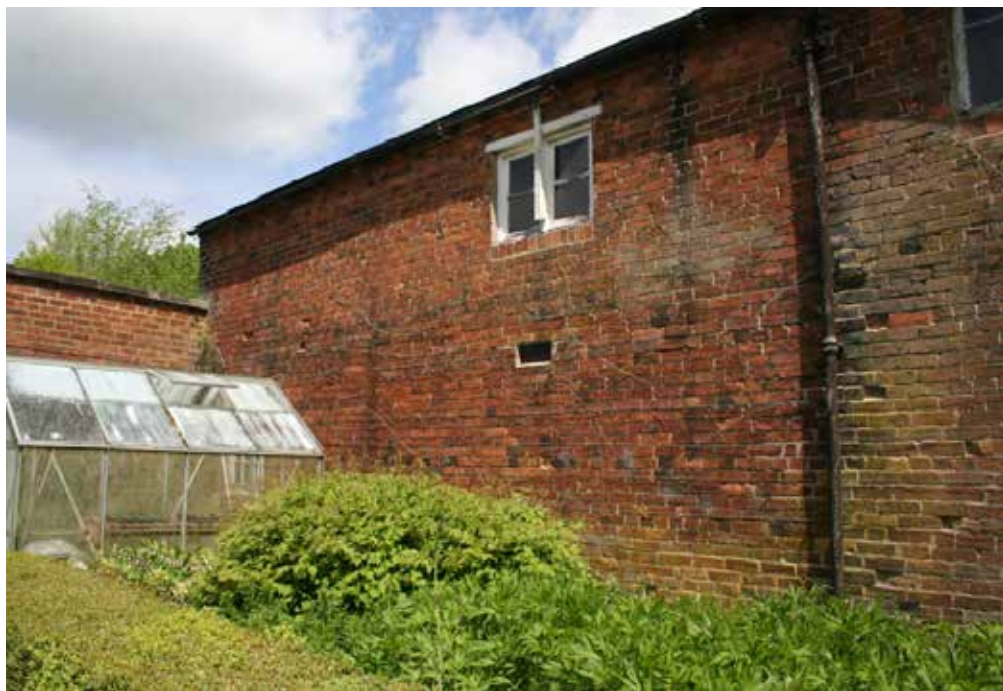
### **Rear (south) elevation of Stableblocks**

The Gothick arched window is a later adaptation, re-using a window from another part of the complex during adaptation to provide staff accommodation. The straight joints reveal that the Stableblocks were probably built onto an earlier building. Casement windows at ground floor are both 20th century.

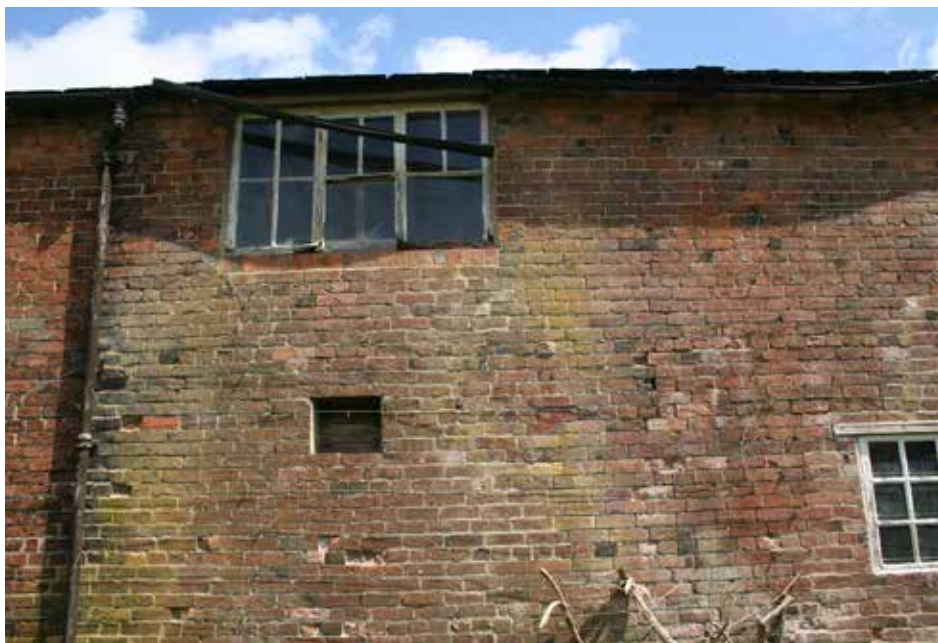
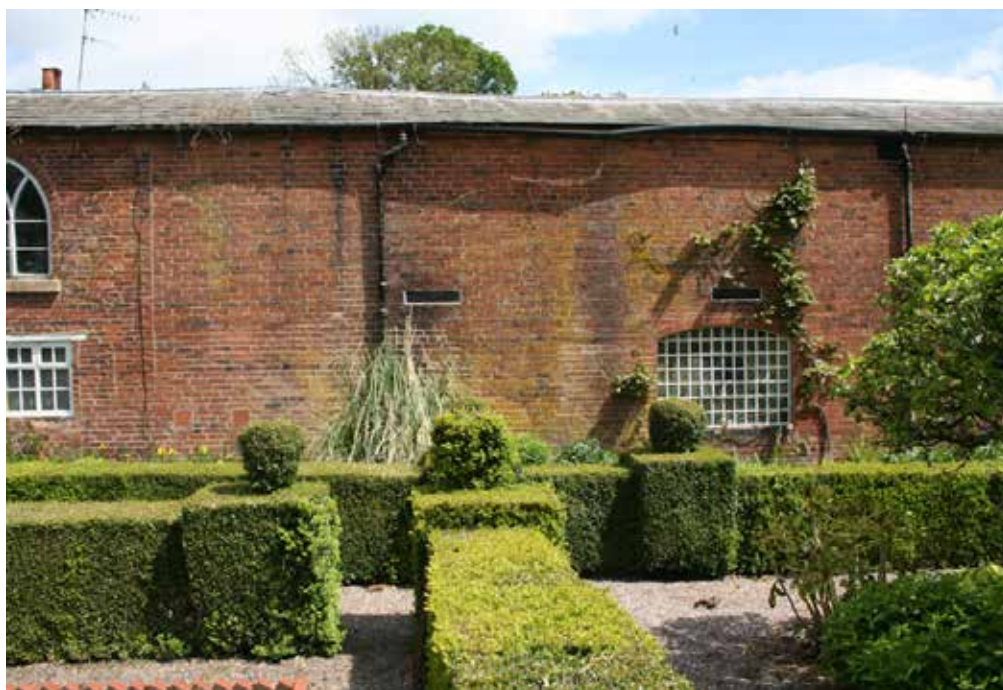
Western bay with plain ground floor, later pierced ventilator to stables and inserted first floor window, added when the building was converted to accommodate a laundry.

Inserted 20th century window to first floor, in poor condition, late 19th century ventilator (altered)

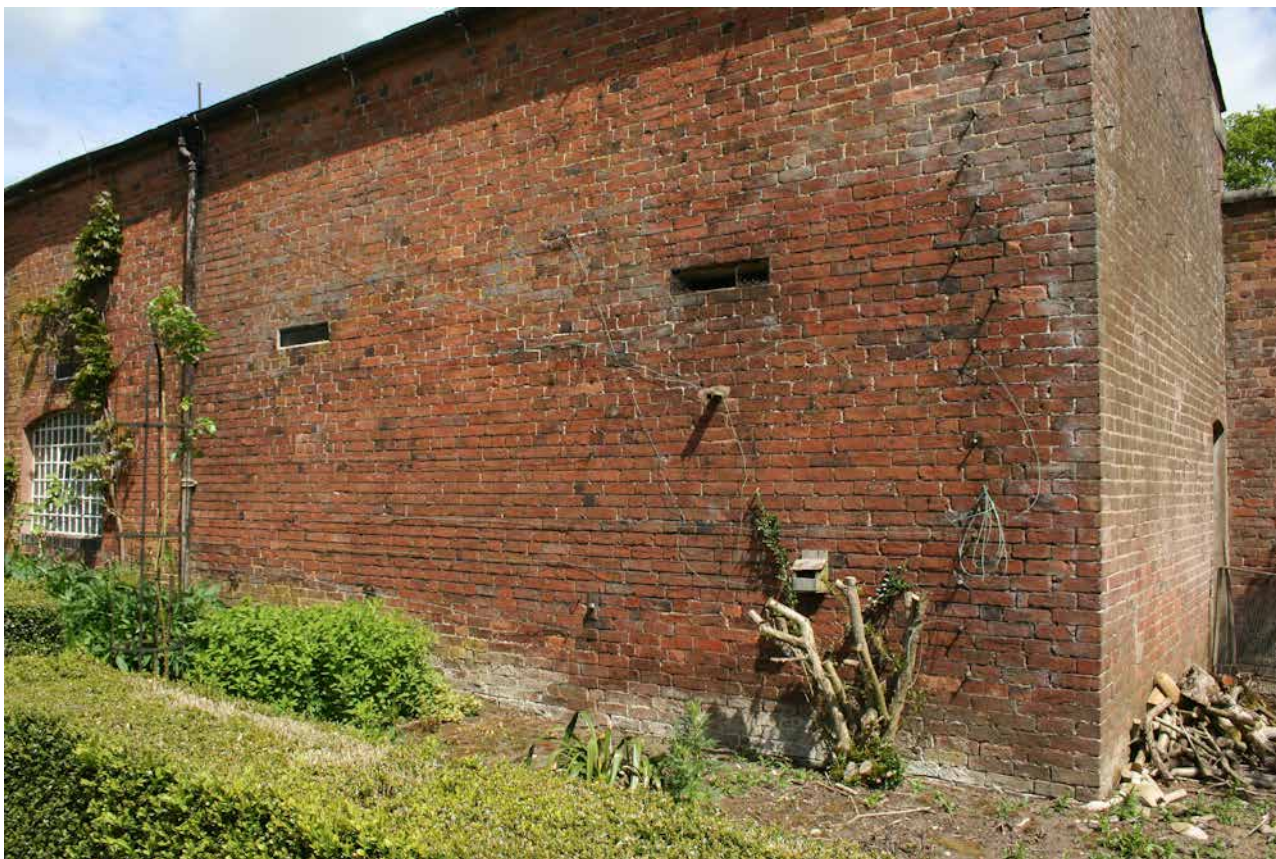
### **South elevation**

The rear elevation of the eastern stableblock, with relocated cast-iron window and late 19th century pierced metal ventilators

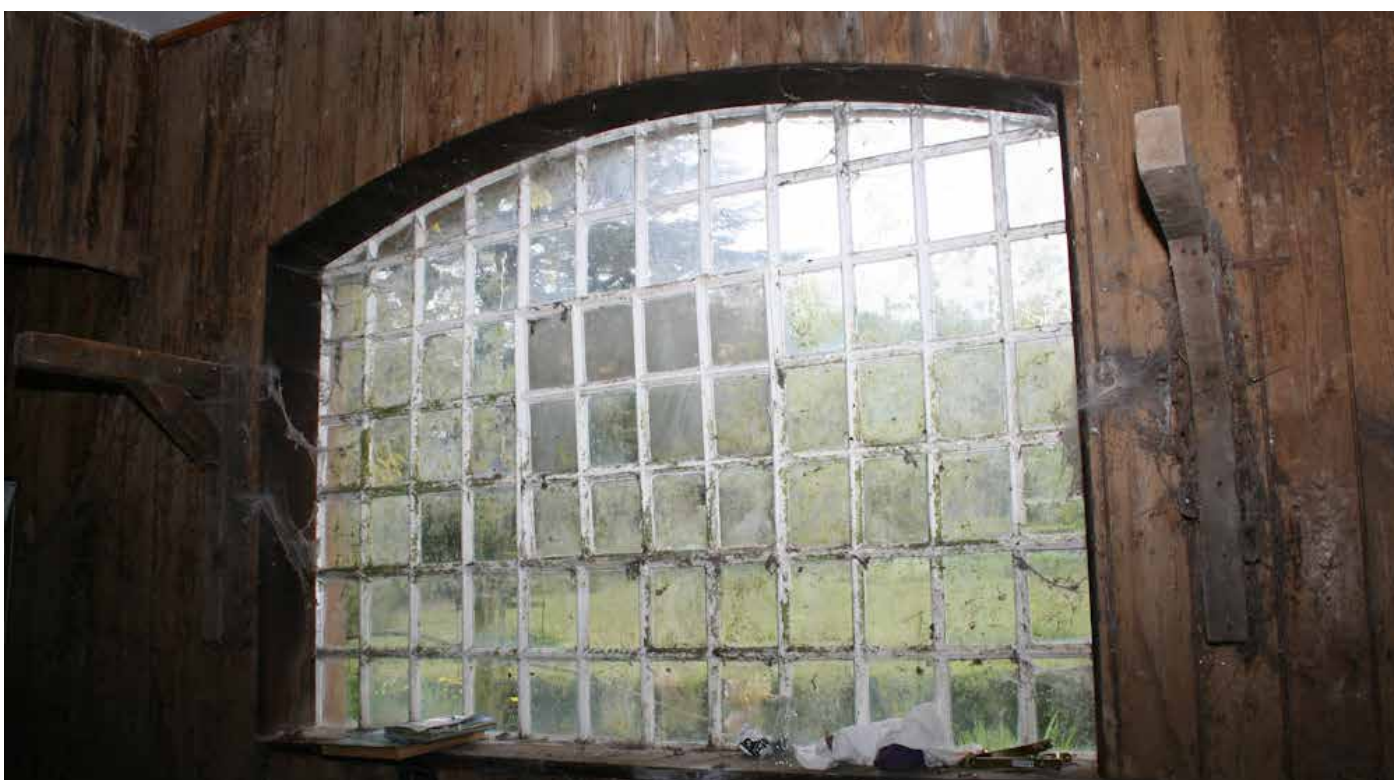
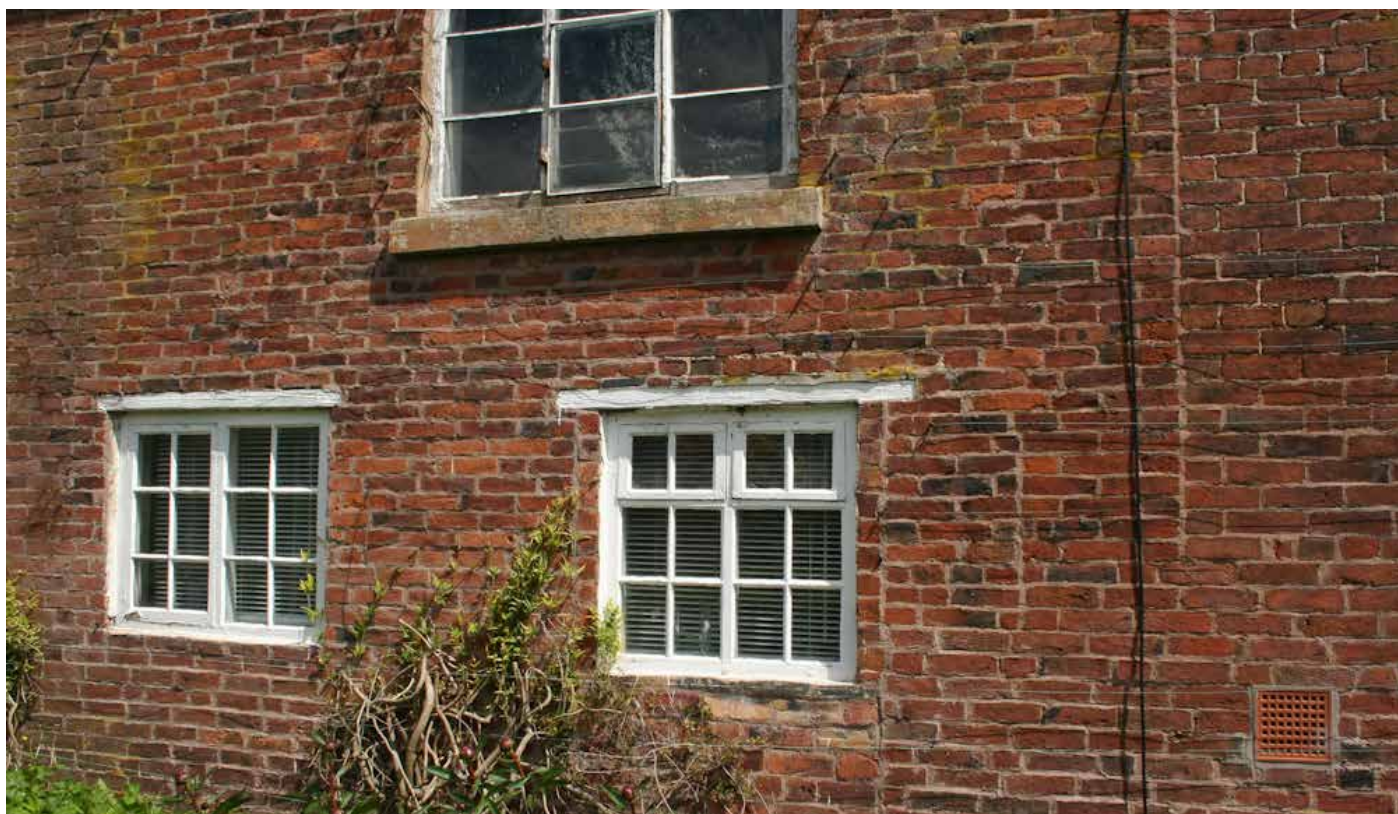
### **South elevation - eastern bay**

The plain elevation reflects the original appearance of the stableblock on this elevation, which did not need rear access onto the garden. The doorway in the central bay and end wall may have been used to provide access for barrowing manure out into the garden. The pierced metal ventilators are later 19th century additions.

Cast-iron window relocated into south elevation. This window is the original window from the north, courtyard elevation and was moved here after building was adapted as a garage / workshop. The timber panelling was carefully cut to accommodate the repositioned window. It would not have been used when the building was in use as a stables in the late 19th century.

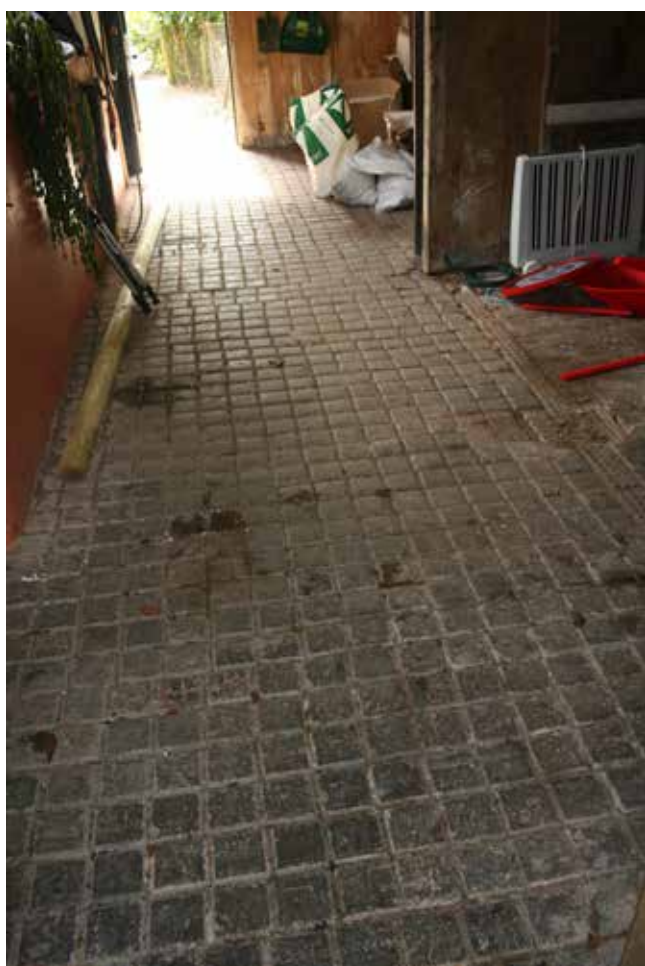
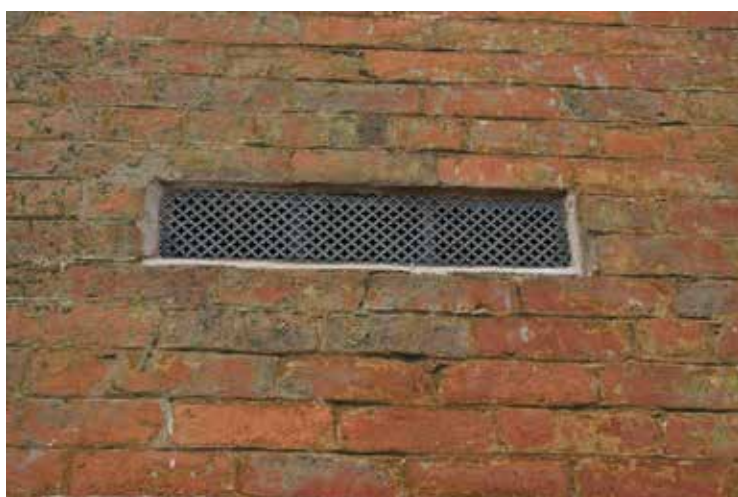
### **Blue brick floor to Eastern Stableblock**

Left - the earlier blue bricks were repaired and replaced in part with small blue clay tiles, with squared pattern, as seen left. Two phases of brick tiles are still evident.

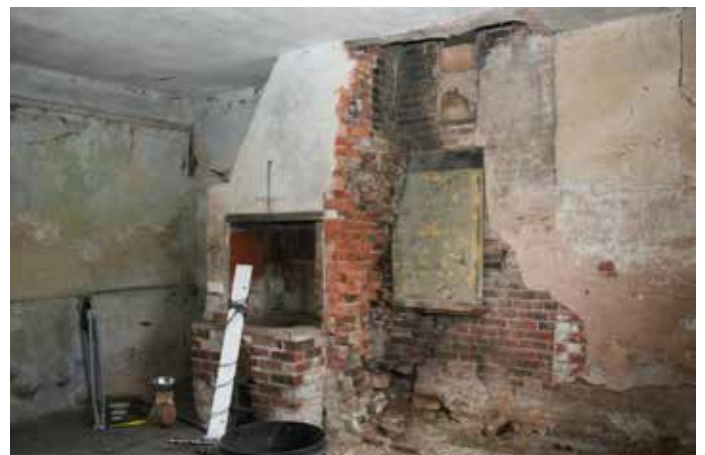
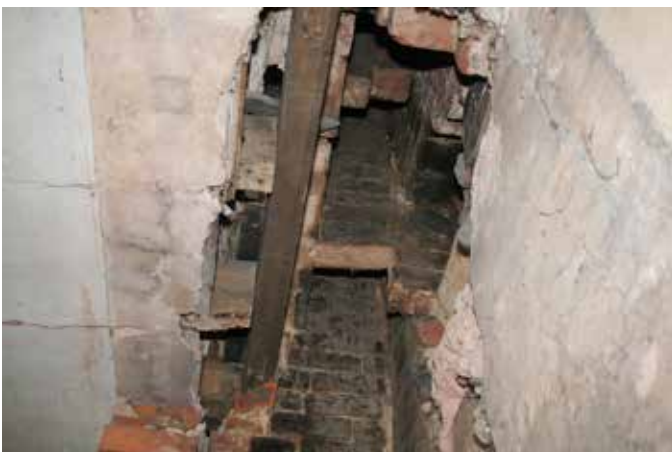
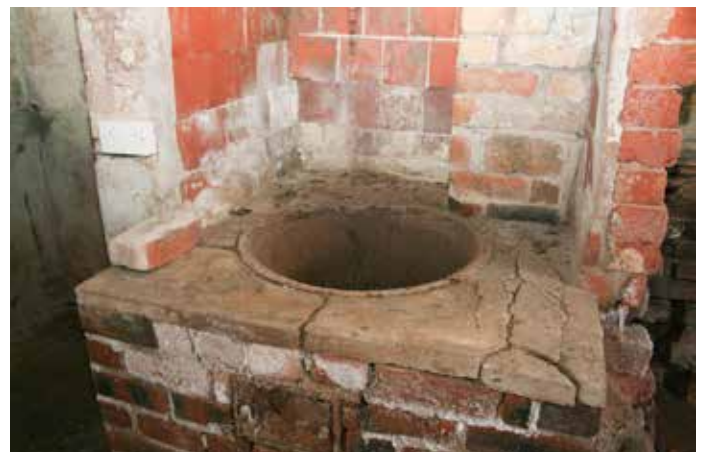
### **Western Stableblock (Ground Floor)**

Late 19th century Laundry Room, converted from a pair of stables (four stalls). The internal dividing brick wall was removed at ground floor level and replaced with an oak beam and cast-iron post, supporting the loadbearing brick wall above and the joists.

The chimney breast and hearth was inserted, not keyed into the masonry, and has largely collapsed (bottom left), leaving just the flue with the 'copper' (bottom right) and small heated chamber below.

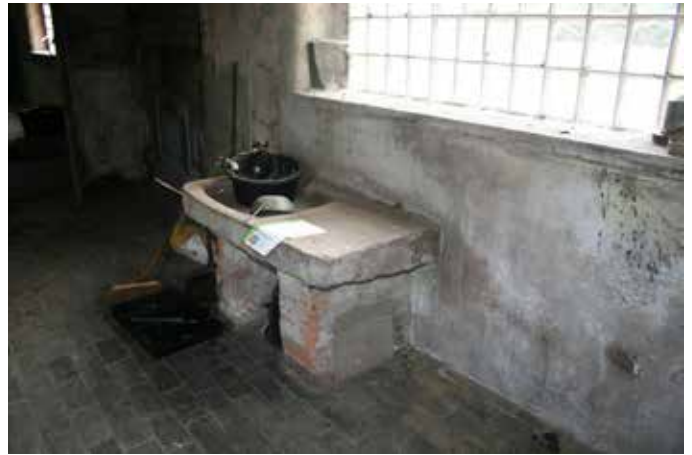
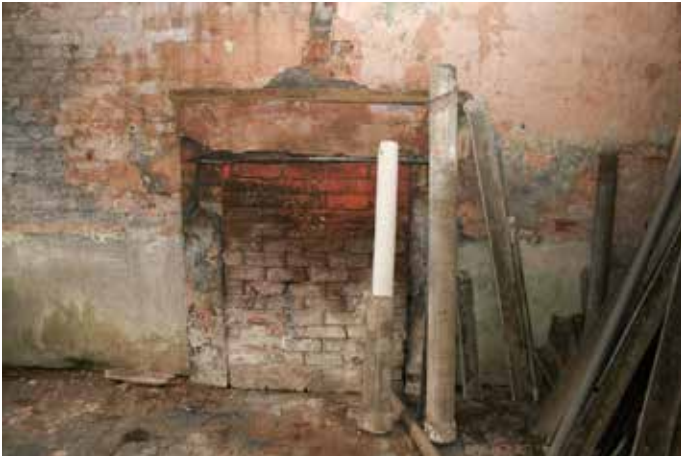
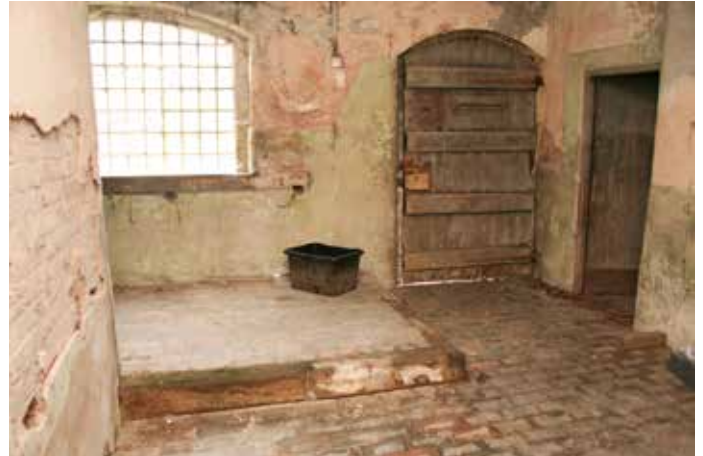
### **Western Stableblock (Ground Floor)**

The western bays of the stables were also adapted into ancillary domestic uses and a second flue and hearth was added to the end wall (the flue has since collapsed). The fireplace was made up of bricks, with a cement-rendered finish, of very low interest. This area may have had a function such as a dairy, which may be the reason for the change in floor level, but the use is unclear.
