ARBORICULTURAL SURVEY
ST. JOHN'S SCHOOL, WETLEY ROCKS,
STAFFORDSHIRE

A Report to Mr Worthington

Report Number: RT-MME-109232-01

March 2011

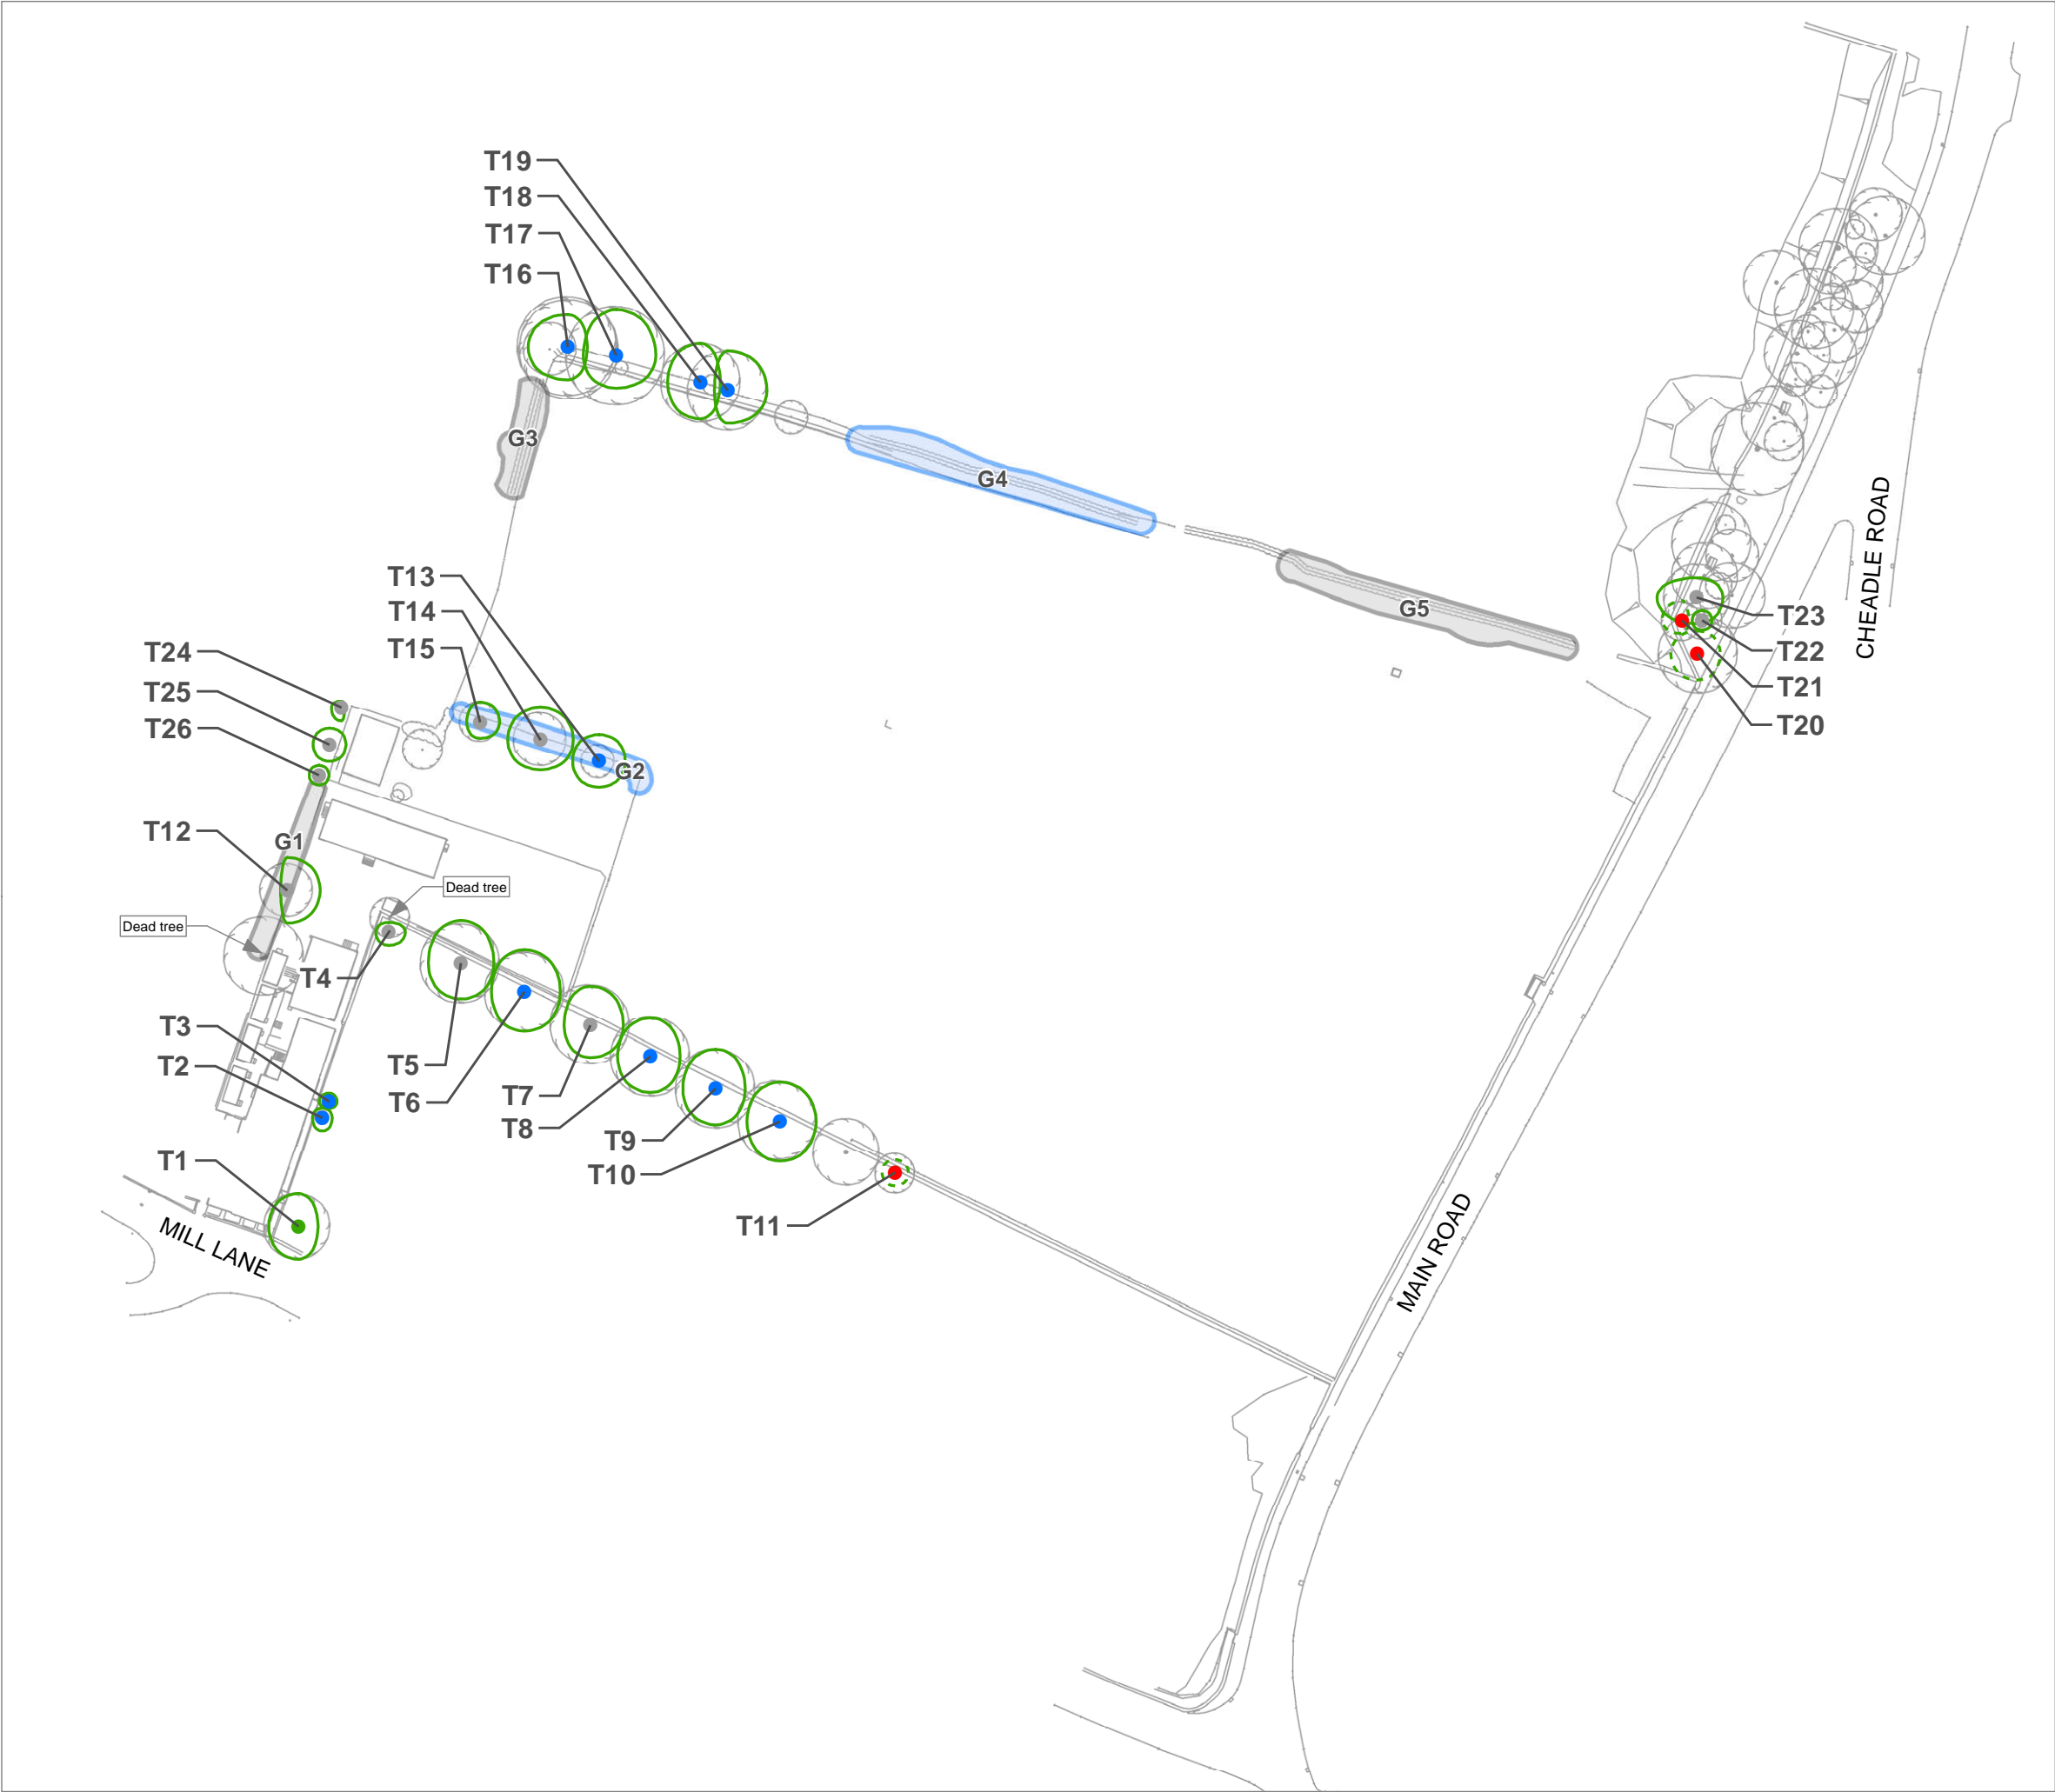
Middlemarch Environmental Ltd Drawing C109232-01-01

The location of the trees surveyed can be found on Middlemarch Environmental Ltd Drawing Number C109232-01-01 in Appendix 1.
