**Building Fabric Condition Assessment**

**PLANNING APPLICATION FOR THE CONVERSION OF A REDUNDANT  
GROUND FLOOR SHOP/RETAIL PREMISES (AND BASEMENT) CURRENTLY  
CLASS A2, FINANCIAL AND PROFESSIONAL SERVICES AT 1 CLERK BANK,  
LEEK ST13 5HE, INTO A RESIDENTIAL DWELLING**

**DECEMBER 2015**

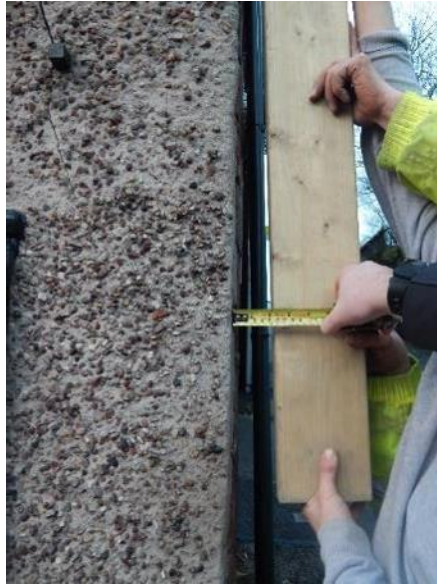
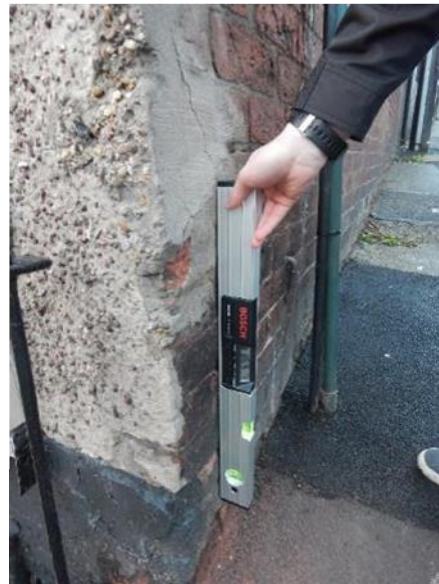
- 5.1** The front right hand corner of the building is bowing out approximately 50mm wider around the area of the ground floor window lintel (shop signage), making the wall lean approximately 3 degrees off plumb at the base

Building regulation would require a minimum of 665mm of brickwork on a corner to the side of a door or window to ensure stability of the corner, unless a steel column is incorporated within the wall, or similar. The slender corner has allowed the wall at right hand (as viewed from the front) to bow out under the load from above. To counteract the effect of weight of the walls, etc from above onto the steel beam(s) which tend to naturally press down and outwards in a sort of pyramid fashion, which is resulting in the slender walls being pushed out. It is proposed to build up the masonry to the side of the window to increase the width of the masonry return by approximately 375mm . equivalent to 1 ½ brick lengths (of those in the building) using engineering bricks, or concrete blockwork laid flat to provide additional support to the steel beams above, and tied into the existing brick structure using stainless steel crocodile ties. The existing brick corners at the side of the window, currently exhibiting cracks in the pebble dash render are to be tied/stitched together to prevent any further movement, before building the additional masonry, to tie the front of the building together at ground and lower half of the first floor, where the walls have bowed. The corners to be stitched using stainless steel helical bars inserted into holes drilled across the corner of the masonry (pebble dashed render removed to facilitate and to cover over following installation of metal stitching). A series of holes at every 4<sup>th</sup> brick course, through the bricks to be drilled at approx. 45 degrees off centre through the corner of the masonry from the front wall diagonally into the side wall, deep enough to penetrate into the outer leaf, but not too deep to protrude through the other side. Helical stainless steel rods to be pushed into the holes into the holes packed with chemical resin grout to bond the brickwork and tie the corner of the building together to prevent further movement.

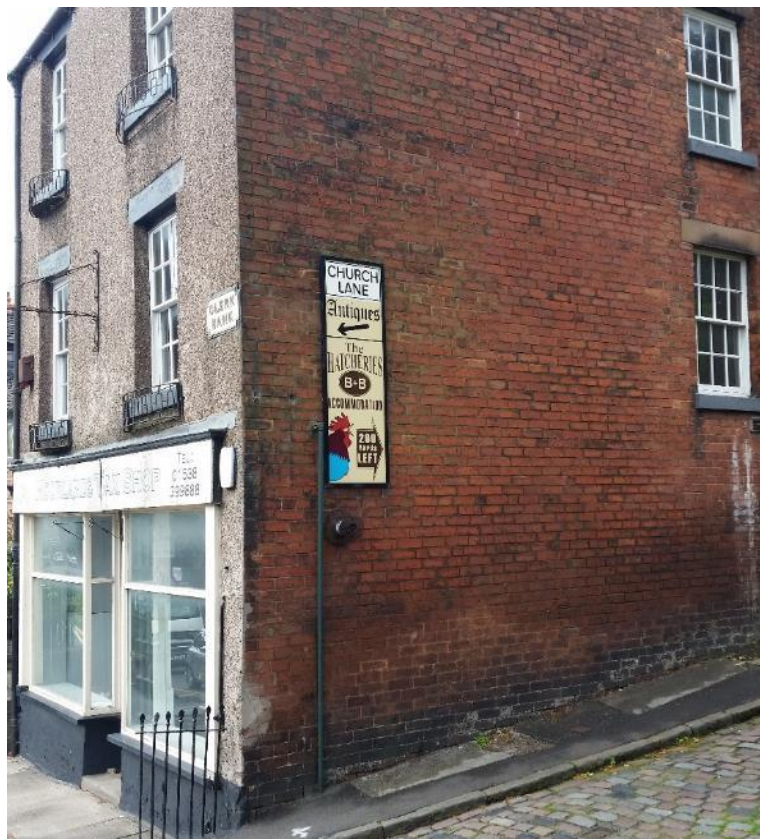
- 5.2** The sides and rear of the building are brick faced, 9inch solid walls, there doesn't appear to be a particular pattern or regular bond to the brickwork, which is largely stretcher bond, with random courses having a header between the stretcher bricks, and then 5 or 6 courses without a header, and a course with a random header amongst the stretchers. The image below highlights the curve in the wall centred around the signage line.

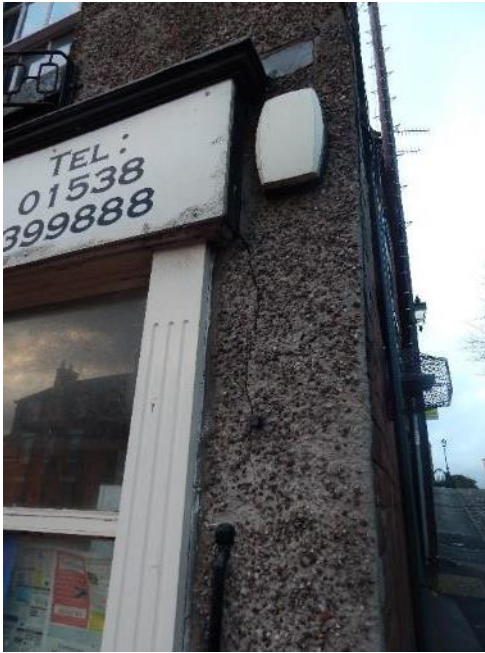
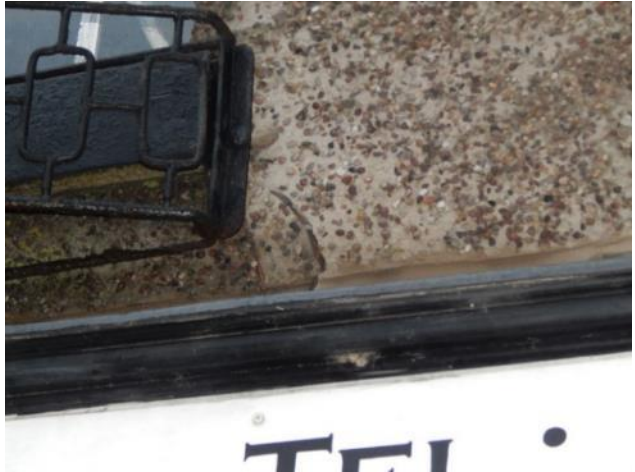
**5.3** The front of the building has been pebbled dashed rendered so defects in the brickwork are difficult to observe, however there is a crack in the render in the area of the signboard. At the time of the inspection it is difficult to determine whether the crack is superficial and pertains to the render only, or is a defect with the brick substrate below.

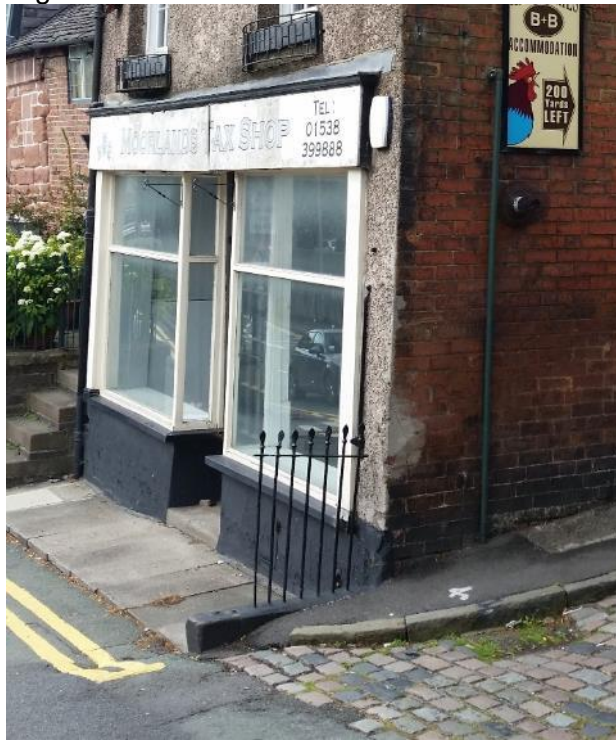
- 5.4** The front of the property has a row of concrete slabs approx. 450mm x 600mm beneath which is a void approx. 1.8m deep similar to the lightwells once common on pavements, generally fitted with a metal grille or thick glass blocks set in a cast iron frame.

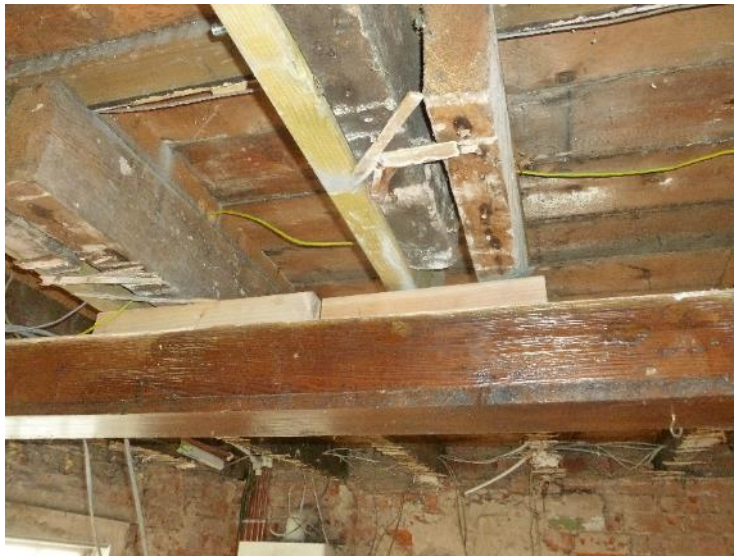
- 6.1** The building is four storey in height to include the basement. The first and second floor were fitted out for a flat with kitchen and lounge on the first floor, with two bedrooms and a bathroom on the top floor. The floors in the upper floors were undulating and sprung quite heavily. When the floor boards were stripped back it was found the floor joists to be bordering on adequate size for the spans, in some instances the joists were cut too short to span onto the structure they were designed to take support from. The joists had bowed to the extent the floor boards had been levelled with tapered timber packers on the top of the joists. The image below shows the original joist falling short of the support beam. A new joist has been partnered to the side during the current works to provide support to the floor.

- 8.3** The defective first floor structure to be stripped out. A new floor structure to be installed tying the front and rear walls shall prevent any movement, providing lateral restraint to the structure at first floor level. A pair of steel beams to be installed at equal third positions, spanning left to right across the building to provide support to new floor joists spanning from front to rear (sizes to suit the span). The steel beam at the front of the building,

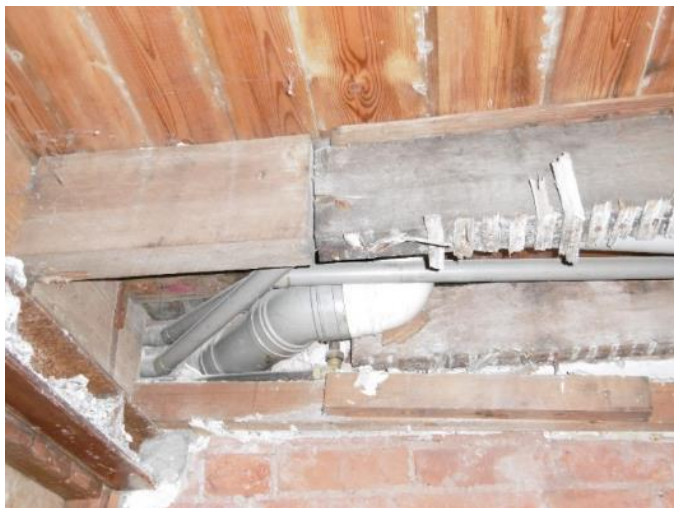
- 6.2** The image below shows a length of floor joist abutting another length of floor joist with no means of mechanical fix between the two timbers. The joist on the right is effectively cantilevered from the pocket in the external wall approximately 2.0m long. The joist in the background has also been cut short to allow the soil pipe to pass through the wall, and has been left with a short section of timber nailed to another batten fixed to the wall to take support from.

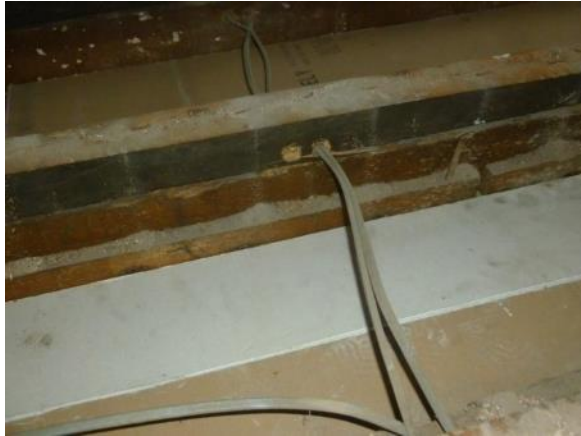
The image below indicated the build up of the first floor structure, the undersized joists have been packed and partnered over past years, holes and notches have been made for electrical and plumbing installation further weakening the structure, joints and joist connections have been poorly carried out, the historic springing/sagging of the floor has resulted in the joists being close to springing out of the seating/support, which allow sections of floor to fall.

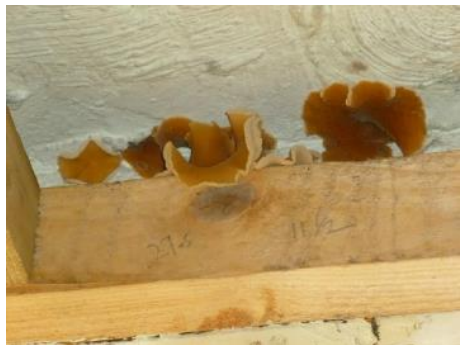
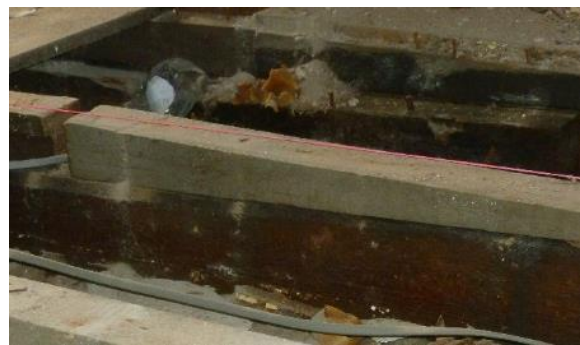
- 6.3** There are visible signs of what appears to be dry rot fruiting bodies within the floor joists, both the earlier beams and later new timbers.

- 8.6** All timbers within the building (new and existing) to be coated with proprietary timber treatment to prevent against rot. Existing walls to be sterilised with proprietary water based treated to eliminate any dry rot mycelia and prevent any further growth.

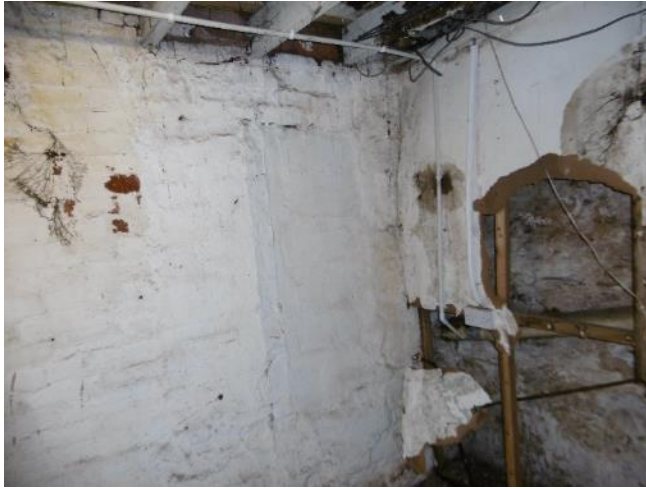
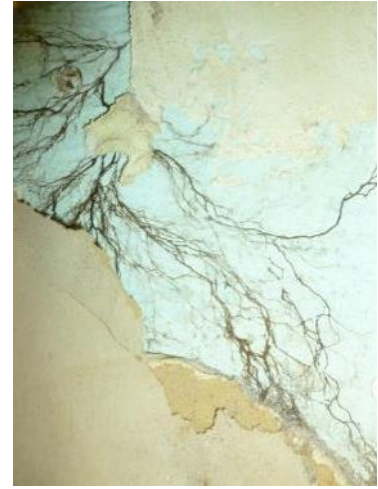
- 6.5** The image below is the basement area, the walls had been lined with a compressed woodfibre (hardboard) type product, behind which the walls have been damp and there are signs of what appears to be dry rot mycelium, there were signs of cuboidal decay in some timbers.

- 8.7** The habitable space proposed in the basement should have mechanical ventilation continually running to provide fresh air and extract the stale air to prevent a build-up of moisture and condensation, which in turn prevents rot recurring.

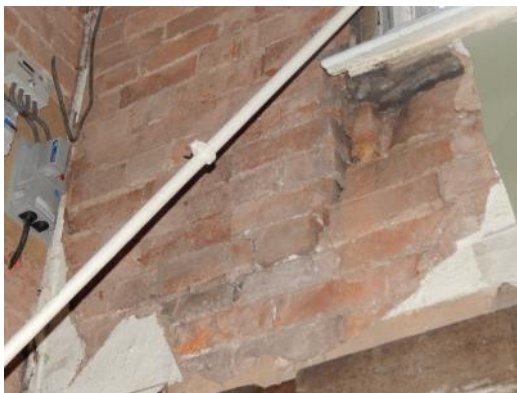
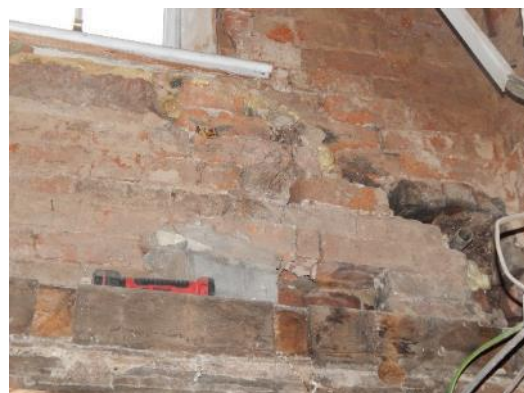
- 6.6** Following removal of the boarding to the ground floor walls around the shop front, to expose the steel beam over the shop front, it was found that the new installed in 2003 was only acting upon the outer leaf of the front wall. The brick walls are generally a 9inch solid wall with random header bricks laid lengthways between the inner and outer leaf to tie the wall together, the inner leaf of the front wall was left supported using a timber beam, which was also taking the load from the part of the first and second floor of the building, and also some of the roof load. The bowing of the timber beam, appears to be allowing the inner brickwork to drop beneath the windows to the first floor and also the stone cills became tilted in the seating. The outer leaf being supported by the steel beam and having the brickwork consolidated with the cement based pebble dashed render was allowing movement within the structure between the two leaves causing cracks in the structure below the cills. The images below are the cracks in the brickwork below the windows on first floor at both corners of the building

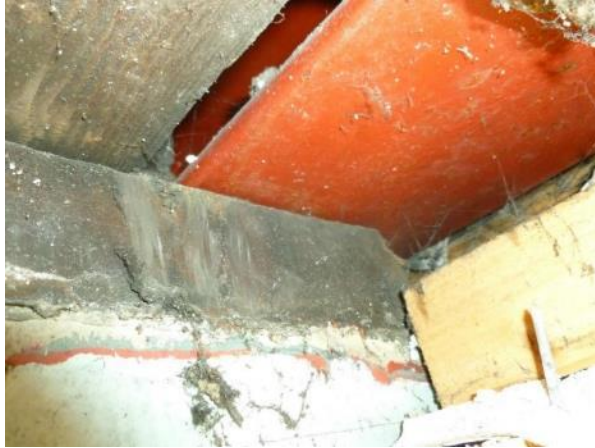
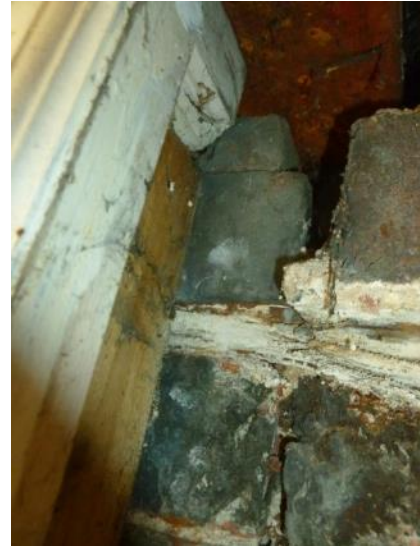
- 6.7** Upon inspection of the existing steel beam above the shop window, it was found that it the beam on one side has been installed bearing on a length of timber, whilst the other end is placed on what appears to be small pieces of engineering bricks placed on a section of timber decaying from rot, the size of the bricks is only providing support to half the width of the beam. The pictures below are of the ends of the steel beam

Whilst the building has undergone some substantial repair work in recent years, it would appear that perhaps more work should have been carried out during that time. The installation of the steel beam over the shop window should have been installed on a solid bearing across the full width of the beam at least.

- 8.1 The defective timber beam providing support to the masonry above the shop window inner leaf. The existing beam providing support to the outer leaf should be re-seated on a suitable bearing structure and the defective timbers beneath the beams (and any found in the wall below, to be carefully stripped out and replaced with brickwork on mortar beds, shimmed with slate packing to ensure the beam is fully supported. The defective brickwork in the inner leaf where the inner timber beam has failed is to be rebuilt using reclaimed brickwork and a lime/sand mortar, allowing the first floor window cills to be levelled.
- 8.2 The front brickwork corners of the building where the shop window jambs occur is very slender with little masonry on the returns (approx. 350mm).

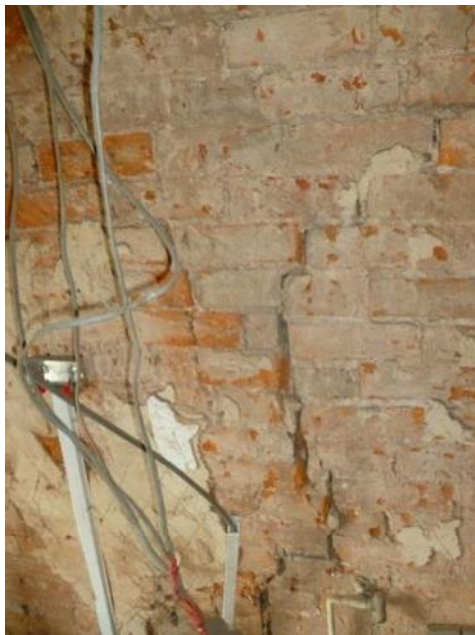
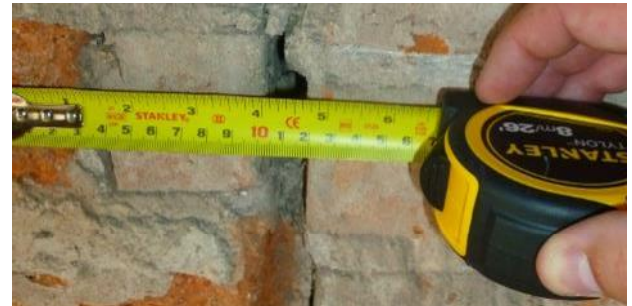
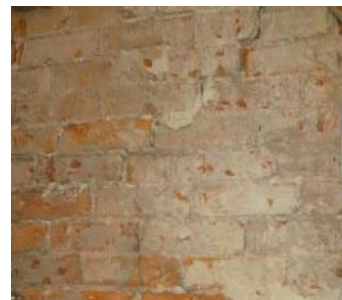
- 6.8** Coinciding almost the with front face of the neighbouring property is a vertical crack in the brickwork approximately 2.0m back from the front wall of the building on the left (as viewed from the front), extending from the internal ground floor level up to almost the underside of the second floor

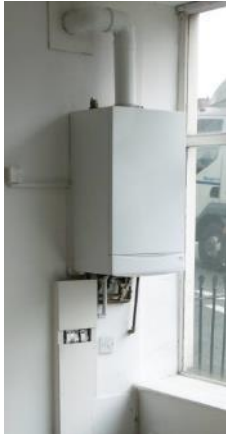
**6.9** The right hand of the shop (as viewed from the front, currently is fitted with a gas central heating boiler, therefore the condition of the brickwork behind hasn't been determined.
