**BUILDING SURVEY**  
**RICKYARD AND BARNs AT BRADLEY LANE**  
**BRADLEY IN THE MOORS ALTON STOKE ON TRENT**

# **BUILDING SURVEY**

## **Rickyard and barns at Bradley Lane Bradley in the Moors Alton Stoke on Trent**

The report has been prepared to accompany an application to Staffordshire Moorlands District Council to convert the buildings into 3 units of living accommodation.

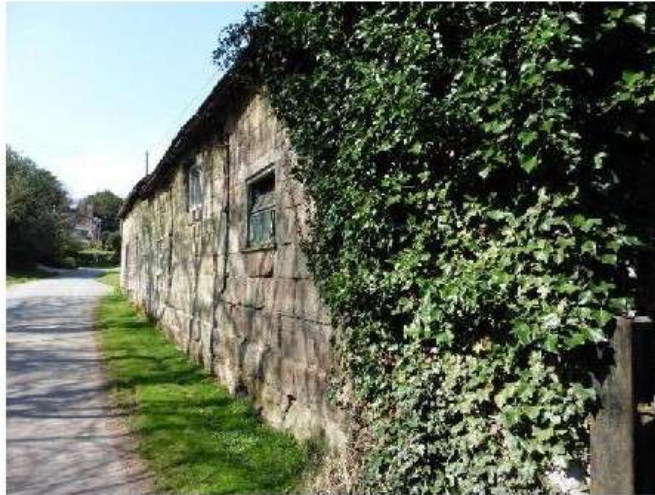
### **Front wall**

Bulge visible at wallplate level

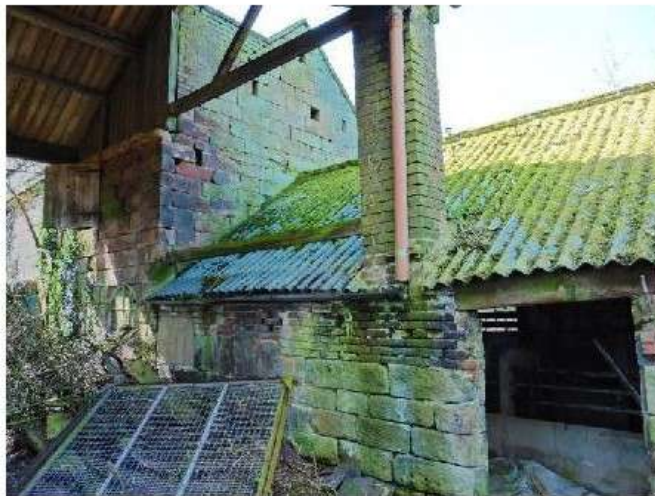
### **Eastern side wall**

This shows the prop for the barn link and defective walling on the single storey section

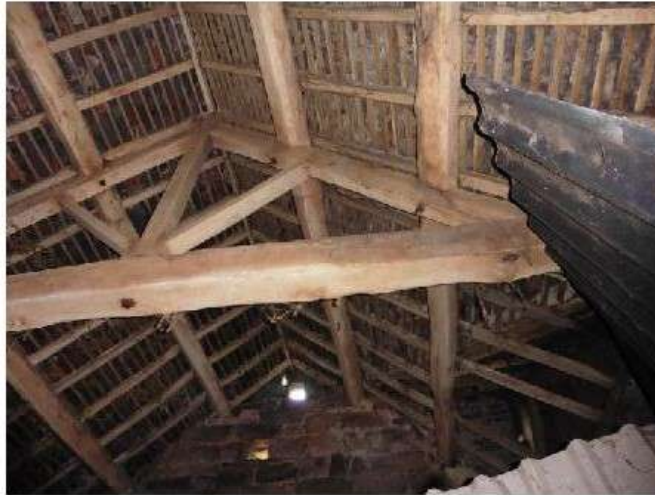
### **King post truss in 2 storey section**

This truss and other timbers can remain but will restrict headroom

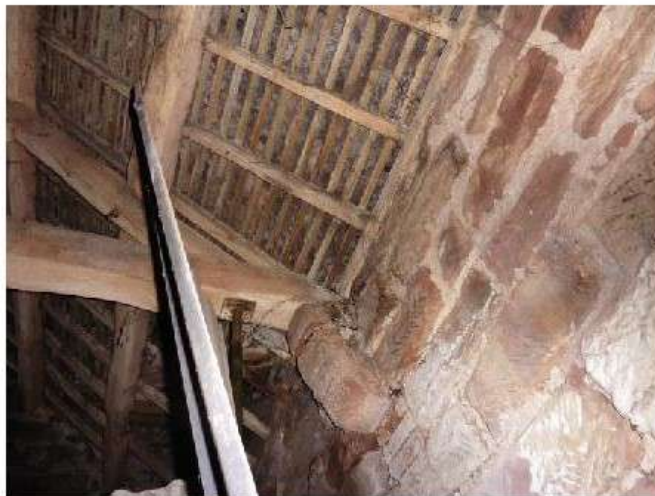
### **King post truss support on Eastern wall**

Examination of external wall surfaces revealed some evidence of movement and localised repairs will be needed in areas where the roof structure has pushed the walling outwards, particularly on the eastern side of section 2. These areas are identified on the plans. Pointing is poor and will need replacement. Photographs showing affected areas are included in the Appendix at the rear of the report.

Walling here has bulged to a significant extent and will need rebuilding

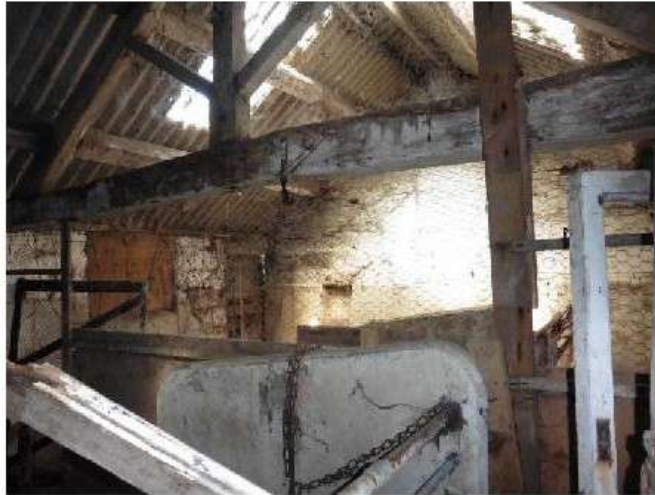
### **Single storey building to rear**

King post trusses can be retained. Roofing otherwise needs replacing.

The roof to the single storey building (numbered 3 on the plan attached at Appendix 2) is at a lower level and is of corrugated asbestos construction. It is supported by a timber framework. This roof will have to be taken off and replaced but the King Post trusses can be retained.

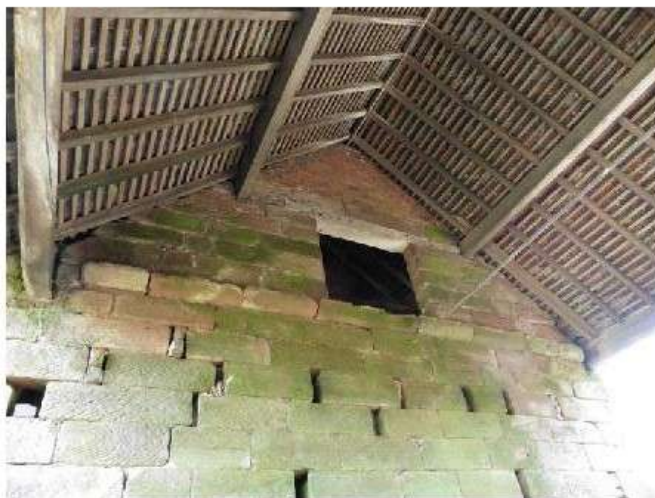
### **Roof to existing access**

Timbers and walling here are in good condition. Roof to be stripped and relaid with new felt and battens.

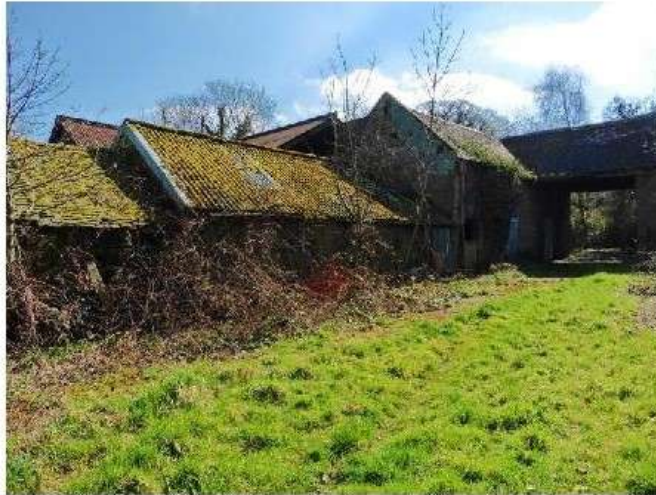
### **General view of Eastern elevation**

This shows corrugated asbestos roofing and rear gable to 2 storey section.

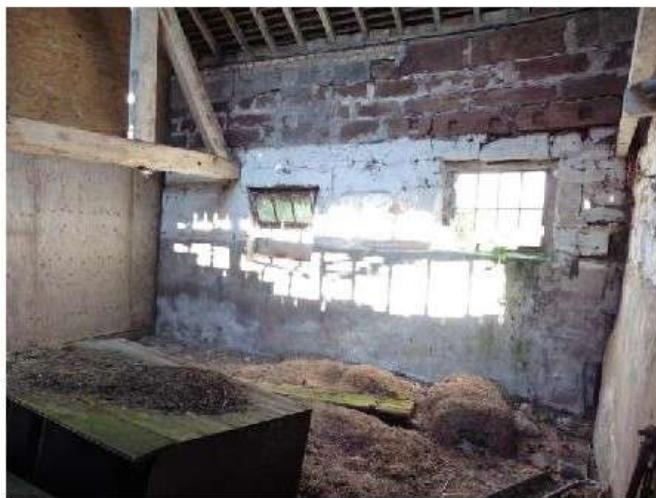
### **Interior of roadside building**

This shows truss with dropped ceiling tie

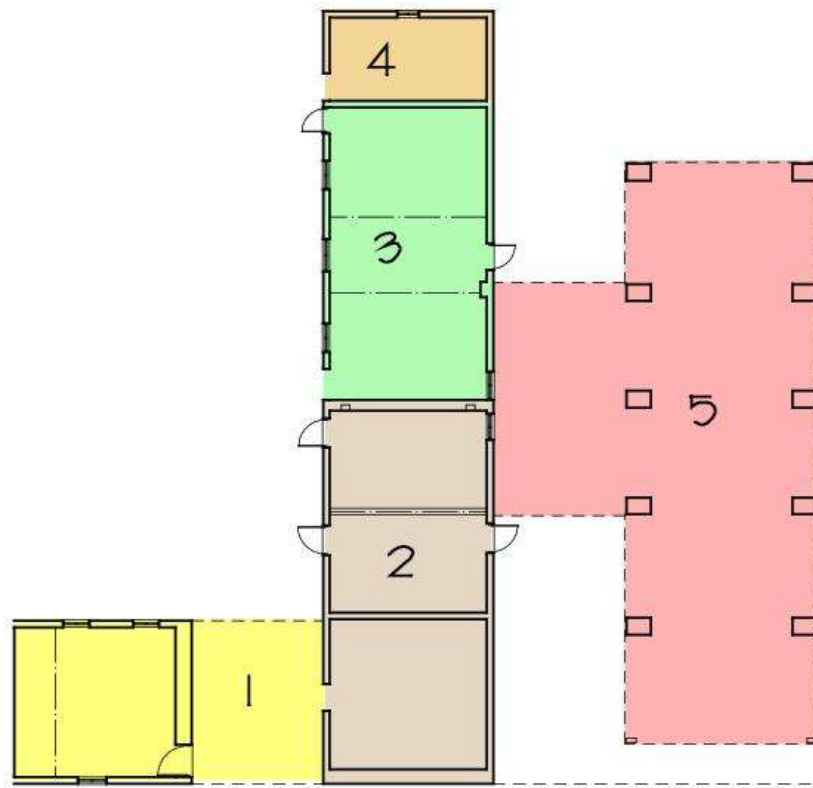
Plan 1-200

Sections 3 and 4 (plan at Appendix 2) are a mixture of solid stonework and brickwork. These sections are in poorer condition and will need more extensive works including probable rebuilding to perhaps half the front and rear walls. These areas are shaded red on the attached plan. The gables should be sufficiently robust to remain intact.
