EAST VIEW - 62 BROOKFIELDS ROAD, IPSTONES - PHOTOGRAPHS

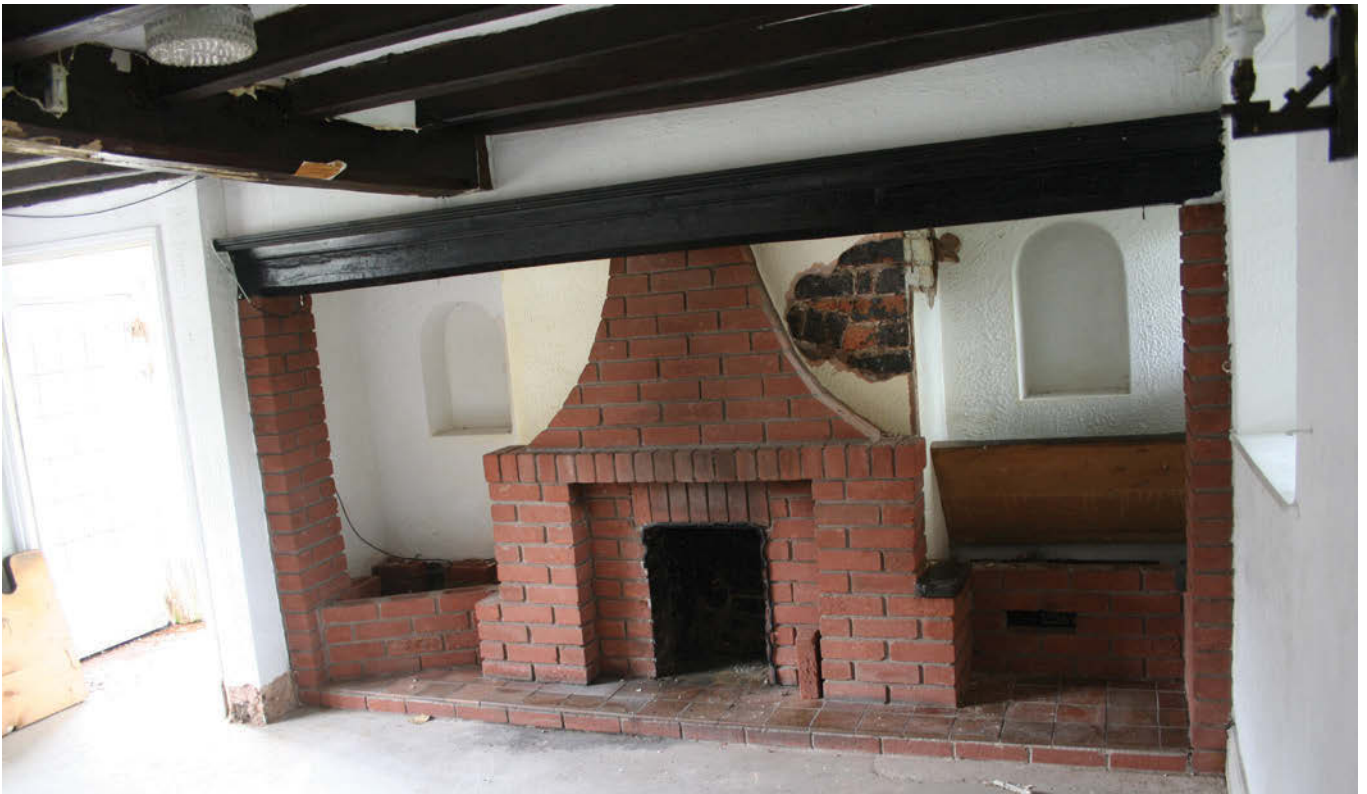
Pl. 1 Firehood to former House Place, with inserted modern brick hearth. This modern brick hearth has been removed by agreement

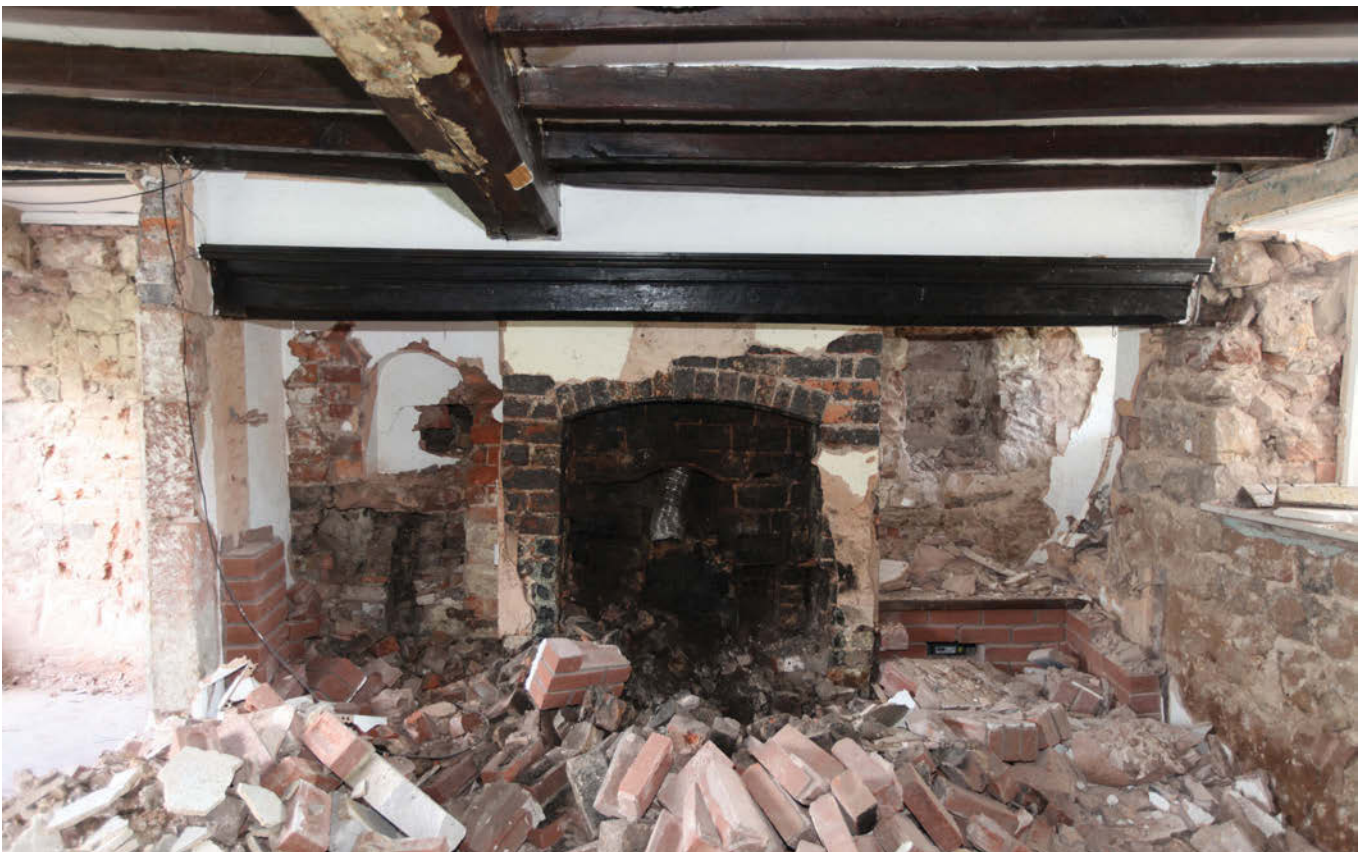
Pl. 2 The firehood after the removal of the modern hearth. The proposal is to retain the opening of the segmental brick arch, make good any small areas of disturbed brickwork, by letting in second hand bricks to match. The square lintel to the salt cupboard will be reinstated and the niche plastered in lime plaster. The flues to the left side of the hearth will be made good by blocking up openings, removing the 'fake niche' in brick and re-plastering in lime to a flat finish. The 19th century brick chimney breast will be painted (not rendered) with compatible water-based paint or limewash. The walls will be plastered in lime and painted in limewash.

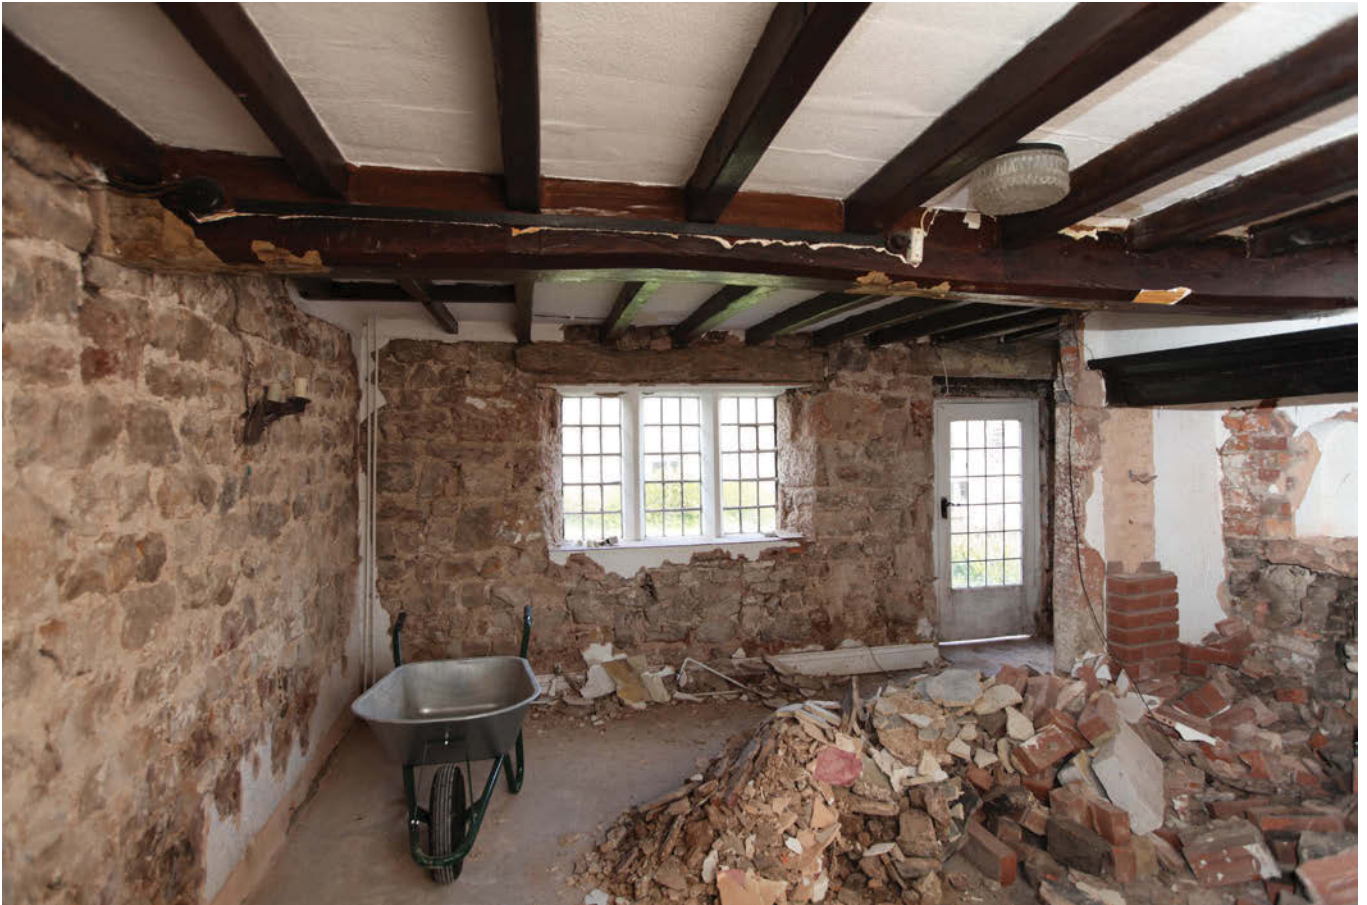
Pl. 3 View of the front wall with concrete and cement render removed. The window cill to the front window will be reinstated to its original level and the walls will be re-plastered in lime plaster.

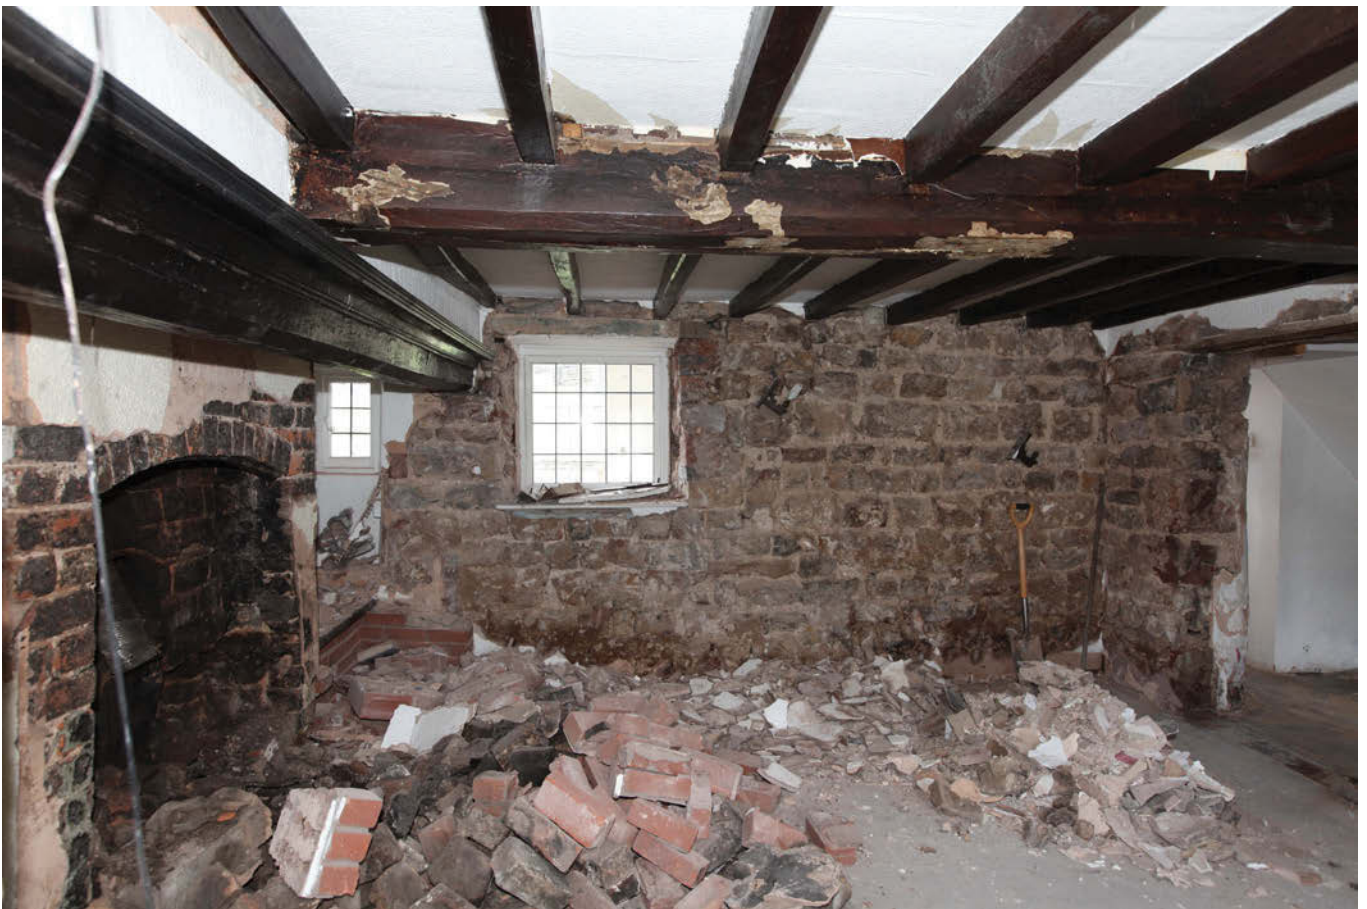
Pl. 4 Back wall to House Place, with fire window and modern leded-light. Artex and gypsum plaster has been removed and the wall is drying out. The proposals involve replacing the rear 'mock-leaded' window with a new pair of side-hung timber casements with single horizontal glazing bar.

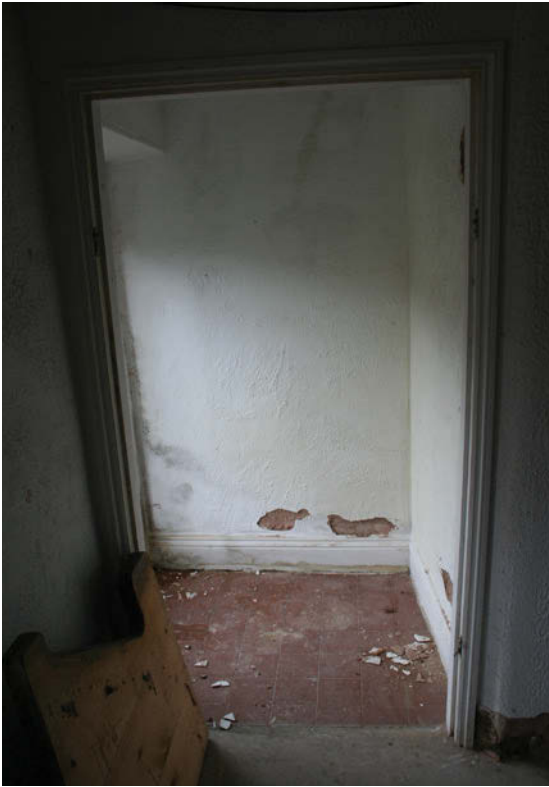
Pl. 5 (above) Artex and gypsum plaster to lobby entrance

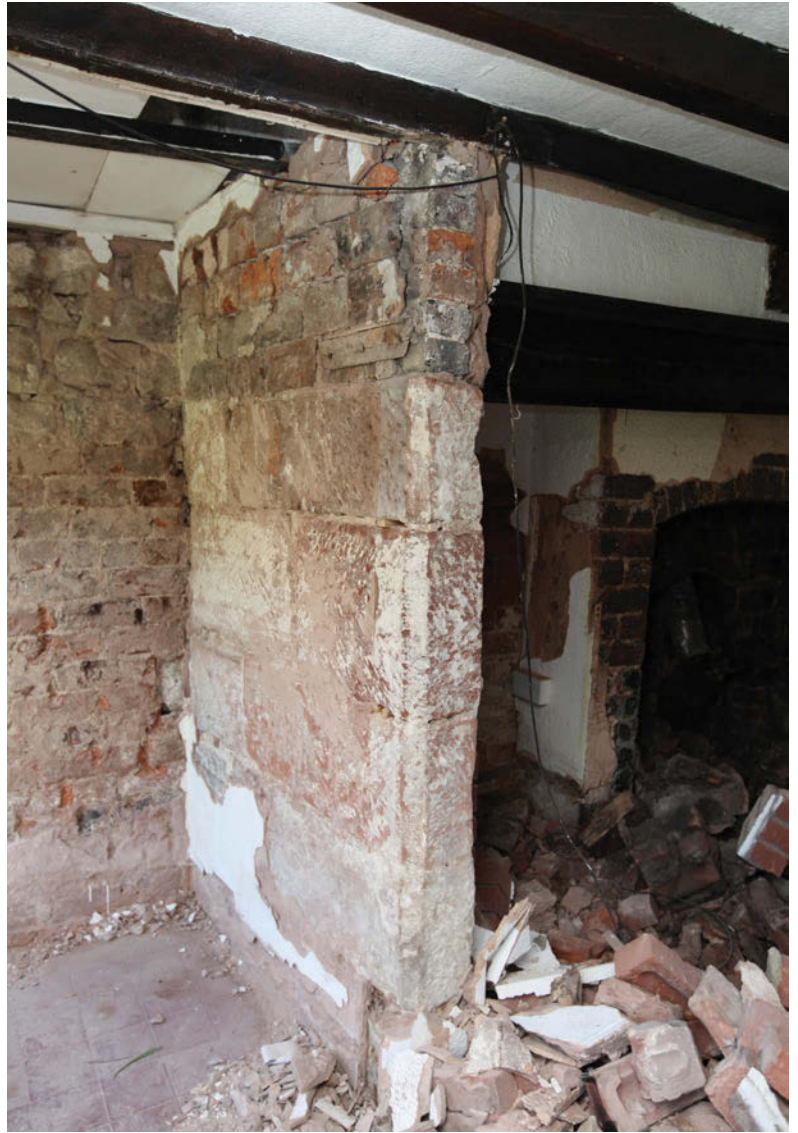
Pl. 6 (right) the Artex and gypsum plaster has been removed to reveal the ashlar heck screen stub wall, with dressed pink gritstone. Brickwork above the screen and along the gable wall of the lobby will be finished in lime plaster but the ashlar will remain visible and simply brushed down.

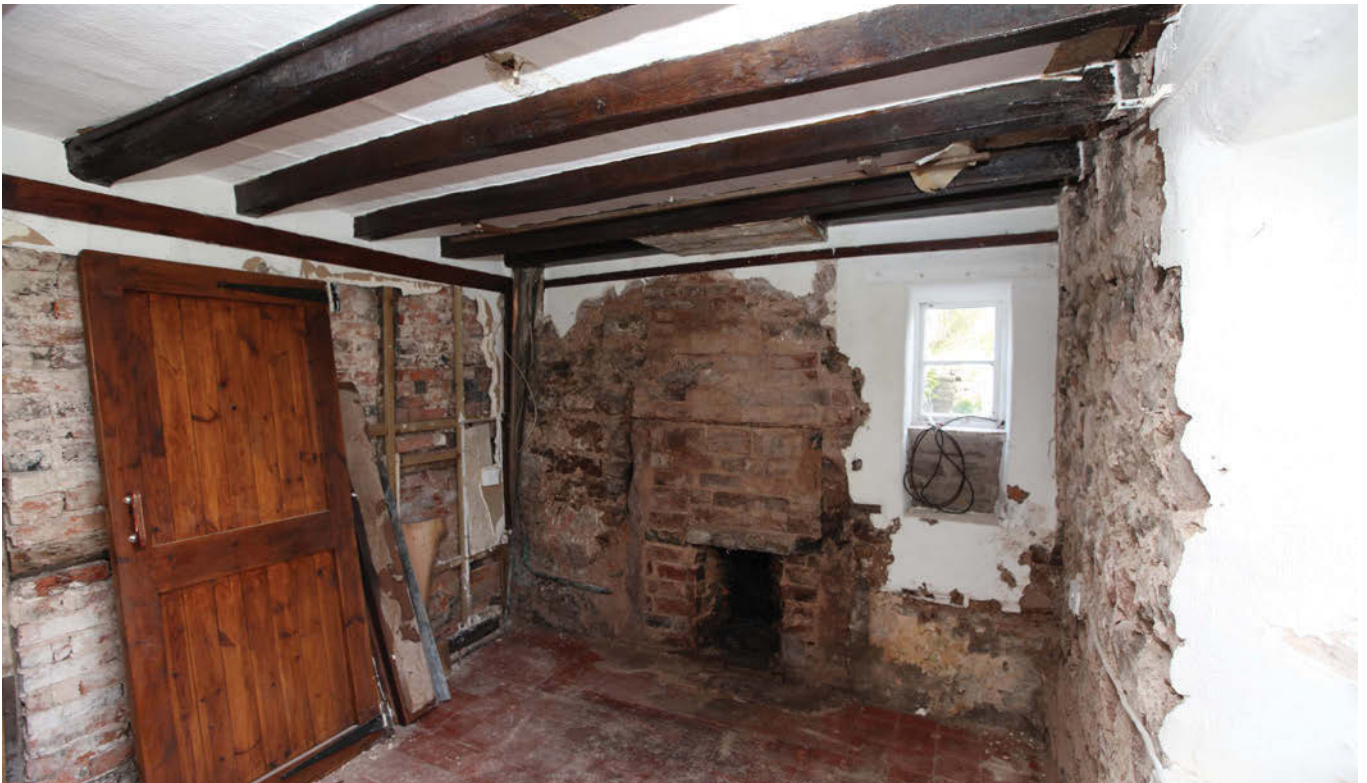
Pl. 7 Detail of parlour wall with blocked up fireplace. The adaptation of this room into a kitchen will require new plumbing, sink waste and services will be located on the fireplace wall. Lime plaster will be reinstated to the fireplace wall and front wall, in combination with kitchen fittings which are slightly off-set from the damp walls.

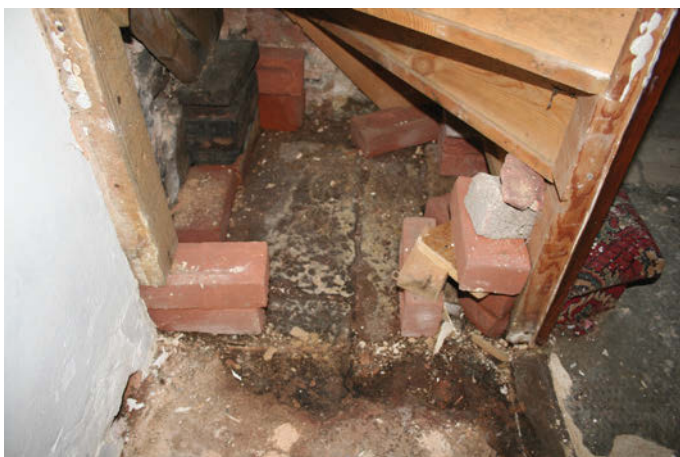
Pl. 9 - below

View underneath existing modern staircase of stone slabs and brick 'propping'.

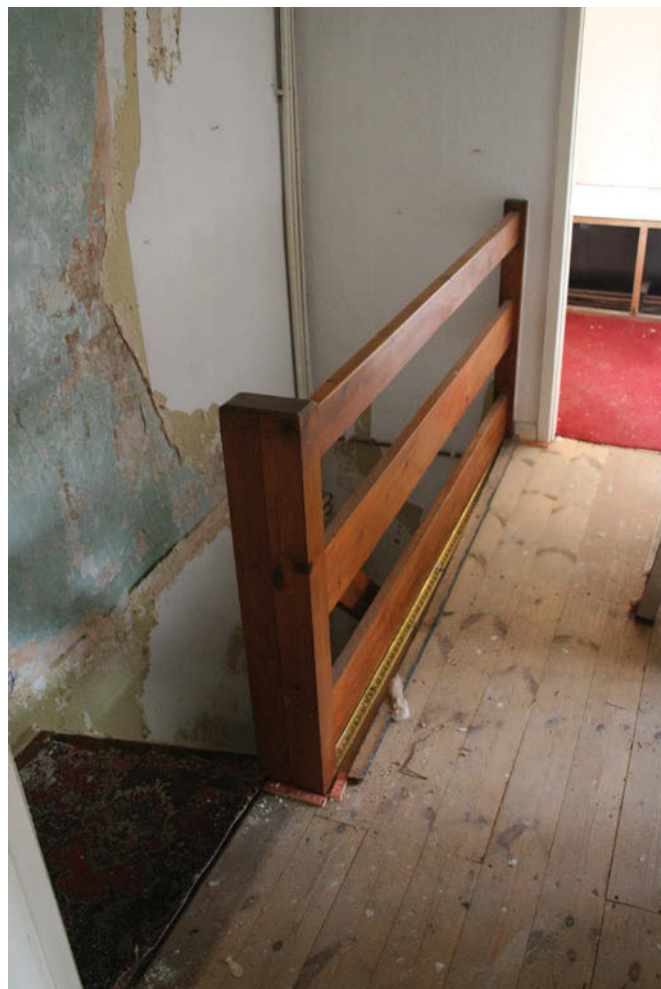
Pl. 8 - right

Modern staircase with modern balustrade at first floor level. The reconstruction of the staircase will provide a new balustrade using a traditional, splat baluster pattern. The staircase window will be opened behind the modern partition and the partition re-aligned to create an enclosed stairwell to the attic floor.

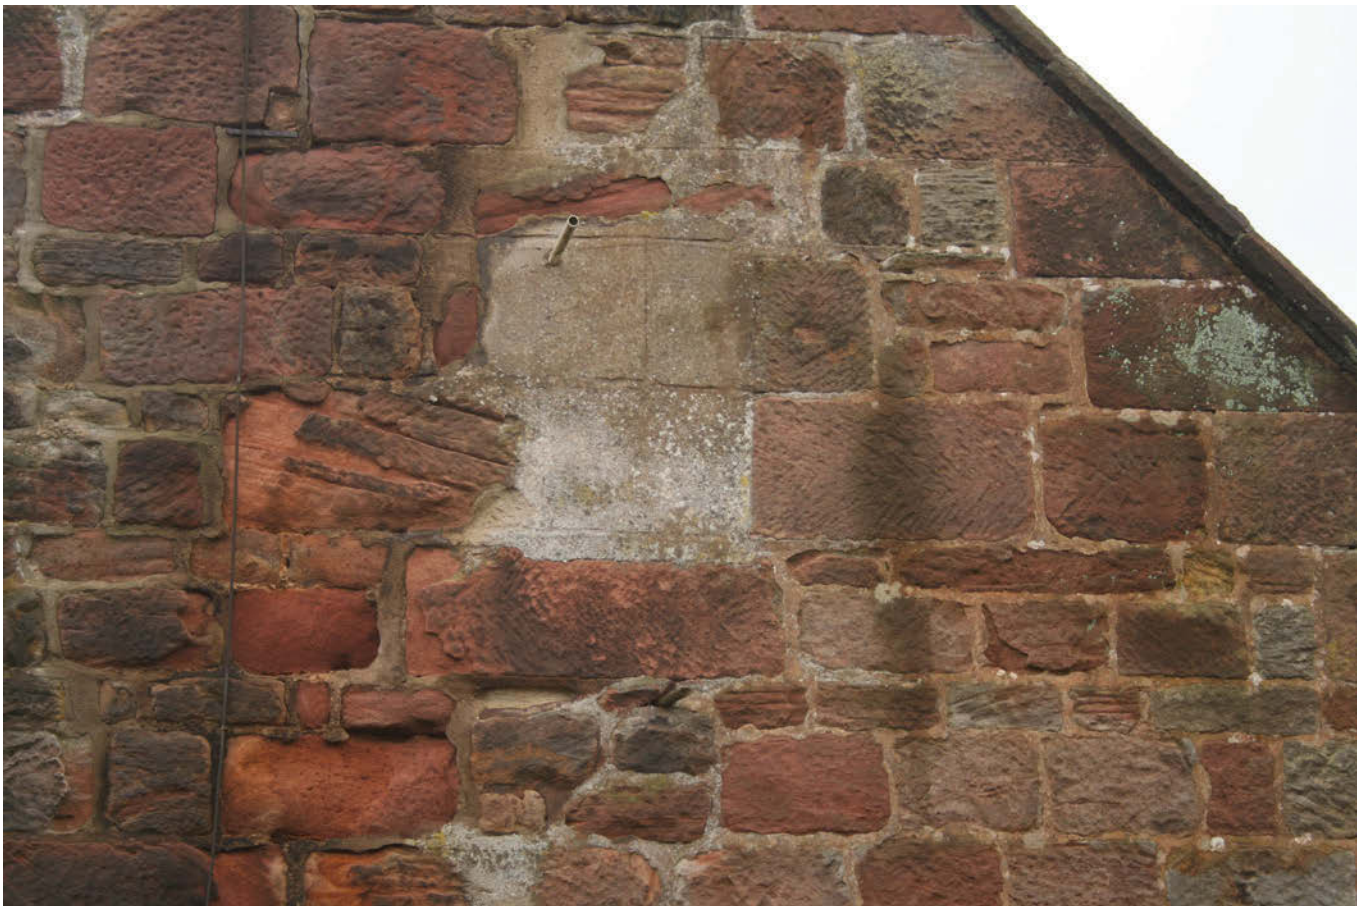
Pl. 10

Detail of northern gable, with areas of heavily-eroded stone. The large patch of render has covered the original chamfered masonry ashlar surround of the leaded-light window. The flush stone cill is still in-situ. A metal casement with leaded lights will be reinstated.

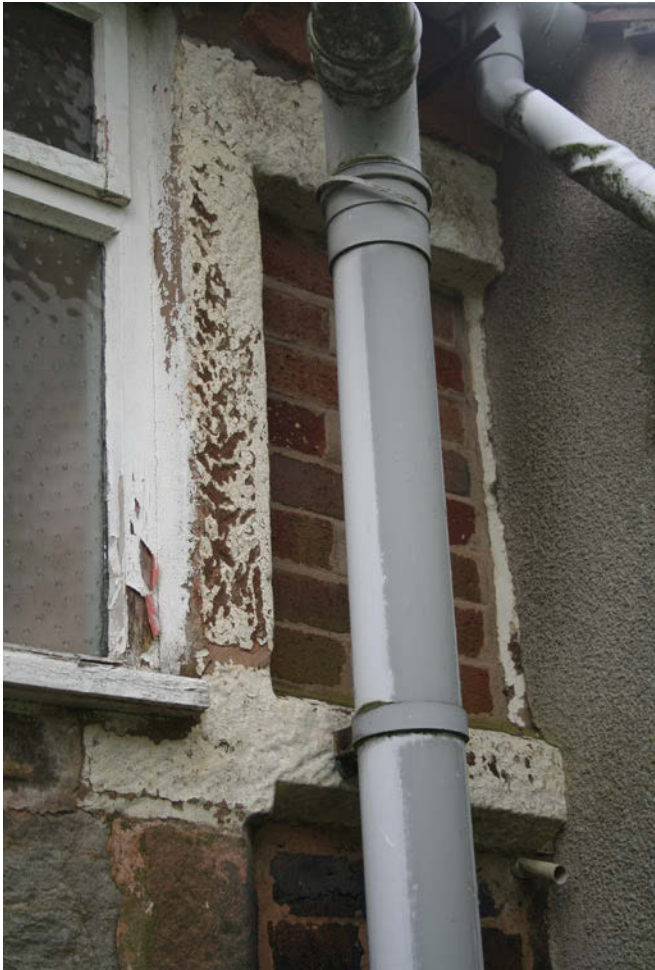
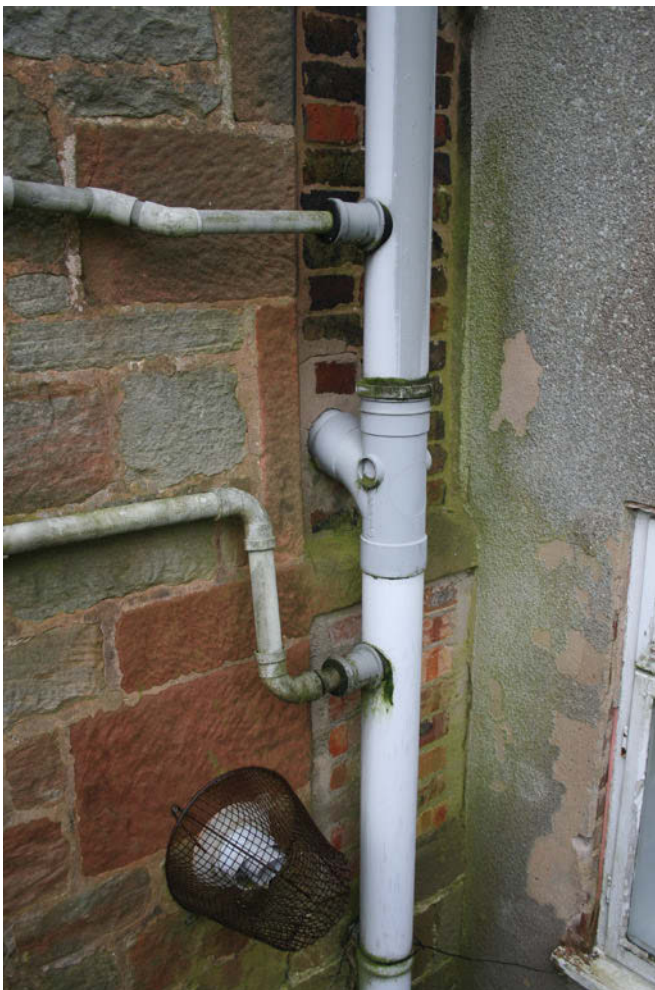
Pl. 11 (left) and Pl. 12 (bottom left)

The soil pipe for the bathroom WC and the waste pipes from the sink waste have damaged the appearance of the rear staircase window. Modern brickwork has been infilled into the former leaded-light openings. The bathroom window sits uncomfortably alongside the staircase window (left). All of these alterations will be removed and the elevation restored to its 18th century appearance; the soil pipe will be relocated inside the building, the bathroom window will be blocked up in pink gritstone ashlar, the boiler vent reduced in size and relocated, and the three-section leaded-light staircase window reinstated.

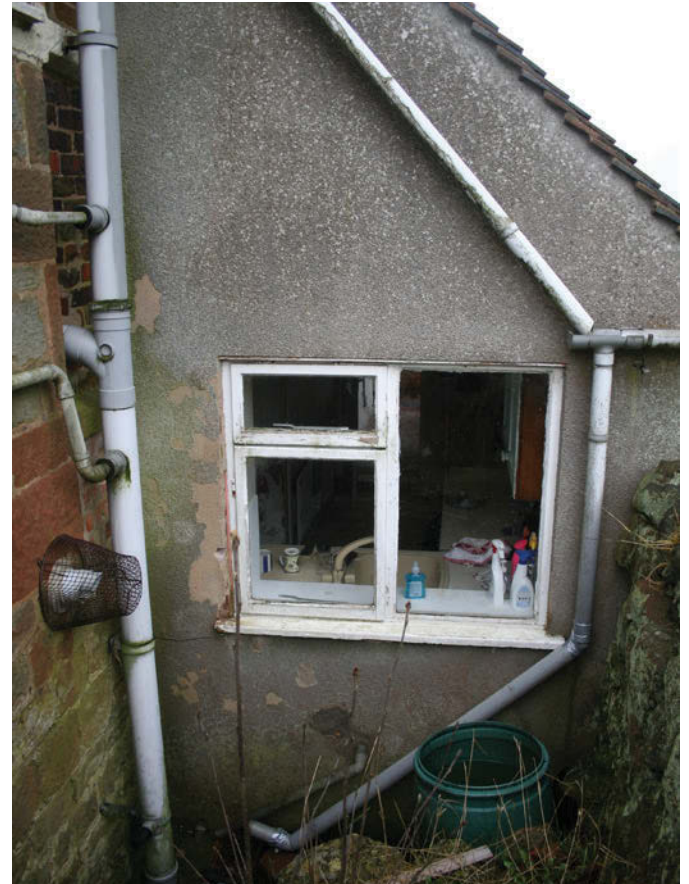
Pl. 13

The existing kitchen window will be reduced in size by a half and will be altered to a side-hung casement, with single horizontal glazing bar. The opening will be built up in blockwork and the render will be made good to match the existing. Rainwater pipes will be rationalised, replaced in cast-iron and will be re-routed into a new gully.

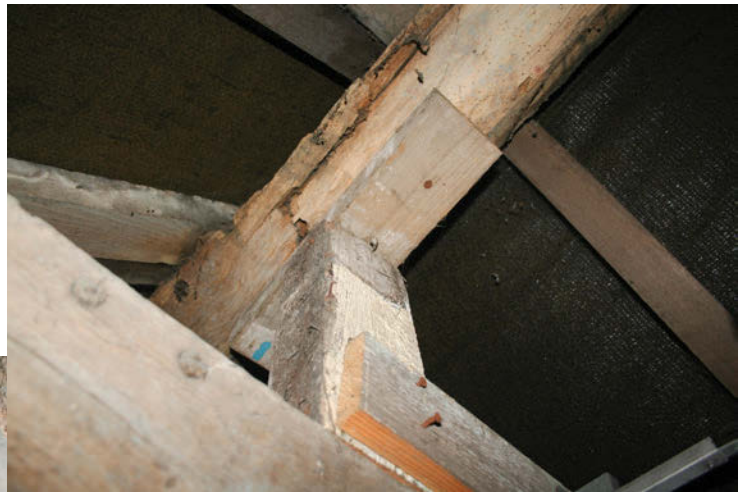
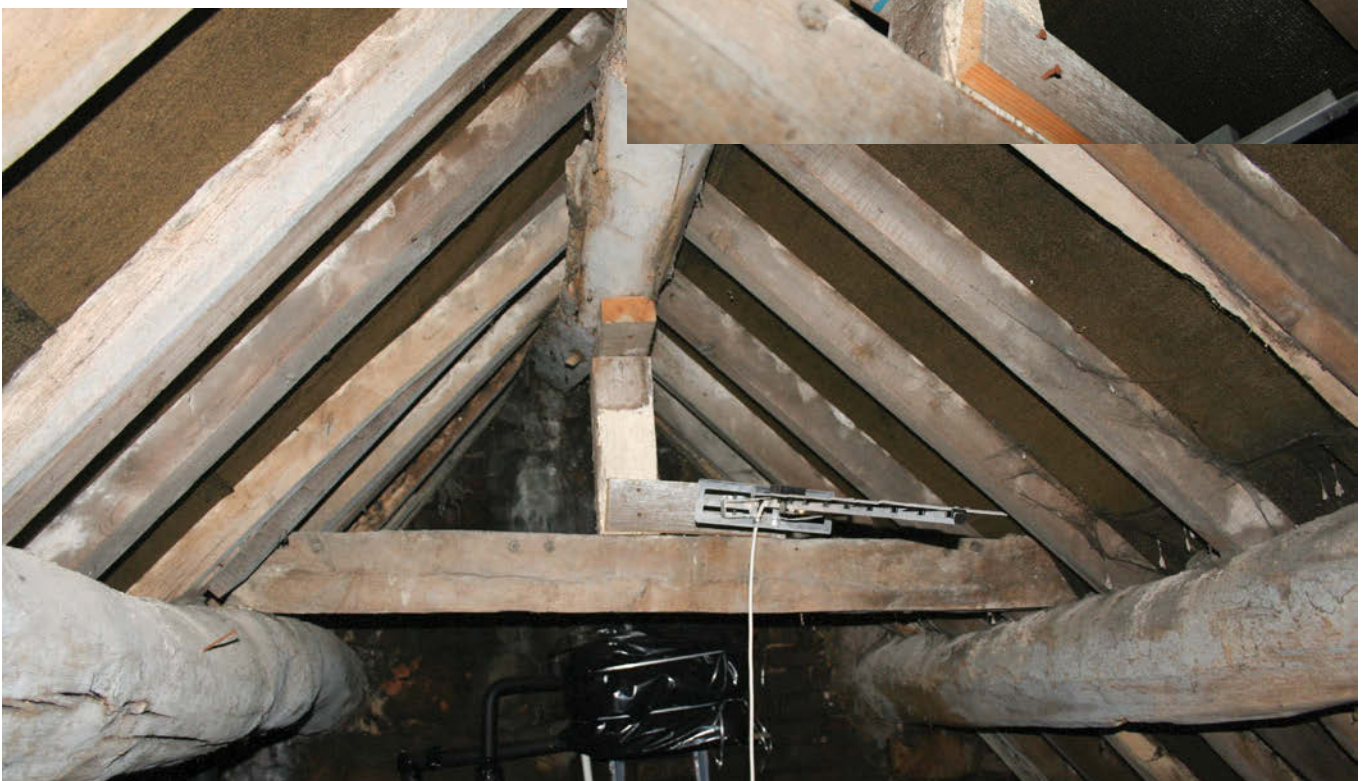
Pl. 15 and 16 (below and right)

Detail of ridge beam repair with inserted collar and strut support to the ridge beam - to be retained in-situ and additional collar struts to be added between rafters at high level to provide ventilation gap and additional structural support (see engineer's recommendations)

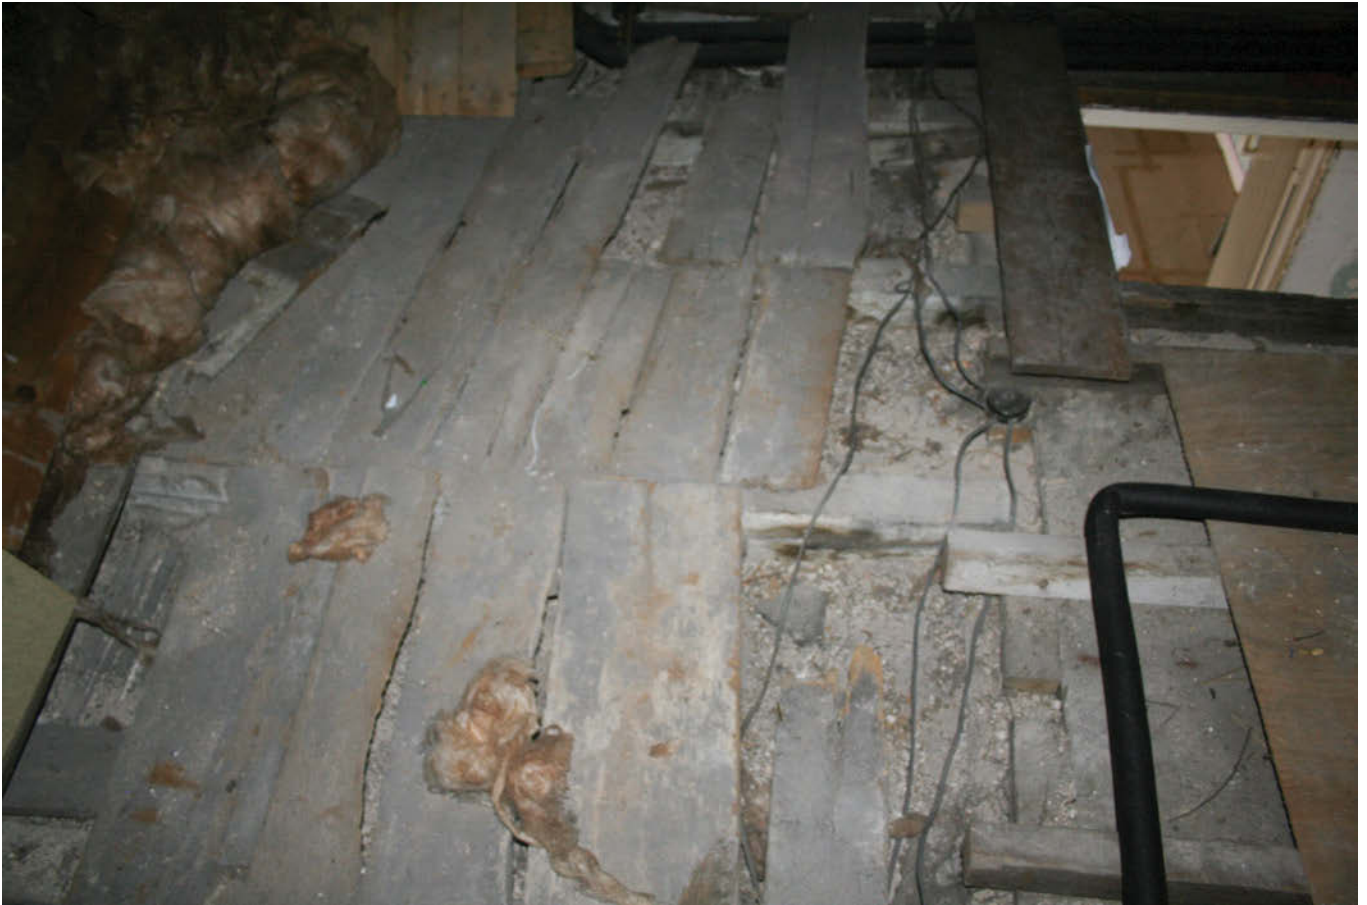
Pl. 17

Detail of original floorboards in attic roof space. The floor boards are too damaged to be retained.

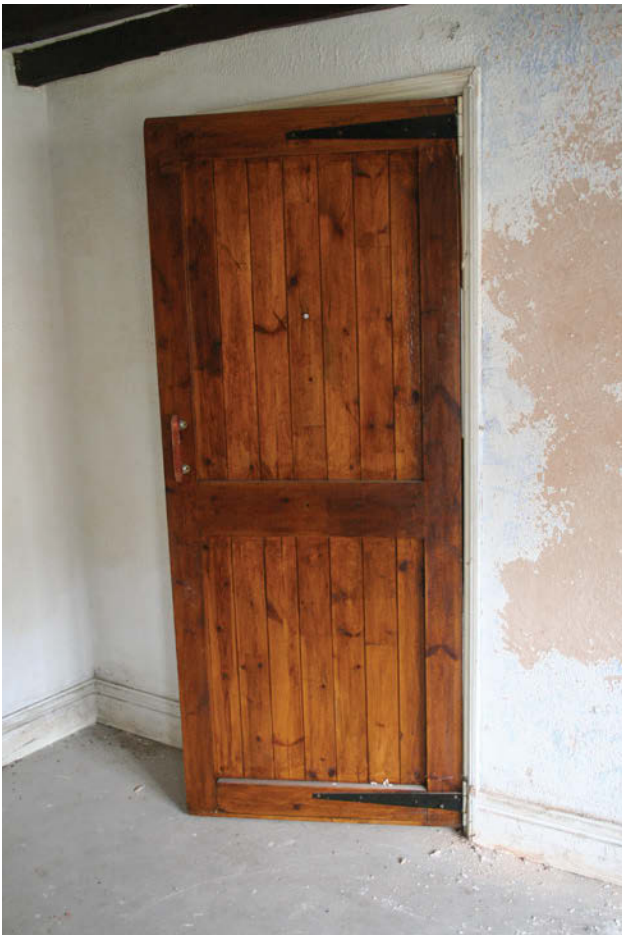
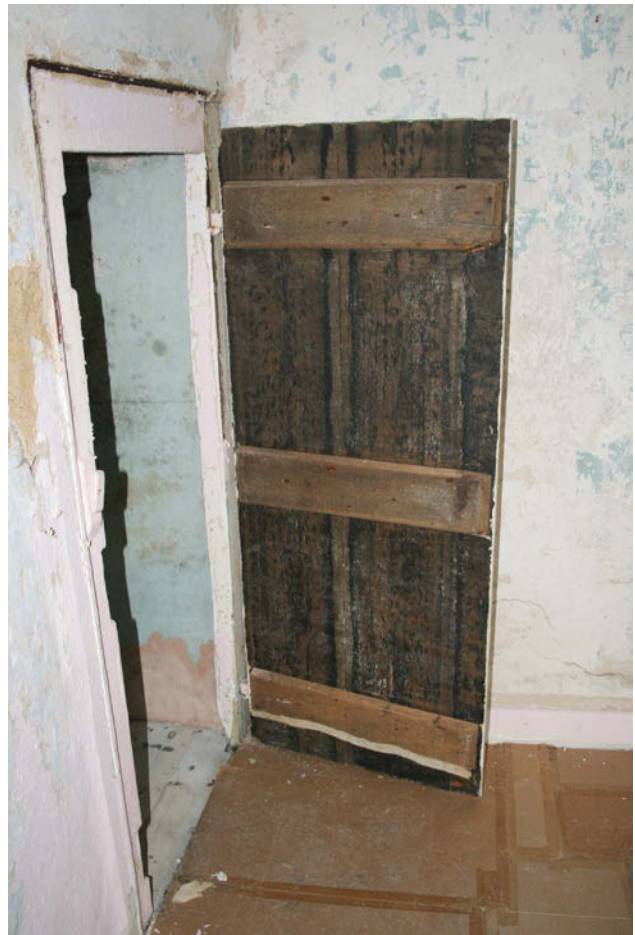
Pl. 18 and Pl. 19

Modern door (left) to living room. All of the doors are 20th century except for the cupboard door to the bedroom - right.
