CHRIS PIKE ASSOCIATES

29th July 2016
REF: PB.904

RE: East View, 62 Brookfields Road, Ipstones, Staffordshire Moorlands.
- **Proposed refurbishment and conversion of attic space**

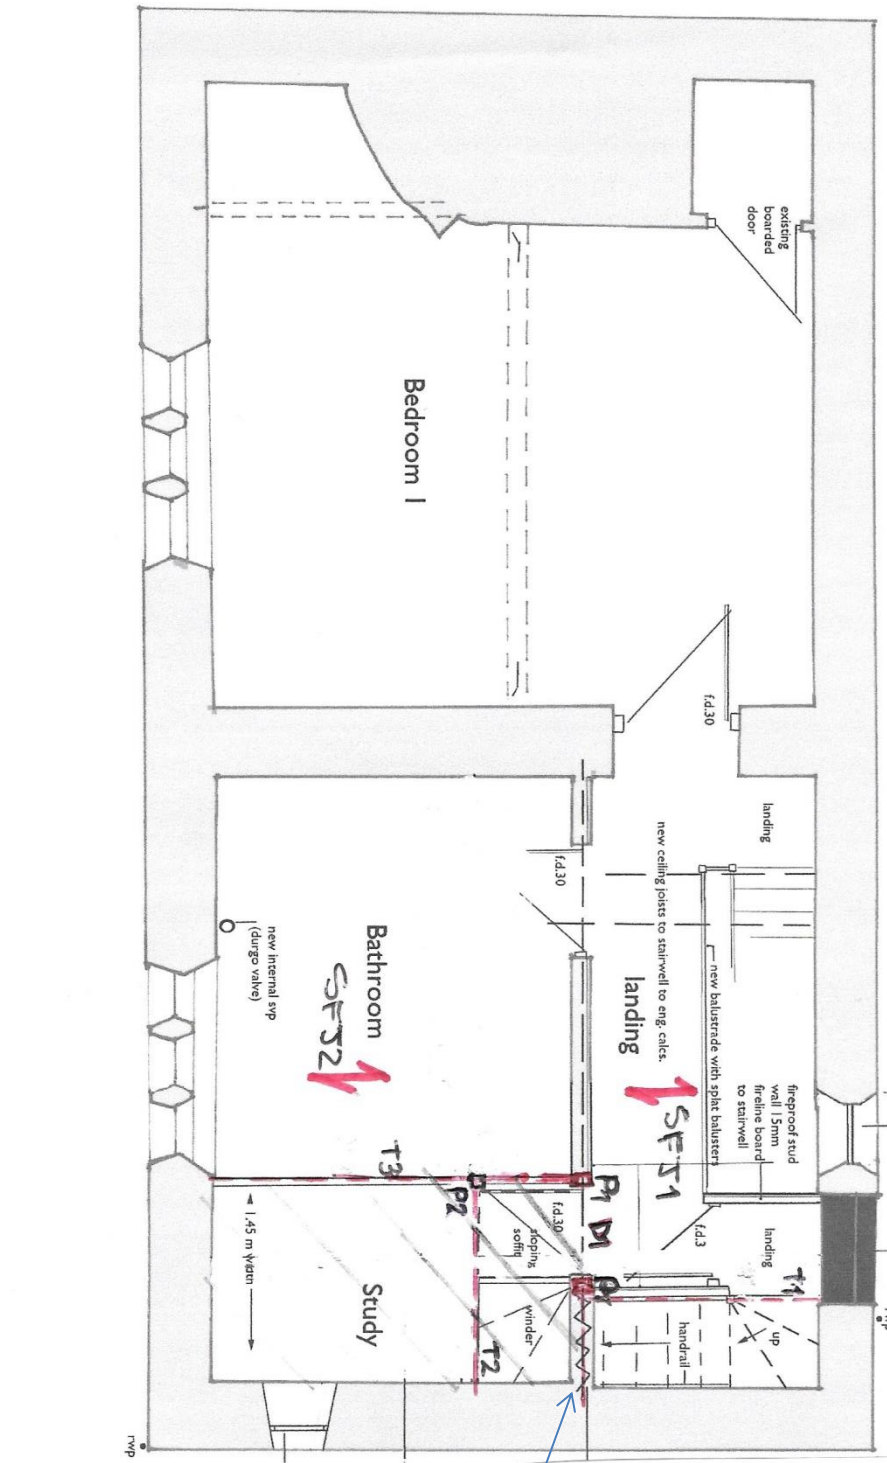
PROPOSED FIRST FLOOR SKETCH PLAN

Existing SFJ1 = 55(w) x 80(d) Oak joists @ 455mm c/c (approx.)

Existing SFJ2 = 115 x 115 Oak joists @ 730mm c/c (approx.) Notched over spine beam by 15mm

Offset Spine Beam = 130(w) x 85(d) at attic floor level

- ix) A new trimmer beam (T3) is needed at first floor level set along the line of the partition walling between the Bathroom and Study. The beam will carry the inner load reaction from the high level trimmer (T2) that acts as the cross trimmer for the upper attic stair flight. A cripple stud post (P2) is to be provided fixed between the two trimmers.

- x) The proposed door opening (D1) into the Study Room at first floor should have a goalpost frame set off the spine wall below. The new hardwood posts (P1), nominally 85 x 100mm section. The inner post needs to be positively connected to the existing spine beam which carries the attic floor above with a face cleat, mortice and tennon joint or half splice connection at the base where the existing mid-level soleplate needs also to be cut to remove the step over. [Photograph 2]

- xi) The new RH post offset the gable wall may then support the attic stair stringer (T1) and mid-level trimmer to the stair corner winder.
- xii) The existing attic floor joists will need to be cut back (or removed entirely) above the proposed Study Room where these conflict with the stair winder and cross stair landing trimmer (T2).

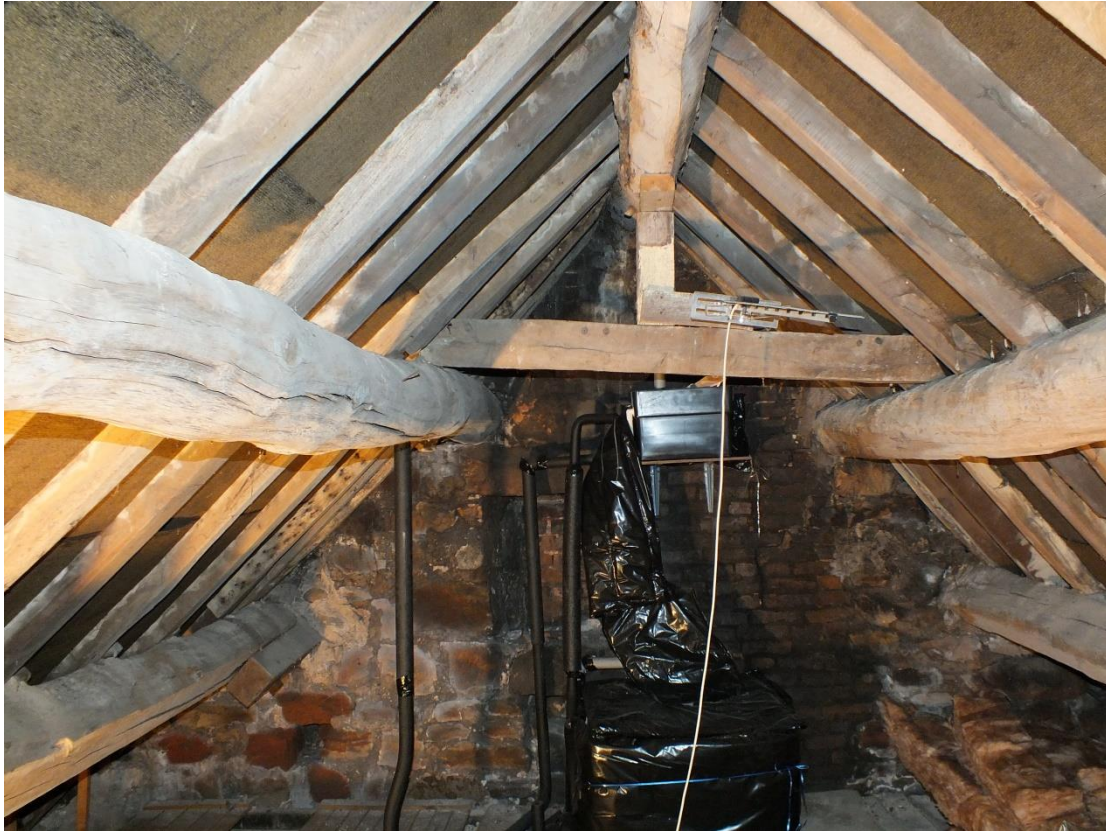
3.

- iii) The timber prop to the ridge purlin member in the RH bay can remain in the existing arrangement but should be provided with a sturdy fixing between the post and crosspiece member using a flat plate or cleat. [Photograph 3]

- iv) Alternatively, the existing crosspiece could be replaced with a smaller section lightweight steel to slightly increase the available headroom on the landing at the top of the proposed attic stairs.

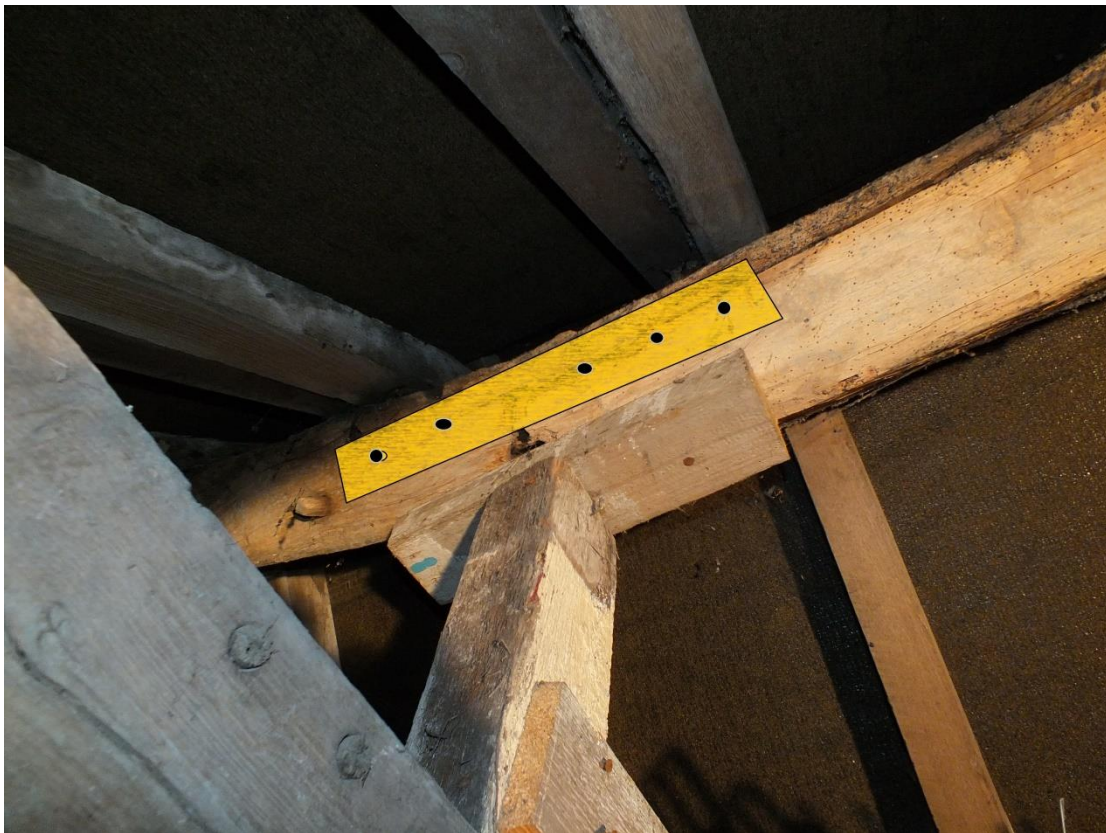
4.

- v) The existing small local split on the ridge purlin above the prop location should be additionally spliced using a steel angle plate, nominally 100 x 100 x 8 fixed into the existing timber using a minimum of 2No. 12mm diameter coach screws on each side of the split. [Photograph 4]

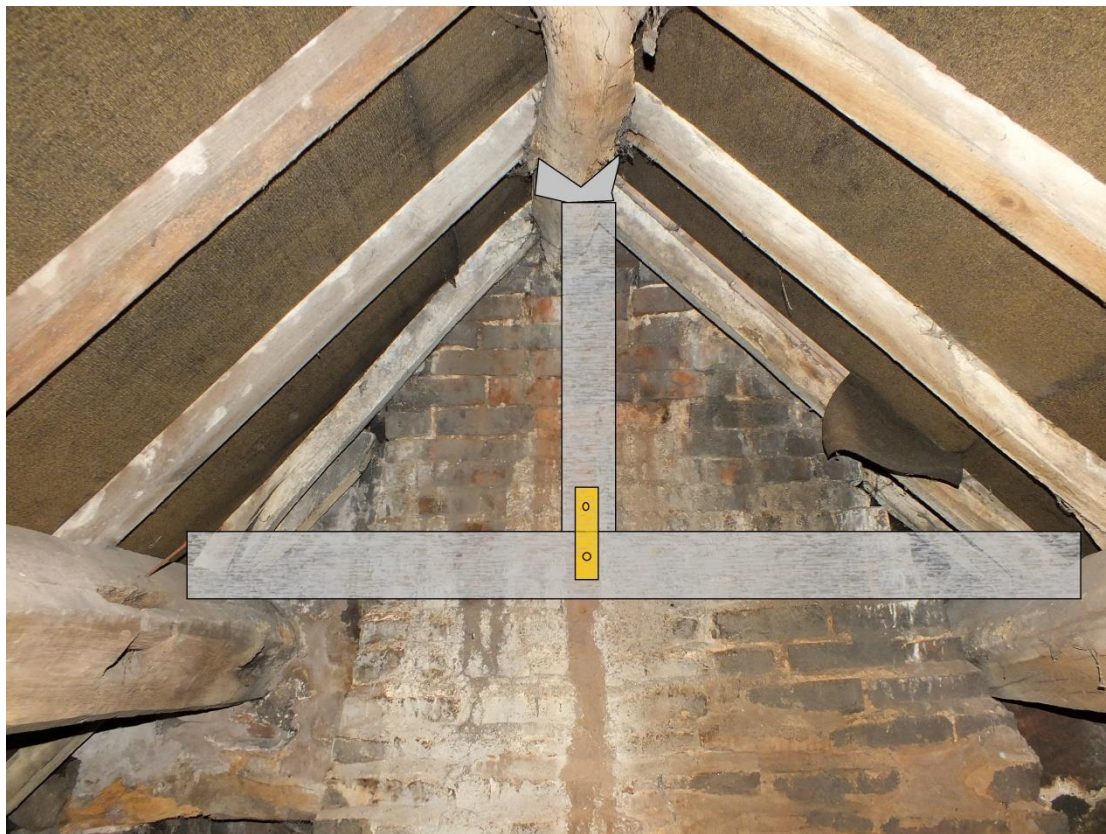
5.

- vi) A similar crosspiece and post prop should be introduced between the upper purlins at the opposing LH gable end wall where the ridge purlin has been reduced at its support set into the chimneybreast brickwork due to past rot and decay. [Photographs 5 & 6]
