**BAT SURVEY REPORT**

**86 ASHBOURNE ROAD,  
LEEK, STAFFORDSHIRE**

**JANUARY 2017**

<b>Project Name</b>	86 Ashbourne Road, Leek, Staffordshire
<b>Project Number</b>	C134
<b>Document Name</b>	Bat Survey Report
<b>Author</b>	Eleanor Weir
<b>Version</b>	00
<b>Date of issue</b>	23/01/17

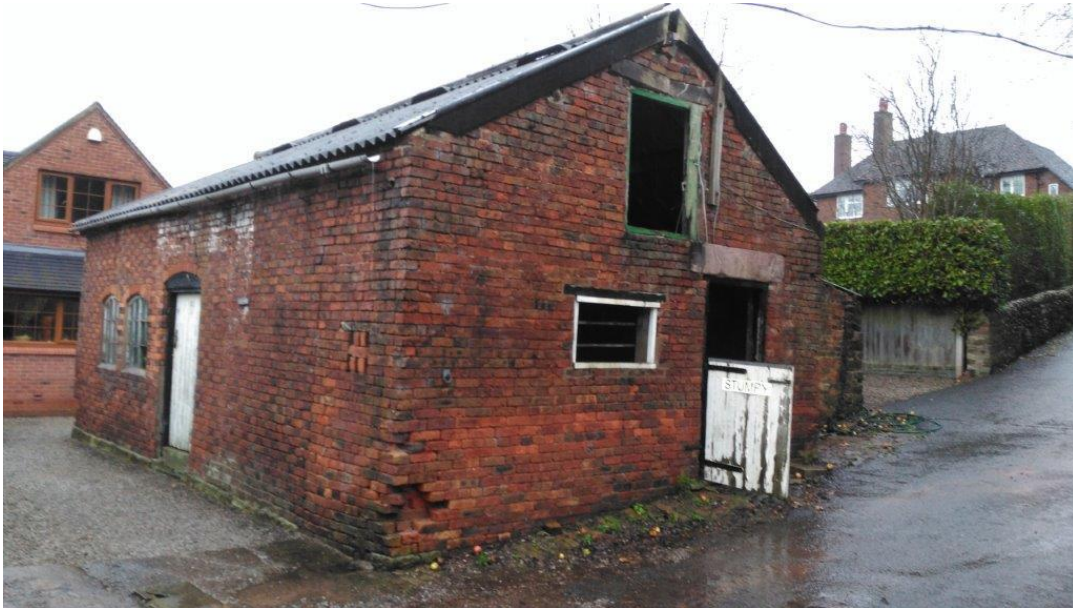
Plate 1: South aspect and east facing gable wall of outbuilding

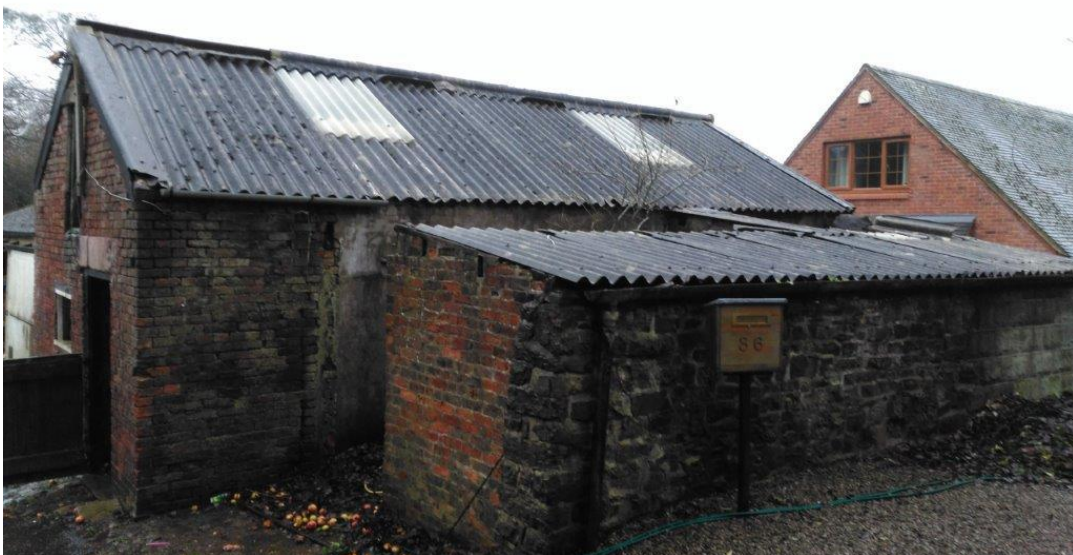
Plate 2: North side of outbuilding showing lean-to

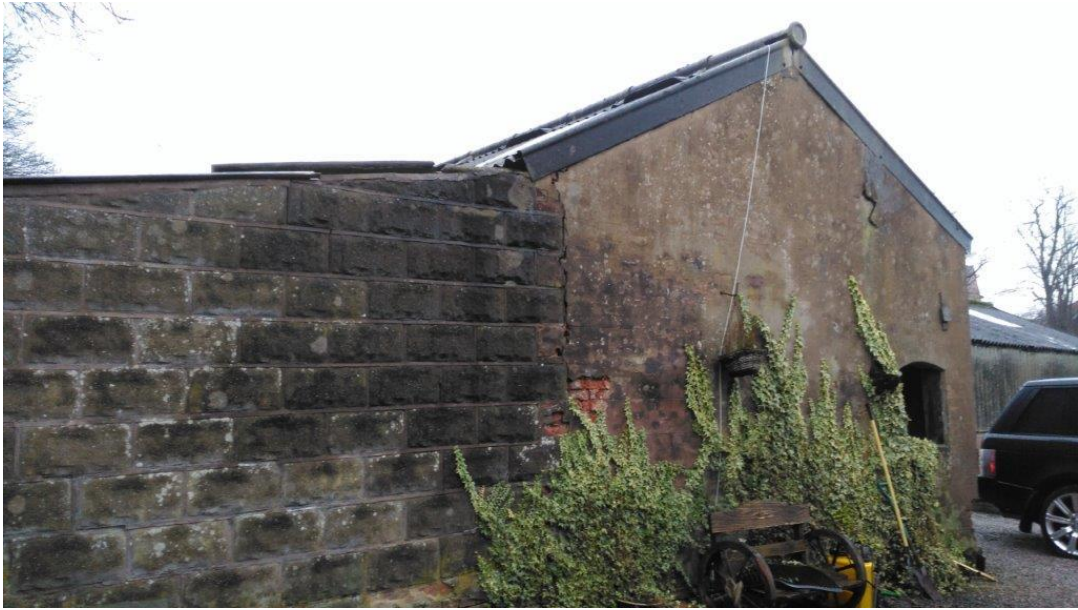
Plate 3: West gable end and lean to

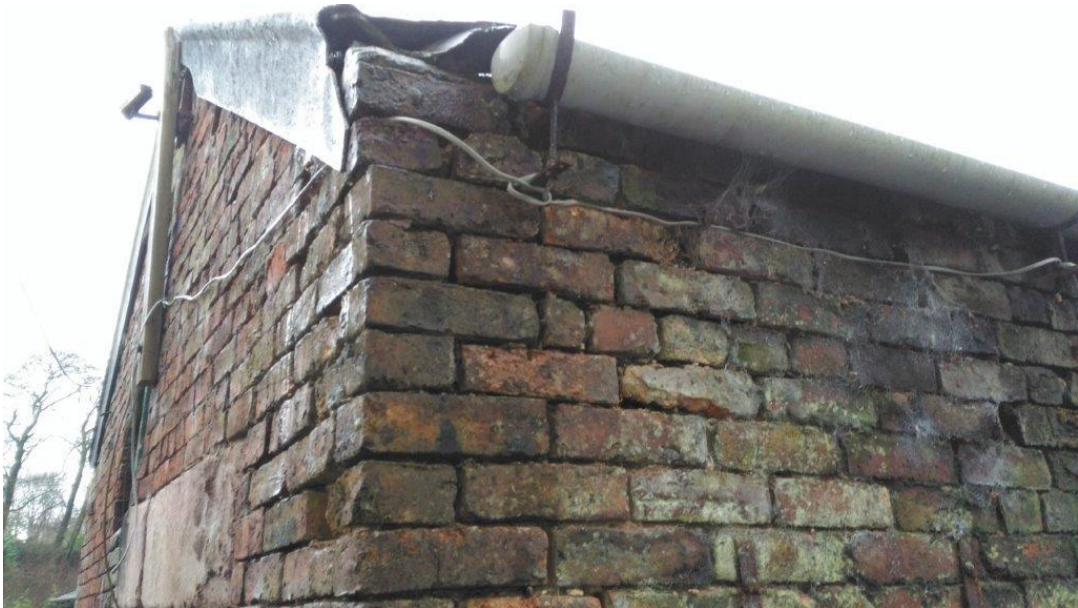
Externally there were several gaps in the brickwork on the north and east walls due to missing mortar and a cracked lintel. The lower gaps which could be safely accessed were checked with an endoscope and no evidence of bats was noted. Due to the poor condition of the roof overlap and broken ridge above the north and east facing walls, it is likely that water drains into these walls (which appears to have contributed to the poor condition of the brickwork in places). This is likely to reduce suitability for roosting bats.

Plate 4: Crevices at top of north wall showing broken roof which is likely to cause water to drain down into the wall

As a precaution, a licensed bat worker should be present during the initial stages of demolition, to undertake an endoscope check of the higher crevices within the lintel and brickwork prior to careful dismantling of these areas.

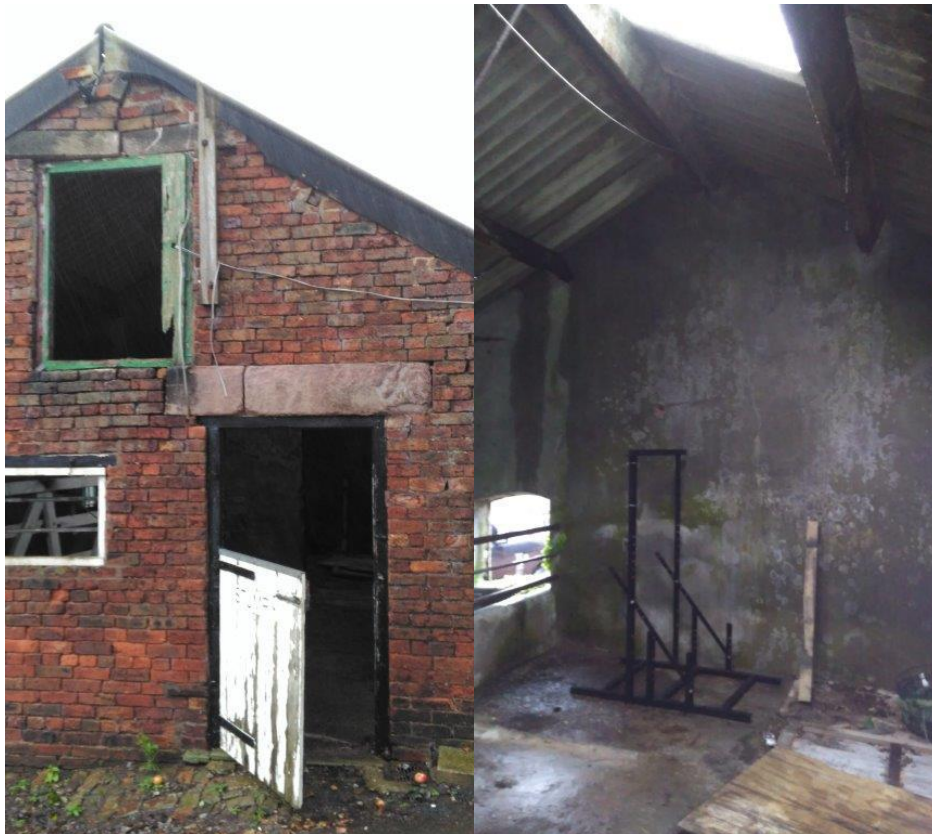
Plate 5: Crevices in brickwork and broken lintel at top of east facing gable wall (left); inside outbuilding (right).

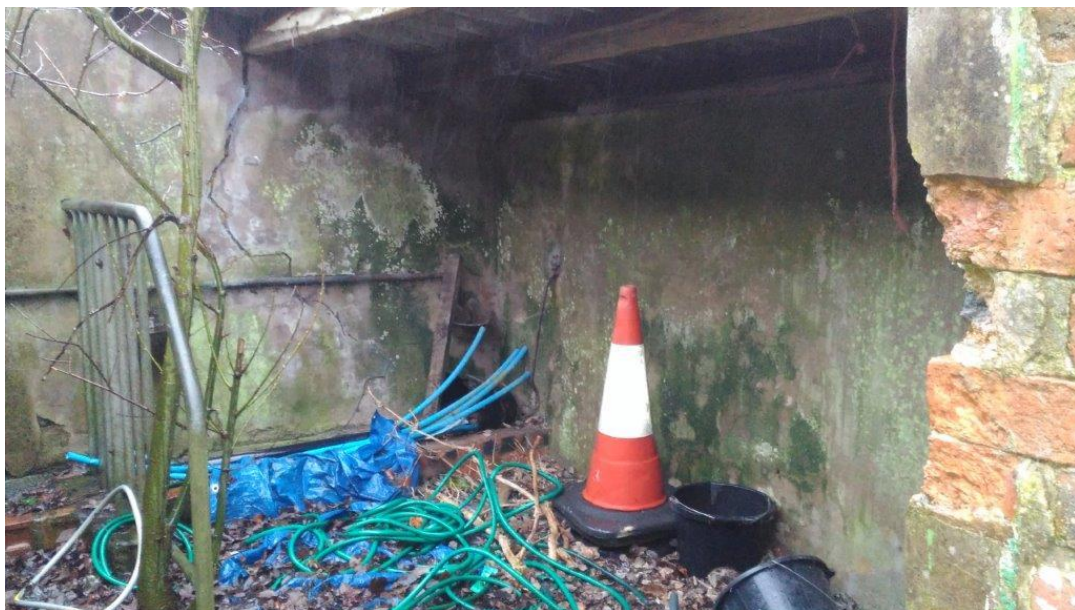
Inside the smaller lean-to area there was a shallow crack in the wall where the roof had collapsed. At the back of one side of the lean-to the stone wall had been lined with vertical clay roof tiles – there appeared to be a cavity between the roof tiles and the external wall but no evidence of bat use.

Plate 6: Inside lean-to with broken roof and shallow crack in wall

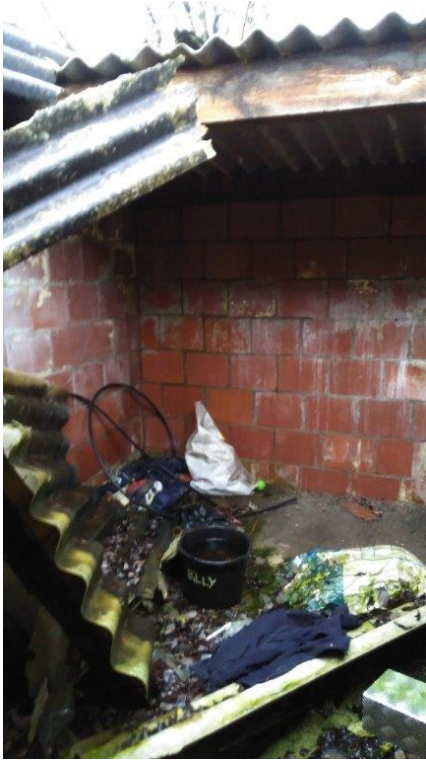
Plate 7: Inside lean-to with broken roof and tile lined wall.

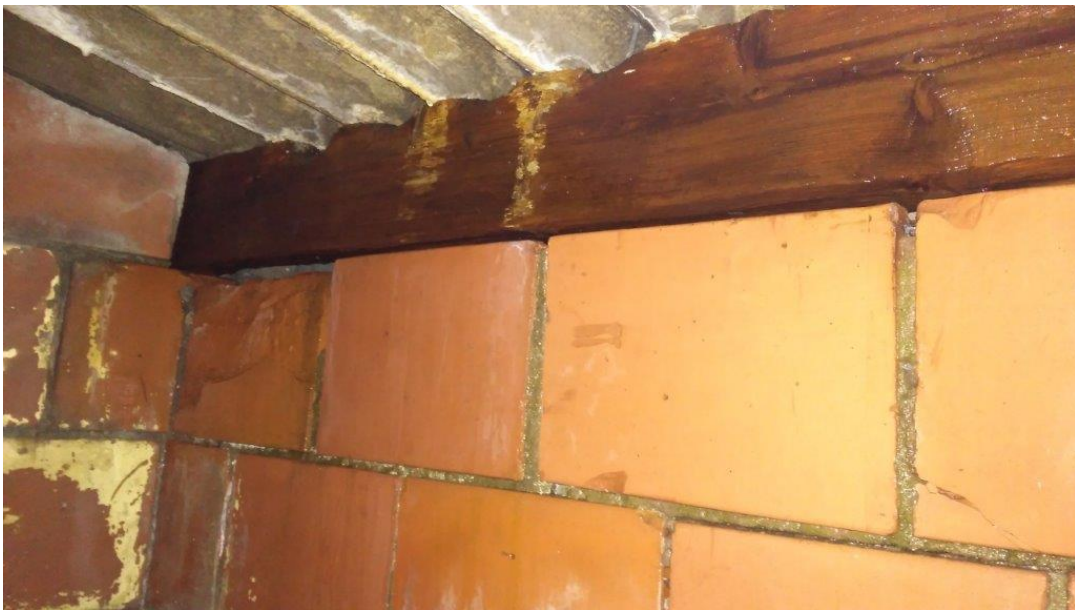
Plate 8: Small gap above tile lined wall leads to a cavity behind. No evidence of bat use found.
