**BS 5837:2012 Tree Survey Report
& Arboricultural Impact Assessment**

Location;
Barn opposite Draycott Arms Pub,
Cheadle Rd,
Draycott in the Moors,
ST11 9RQ
Staffordshire

Date of Inspection;
30th March 2017

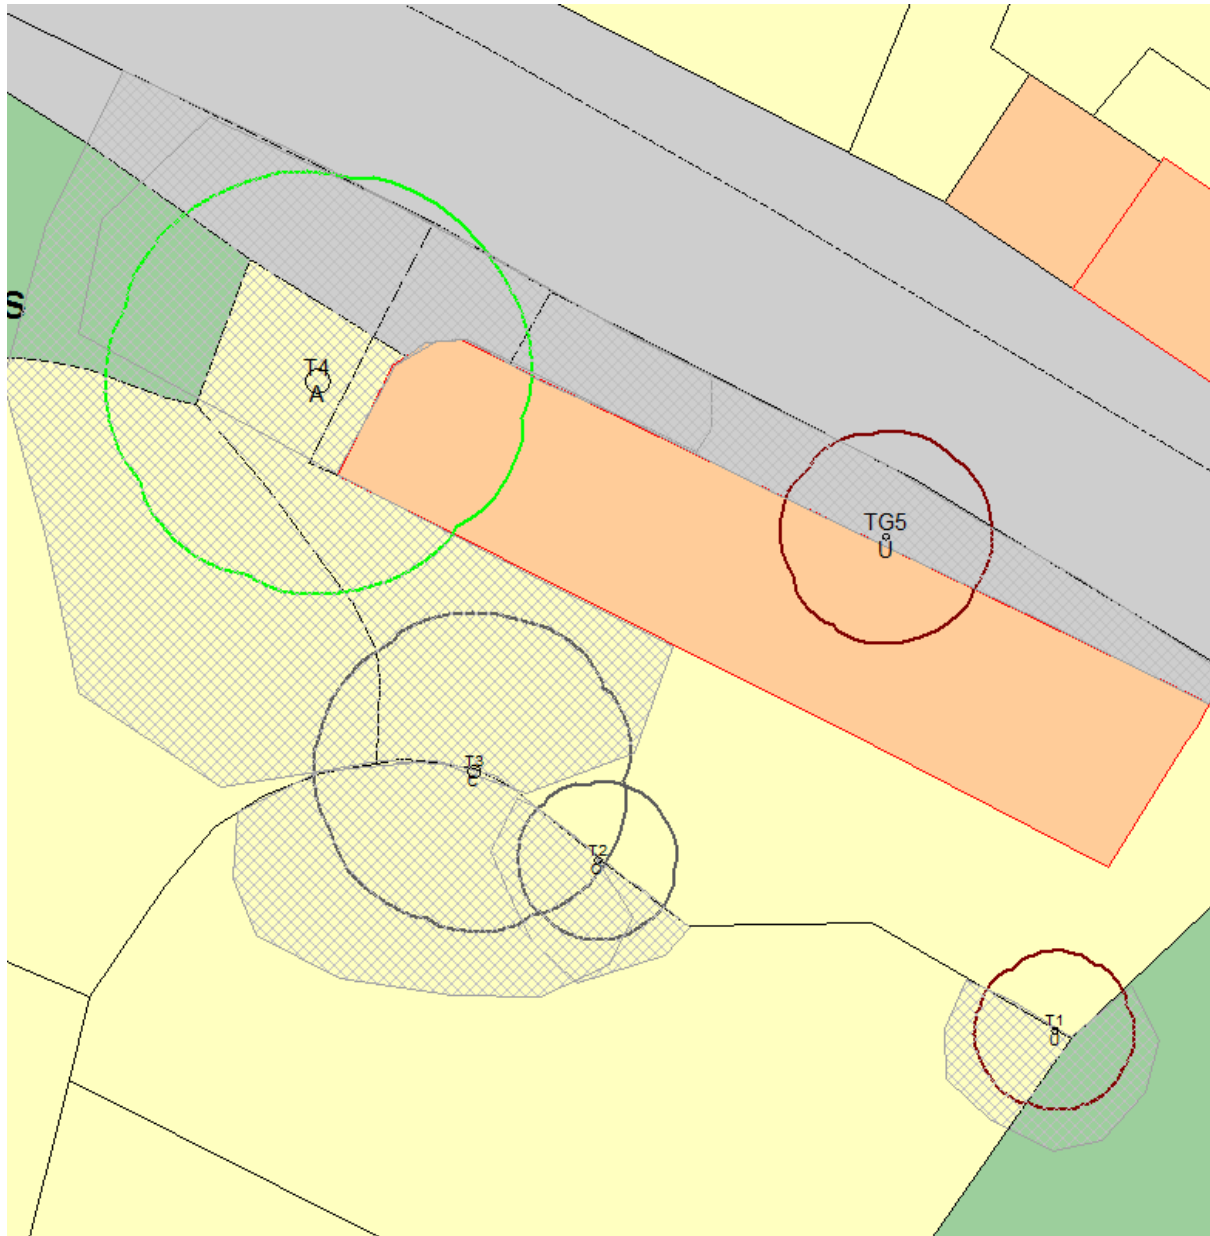
5.5: Tree T1 Semi-mature Sycamore, multi stemmed. Poor fork at 1 m. Poor specimen. Growing on top of the highest point of the retaining wall. This tree will be damaging the retaining wall, the wall may become dangerous at this height.

5.6: Tree T2 Mature Holly, multi stemmed. Canopy is down to the floor. The tree is growing on a lower part of the retaining wall. This tree will be affecting the wall but will not be a safety issue.

5.7: Tree T3 Semi mature Sycamore, low canopy, reasonable shape tree. Growing on a lower part of the retaining wall. This tree will be affecting the wall but will not be a safety issue

5.8: Tree T4 Mature Sycamore, a large and good specimen. There is Ivy growing on the main stem. this should be removed and the main fork re-inspected by an arboricultural consultant. The crown is touching the roof of the barn in places. It has some broken branches and cavities throughout but looks in fair health.

5.9: Trees TG5; Semi mature Sycamores, a couple of multi-stemmed sycamores growing on the road side of the barn. These trees have poor fork unions near the base. They have several stems that are touching the barn. They are not good specimens and will grow to be a hazard to the road due to the weak forks at the base not coping with the weight and movement of the different stems and shallow rooting on the rock bed.

Appendix 1 A plan of the trees on site. The RPAs shown as the shaded areas. The crown spread in coloured outlines. Only T4 is to be retained.

8.1: T1 & TG5, Remove regardless of development. T1 will cause continual damage to the retaining wall, this will become a safety issue due to the height of the wall at this point. TG5 have very poor stem growth form, with future growth these trees will become a safety issue for the highway.

8.2: T2 & T4, Holly and Sycamore. Although neither of these trees has poor growth they are both growing on top of the retaining wall and give a lot of shading to the shed. It is recommended that they be removed and replaced with suitable species. Once the building work has finished and any work to the retaining wall has been completed, two trees should be planted in a similar position except a gap of two meters from the wall should be given for growth. It is recommended that the new trees from species with either slow growth, low growth form or that can be easily pruned to maintain a height, i.e. fruit trees or ornamental Acers etc.

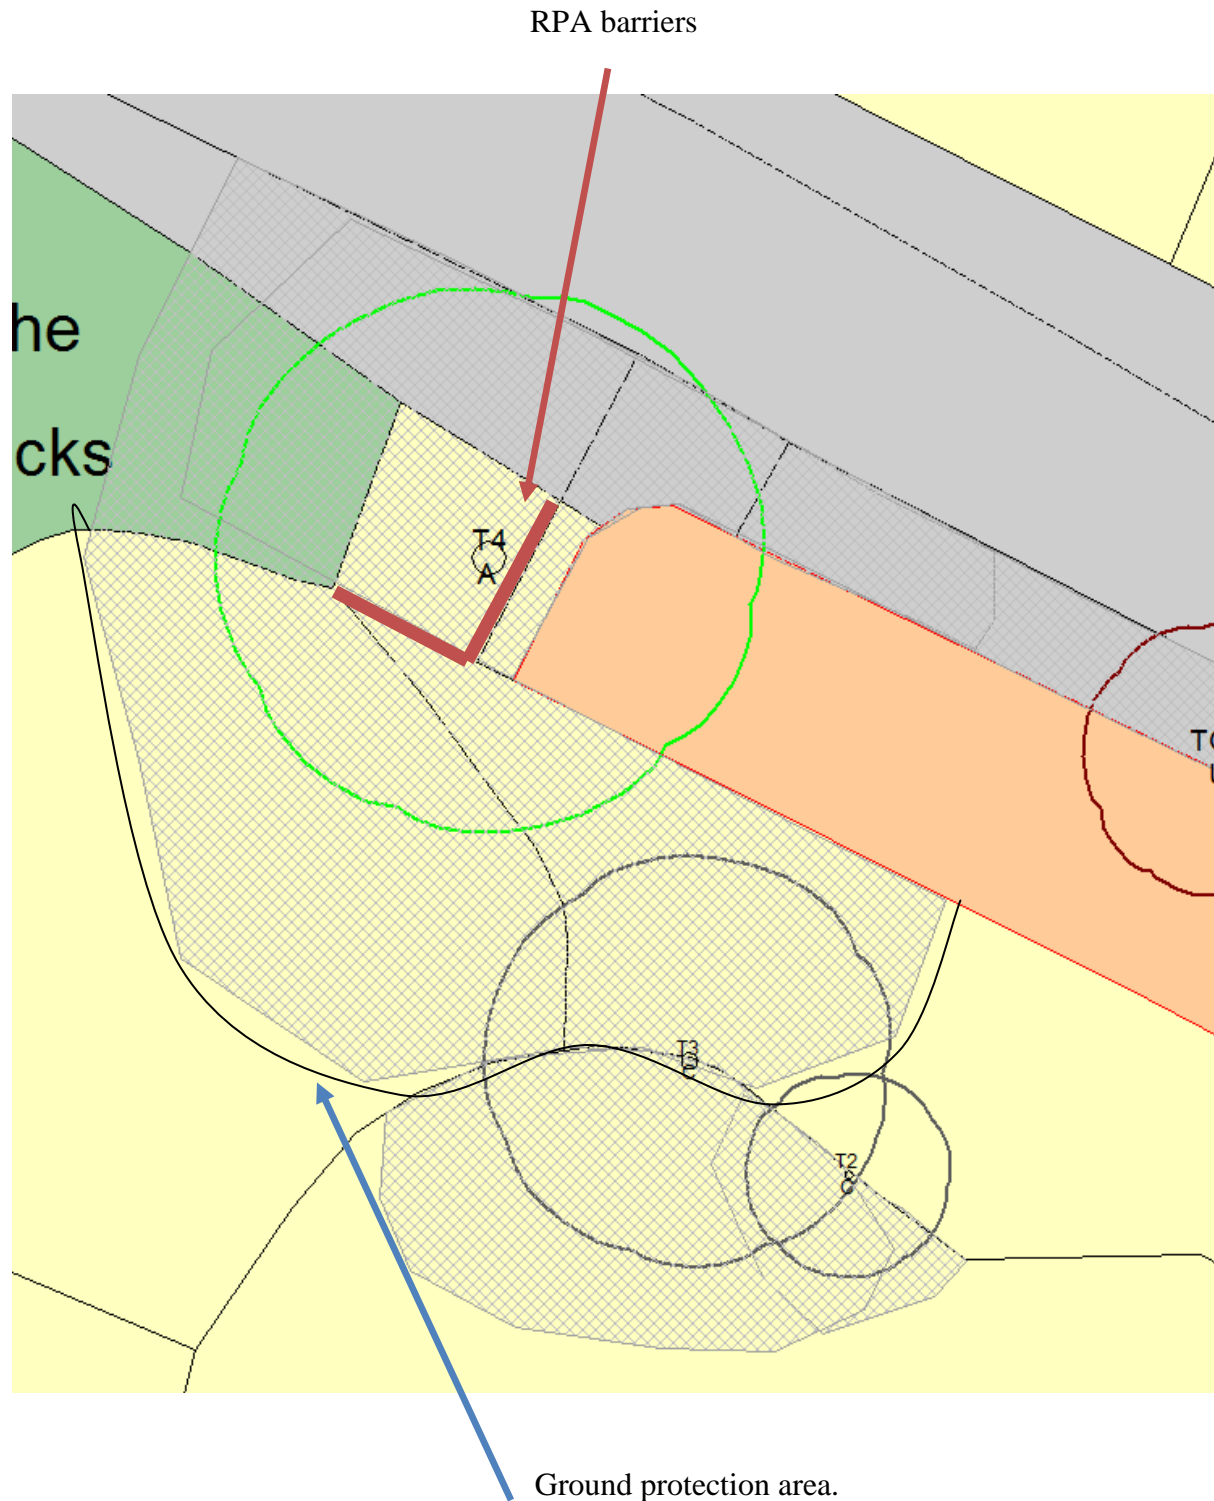
Appendix 2, The RPA barriers, and ground protection.
