Structural Appraisal

Property: **THE BARNS LOWER FARM**
CONSALL

Date: November 2016

Project Ref: 16397

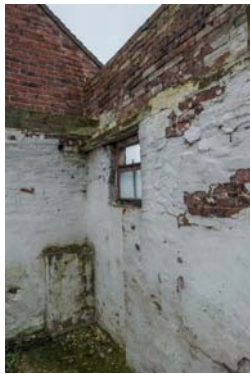
BUILDING '1A'		
4.01	Masonry (Walling)	
	Common Defects:	
	<ul style="list-style-type: none"> Inherent material defects i.e. poor firing, material selection, mixing. External environmental influences i.e. aggressive chemicals, sulphate attack, freeze thaw action, weathering. Physical damage i.e. collision, associated defects i.e. eccentric loading. Poor Repairs incorrect pointing. 	
	Observations:	
	Moisture penetration to brickwork.	P4 P5 P6

Comment:	
	Evidence of prolonged exposure to moisture has caused a deterioration in mortar, evident to top 1.0m+ of walling.	
4.02	Timber (Lintels)	
	Common Defects:	
	<ul style="list-style-type: none"> Inherent material defects i.e. knots, splits, species selection. External environmental influences i.e. water penetration causing decay i.e. Rot insect activity. Overstressing/loading. Poor assembly/fabrication. 	
	Observations:	
	Lintels over openings in external elevations, exposure to moisture.	P4 P6

Comment:	
	Surface softening and localised decay noted in timber.

<p>6.02</p>	<p>Remedial Work:</p> <p>Building 1A</p> <p>Evidence as presented suggests the remaining masonry elevations will need to be partially rebuilt; full extent is difficult to measure and may only be apparent once work has commenced.</p> <p>Building 1B, 2A, 2B& 3</p> <p>Repairs and enhancements need to be concentrated on external elevations consisting of localised consolidation of the masonry walls. Truss bearings and member connections will need to be examined to check fixity/robustness.</p>
<p>6.03</p>	<p>Conversion:</p> <p>A strategy for converting these buildings is to accept that to avoid excessive scrutiny and intervention the existing construction cannot be fully relied upon to provide the support for the associated elements. By introducing supplementary support the existing structure can be relieved of some applied loads. Typically this consists of a load bearing ground slab with a new internal frame which acts to support floors and roof construction. The framework can be tied to the external masonry to enhance transfer of wind forces back into the internal structure.</p>

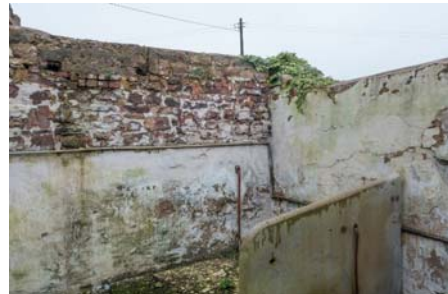
BUILDING '1A'		
5.01	Masonry	
	Common Defects:	
	<ul style="list-style-type: none"> Vertical Settlement/subsidence i.e. loss of support or lack of capacity in supporting soils - deterioration in foundation construction. Loss of integrity – bond, inherent lack of cohesion. Lateral movement – insufficient strength to resist horizontal forces. 	
	Observations:	
	No discernible evidence of vertical movement noted.	P5
	Horizontal misalignment to front and rear walls, most pronounced at wall head.	P6

Comment:	
Movement associated historic instability.		
5.02	Timber (Lintels)	
	Common Defects:	
	<ul style="list-style-type: none"> Overloading causing deformity or failure. Loss of support – inadequate bearing conditions or displacement of supporting member. Inappropriate modifications – removal of frame members 	
	Observations:	
	No discernible evidence of member distress or loss of strength.

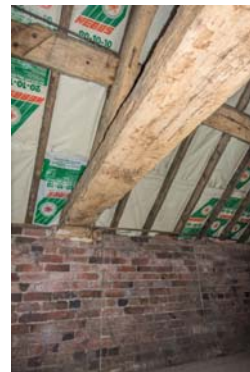
Comment:	
	Overall material condition of the masonry is reasonable.	
4.12	Timber (Floor & Roof)	
	Common Defects:	
	<ul style="list-style-type: none"> Inherent material defects i.e. knots, splits, species selection. External environmental influences i.e. water penetration causing decay i.e. Rot insect activity. Overstressing/loading. Poor assembly/fabrication. 	
	Observations:	
	Floor Joists, rafters. Generally, material condition is good with no obvious evidence of decay or defect.	P7 P9 P8

Comment:	
	<p>No significant material defects noted to those components which are currently contributing to the structure.</p> <p>Timber frame components appear to be performing well significantly the roof covering has been maintained ensuring protection to the timber.</p> <p>No evidence of overloading in the floor components although closer examination of the bearings may be necessary.</p>

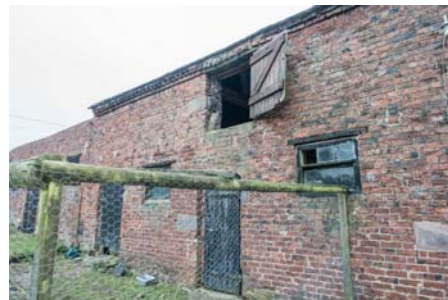
BUILDING '1B'		
4.11	Masonry (Walling)	
	Common Defects:	
	<ul style="list-style-type: none"> Inherent material defects i.e. poor firing, material selection, mixing. External environmental influences i.e. aggressive chemicals, sulphate attack, freeze thaw action, weathering. Physical damage i.e. collision, associated defects i.e. eccentric loading. Poor Repairs incorrect pointing. 	
	Observations:	
	Localised superficial degradation of brickwork noted not serious.	P13

BUILDING '1B'		
5.11	Masonry (Walling)	
	Common Defects:	
	<ul style="list-style-type: none"> Vertical Settlement/subsidence i.e. loss of support or lack of capacity in supporting soils - deterioration in foundation construction. Loss of integrity – bond, inherent lack of cohesion. Lateral movement – insufficient strength to resist horizontal forces. 	
	Observations:	
	No discernible evidence of vertical movement noted.	P13
	Nominal movement at wall head (dentil course) over opening yard elevations.

Comment:	
No evidence of significant movement or misalignment.		
5.12	Timber (Roof & Floor)	
	Common Defects:	
	<ul style="list-style-type: none"> Overloading causing deformity or failure. Loss of support – inadequate bearing conditions or displacement of supporting member. Inappropriate modifications – removal of frame members 	
	Observations:	
	No discernible evidence of horizontal or vertical movement was noted.

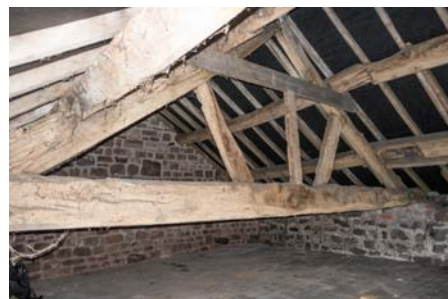
4.22	Timber (Floor & Roof)	
	Common Defects:	
	<ul style="list-style-type: none"> Inherent material defects i.e. knots, splits, species selection. External environmental influences i.e. water penetration causing decay i.e. Rot insect activity. Overstressing/loading. Poor assembly/fabrication. 	
	Observations:	
	Roof covering is complete, no evidence of significant material decay. Evidence of localised surface insect activity with minor surface damage.	P15 P16

Comment:	
	Roof timbers are old and rustic but show no material issues. Floor joists are comparatively new.

5.22	Timber (First Floor & Roof)	
	Common Defects:	
	<ul style="list-style-type: none"> Overloading causing deformity or failure. Loss of support – inadequate bearing conditions or displacement of supporting member. Inappropriate modifications – removal of frame members 	
	Observations:	
	Roof Structure: 3No. Truss Frames, two hardwood appear salvaged, third truss is amalgam. Frame Setting out not symmetrical along building length. Side purlins propped off truss rafters. Fractures and member connection/bearing defects noted in truss and purlins. First Floor: No apparent structural defects.	P15 P16 P17

Comment:	
	Roof structure is incongruous with the building and has a number of structural deficiencies. These can be addressed, it is not displaying signs of distress and the underlying primary members conform to traditional arrangements and if the material issues are resolved it will be possible to nominally enhance the strength to enable installation of the domestic construction.

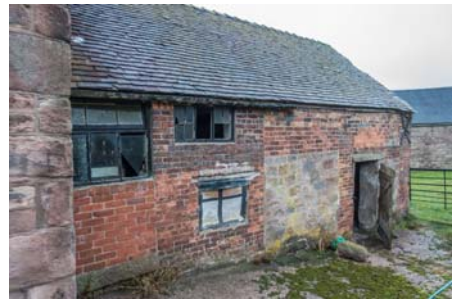
BUILDING '2B'		
4.31	Masonry	
	Common Defects:	
	<ul style="list-style-type: none"> Inherent material defects i.e. poor firing, material selection, mixing. External environmental influences i.e. aggressive chemicals, sulphate attack, freeze thaw action, weathering. Physical damage i.e. collision, associated defects i.e. eccentric loading. Poor Repairs incorrect pointing. 	
	Observations:	
	Stone: No significant material defects noted, localised mortar loss on external face. Brickwork: degradation and mortar perishing noted to external face of rear elevation, this refers to the infill panels and small surrounding sections.	P19

Comment:	
	Localised disruption to the yard elevation attributed to C19 alterations/reconstruction.	
4.32	Timber (Roof)	
	Common Defects:	
	<ul style="list-style-type: none"> Inherent material defects i.e. knots, splits, species selection. External environmental influences i.e. water penetration causing decay i.e. Rot insect activity. Overstressing/loading. Poor assembly/fabrication. 	
	Observations:	
	No apparent significant material decay evident; localised issues where roof membrane is torn.	P22 P21

BUILDING '2B'		
5.31	Masonry (Walling)	
	Common Defects:	
	<ul style="list-style-type: none"> Vertical Settlement/subsidence i.e. loss of support or lack of capacity in supporting soils - deterioration in foundation construction. Loss of integrity – bond, inherent lack of cohesion. Lateral movement – insufficient strength to resist horizontal forces. 	
	Observations:	
	Yard elevation; alterations to the elevations, new and infilled openings, creating vertical joints.	P28 P31 P19

Comment:	
	Walling has performed adequately with few notable defects. Joints and irregularities can be seen but this is not necessarily evidence of a defect.

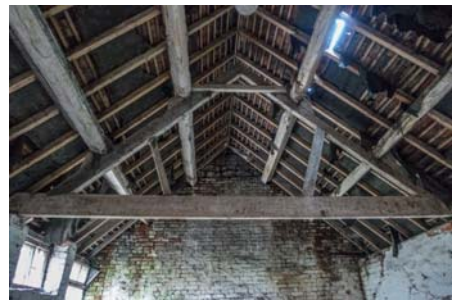
Comment:	
Condition of the timber framing elements appears good.

5.32	Timber (Roof)	
	Common Defects:	
	<ul style="list-style-type: none"> Overloading causing deformity or failure. Loss of support – inadequate bearing conditions or displacement of supporting member. Inappropriate modifications – removal of frame members 	
	Observations:	
	No defects noted.	P21

Comment:	
Roof construction; size and arrangement of members is appropriate for loads.

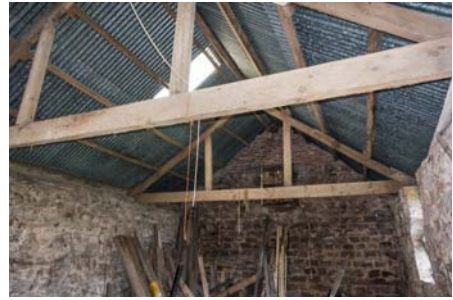
Comment:	
	No comment.	
4.42	Timber (Roof)	
	Common Defects:	
	<ul style="list-style-type: none"> Inherent material defects i.e. knots, splits, species selection. External environmental influences i.e. water penetration causing decay i.e. Rot insect activity. Overstressing/loading. Poor assembly/fabrication. 	
	Observations:	
	No apparent evidence of material defect noted.	P33

Comment:	
	Stone walling has performed adequately with few notable defects.	
5.42	Timber (Roof)	
	Common Defects:	
	<ul style="list-style-type: none"> Overloading causing deformity or failure. Loss of support – inadequate bearing conditions or displacement of supporting member. Inappropriate modifications – removal of frame members 	
	Observations:	
	No notable defects.	P33

Comment:	
	The roof structure is lightweight and modern and would not be adequate to support a tiled roof. Presumably it should be replaced.

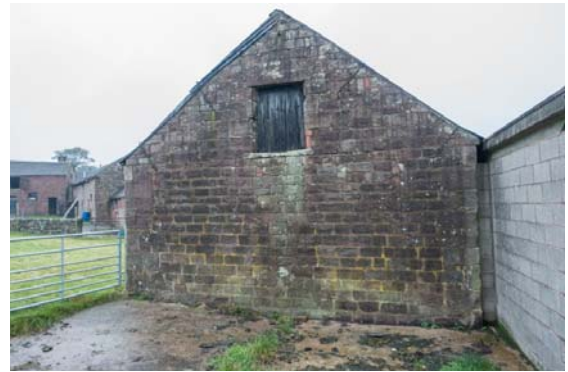
P35

BUILDING '2A'		
4.21	Masonry (Walling)	
	Common Defects:	
	<ul style="list-style-type: none"> Inherent material defects i.e. poor firing, material selection, mixing. External environmental influences i.e. aggressive chemicals, sulphate attack, freeze thaw action, weathering. Physical damage i.e. collision, associated defects i.e. eccentric loading. Poor Repairs incorrect pointing. 	
	Observations:	
	Stone: No significant material defects noted, localised mortar loss on external face.	P36

Comment:	
	Two elevations have been reconstructed recently the remainder appear satisfactory localised superficial surface degradation noted in stone and brickwork.
