**Report 17158\_R001**  
**134 Mow Lane, Gillow Heath**  
**Stoke-on-Trent, ST8 6RJ**

**Visual Structural Report in respect of an  
Existing Barn Structure for the purpose  
of a proposed conversion to a dwelling**

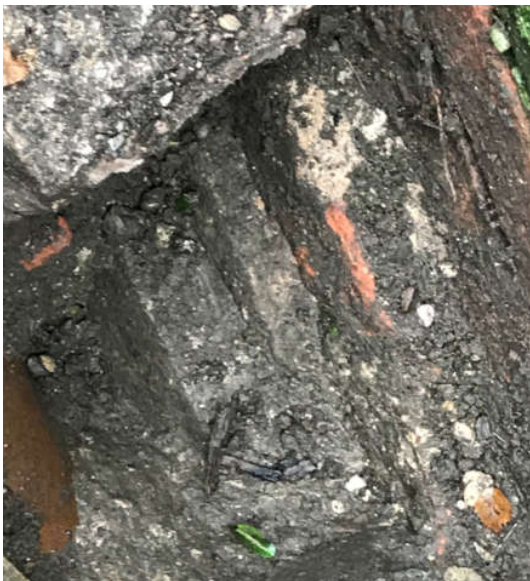
**Photo 7**

A number of small hand dug trial holes had been undertaken by the client which exposed the stone spread footings supported from a firm natural clay sub-stratum (Refer to Photographs 7 & 12). There was no evidence of settlement to the structure and the foundations should be suitable for conversion provided that both the external and internal floor levels are not reduced from the current levels.

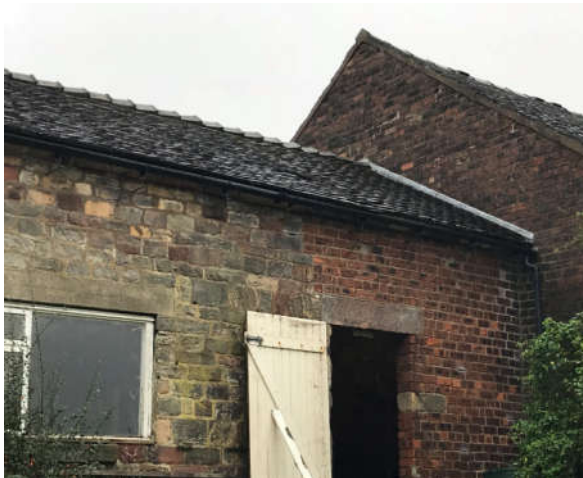
**Photo 11**

There was evidence of movement to a section of the rear wall (Refer to Photograph 11) which again, in our opinion, appeared to have been caused by spread of the original roof, however, this could not be confirmed. It is recommended that during the conversion of the barn, this section of wall is rebuilt and adequately tied to the structure to prevent further movement from occurring.

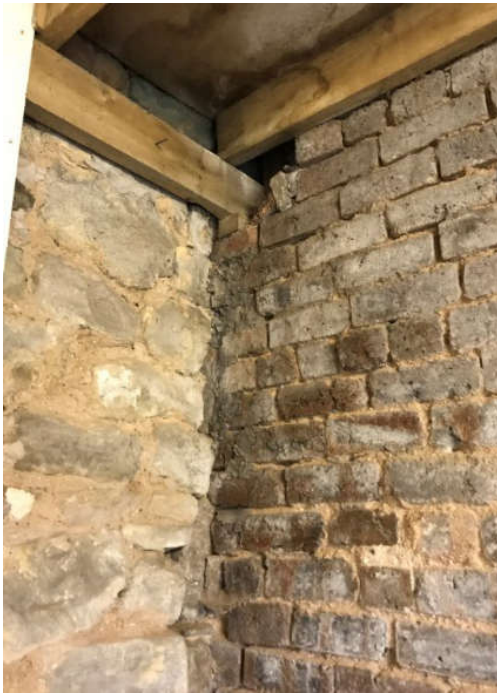
**Photo 13**

The aforementioned movement has also affected some of the internal cross walls which have become detached from the external walls (Refer to Photographs 13, 14 & 16). As part of the conversion works, it is recommended that these walls are tied into the external walls and strapped to the floors. The proposed method of tying should be determined during the design of the conversion works.

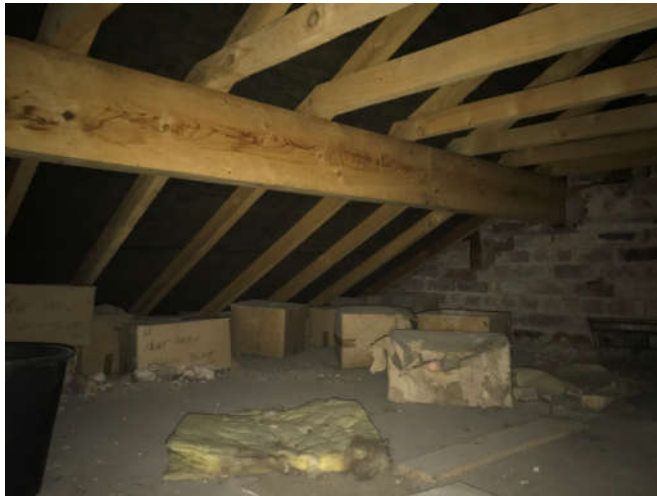
**Photo 15**

The roof structure is understood to have been replaced recently and comprised of a traditional timber rafter and purlin construction with the purlins supported from load bearing masonry walls (Refer to Photographs 15, 19, 20 & 24). The gable walls appeared to be supported from steel beams in places. There were no apparent structural defects to the timber roof structure as would be expected of a recently replacement structure. However, the bearings of the steel beams onto the inner leaf of the external wall did not have concrete padstones (Refer to Photograph 23) and we

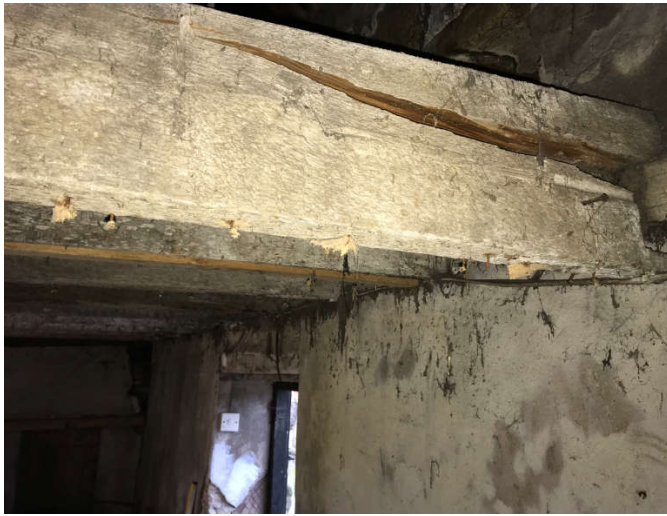
**Photo 21**

The suspended timber upper floors were not in an acceptable structural condition for use in a dwelling (Refer to Photographs 21 & 22) and should be replaced with new joists sized in accordance with current Building Regulation standards as part of the conversion. The floors should be strapped both the internal and external walls to enhance the stability of the structure in accordance with current Building Regulation standards.

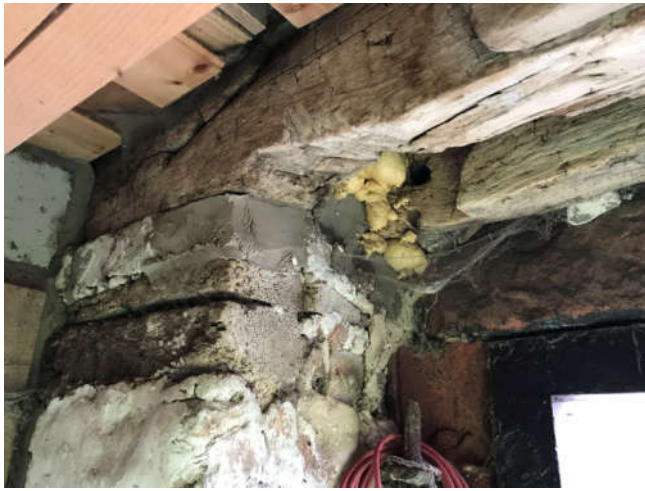
**Photo 25**

There were a number of timber lintels which were supporting the inner leaf of the external wall which should be replaced with new pre-cast concrete lintels as part of the conversion works due to deterioration and possible woodworm (Refer to Photographs 25 & 26).
