**Report 17203\_R001**

**Farley Cottage, Farley**

**Visual Structural Inspection in respect of  
an Existing Single Storey Garage for the  
purpose of constructing an additional  
storey over**

January 2018

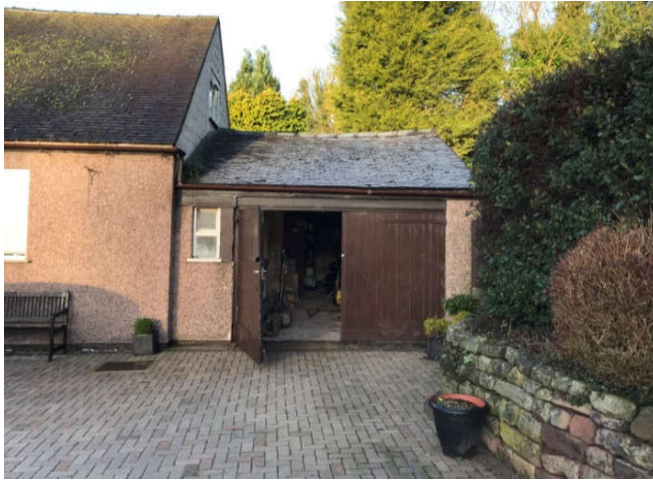
**Photo 1**

The roof structure comprised of a traditional timber rafter and purlin construction with the purlins supported from the gable wall and the main house wall (Refer to Photographs 1, 3, 4 & 5). The timber purlins appeared to be undersized and it is unlikely that their suitability could be proven by structural calculation. The timber purlins were visibly sagging and the lack of restraint to the gable wall is, in our opinion, likely to have contributed to the apparent bow / bulge in the wall.

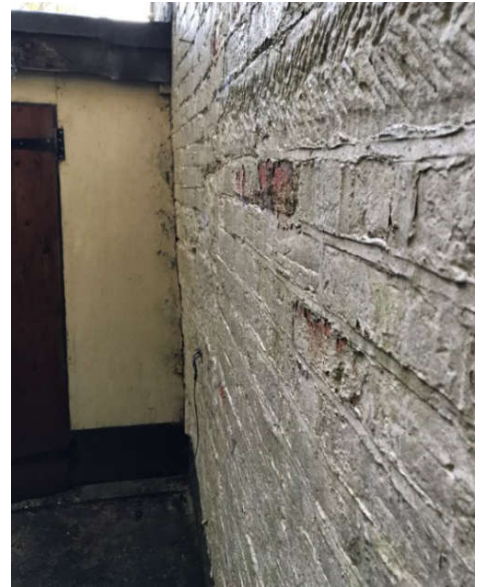
**Photo 2**

There was evidence of significant bowing / bulging of the gable wall (Refer to Photograph 2) which could be due to spread from the sagging roof purlins.

It is our opinion that that existing structure should be demolished, and new structural walls and foundations constructed which are capable of safely supporting a two-storey property.

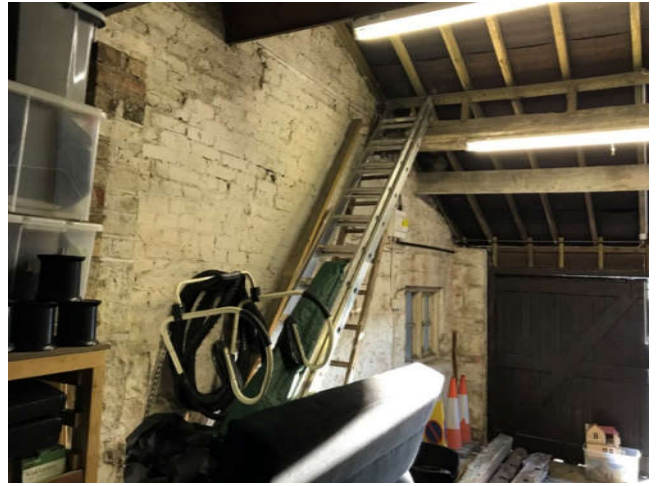
**Photo 6**

There was also evidence of cracking within the gable wall (Refer to Photographs 6, 7, 8, 9 & 11) & within the rear wall (Refer to Photographs 10 & 11)
