### Service / Operational Defects (SRM 4)

Project name :  
**7392 - Leek Railway**

Date :  
**21-Nov-17**

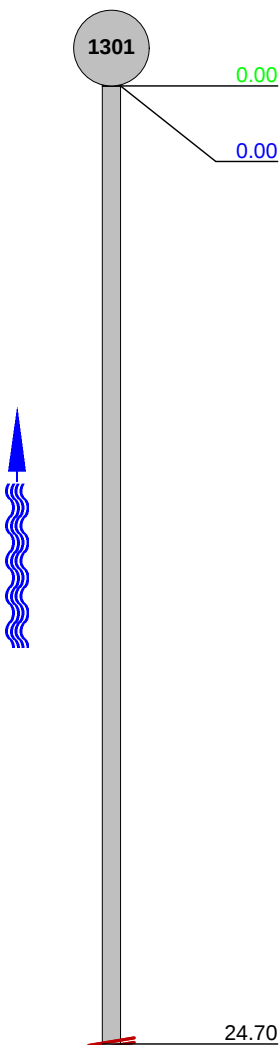
| 1:195 | Position | Code | Observation | Grade |
|---|---|---|---|---|
| | | MH | Start node type, manhole, reference number :<br>1301 | (Constr) 0 |
| | | WL | Water level, 5% of the vertical dimension | (Serv) 0 |
| | | SA | Survey abandoned | (Misc) 0 |

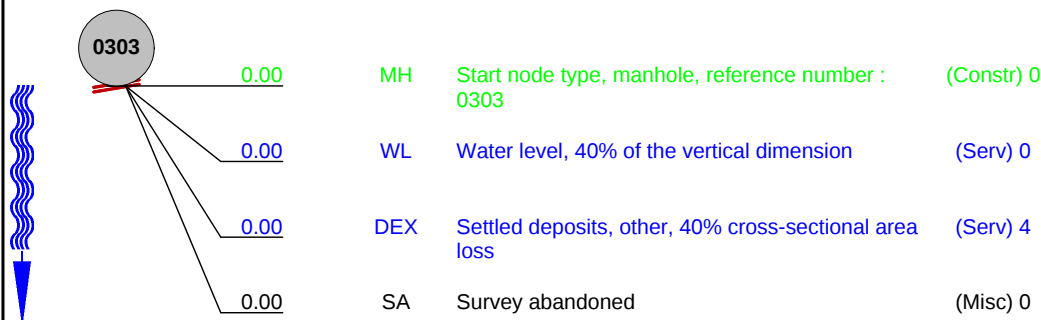
0 m // 00:00:17

| STR no def | STR peak | STR mean | STR total | STR grade | SER no def | SER peak | SER mean | SER total | SER grade |
|---|---|---|---|---|---|---|---|---|---|
| 0 | 0 | 0 | 0 | 1 | 1 | 5 | 0 | 5 | 4 |
