## THE TOWER, COMPTON MILL, LEEK

### Schedule of Repair Work

Chambers Conservation Ltd, March 2018 – Issue 2

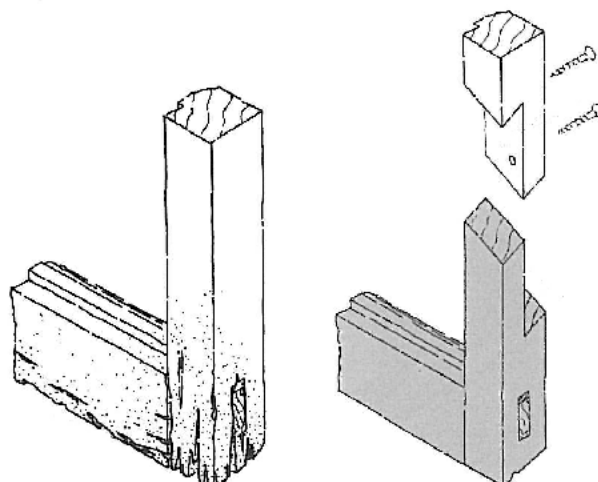
**Fig 01** Repair to timber window frames as proposed.

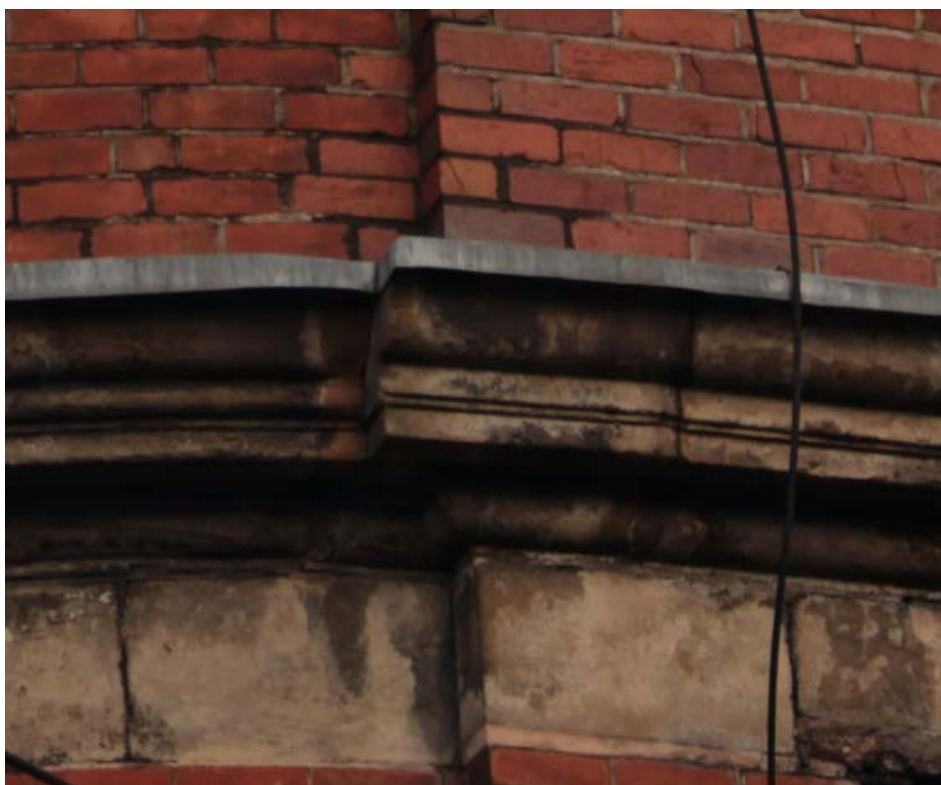
**Fig 02**  
Potential evidence of past movement to cornice. Cementitious mortar repair visible between stones.

3.3.3.4. Carefully remove cementitious repair (as indicated in photo, above). Indent stone repair, profile to match cornice, full height of cornice stone, 150mm wide.

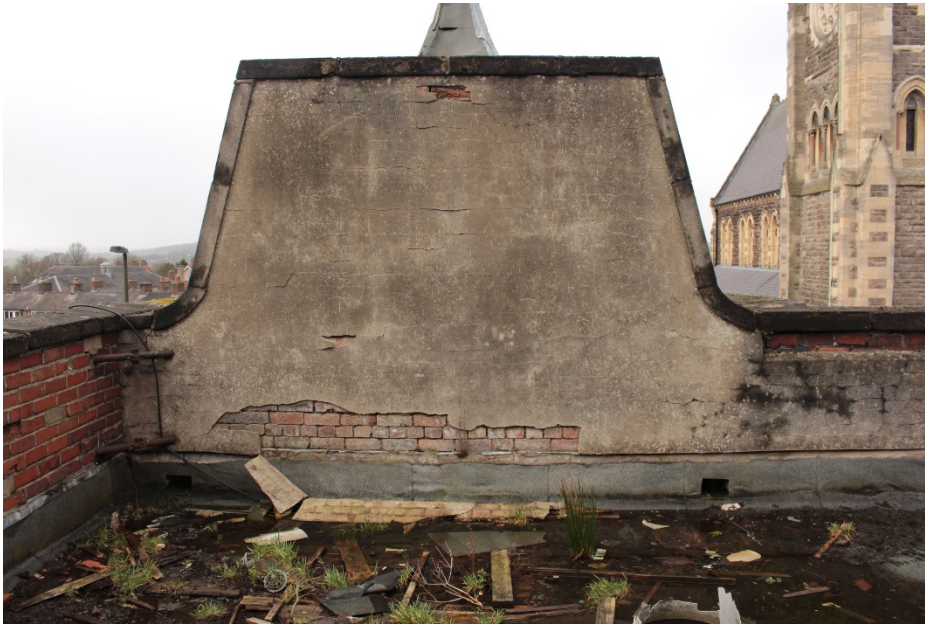
**Fig 03**  
Rear of tall eastern parapet wall, with failing cementitious render. Corner bracing visible to left hand side.

- 3.4.1.1. Subject to scope of work for adjoining new construction (i.e. amount of parapet remaining exposed), carefully remove all cementitious render (cracked and delaminated) from the rear parapet to enable inspection of the brickwork. Allow to carefully dismantle parapet to reveal lantern timberwork (Lantern to be supported independently whilst this work is undertaken). Reconstruct parapet (with amended drainage detail). Allow to replace 25 no. bricks to match existing (salvaged from adjoining demolitions). On completion, cover whole in stainless steel expanded metal lath (to BS 1369), fixed with stainless steel screws and suitable large-diameter stainless steel washers. Fix with with all strands sloping downwards and inwards from the face of the coating. Ensure when fixing that allowance is made for overlapping sheets by 50mm lengthways and 25mm widthways.
