SUTTON BARN, BROOK LANE, ENDON

LEVEL 3 SURVEY

Prepared on behalf of MR and MRS D PENNINGTON

21ST SEPTEMBER 2016

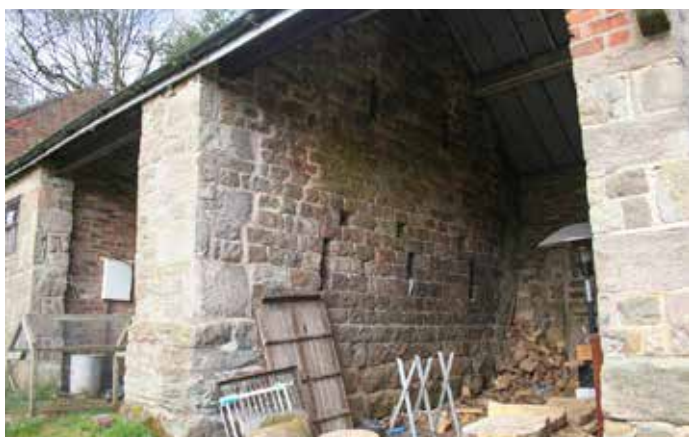
The former end wall of a late 17th century barn survives within the dividing wall of the 19th century cart bays

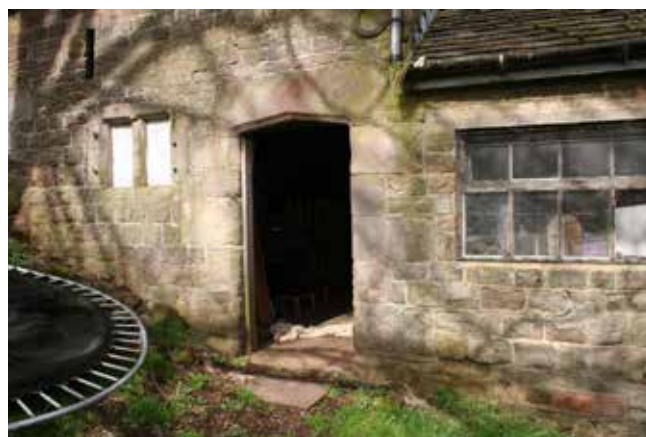
The Tudor-arched stable door and window are coeval with the end wall (left) with its ventilation slots

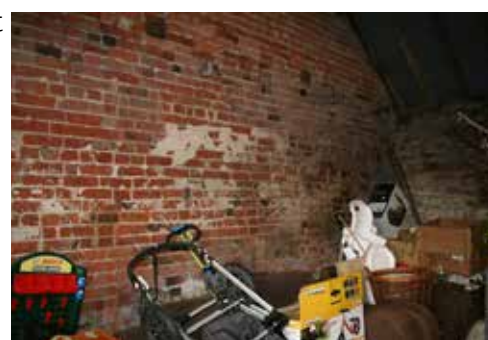
Brickwork dating from after 1725 divides the bottom bay from the upper two bays.

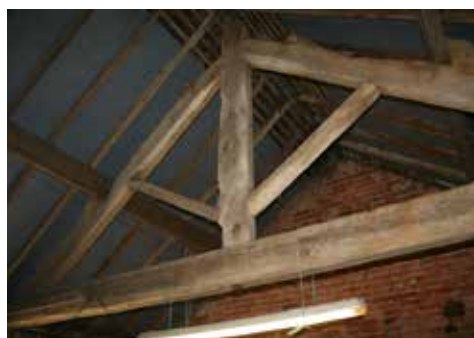
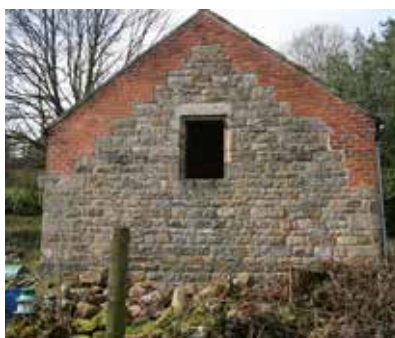
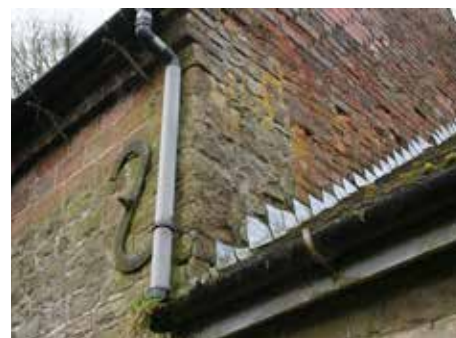
19th century re-roofing comprised inserting king post roof trusses, raising the eastern gable in brick, and lowering the eaves of the barn, remodelling the stable and inserting a new brick dividing wall to form a separate brick gable

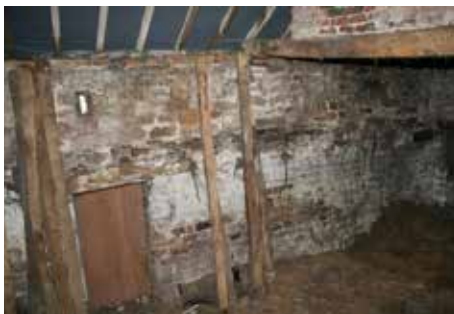
Oak posts (former joists) set aside. The sockets for the joists can still be seen in the masonry

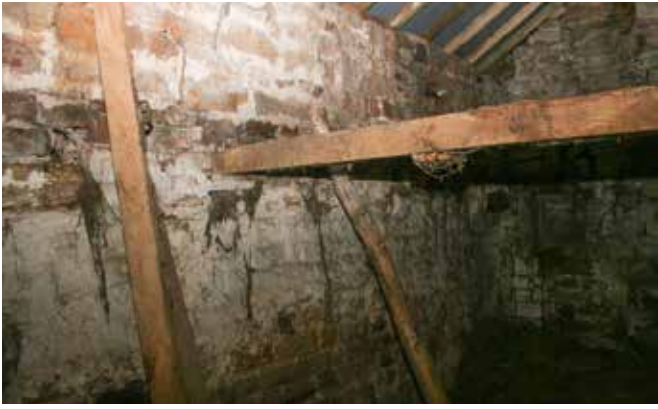
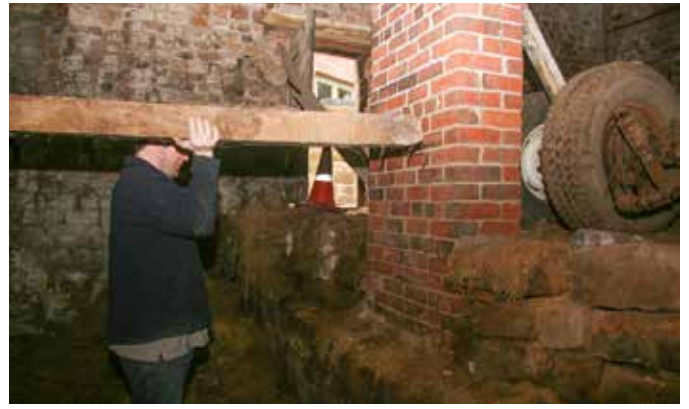
Oak joist re-positioned in wall socket and supported to demonstrate the level of the former hayloft floor. This demonstrates that it would have been efficient and simple to pitch hay and straw into the loft from the barn floor.

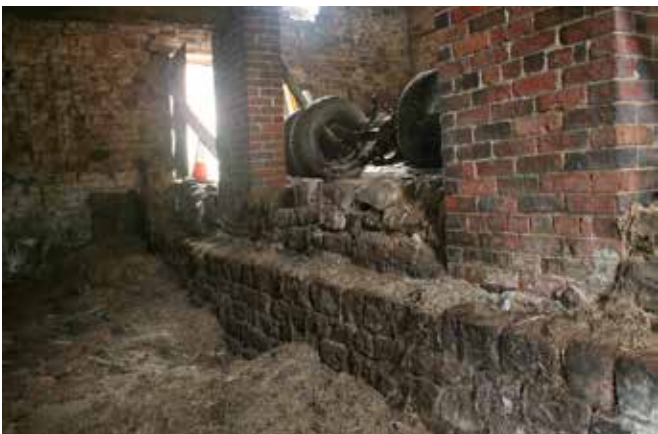
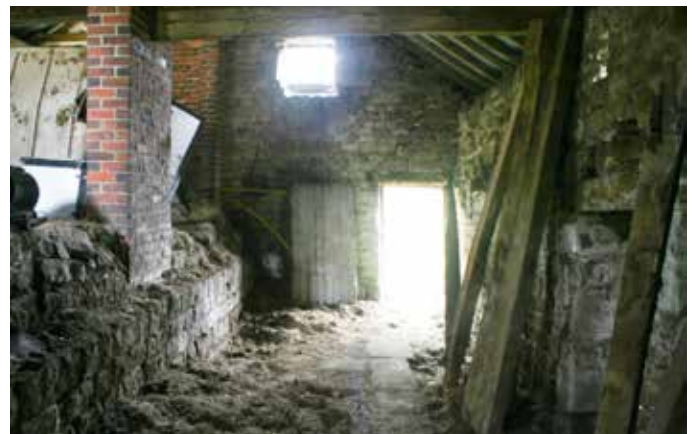
Left - coursed and mortared stone plinth (looking south), which would have supported a short timber-framed structure of posts and horizontal rails; sockets survive in the south wall. Right - the cowhouse looking north, with 19th century brick piers.

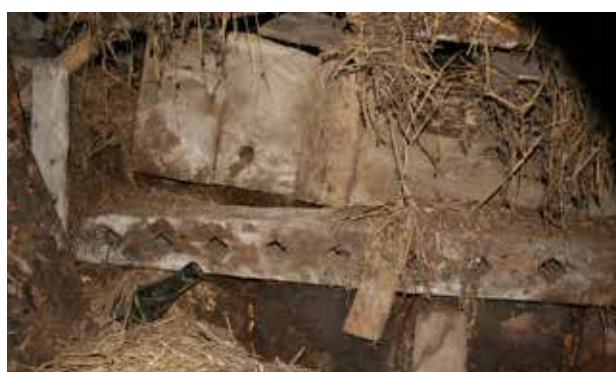
Fragment of oak rack with sockets for staves is part bedded in the lower wall

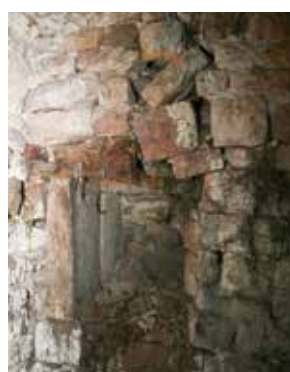
Window - to south wall recently blocked

There was a later window inserted in the southern elevation, which has been rather clumsily blocked up in stone, and this would have provided some limited light and ventilation at ground floor level, and is part of the interesting development of the building and changing agricultural practices. The addition of a second, later, doorway to the roadside elevation (probably 18th century) also suggests that it may have been adapted as a milking shed, with a second doorway to enable a continuous in and out process and a much easier way to remove manure. Practices varied around the country and in some places cows were tethered, nose towards the cross wall, and tail onto a single manure passage, the fodder being brought to individual feeding boxes from within the building from the upper level and dropped down. This appears to have been the last designed use of the building.

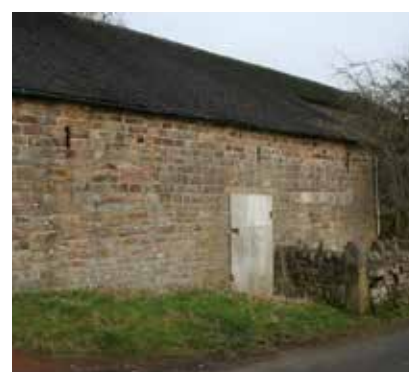
Roadside elevation, with inserted doorway (C18?)

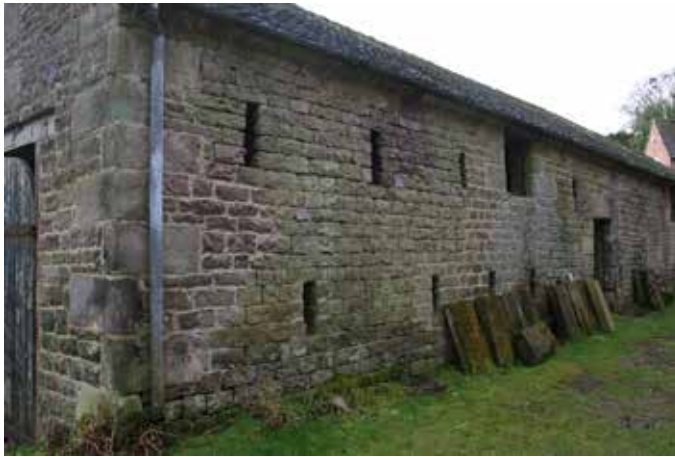
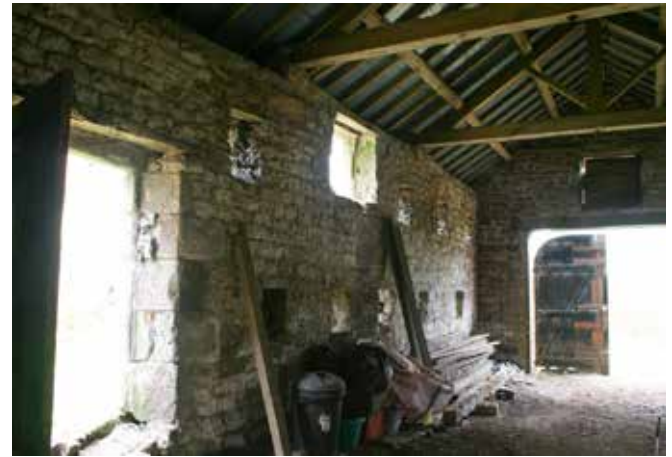
Left - three-bay threshing barn with multiple levels of ventilation for an open internal structure. Right - the door on the left is the main door, the two pitching eyes enable a continual process of adding unthreshed crops into the barn during harvest, until it slowly filled up. The large double-doors opening in the northern gable is a 20th century insertion.

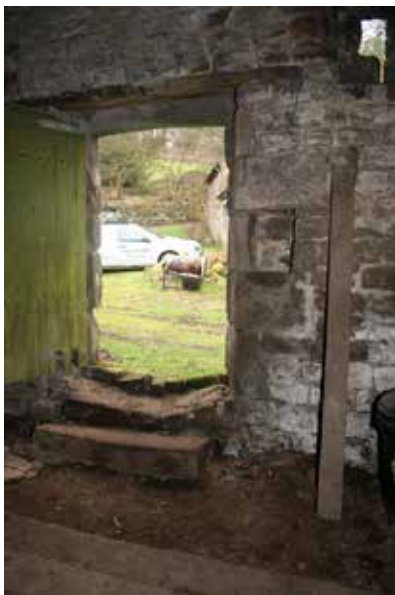
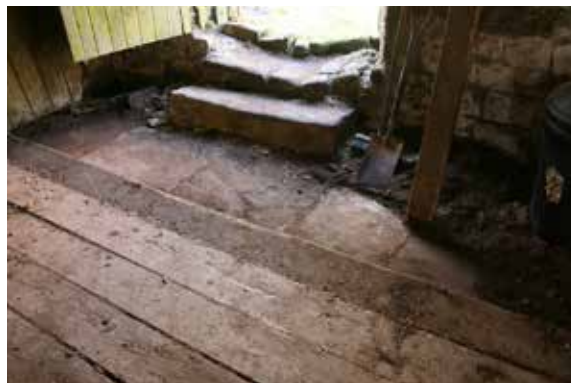
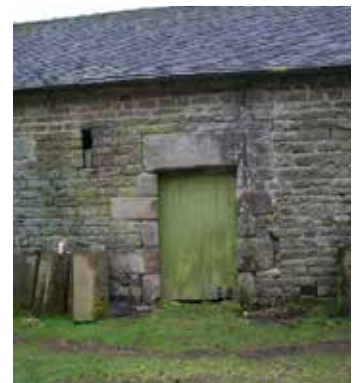
Main door (left) with keeping hole to the right. Above - stone threshing floor and 20th century butted boards, which may have replaced an earlier timber floor. Right - front elevation of wide doorway to threshing barn.

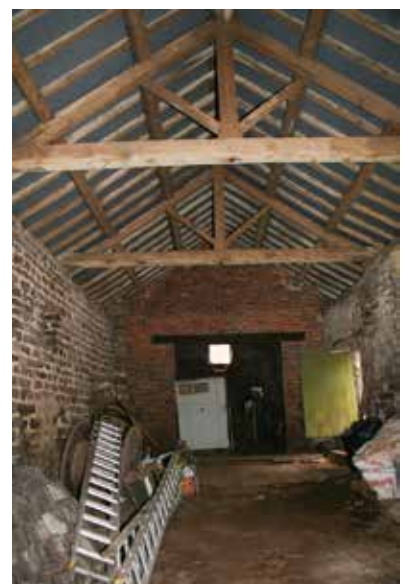
The building was re-roofed during the 19th century with a king post truss construction (pictured right) and double purlins but we can establish from the physical evidence that it once had a very different roof structure; during re-roofing in the 19th century the principal oak posts, with the tied trusses and struts were replaced with the present pair of brick piers. The roof was still supported in part by the existing stone eaves to the western side (facing the slope of the hill), but the roof pitch was lowered, which necessitated the removal of the stone coped gables and some of the larger verge stones. The reconstruction drawing (Plate 4) shows how this was carried out, leaving a section of the original large verge stones in-situ in the lower catslide wall.

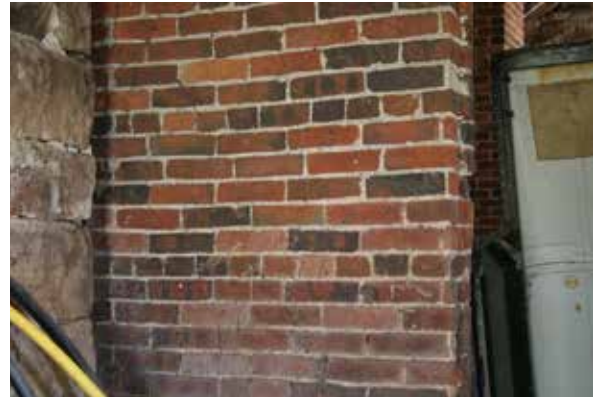
The two halves of the building were separated in the 18th century by a brick dividing wall. The lower section of brickwork is built in English garden wall bond and the bricks measure $9\frac{1}{2}'' \times 2\frac{1}{2}''$ (pictured right). Although there were government statutes controlling brick sizes, local guilds still tended to control brick sizes, and it is not always reliable to use this for dating evidence. Nevertheless, we can definitely see that the brickwork predates the mid 19th century brickwork and the bricks are a similar size to the brickwork in the Stable block. They were probably made after 1725, when place bricks were to measure $9'' \times 2\frac{1}{2}''$ by statute.

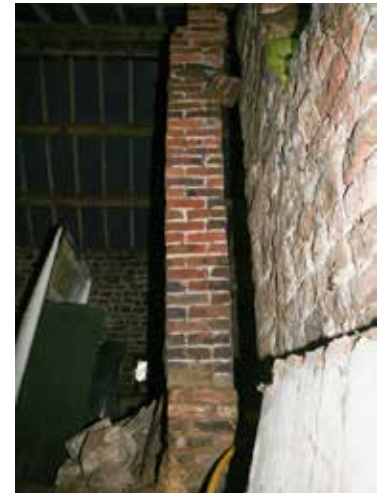
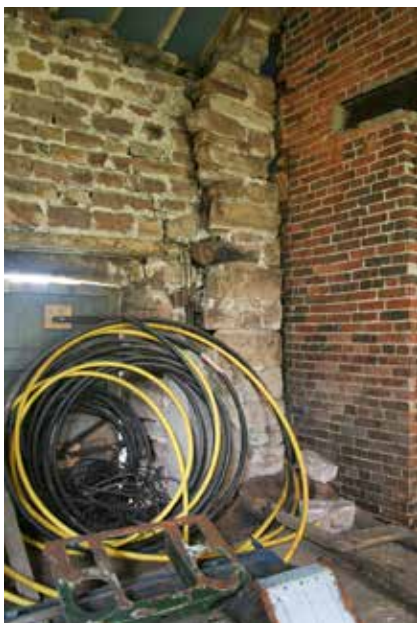
The large lump of coursed and dressed masonry which survives near the large brick dividing wall (pictured left) seems to represent the point at which the barn was originally divided. This masonry has no reasonable explanation other than that it was required to support both the base of a truss to the long western wall and the end of the wall-plate for the southern section of the building. The construction techniques are consistent with other parts of the early masonry, with long dressed stones. They appear to be left unfinished deliberately, rather than represent a section of masonry that has been removed, and the long eastern masonry wall of the threshing barn is recessed behind this inner corner; this could simply be explained as a reinforced section of masonry, required at a point in the building which was supporting two roofs.
