HBL ASSOCIATES LTD.
STRUCTURAL REPORT

RIDGEFIELDS FARM

CELLARHEAD

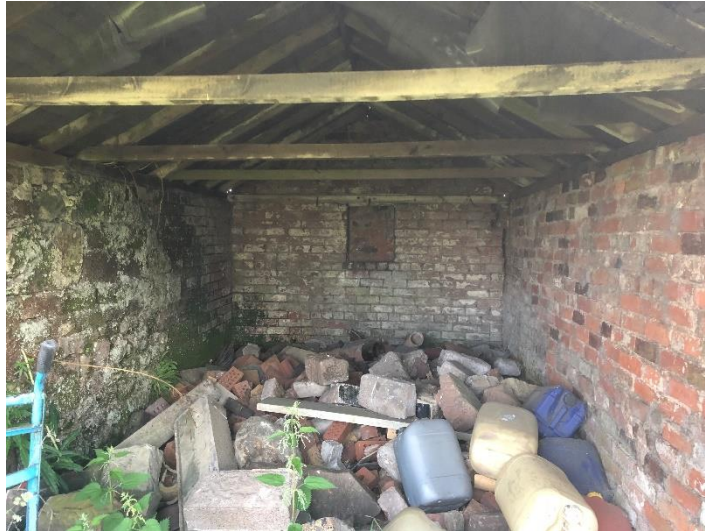
Figure 2-2

- 2.2. The buildings followed a common construction pattern of coursed stonework to all of the walls other than the garage building to the extreme front edge of the proposal which was part stone and part brickwork. All of the tiles on the single storey and two storey sections were recorded as Staffordshire Blue clay tiles supported on traditional rafters and purlin constructions in each case.
- 2.3. The floors were primarily concrete in the areas which were formerly livestock pens with blue brick floors elsewhere. No discernible floor slab was visible within the garage although this was somewhat overgrown and filled with debris at the time of inspection.

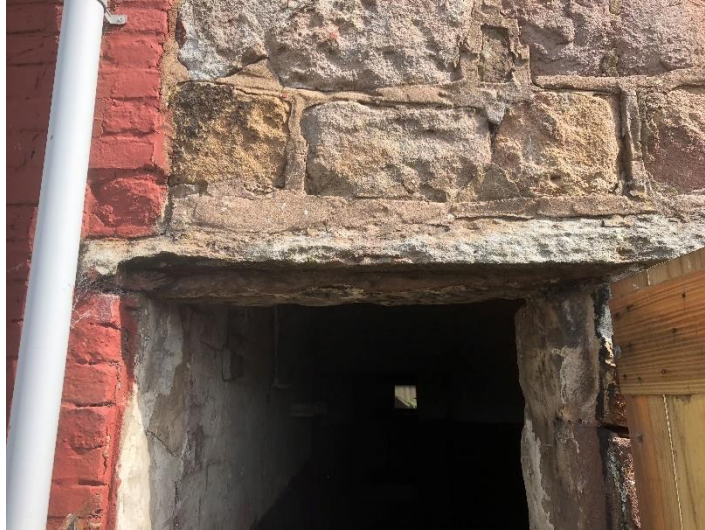
Figure 2-3

- 2.5. Within the coursed stone walls the door and window openings were framed with cut stones lintels with a timber backing, with some minor movement being present in the form of repaired cracks over the primary entrance immediately adjacent to the farmhouse.

- 4..6.3. Stiffening of the existing stone/timber lintels above the door and window openings on the external walls. We would suggest that at least the lintels to the inner parts of the walls are removed and replaced in either pre-cast concrete or in a steel box section.

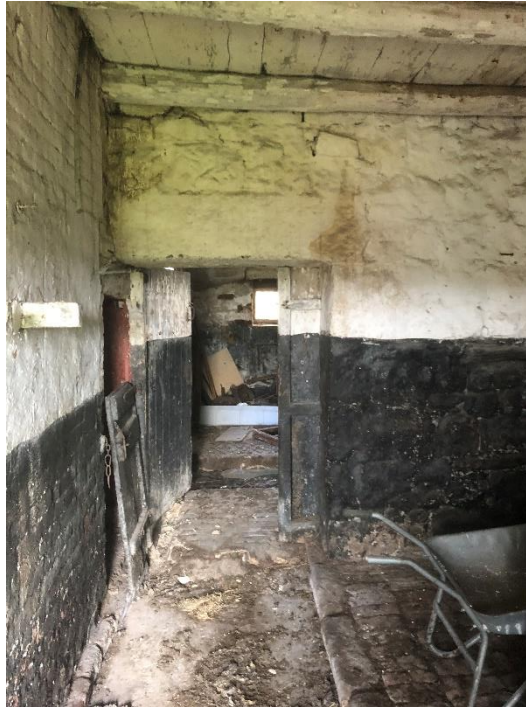
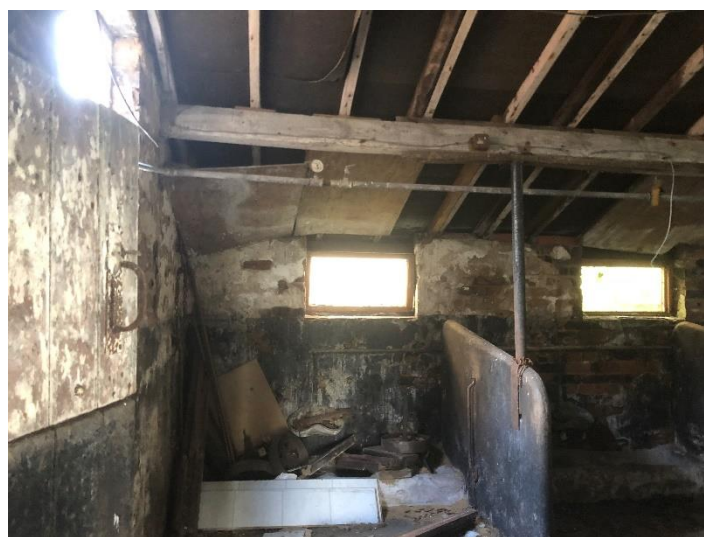
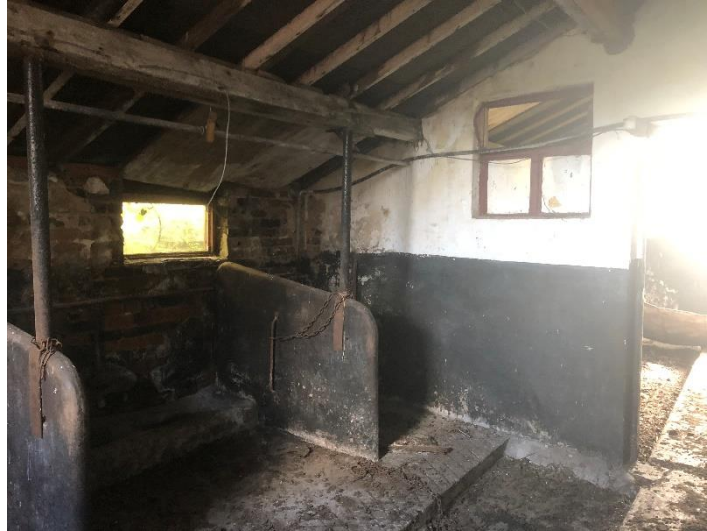
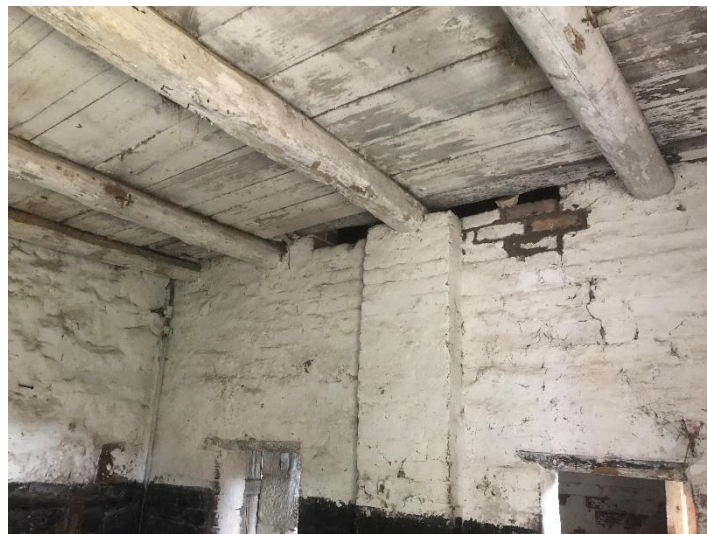
- 3.1. The existing ground floor was noted as being part concrete and part blue brick with the blue brick sections of floor in particular being uneven beneath your feet. Obviously neither of these floor slabs would have any insulating properties and will require renewal with a new insulating slab should the buildings be refurbished for residential use. The concrete slabs within the stock holding areas also incorporated reinforced concrete pen division partitions which will also require removal. These would be reinforced and tied into the floor slab and will require some considerable work to break out:

- 4..6.1. Replacement of the existing windows in UPVC or hardwood double glazing units.
 - 4..6.2. Replacement of the ground floor slab with a suitable threshold and insulation either beneath or below the slab to bring the floor into line with building regulations.

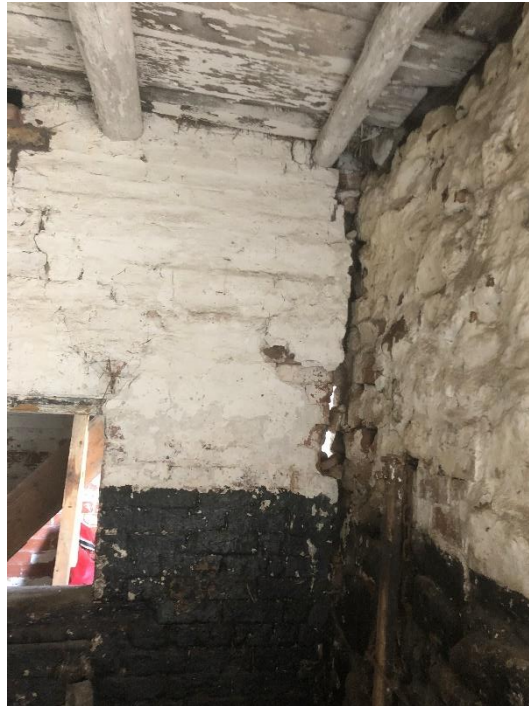
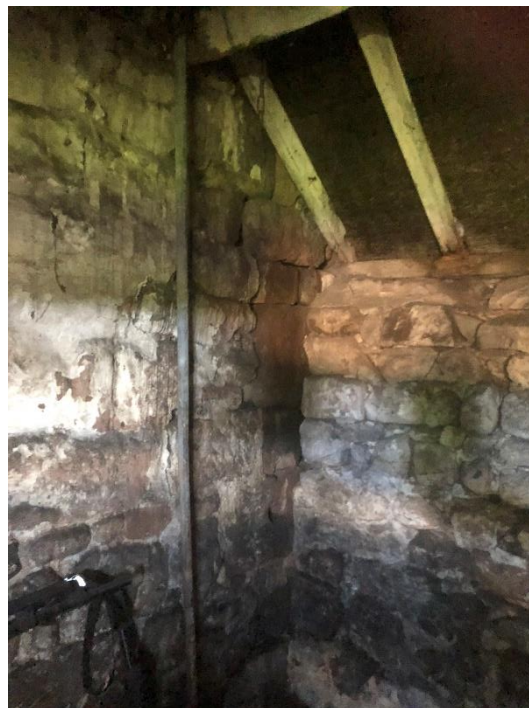
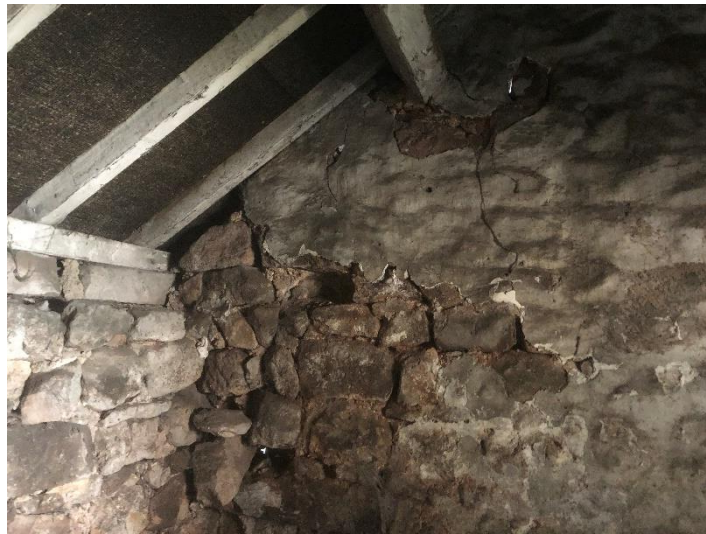
- 3.2. A number of the internal walls (in effect the vast majority of the internal walls) would not be tied into the external stonework and could be seen to be visibly pulling away at the interface between the internal and external walls.

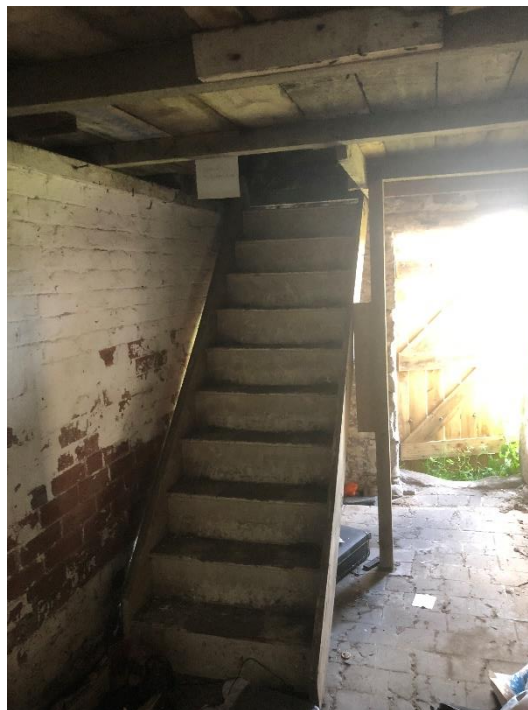
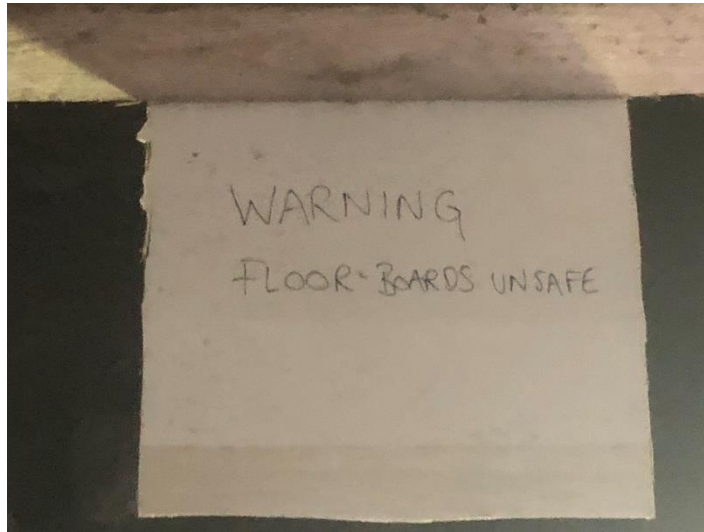
- 3.3. The first floor was accessed via a single timber staircase adjacent to the main entrance and was seen to be comprised of conventional timber tongue and groove boards supported on irregularly cut floor joists. There was signage indicating that the first floor was unsuitable for use and even in the aid of a ladder used as a crawling board, the floor was showing some degree of deflection under a single persons weight. As such a full survey of the upper floor could not be carried out for safety reasons.

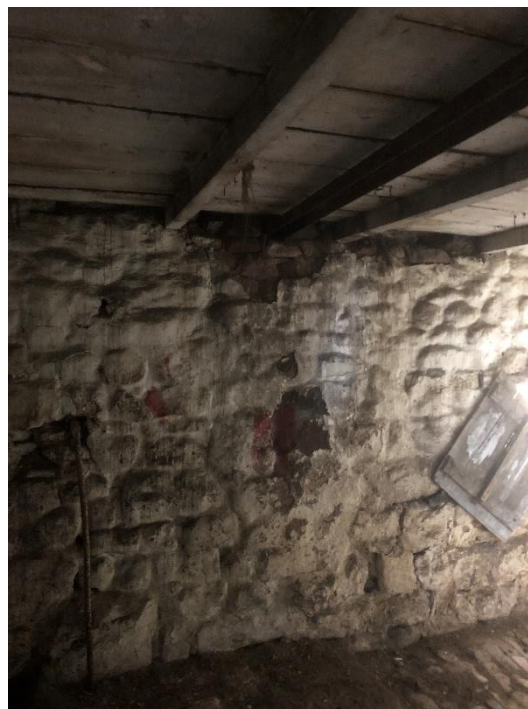
Figure 3-6

- 3.4. The floor was examined from below however and signs of rot and work infestation were present in the majority of the joists and boards which would suggest that the entire first floor structure would need to be stripped out and burned prior to replacement.
- 3.5. As a result of the first floors inadequacies, the underside of the roof was inspected from ground floor level where possible and from the head of the first floor access stairs.

- 4.2. The first floor timbers were in very poor condition structurally and we would suggest that the first floor will require stripping out and renewing completely.

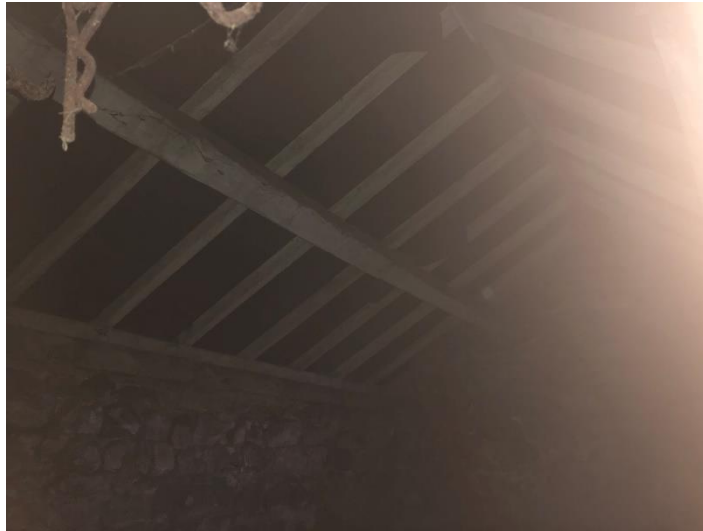
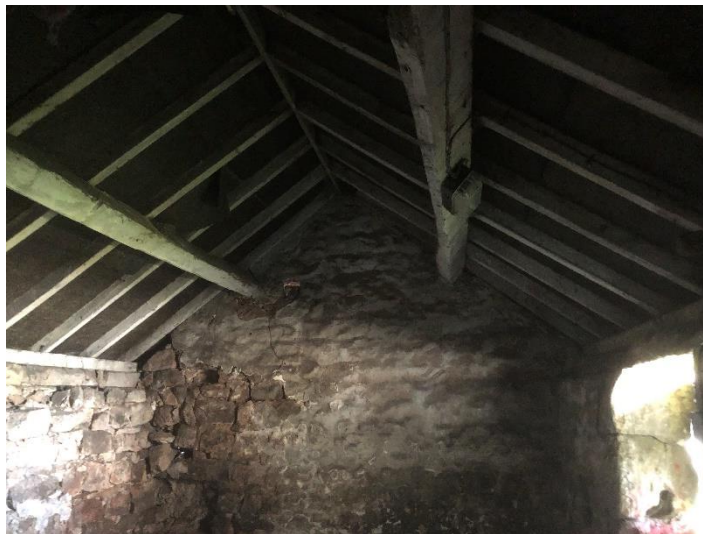
- 3.6. It was noted that whilst the roof purlins appeared to be performing their function adequately, some degree of vertical deflection was present in the primary purlins and also in the rafters, this was visible both internally and externally.
- 3.7. Given the above and the lack of formal roofing felting it is envisaged that the roof would also require renewal if the buildings were to be adapted for residential use.

- 4.3. The roof structure, whilst in a better condition than the first floor, showed signs of deflection and beetle infestation in the purlin ends where visible, again we would strongly recommend that the roof structure is stripped out and reconstructed.
