**BS 5837:2012 Tree Survey Report
& Arboricultural Impact Assessment**

Location;
Land to the rear of 14 Market Place,
Leek,
Staffordshire, ST13 5HH

Date of Inspection;
08th August 2018

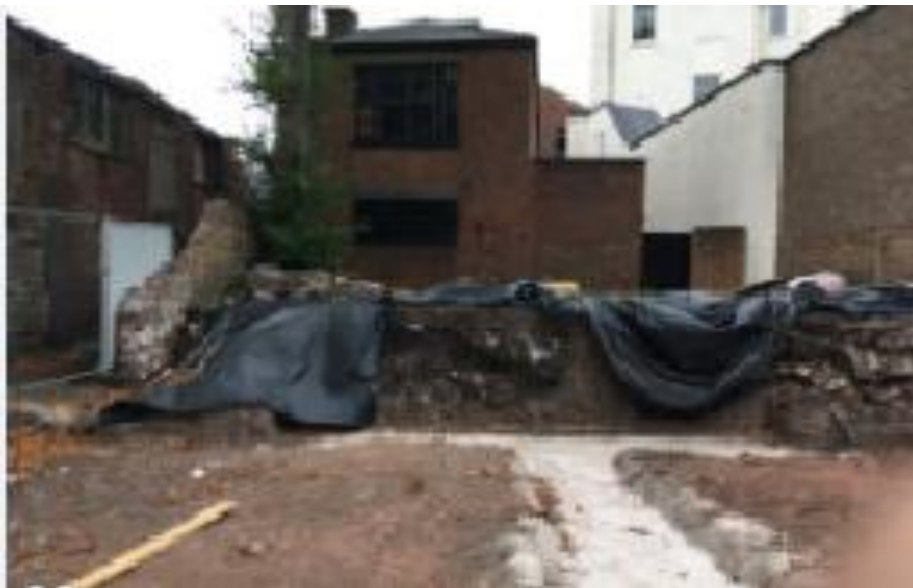
Fig 2: The change in ground level, looking from the South of the site. T1 with the basal shoots and epicormic growth on the trunk in the NW corner.

5.5: T1 Mature Lime, 20m high. Cat A. The tree is in fair condition. Previous tree work has left the tree with a high canopy. The tree sits on the higher ground within the site. The excavation to change the ground level has happened within the RPA of this tree, although no major root severance is noticeable on the edge of the cut ground. the tree is located very close to a wall, just to the West of the tree, the ground on the other side of the wall is also lower than the tree, Fig 2.

8.1: The excavation that has previously occurred within the RPA of T1 will have caused damage to the root system of the tree. All efforts must be made to prevent further damage to the tree or its roots. The partial loss of some of the roots system from T1 will cause stress to the tree, this may manifest into parts of the crown dying. Re inspection is recommended within two years.

All impact on the local trees will be negated by using the tree protection plan and keeping to the AMS. The partial loss of some of the roots system from T1 will cause stress to the tree, this may manifest into parts of the crown dying. Should this happen the dead areas should be removed.

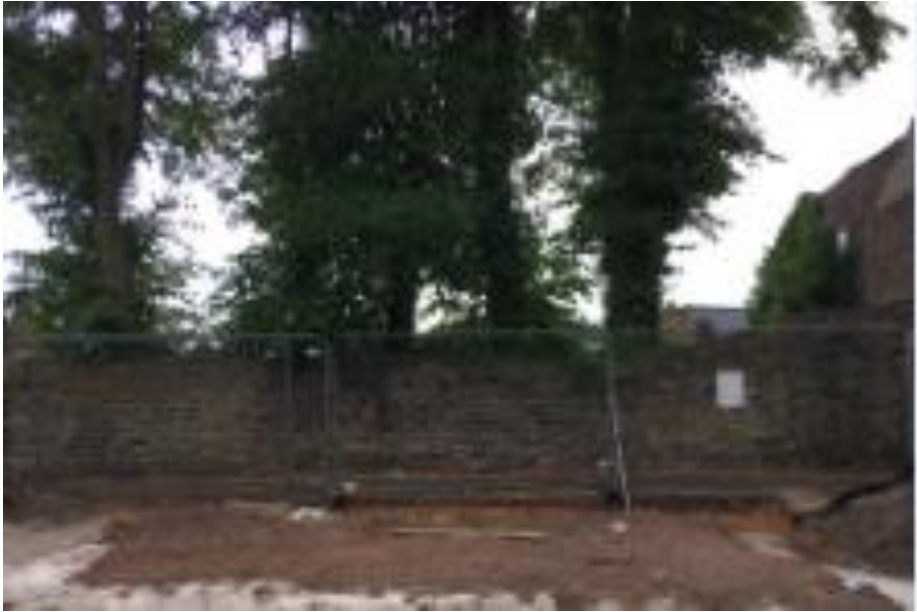
Fig 3: Looking to the West boundary. Showing the cobbled path, wall and the tree group on the other side of the wall.

5.6: T2 and T3 (the two largest trees in the group) are part of a group of trees, 3 Limes and a Holly 17m high. Cat B. Located to the West of the site. They are sitting on higher ground on the opposite side of a wall from the site, Fig 3. The wall seems well built without many large cracks or bulges. This points towards good foundations. This wall will have acted as a barrier to root growth. The cobbled path also has few defects in, again showing the lack of roots growing under it.
