**DESIGN, ACCESS AND HERITAGE STATEMENT OF SIGNIFICANCE AND IMPACT**

**PARKER HOUSE**

**2 Church Street, Leek**

**PROPOSAL:  
INSERTION OF OAK STRUCTURAL  
SUPPORTING FRAME  
NORTH ROOM FIRST FLOOR**

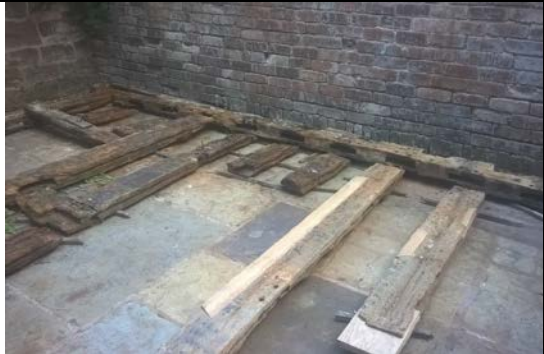
| North frame elevation frame elements being repaired | Ready for reassembly |

Careful repairs were being undertaken by an experienced oak carpenter using seasoned English oak ready for reassembly.

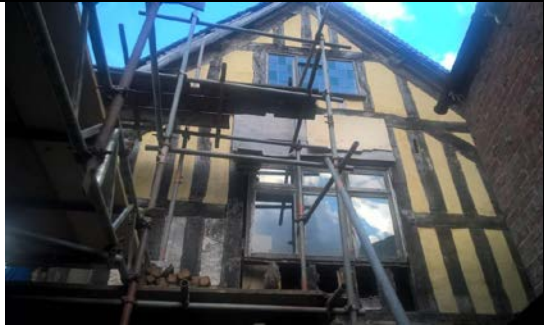
The west elevation remained in place and was stable.

| West elevation | View of north (behind sheeting) and west elevation |

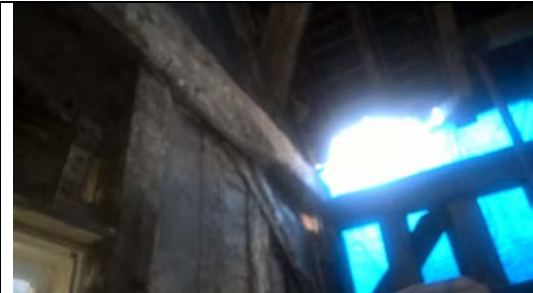
| Eaves beams which were unsupported at the north west corner | Corner steps to north west corner were taken down, the elements numbered ready for reassembly. |

Listed building consent is being sort in retrospect for a permanent internal seasoned oak frame which has been mounted internally on both the north and west elevations. This was installed as an urgent repair to ensure the structural integrity and stability of the intact west elevation. It was also installed to provide structural support at the north west corner which was unsupported after the collapse of the north elevation.

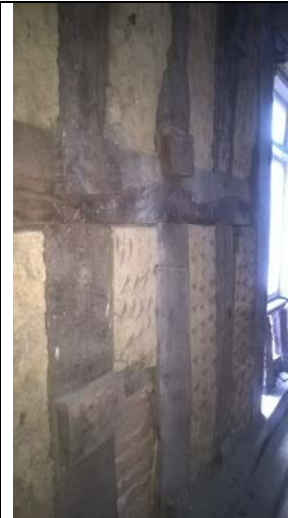
The wattle and daub panels on the west elevation remained in tact with little sign of alteration or improvement since they had been installed.

| Surviving wattle and daub west elevation internal view | | 1930's/40's 3 light window to be replaced within the restored frame to original size and detail; matching an existing leaded light window. | |
