**STRUCTURAL APPRAISAL OF**  
**MILL HOUSE**  
**OAK STREET**  
**CHEADLE**  
**STAFFORDSHIRE**  
**ST10 1NX**

DATE: SEPTEMBER 2020

OUR REF: A4940

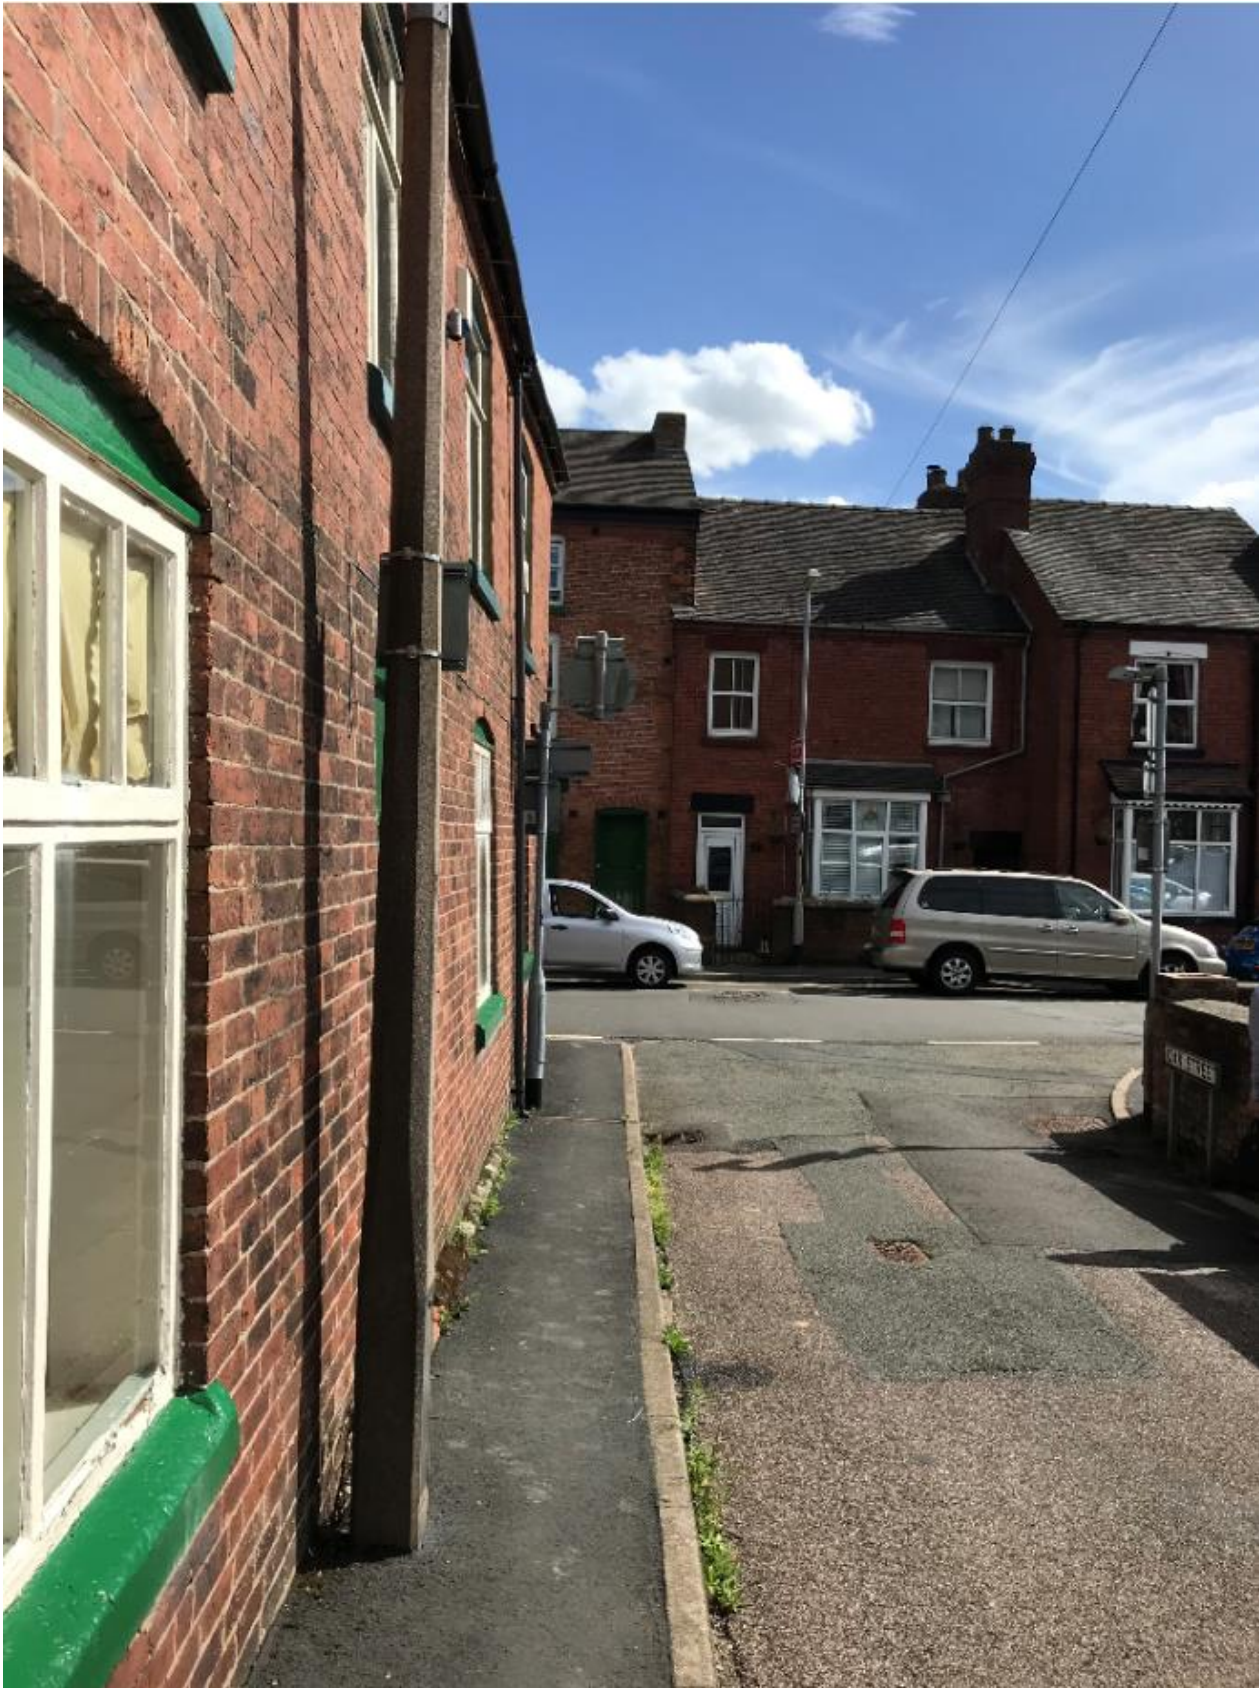
The building is located extremely close to the edge of the carriageways to its front and gable elevations; there is a footway of 600-800mm width to the front elevation (Figure 2), and the gable is immediately adjacent to Bank Street. To the rear of the property there is a small yard which falls within the curtilage of the nearby garage (Figure 3).

Figure 2 – front (western) elevation.

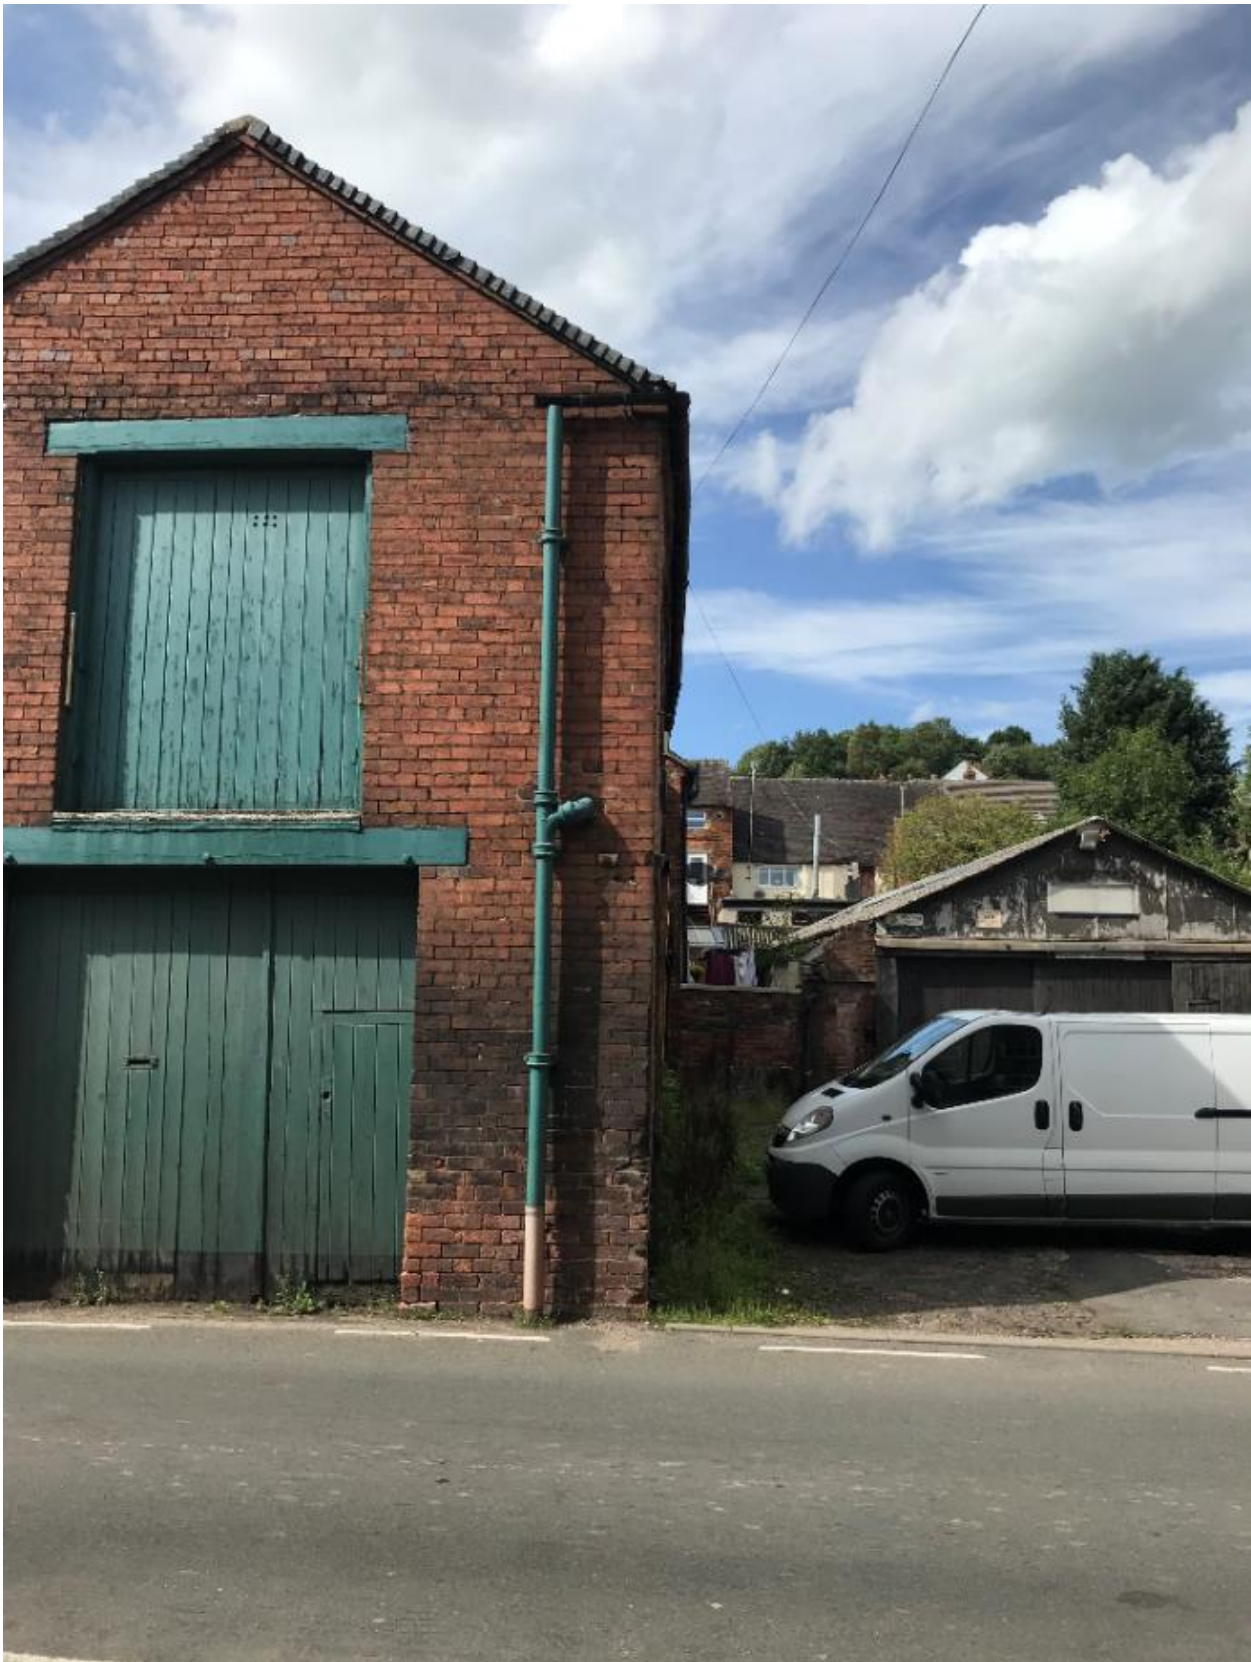
Figure 3 – gable elevation and rear yard

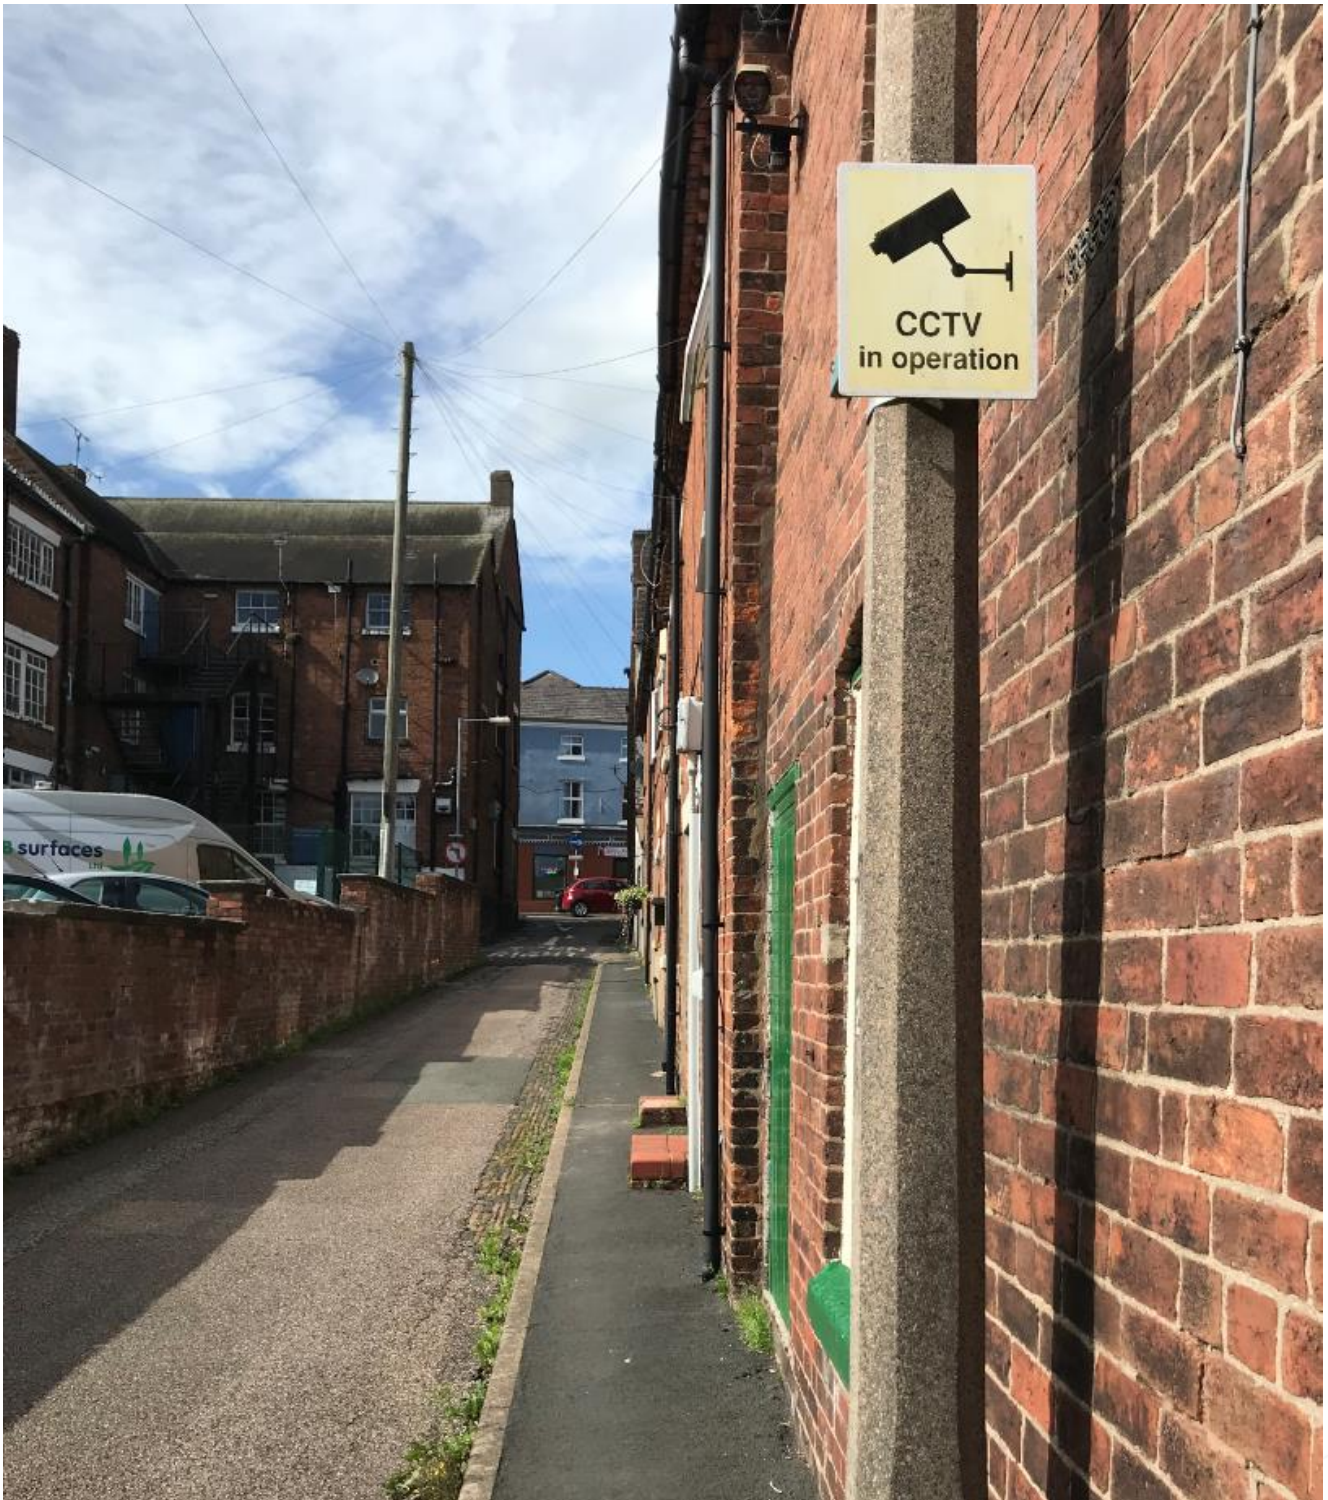
There is a slight inward lean to the front elevation brickwork along the whole elevation, most pronounced at the southern end of the building. There is evidence that Mill House pre-dates the adjacent (plumb) building (Figure 4), and that the lean had already taken place at the time when the neighbouring building was constructed (although both were built in the 1800s). This supports the assertion that the movement in the building is historic and not ongoing. The buildings do not appear to be toothed into each other.

Figure 4 – deviation of front elevation from adjacent plumb building

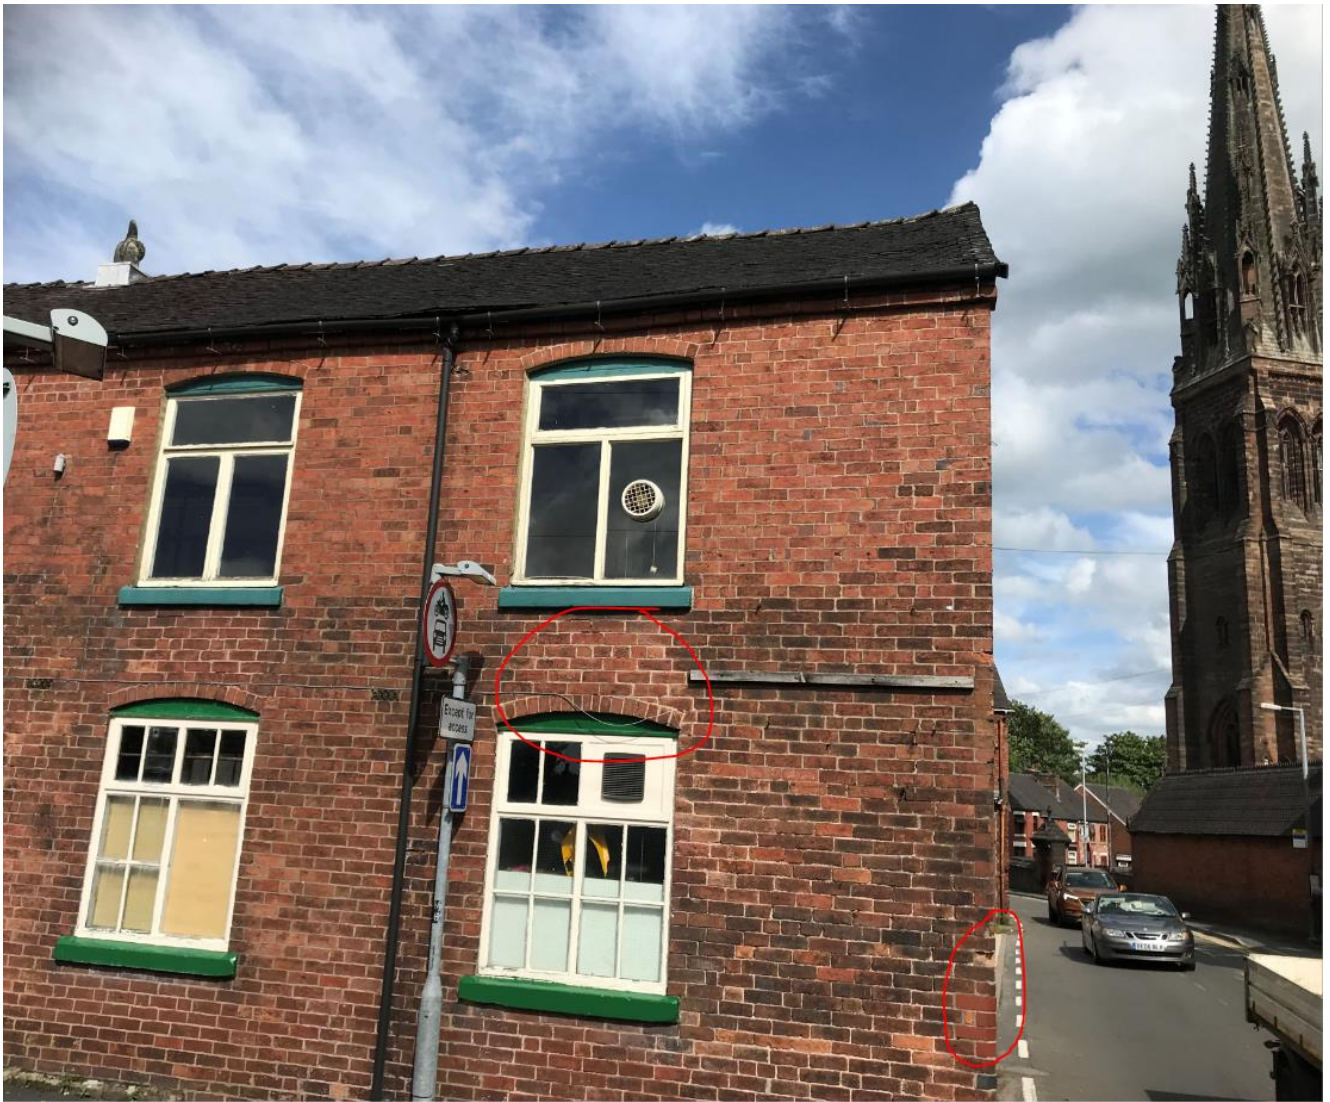
In spite of the historic movement in the property, there is little cracking in the front elevation brickwork. There is some evidence of past movement in the southernmost ground-floor window arch; the brickwork over it has been repointed (Figure 5). There is a patch on the southwestern corner of the building where several bricks have been replaced, clearly because of vehicular damage (Figure 5). At low level, some of the brickwork is somewhat weathered and the mortar eroded.

Figure 5 – cracked and repointed brickwork over arch, vehicle-damaged brickwork on corner

Cracked or excessively frost-damaged bricks on all elevations should be chased out and replaced with suitably matching materials. The property would benefit from repointing to all elevations with a suitable mortar mix and profile.

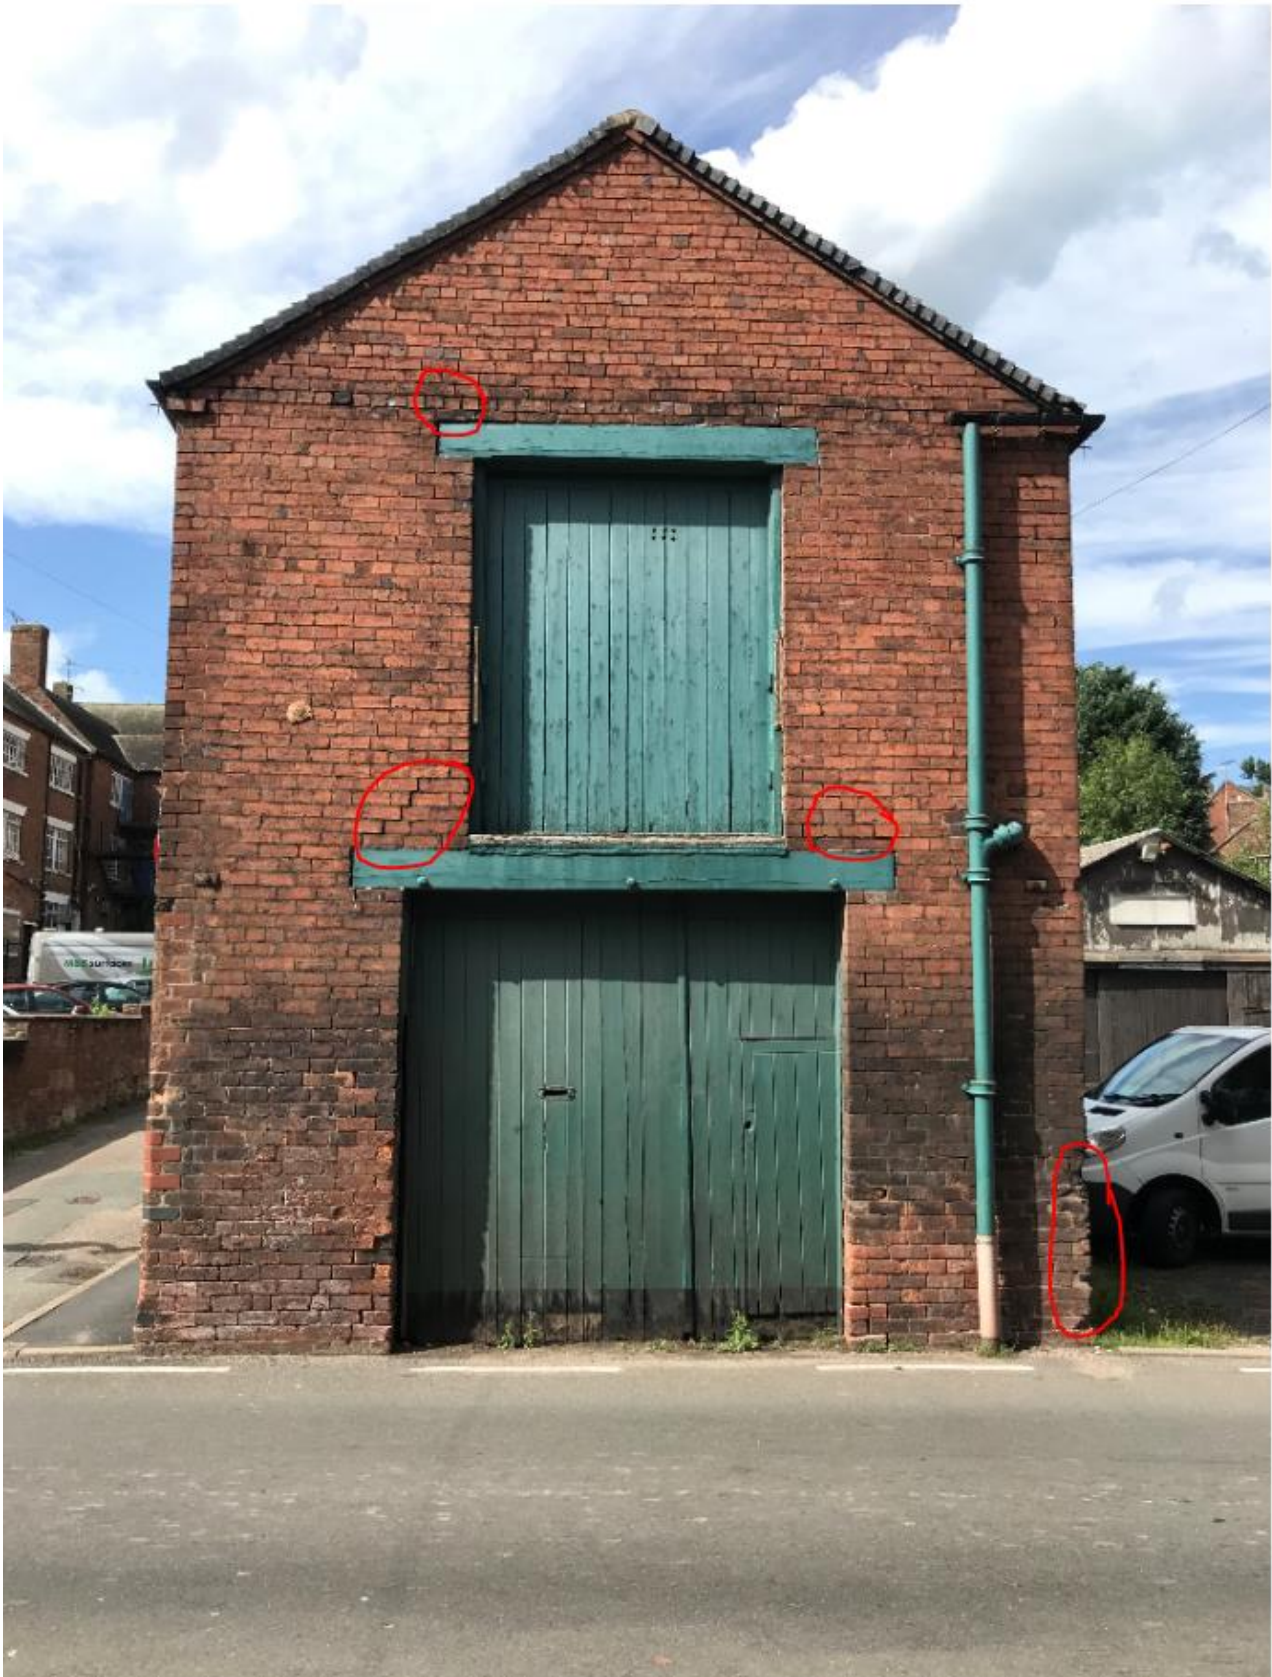
The gable elevation, directly on Bank Street, features 2no large doorway openings – one each at ground floor and first-floor level. The openings are surmounted by timber lintels which have evidently deflected and are giving rise to cracking above (particularly the left-hand end of the lower lintel), and there is vehicular damage to both corners (Figure 6). There is a noticeable belly in the shape of the wall.

Figure 6 – gable elevation; cracking caused by deflection of lintels, vehicular damage to corner

All timber lintels should be replaced with suitably-designed alternatives. We would recommend that the cracked masonry above the failed arch and lintel in the southeasternmost window should be locally taken down and rebuilt.

It is proposed that the ground-floor opening in the gable be infilled with masonry, which will add considerable strength to that wall panel. The cracked exterior masonry on the first-floor gable wall panel should be locally rebuilt once the existing timber lintel has been removed and infilled; the extensive cracks to the inside of the wall should be strapped over with 3mm x 30mm x 1200mm mild-steel straps, perpendicular to the crack direction and positioned at approximately 600mm centres.

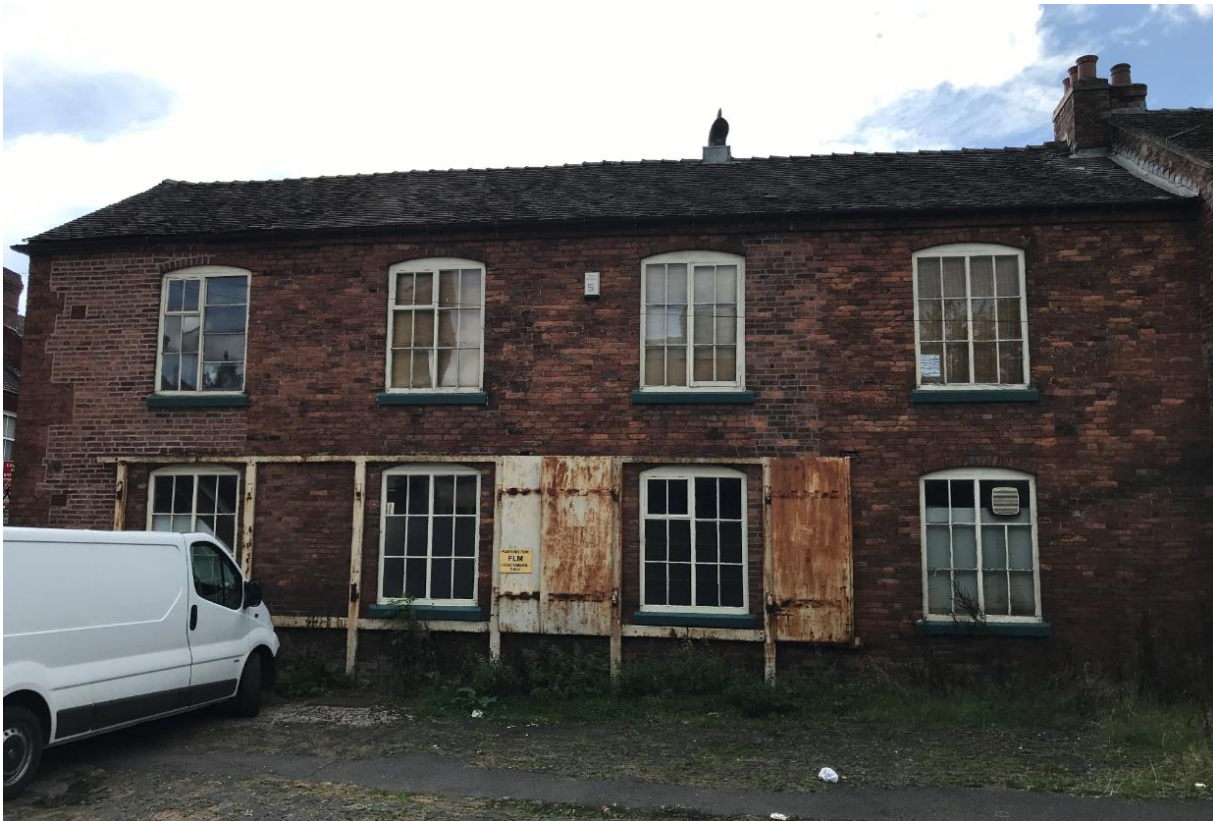
To the eastern elevation, a large amount of brickwork has been replaced, using bricks which are approximately three-quarters as deep as the original units, so that the toothing pattern is somewhat irregular (Figure 7). The corner brickwork appears to be slightly damaged, probably by vehicular impact, and much of the low-level masonry is affected by efflorescence (Figure 8). There does not seem to have been significant cracking or movement on this elevation, with the exception of over the

Figure 7 – eastern elevation; unsympathetic toothing and pointing of replaced masonry

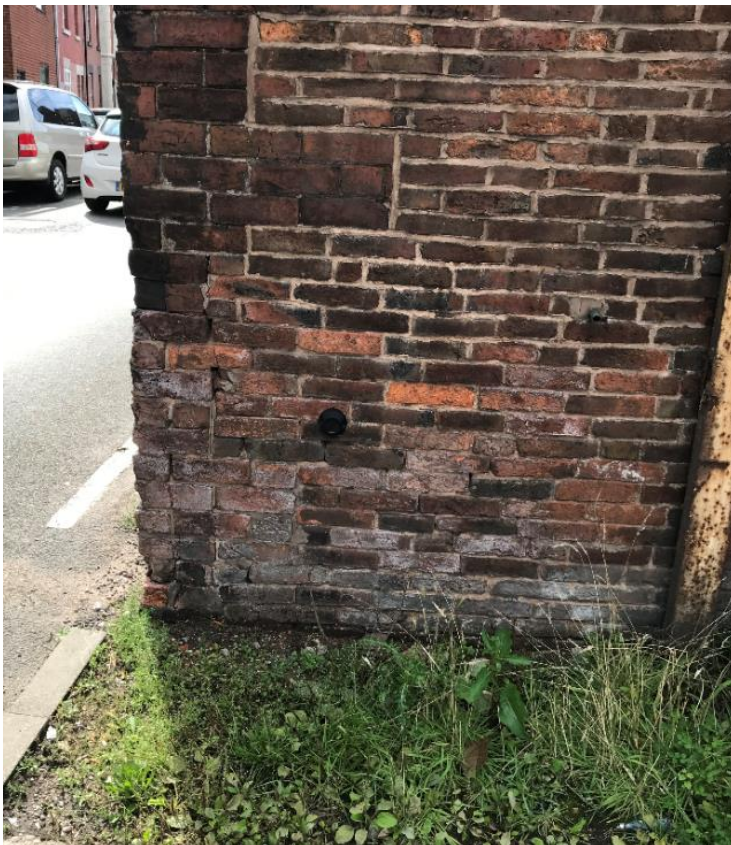
Figure 8 – efflorescence, poor condition of bricks and weed growth at low level

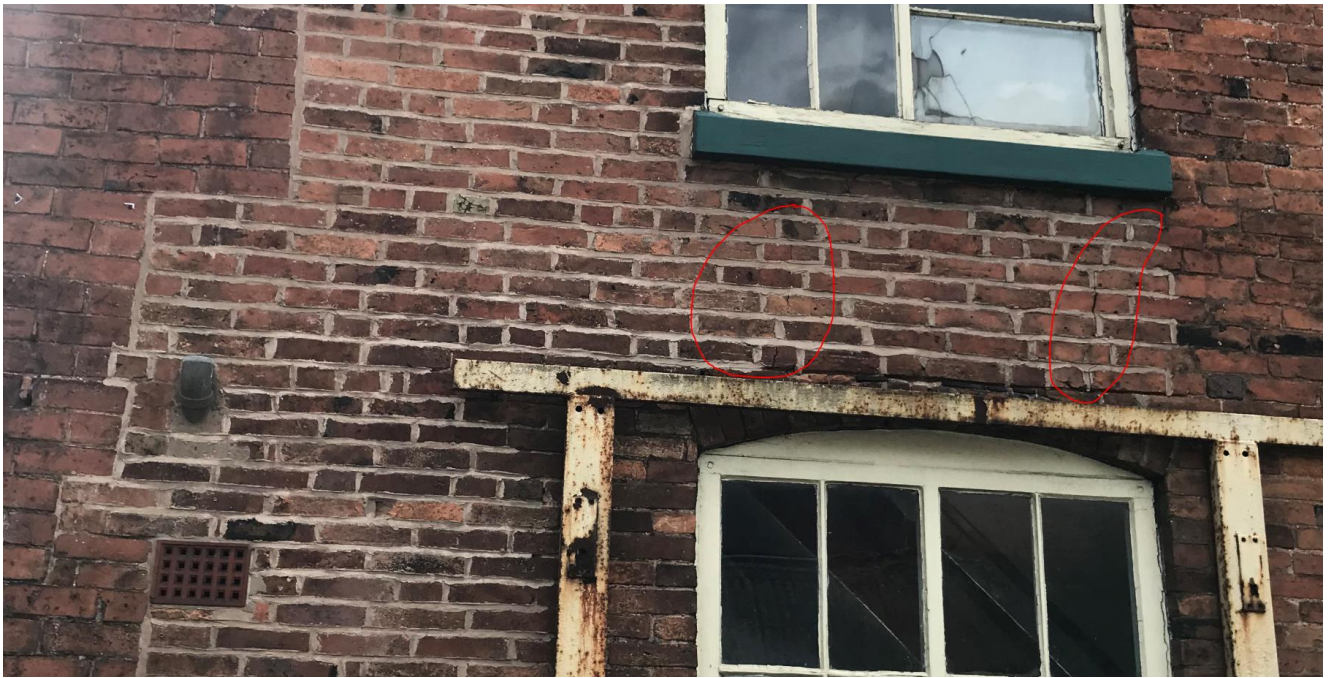
southernmost ground-floor window arch – Category 1 or 2 cracking (Figure 9). The overall sway in the building is less apparent on this elevation.

Figure 9 – cracked brickwork over window arch

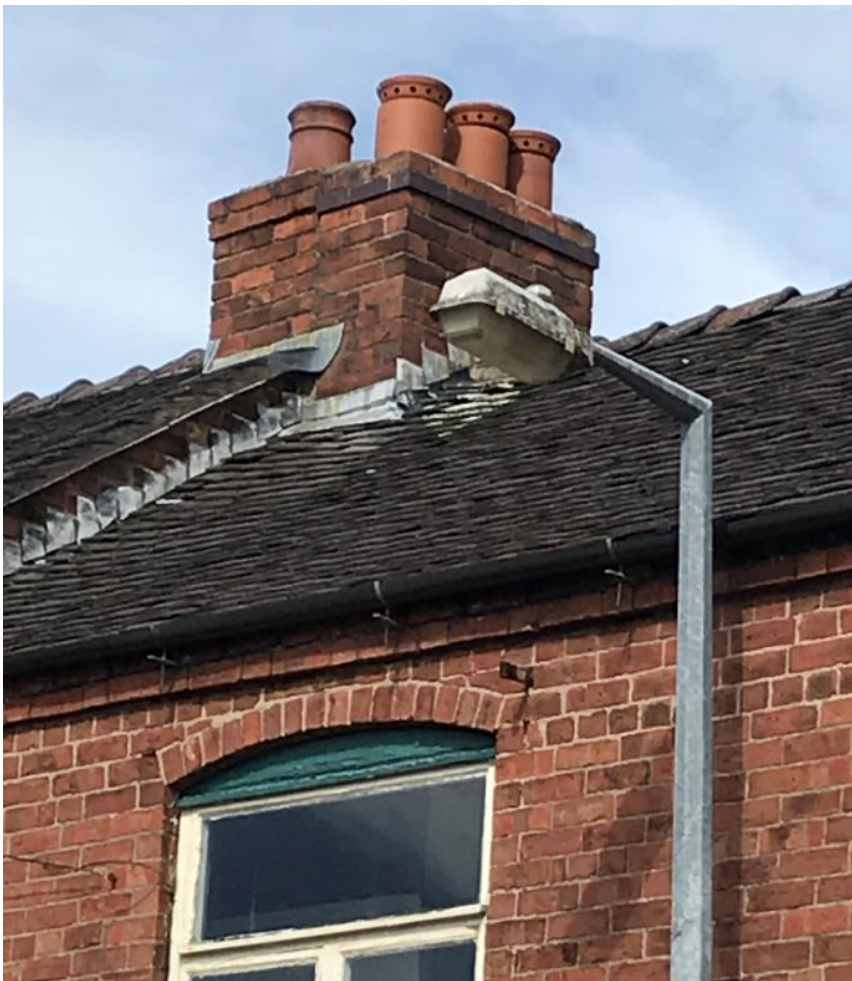
The roof, which is earmarked for replacement, bears Staffordshire blue tiles. There is a noticeable dip in the ridgeline away from where it is supported at the gables, and at mid-rafter, close to the chimney (Figure 10).

Figure 10 – bowling roof structure

It is proposed that the roof be stripped and refurbished. We would recommend that an additional purlin be installed on each pitch of the roof, close to the apex, to a suitable structural design. It may be possible to use a timber member, but otherwise a flitch beam could be designed for the purpose. This would substantially relieve the load from the existing purlins, and provide triangulation. The trusses are deemed to be in adequate condition to keep.

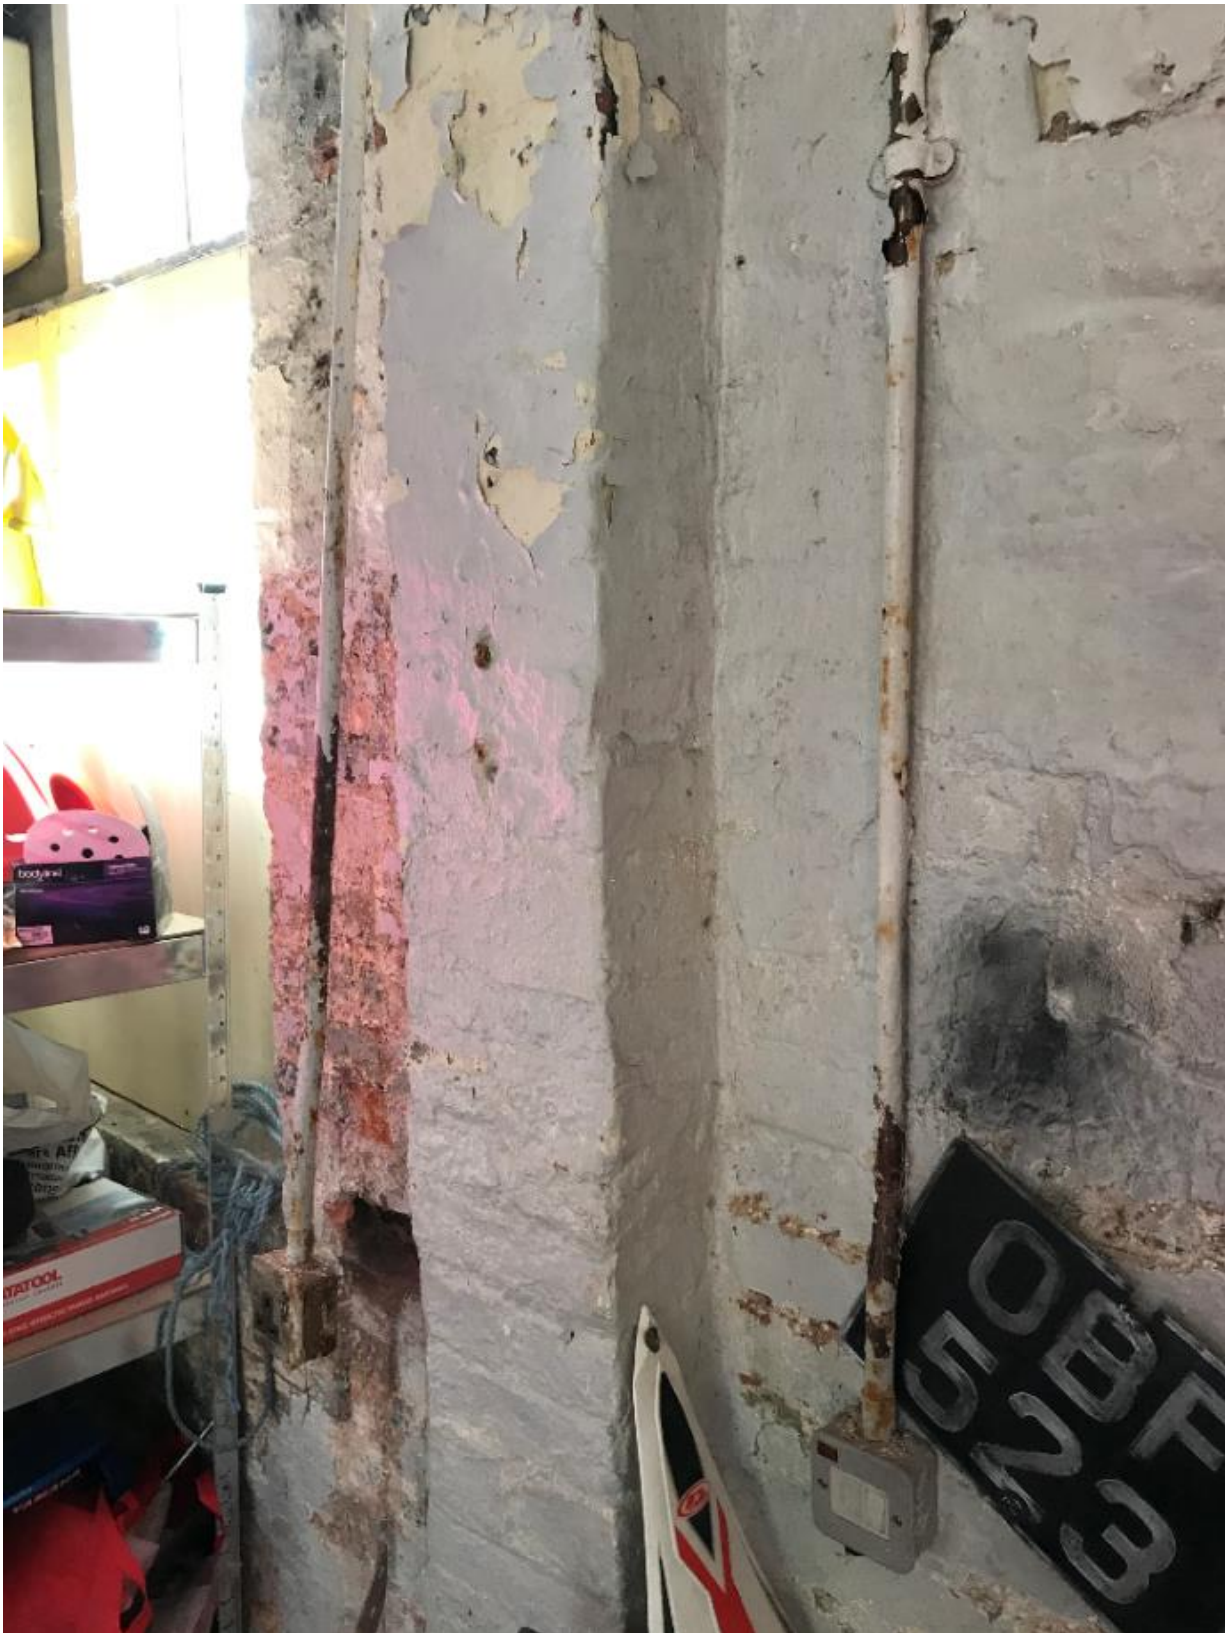
The elevation walls are buttressed at approximately 3500mm centres by 225mm wide x 125mm deep (overall 350mm deep) masonry piers (Figure 11). These piers support the 3no timber roof trusses onto which the roof purlins bear. The trusses consist of 240mm x 125mm bottom chords, 175mm x 100mm rafters and kingpost, and 100mm x 100mm counterbrace struts.

Figure 11 – typical masonry pier

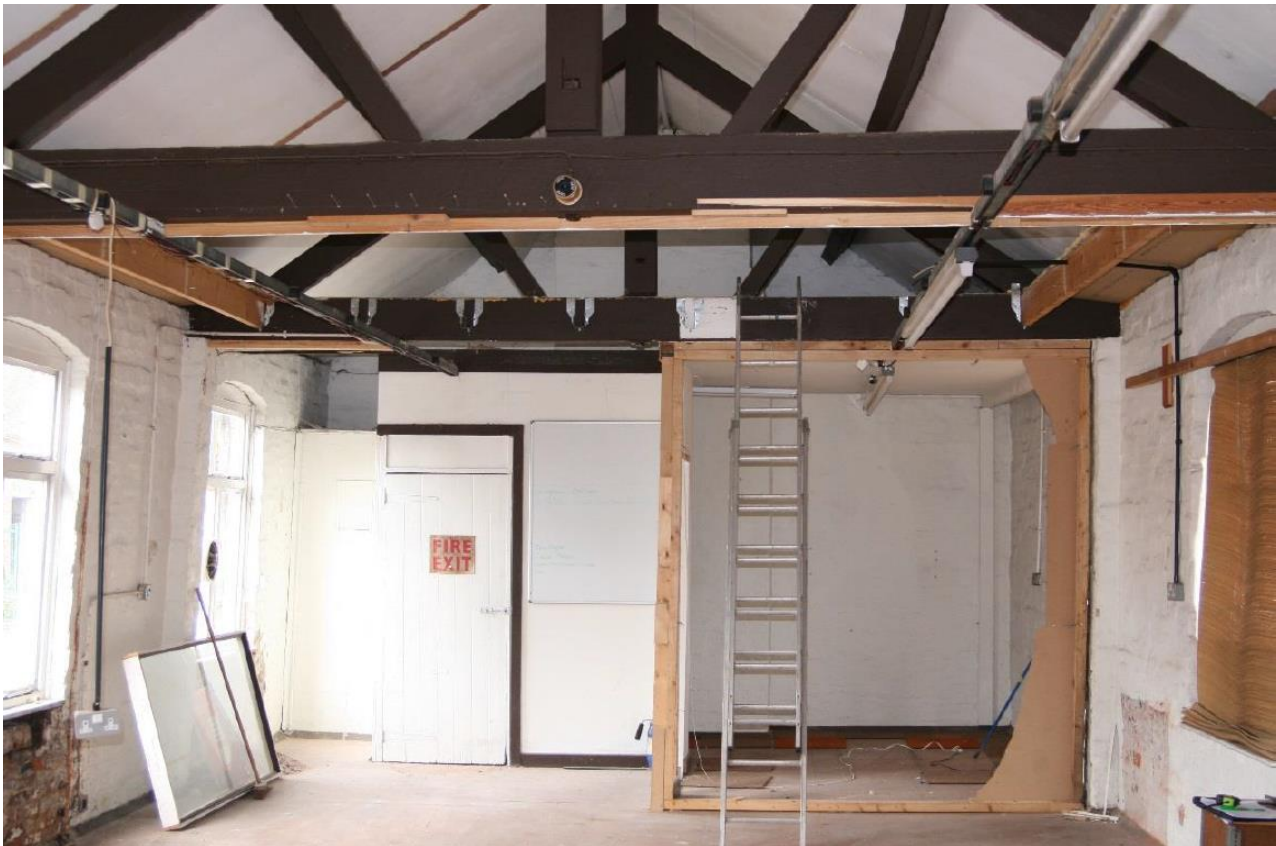
The purlins are 200mm x 100mm timbers, spanning 3500mm between supports, and they are aligned perpendicular to the roof slope, and are slender for their span. There is a single purlin per roof pitch and no structural ridge beam. Without a tie member across the roof within the bottom third of the rafter length, there is no effective triangulation to the roof except at the truss locations (Figure 12).

Figure 12 – timber major roof trusses (first floor, looking northward)

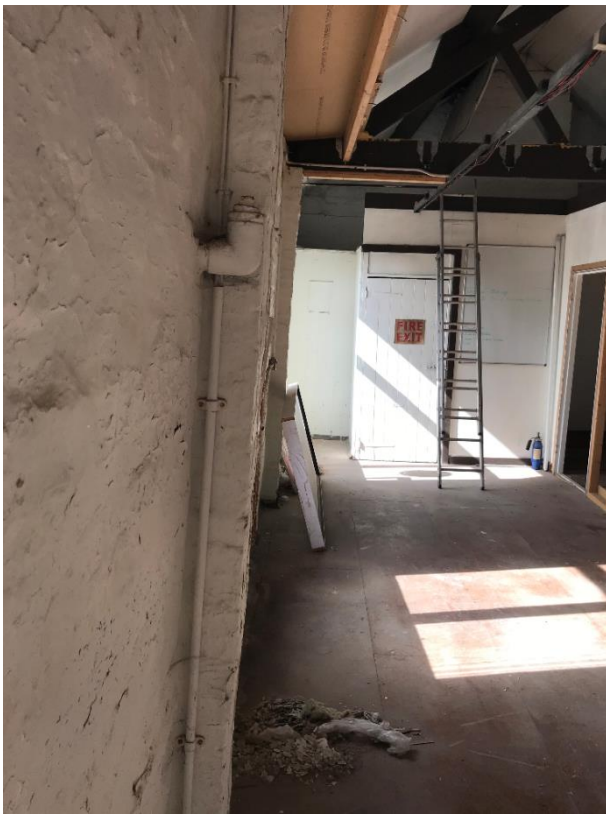
The leaning walls are apparent from inside the property – most obviously when viewed from the first floor (Figure 13).

Figure 13 – leaning elevation walls (extent exaggerated)

It is proposed that the property be divided into 2no units by the installation of a full-height 225mm-thick loadbearing wall on a thickened region of floorslab or new trenchfill footing, to one side or other of the central truss position. This would build considerable strength back into the structure and allow reconfiguration of the first-floor layout. Where the walls are perpendicular to the joists, strapping should be applied from the walls across the underside of the joists, in accordance with the requirements of Building Regulations Approved Document A.

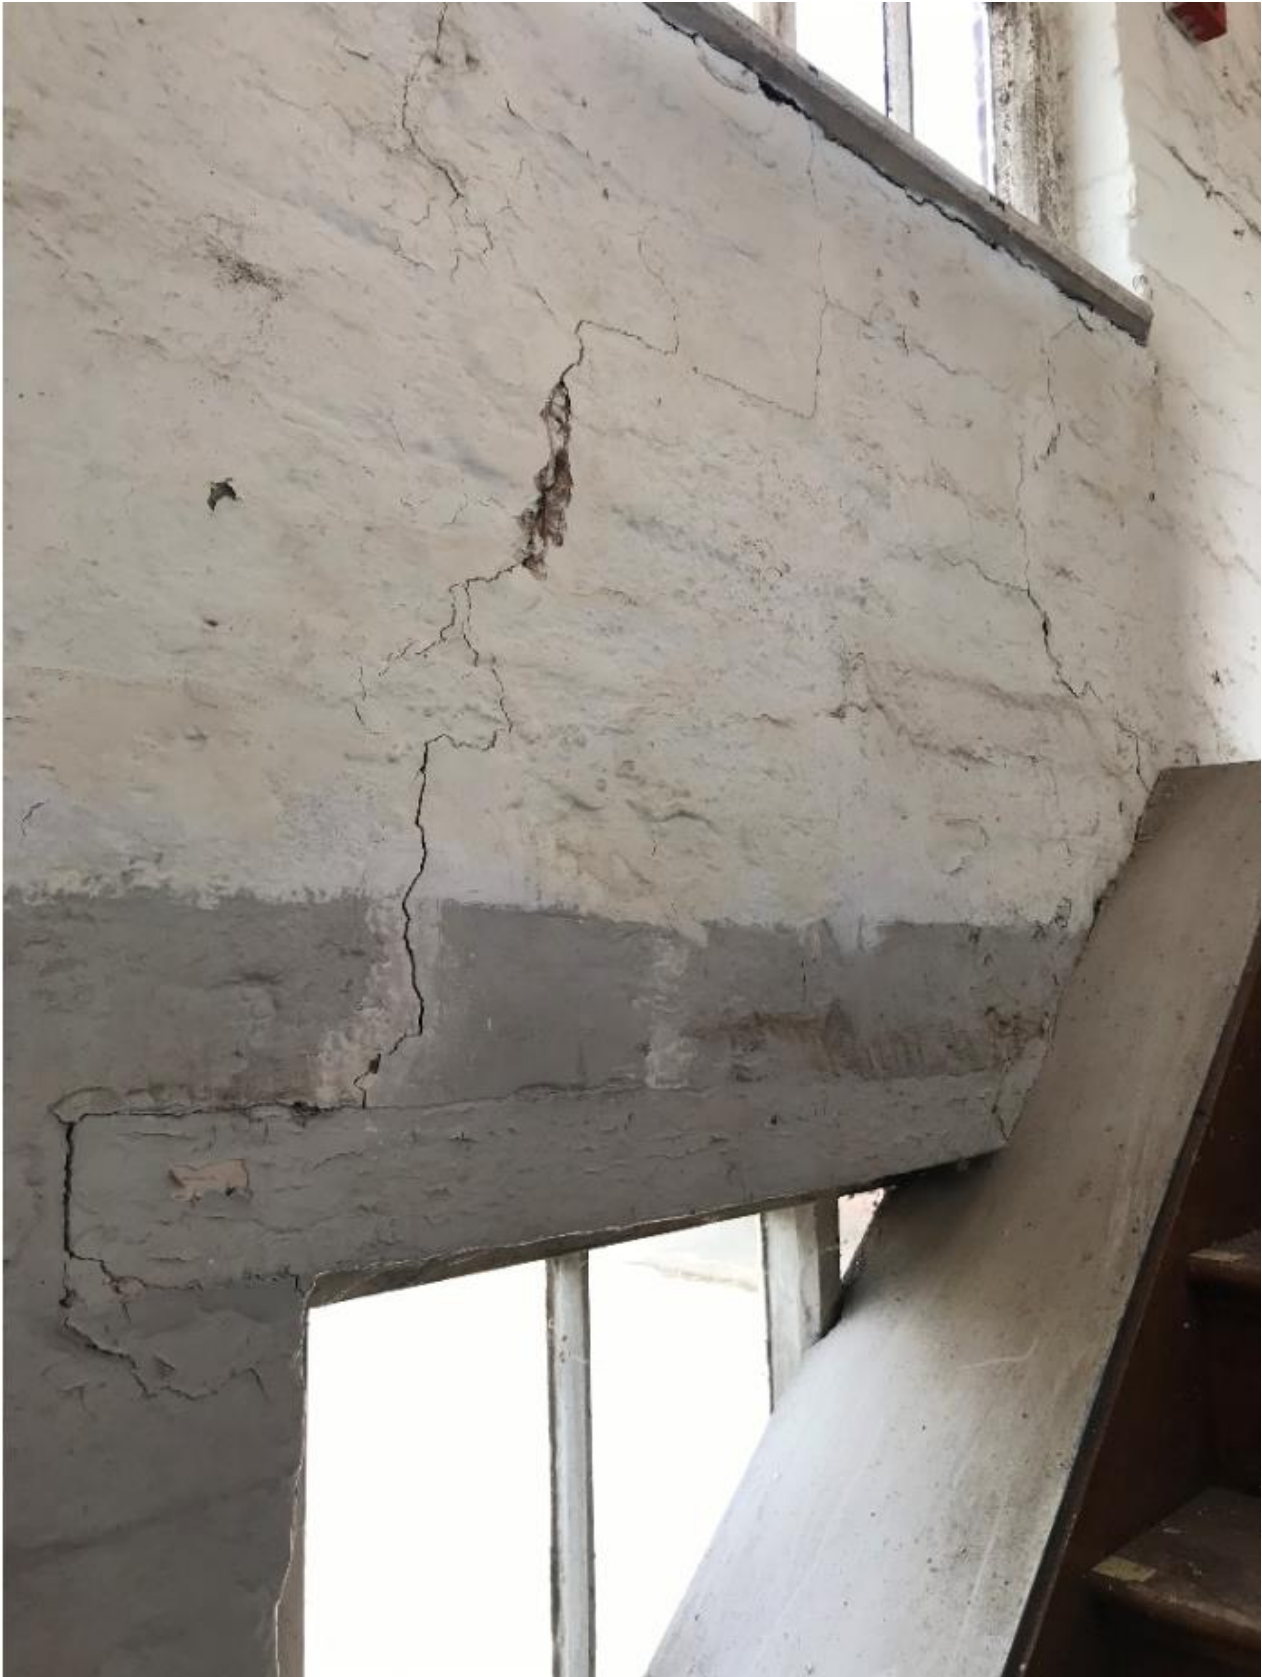
Largely on account of the flexible lime mortar, there are few cracks to the front and rear elevation walls, the exception being above the ground-floor window at the staircase on the southeastern corner, where the combination of timber lintel and shallow arch has given rise to movement throughout the masonry – Category 2 cracking (Figure 14).

Figure 14 – cracking to rear elevation wall over failed lintel
