**STRUCTURAL APPRAISAL OF**  
**MILL HOUSE**  
**OAK STREET**  
**CHEADLE**  
**STAFFORDSHIRE**  
**ST10 1NX**

DATE: SEPTEMBER 2020

OUR REF: A4940

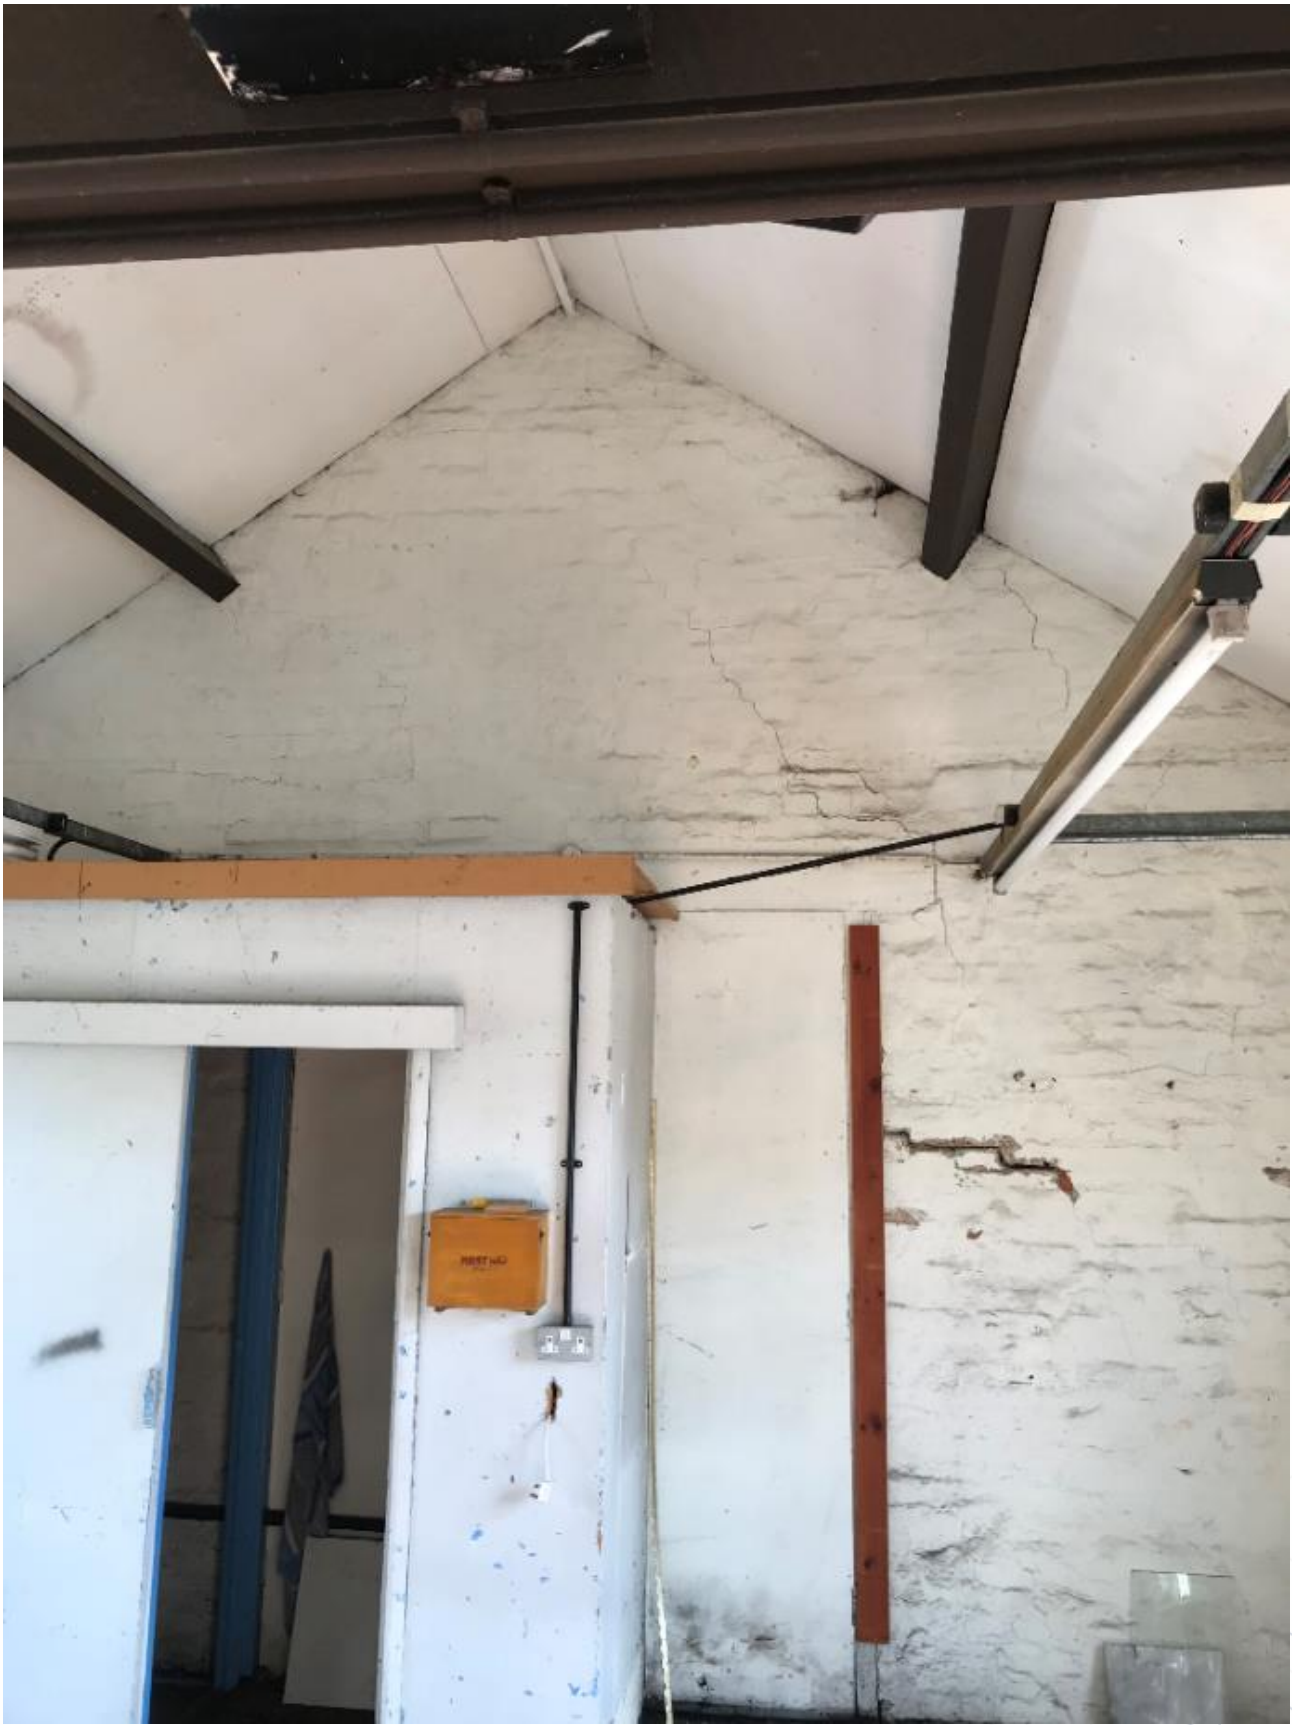
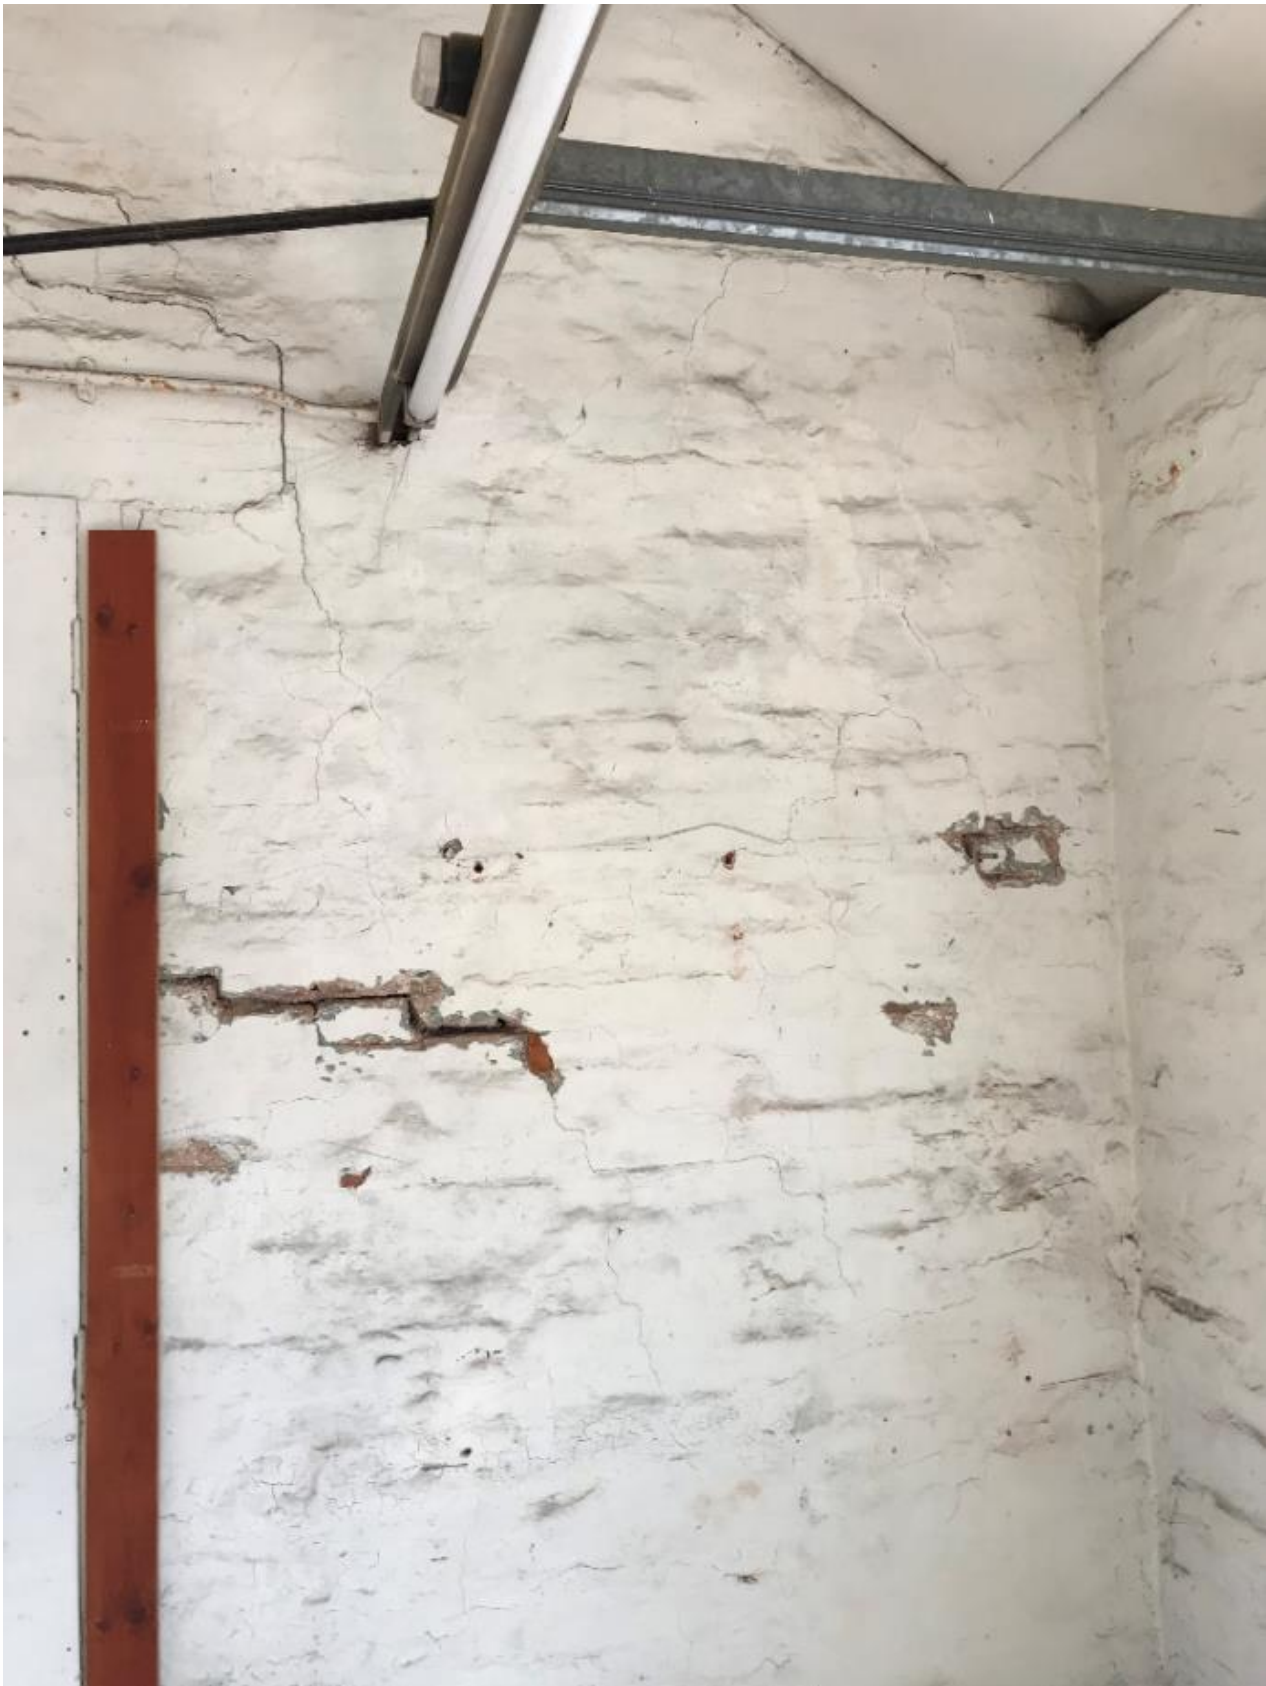
However, there is widespread cracking (Category 3 – Category 1) in the gable wall, particularly above first-floor level, where the sway of the building has caused shearing in the brickwork, already weakened by the large openings (Figure 15 and 16).

Figure 15 – cracking to gable elevation wall

Figure 16 – large and harline cracking in gable masonry

It is proposed that the ground-floor opening in the gable be infilled with masonry, which will add considerable strength to that wall panel. The cracked exterior masonry on the first-floor gable wall panel should be locally rebuilt once the existing timber lintel has been removed and infilled; the extensive cracks to the inside of the wall should be strapped over with 3mm x 30mm x 1200mm mild-steel straps, perpendicular to the crack direction and positioned at approximately 600mm centres.
