## **Building Fabric Condition Assessment**

### **PLANNING APPLICATION FOR THE PARTIAL DEMOLITION OF THE SINGLE STOREY PORTAL FRAME BUILDING at 14 FOUNTAIN STREET, LEEK**

March 2021

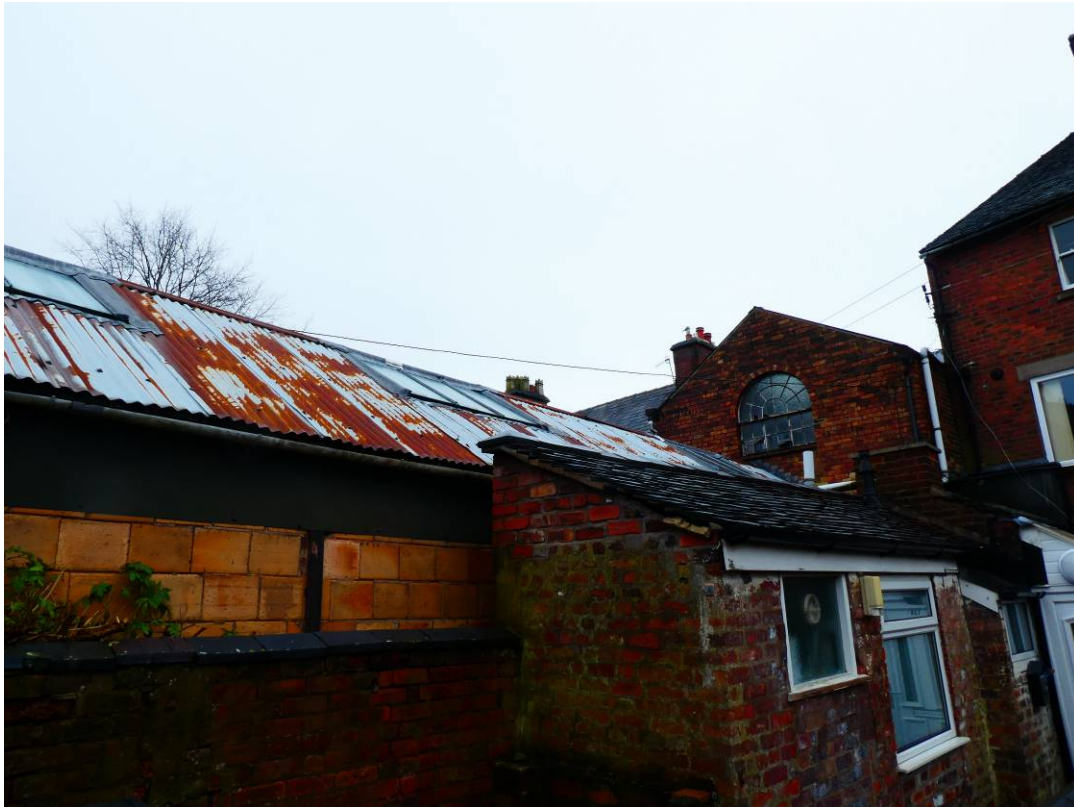
- 5.1 The rear of the building is only visible from the rear yards of neighbouring buildings, as such it is difficult to get close to carry out a visual appraisal.
- 5.2 The steel columns are exposed and proud of the block walls.
- 5.3 The block infill wall appears to be a sandstone block rather than concrete, built in a simple stretcher bond, but unusually this is only a partial bond rather than the normal half lap seen in the brick walls forming the garden wall and the building walls in the image below. The mortar joints have some gaps and need pointing with a lime/sand mortar to match the existing. Otherwise the external walls appear to be sound.

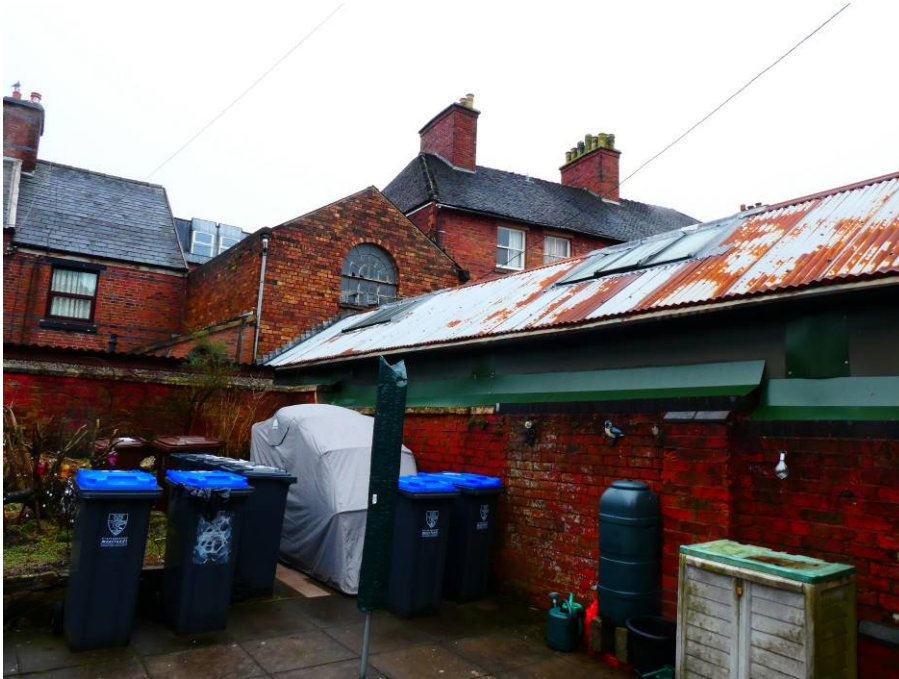
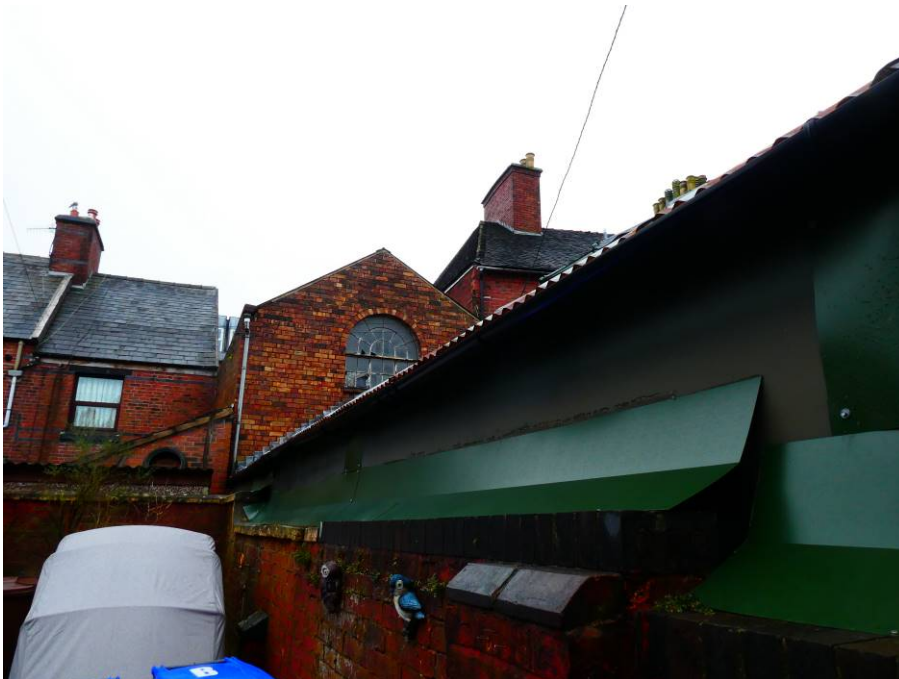
- 5.6** The eastern elevation can only be seen from the rear yard of the apartment block off Queen st. Additional pressed metal flashings have been screw fixed to the side walls, and dressed over the boundary wall, presumably the gap between the garden wall and the external wall of the subject building was gathering debris and water, causing damp problems inside the building,

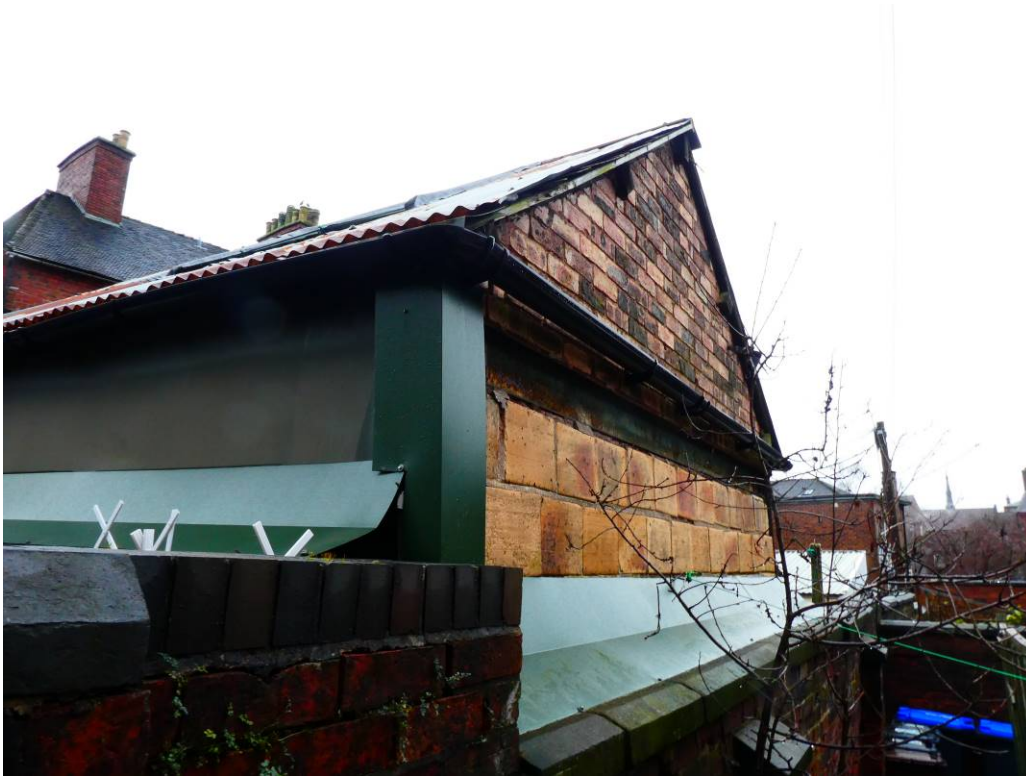
- 5.7** The rear gable can only be partially seen from the shared alley above the brick boundary wall. The flashing has also been fitted on the rear wall over the garden wall to keep the water away from the block wall. Again there is sections of mortar missing from the coursing joints. There is a steel cross bracing visible which wall tie the stanchions together in the absence of a truss in the gable. Above the steel tie the gable becomes a brick wall.

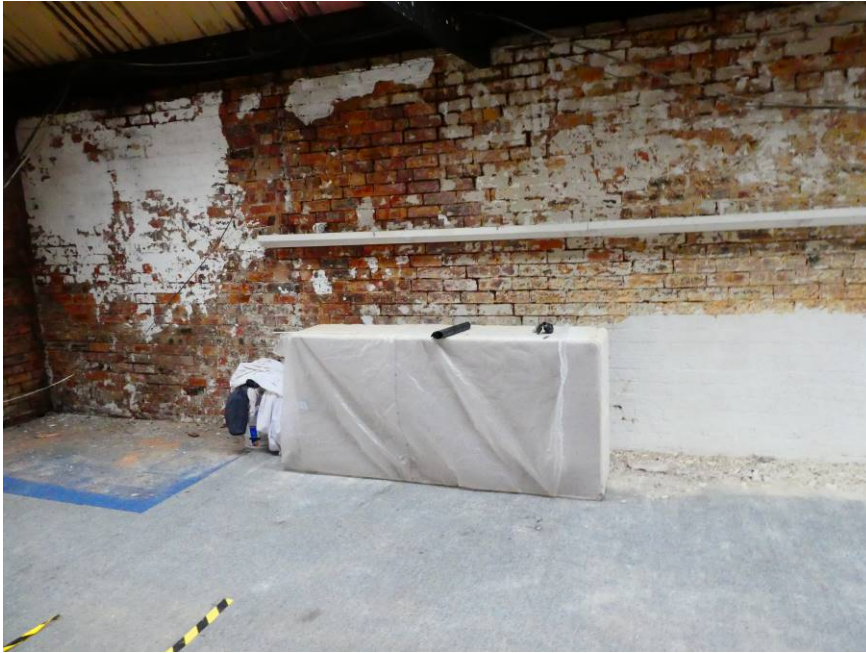
- 6.1 The inside of the two storey element of the property appears to be generally weathertight, the internal pointing in the brickwork has some gaps in the mortar, but otherwise in reasonable structural condition, for the nature and use of the building.

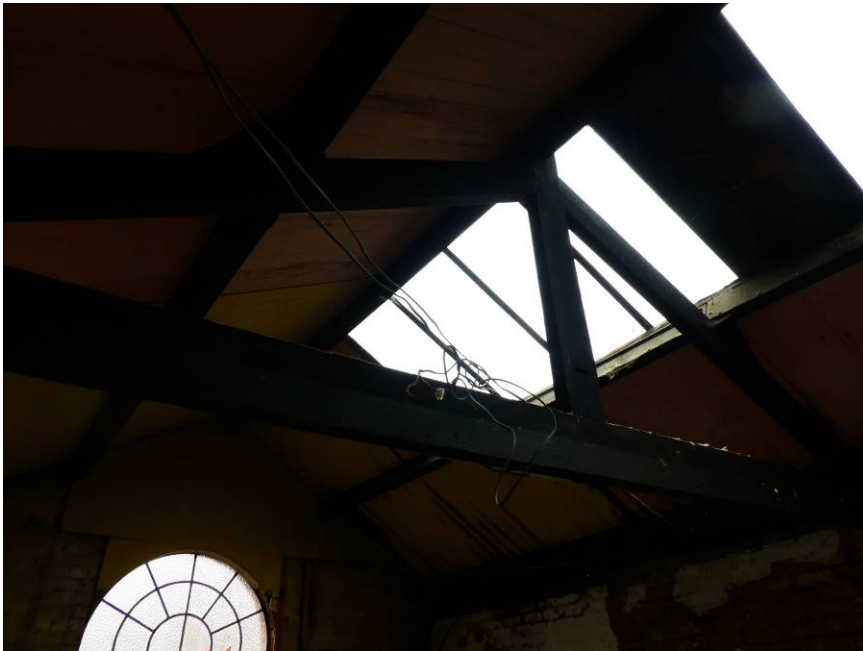
- 6.2 The first floor roof structure is supported by a King Post Truss at mid span, tiles are underboarded.

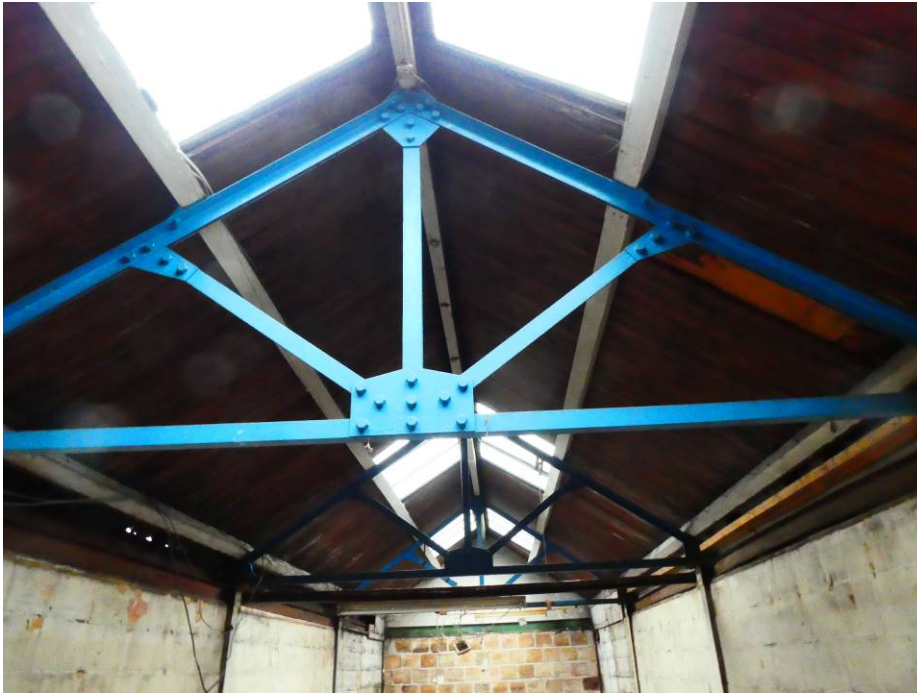
- 6.3** The exposed steel trusses and supporting stanchions have been tidied up and painted after cleaning of the rust, with fabrication repairs carried out as necessary. The steel structure is in a sound structural condition and capable of supporting the roof structure for many years to come. The steel stanchions are an estimated 6" x 4" steel I beam.

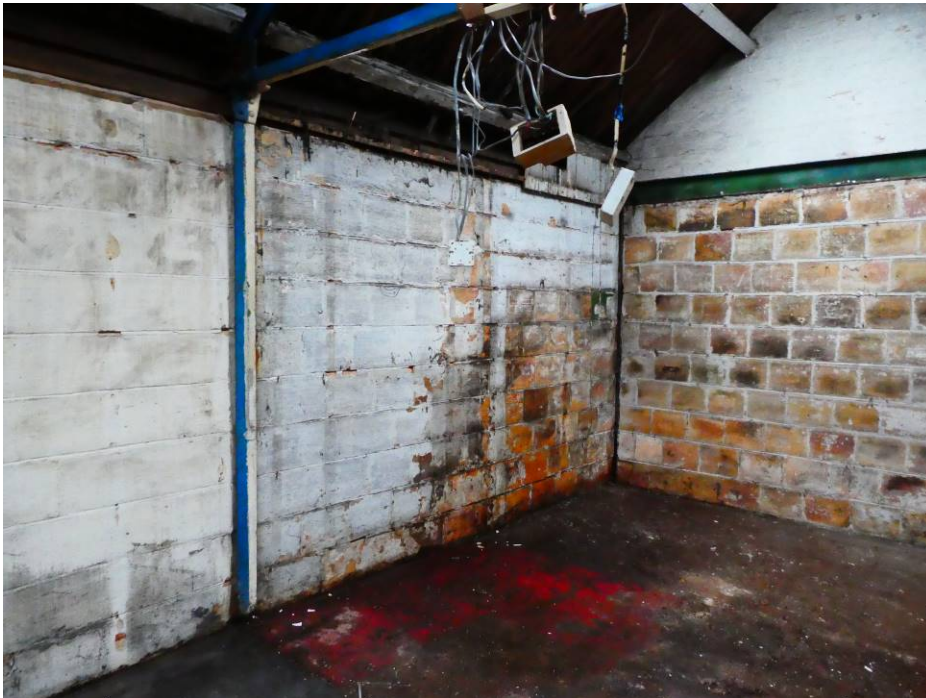
- 6.4** The roof covering is in a poor condition and would be replaced with planning permission using an insulated metal clad panel.
- 6.5** The internal block walls have been painted as the bricks have elsewhere, the pointing appears to be generally sound, although there are some damp/mould patches evident likely caused by the water and debris falling between the garden boundary walls and the building walls. The internal walls are single leaf blocks, approximately 100mm thick width.

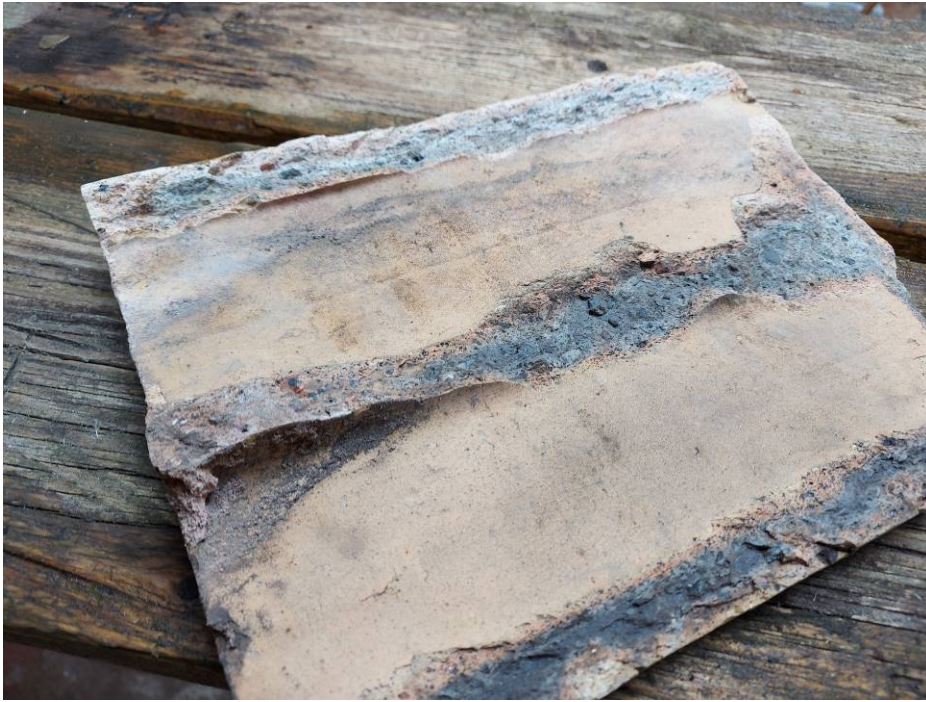
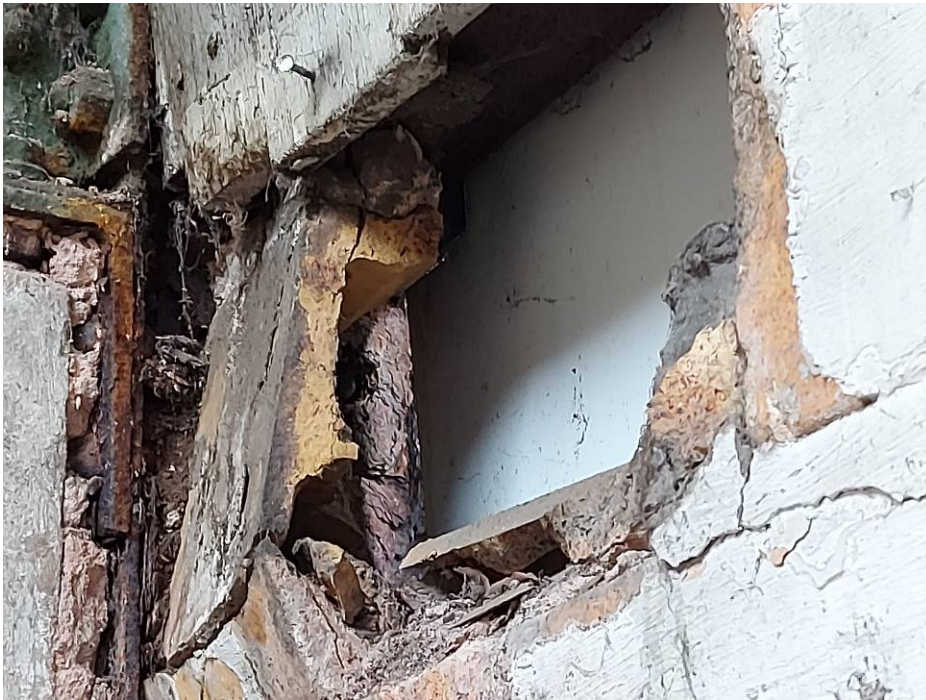
- 6.6 The examination of a damaged block reveals it be a slim hollow cinder block that appears be coated with a clay slip to produce the sandstone/terracotta appearance.
