19th Feb 2021

**Re: Structural survey of Barns & Portal framed sheds at Willoshaw Farm, Cloudside, Congleton.**

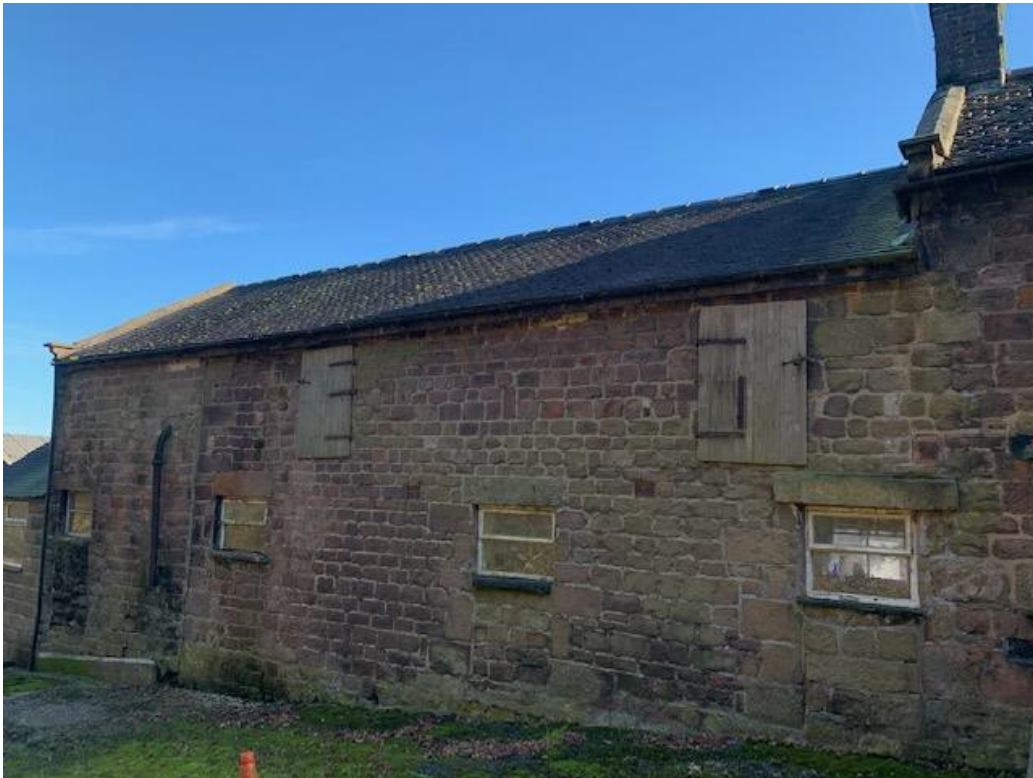
General view of west elevation of barn

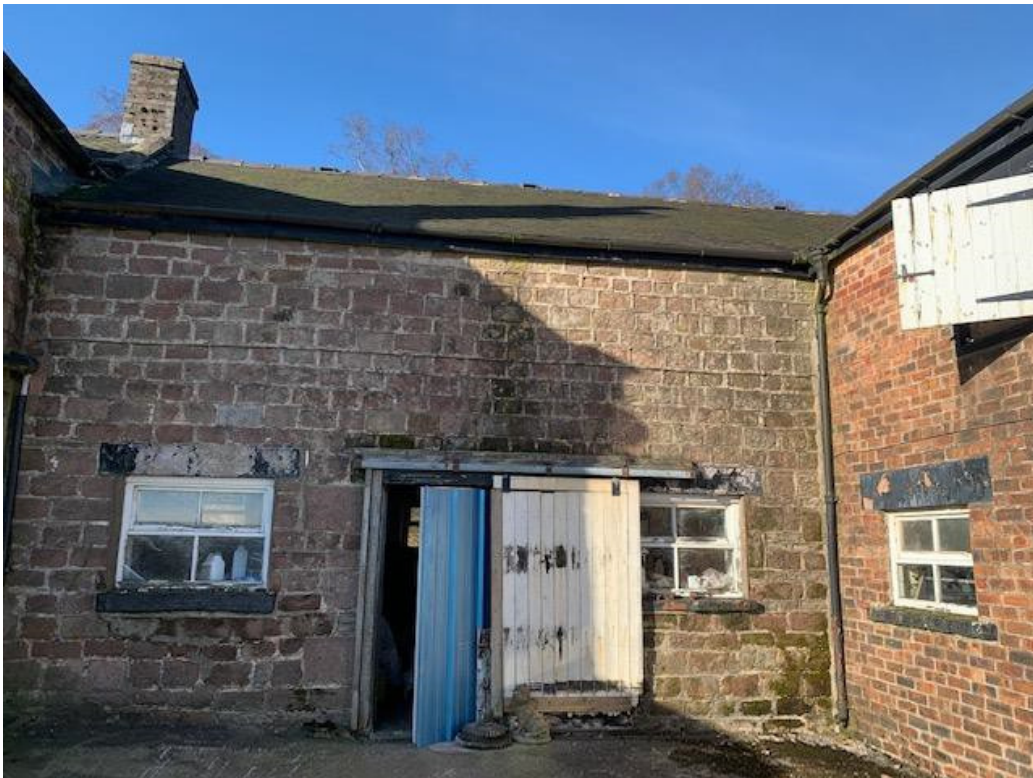
General view of eastern elevation

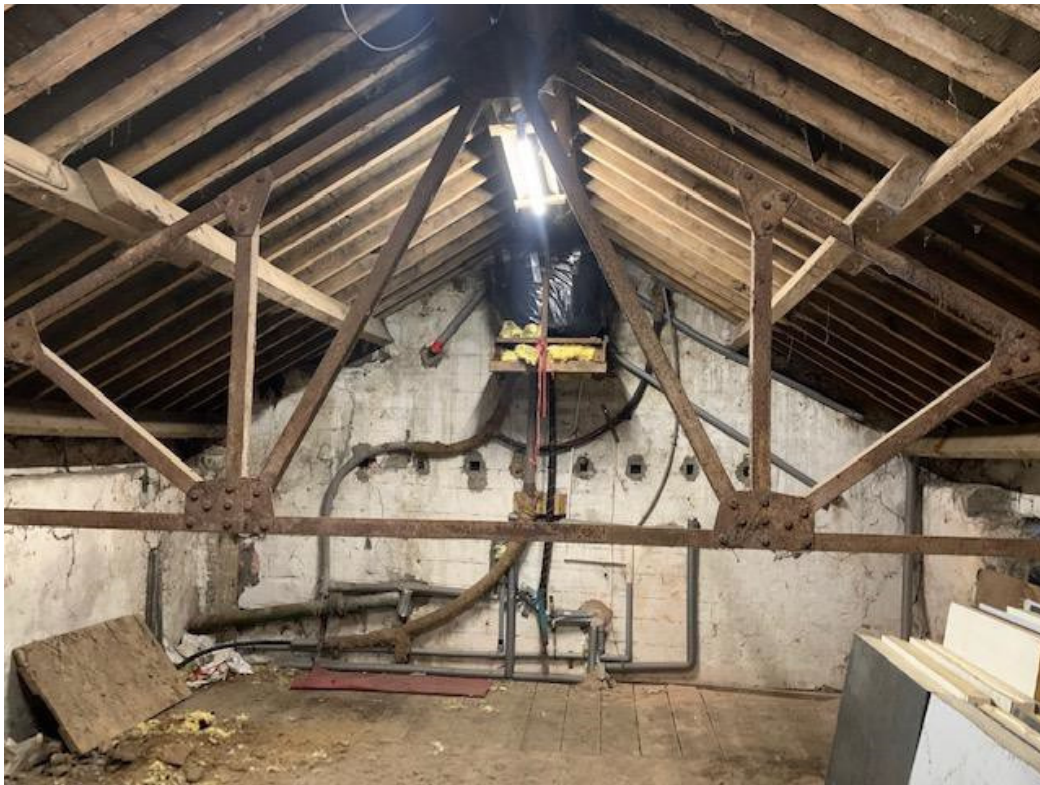
The purlins and steel trusses appear to be in good condition generally, the purlins have suffered some lateral bowing and creep over the years, which has caused some minor roof spread. The steel trusses supporting the timber purlins have suffered minor surface corrosion.

Typical internal view of stone barn showing timber purlins and steel truss.

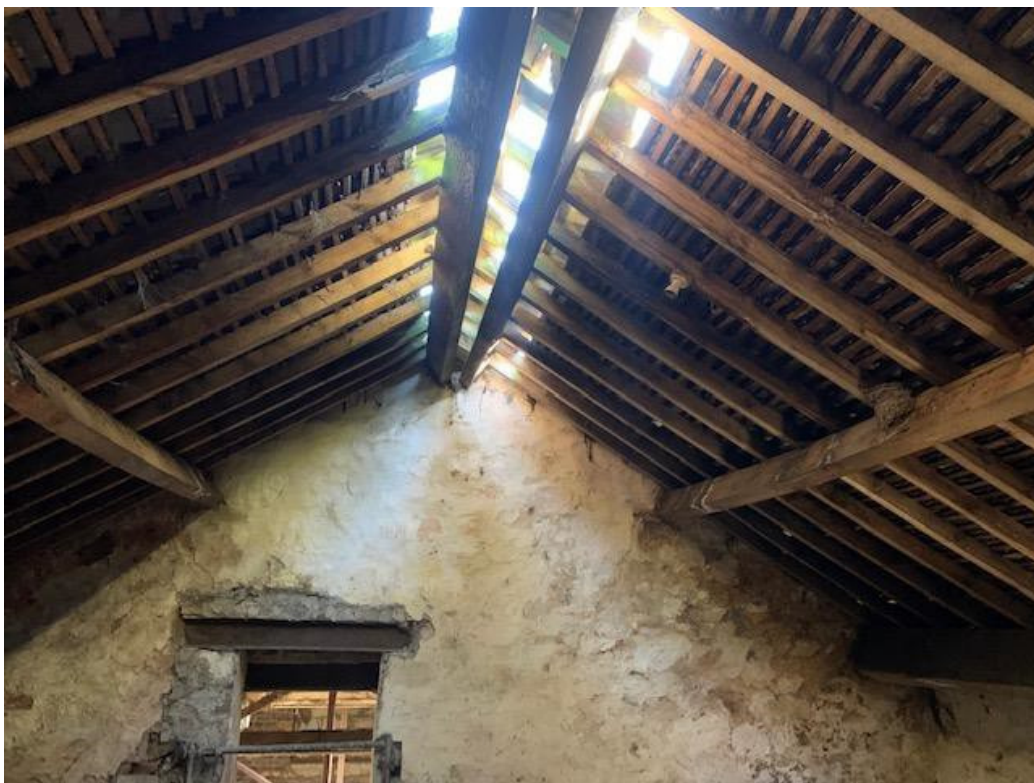
The roofs are finished with Staffordshire blue tiles, which is generally in fair condition with some broken and missing tiles particularly at the ridge of the brick work barn which has large sections of missing tiles, old style roofing felt is present in some locations, however this is in poor condition with numerous holes, and day light and gaps can be observed internally. The timber rafters are in reasonable condition with only very minor localised signs of rotten elements and distortion at the ends particularly.

Internal view of brick work barn showing missing tiles at the ridge

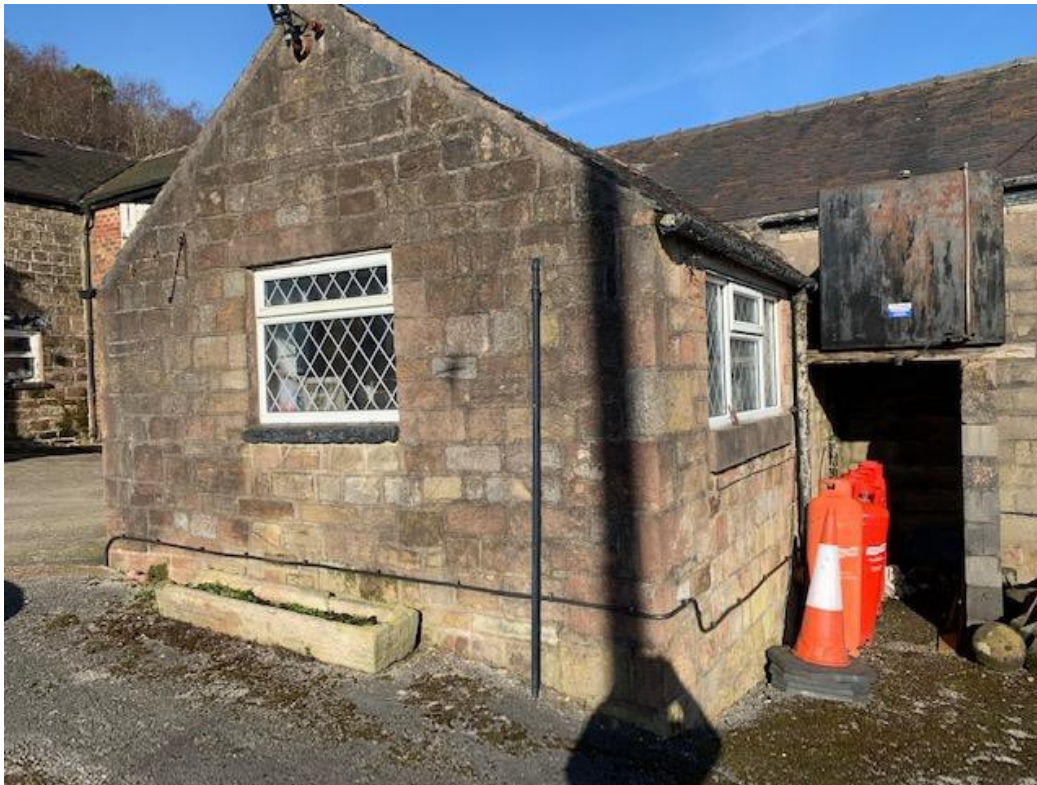
Small outrigger outbuilding in good structural condition.

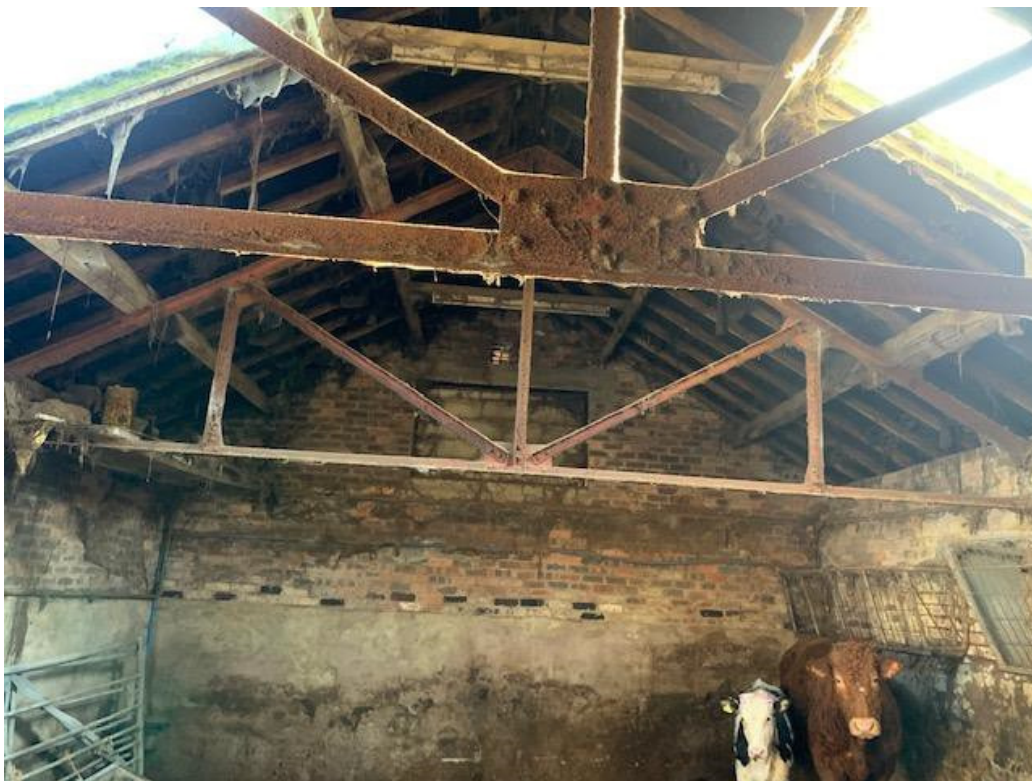
Masonry barn structure showing surface corrosion to steel trusses.

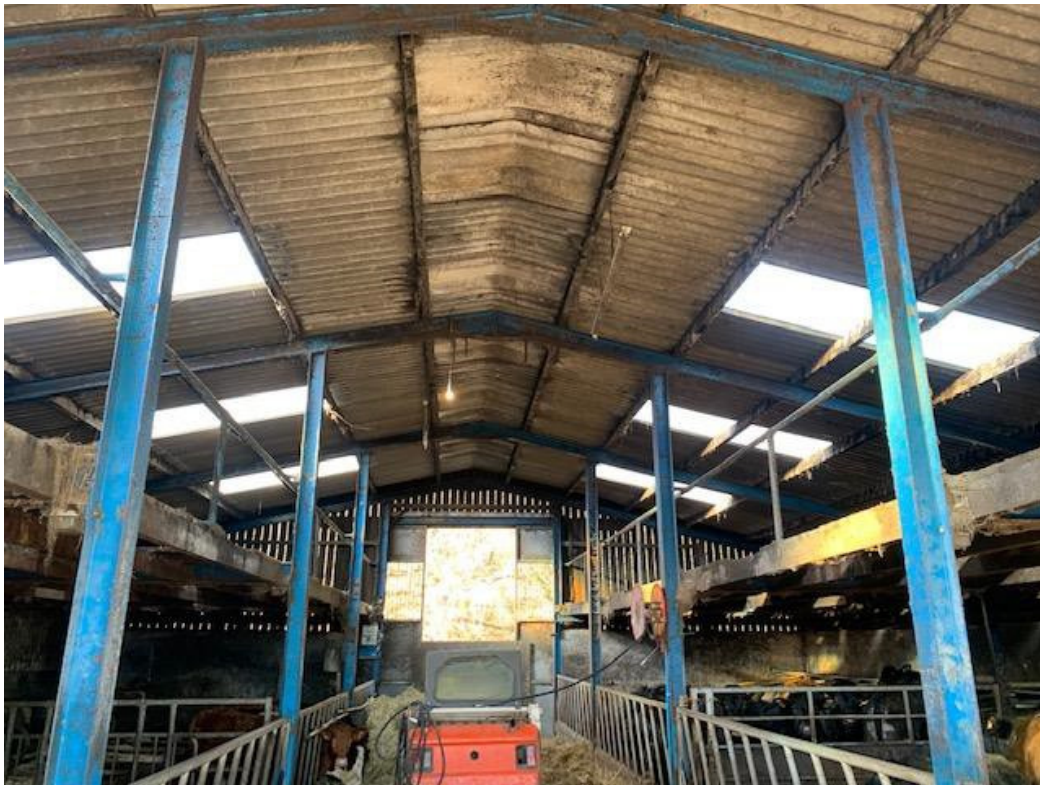
General internal view of larger portal frame with minor surface corrosion

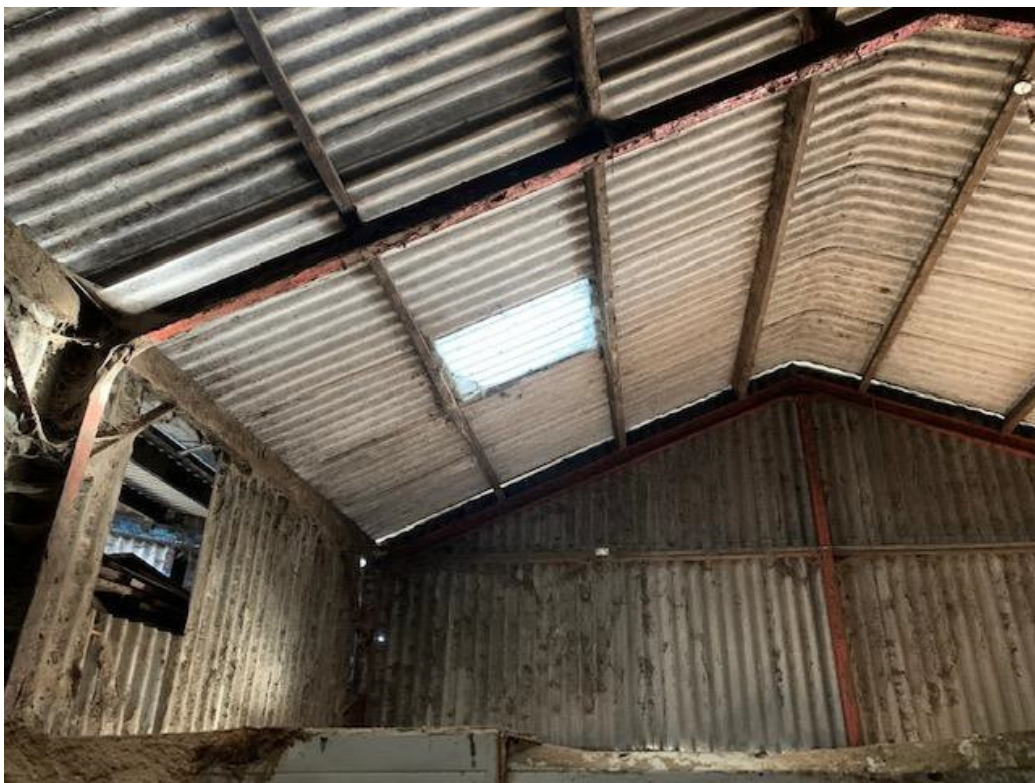
General internal view of smaller portal framed building with surface corrosion to steel elements.
