# Structural Survey on a Barn. Town Head Farm. Foxt, Staffs, ST10 2HW.

Prepared For  
**Ideal Design Solutions**

Date: Mar 2021

Prepared By: Craig Wynne MSc (ENG) BSc

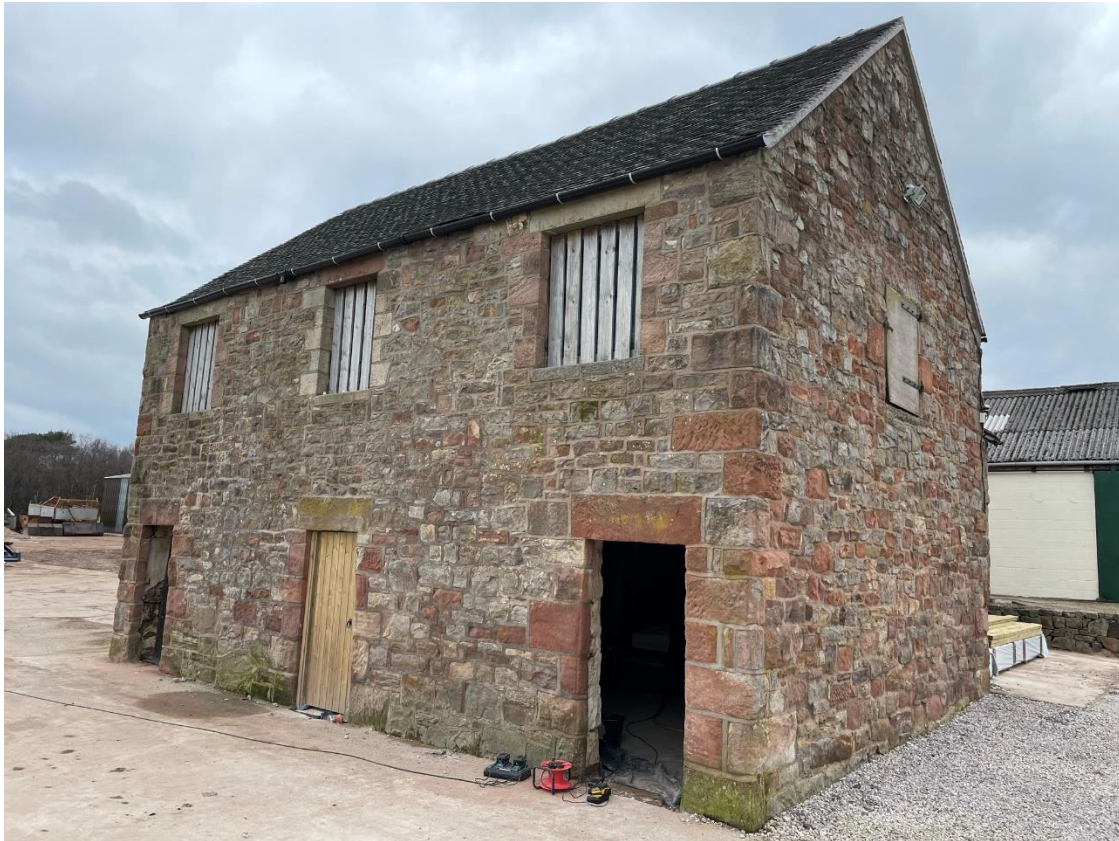
Photo 1

The structure comprises of stonework walls to the envelope, each skin of stone formed with 225-250mm thick local stones. The cavity width if any is currently unknown, however due to the age and type of property it is assumed to be 25-50mm max. (see photos 1-2).

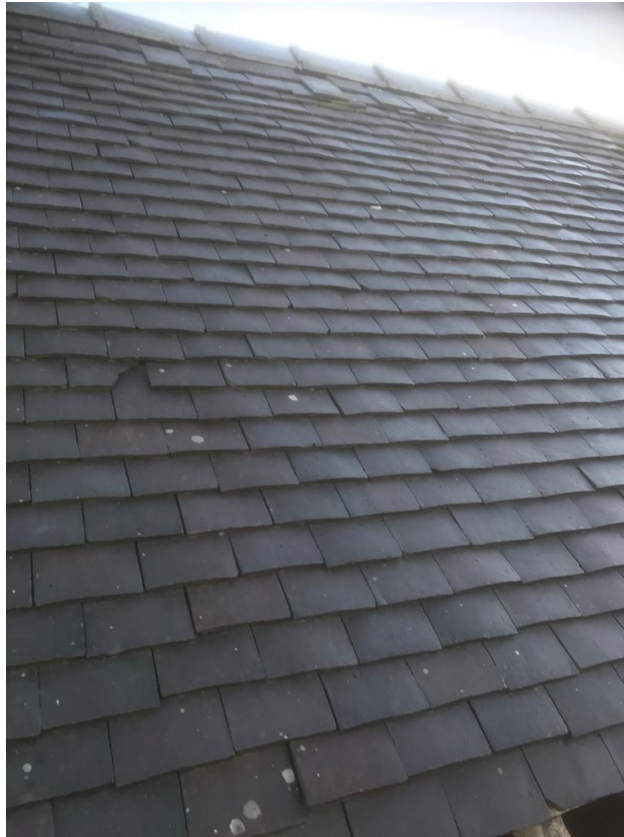
Photo 3

The roof is approximately 35° pitch and clad with Staffordshire Blue roof tiles and ridge tiles running along the full length of the barn. (see photo 3).

The roof is held in place by traditional 'A' framed timber trusses which look in particularly good condition with no signs of weather damage or woodworm.

It is proposed to remove the roof tiles to enable a new water-tight and breathable felt layer to be installed.

The roof will then be re-lathed and retiled. It is proposed fit insulation to the underside of the rafters to ensure that the barn complies with the latest building regulations.

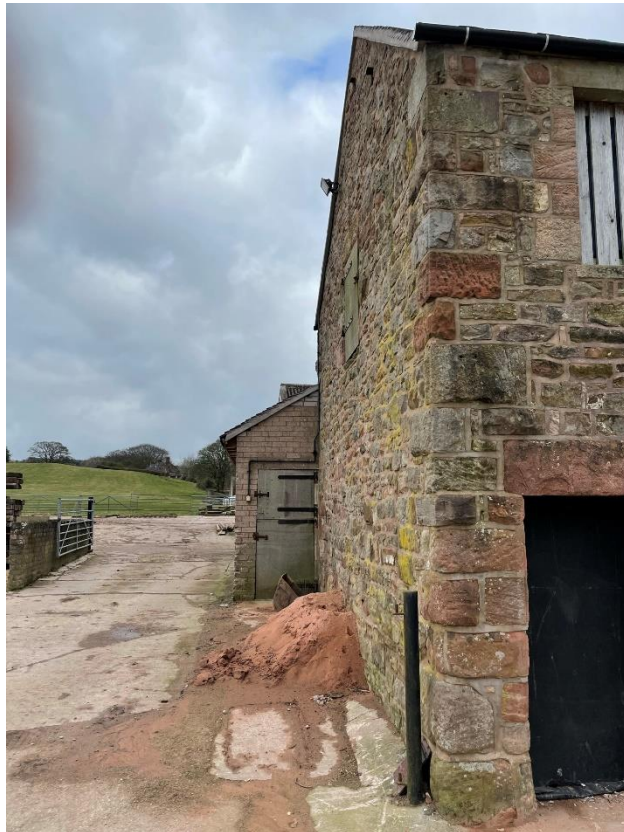
Photo 4

Both gables are full height stonework wall to the apex (see photo 4). The walls appear in a good state of repair with no signs of significant distress. Superficial cracking can be seen on the face of the walls however this does not appear to have occurred recently and will not have a detrimental effect on the performance of the structure.
