**HBL ASSOCIATES  
STRUCTURAL REPORT**

**Cow Byre  
Moorside Farm  
Cauldon Lowe**

**HBL Ref: 21/9183**

Document reference: 9183-HBL-XX-XX-RP-S-0001

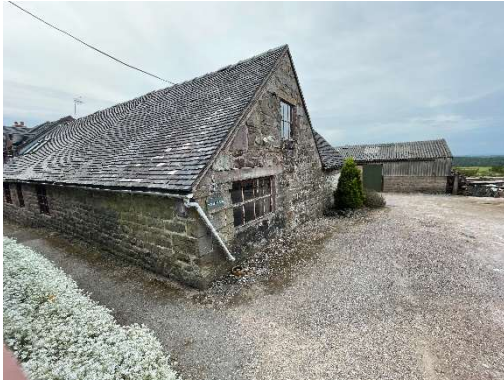
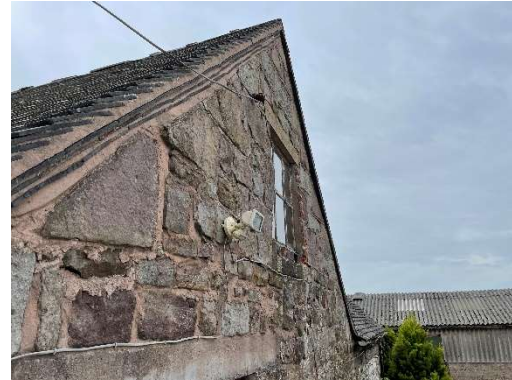
- 4.1. There were no obvious signs of movement, cracking or bowing associated with on going settlement in the building. All walls appear vertical and there were no obvious signs of any structural distress in the building.
- 4.2. As noted previously the roof tiles were more modern concrete tiles, and had been added at a later date. There were no visible signs of excessive bowing or sagging in the roof, and the mortar to the eaves and gables all appeared modern and in good condition.

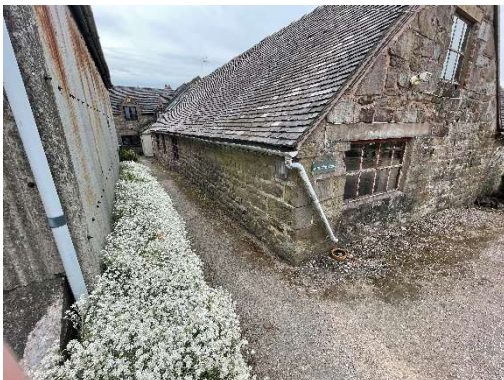
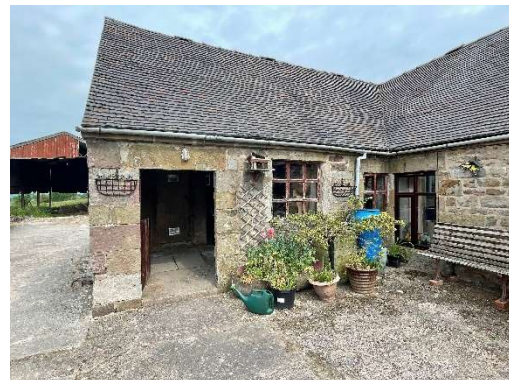
- 4.3. The stone work to the walls was in reasonably good condition for a building of its age. There were obvious signs that the pointing had been maintained over the years, although there were still isolated areas that had weathered.
- 4.4. The building was largely sheltered by the surrounding farm buildings with western elevation being the most exposed. The sheltering meant that the North and west elevations showed very few signs of weathering to the pointing or stone work.

- 6.1. For an agricultural building of its age the building is in excellent condition.
- 6.2. The building shows no signs of any significant structural issues and we see no issue with reutilising the existing structure for the proposed conversion.
- 6.3. To ensure the condition the external walls is maintained a suitable long term maintenance strategy for the pointing should be utilised, and any minor repairs required carried out. As noted above there is clear evidence that the pointing has been well maintained by Mr Cooper over the years so this should be continued.

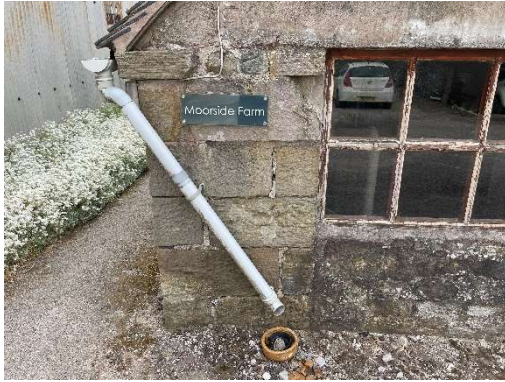
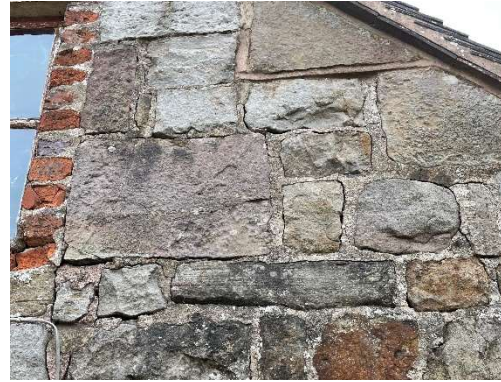
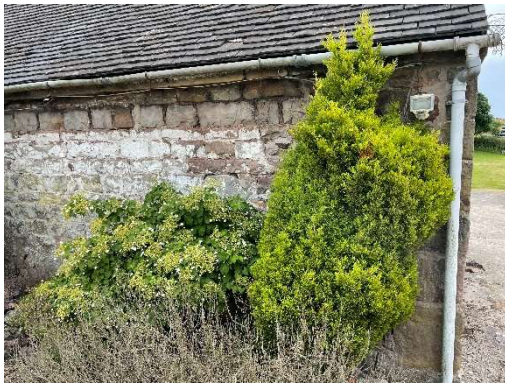
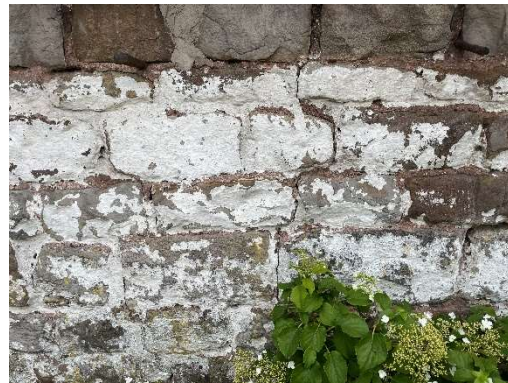
- 4.5. The western and southern elevations as expected due to the prevailing weather being from this direction, and the more exposed nature of the western elevation showed some signs of wear to the stone work and pointing. Even though these elevations had experienced more weathering the level of missing or softened pointing was only minimal especially when considering the age of the building.
- 4.6. As can be seen in the photographs below, the areas of missing, cracked or damaged pointing is limited and this is not considered to be a major structural concern and could easily be remedied with some minor repointing works

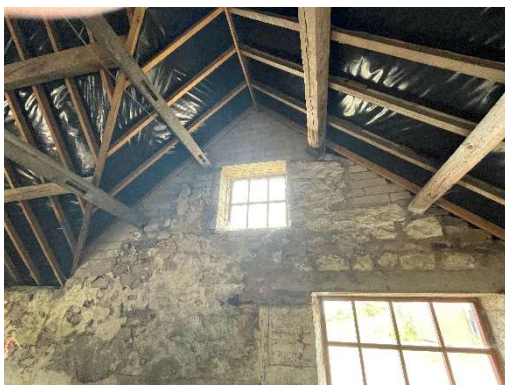
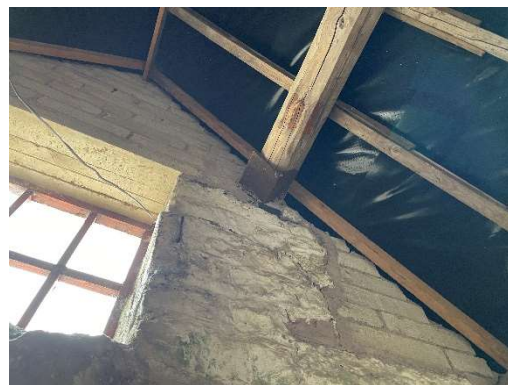
- 5.1. Internally there were no finishes to the walls or roof so the internal structure could be seen.
- 5.2. The stone walls appeared in good condition internally and showed no signs of erosion typically caused by cow urine or dung. There was an area of wall, adjacent the gable window, on the western elevation, that had been previously repaired using block work. It is assumed this area was repaired when the new roof was installed and the repair appeared intact and showed no signs of any further movement.

- 5.3. The internal lintels over the doorways and windows were timber, and these all showed signs of historic wood worm attack, and would all require replacing with suitable concrete lintels.
- 5.4. The roof had a modern membrane layer, that confirmed the assumption that the roof had recently been replaced

- 6.4. The timbers need to be checked by a suitable specialist to ensure there is no current or ongoing wood worm infestation, and any treatments required are carried out. All internal timber lintels should be replaced with new concrete lintels.
- 6.5. There are currently no restraint straps or ties between the roof and the gables, we would recommend adding any required ties between the roof and wall in line with the details in BS EN 1995-1-1:2004 and current Building Regulations. This is again a minor repair and would not affect the conversion of the building.

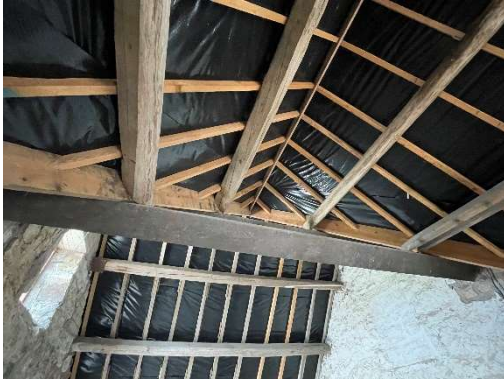
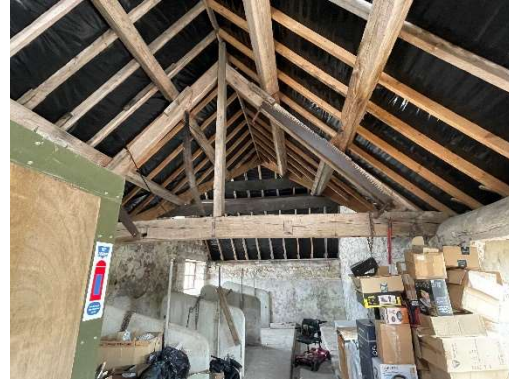
- 5.5. The roof timbers were generally in good condition and as noted externally showed very few signs of distress or excess deformations.
- 5.6. The southern section of roof appeared to still have the original trusses and purlins although the rafters had been replaced, the northern section of roof appeared to have had some repairs done to the purlins, with a steel angle being installed to pick up the end of the purlin. (See photograph in section 5.3 above)

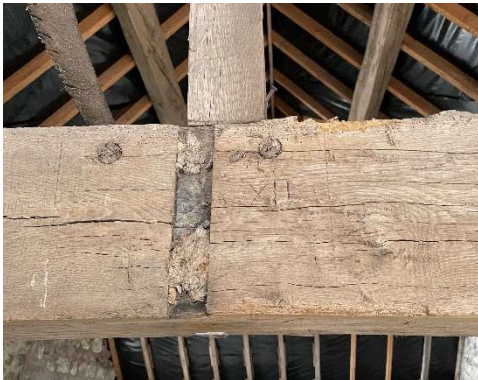
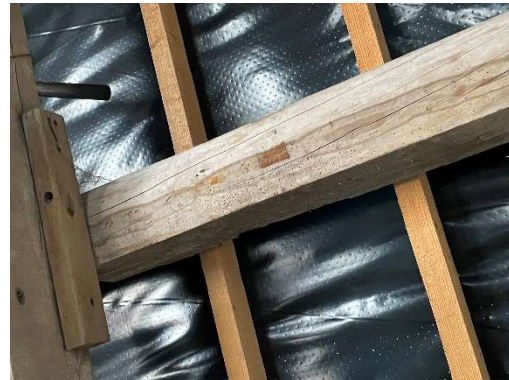
- 5.7. There were signs of pin holes in some of the newer rafters as well as the existing timbers that suggest there had been issues with wood worm to the timbers. The top of the bottom chord to the original roof truss showed some signs of softening due to the wood worm, but the depth of this was limited. As long as the wood worm is no longer present or treated the we see no issue with these timbers moving forwards

- 5.8. There was some damage and rot to the lower purlin on the western side of the southern section of the roof, this purling may need to be repaired or replaced.
