## BS 5837:2012 Tree Survey Report and Arboricultural Impact Assessment (AIA)

Location;  
Land off Stanley Road,  
Stanley Road,  
Stockton Brook, Staffordshire

Date of Inspection;  
07<sup>th</sup> July 2021

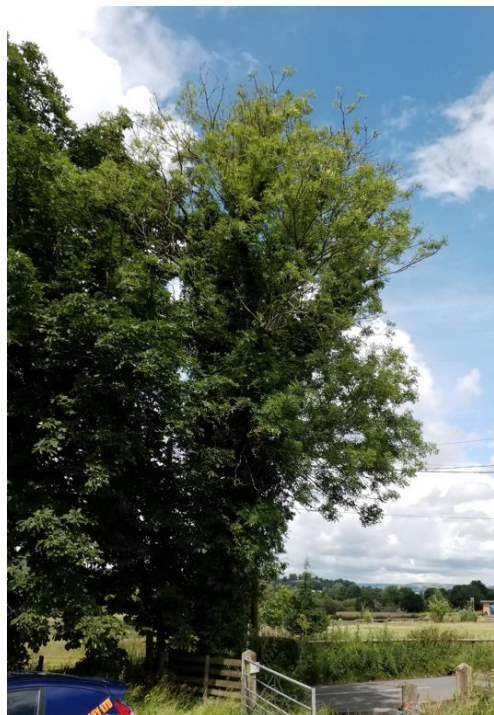
5.5: T1 Mature Ash Cat C. The tree has a one sided crown due to group pressure from the adjacent Chestnut. The crown looks sparse in places with some dieback (not identified as Ash Dieback). There are some branches rubbing on the phone lines. The stem is thick with Ivy.

Fig 3: T1 Ash by gateway.

8.2: T1, Ash. This tree requires monitoring to assess the health of the tree due to its location adjacent to the road. If, in the future, the decline becomes severe with a higher risk of failure of large parts or total tree failure then it will require removal. At present the tree should be considered within the planning process.

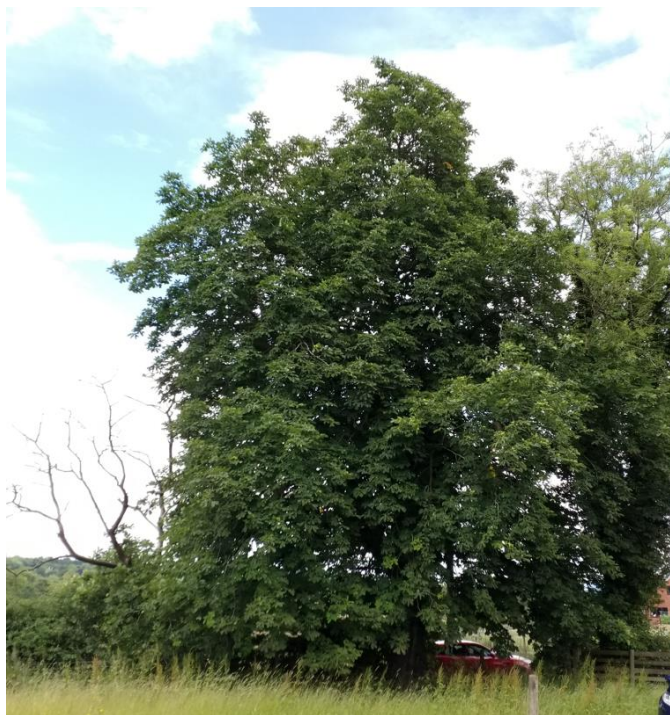
Fig 4: T2 Horse Chestnut

5.6: T2 Mature Horse Chestnut Cat A. A really good example of this species with good structure and health. There are some areas of foliage that have leaf minor, this is quite common for the species.

8.3: T2 Horse Chestnut. This tree is a really good example of the species and is protected under a tree preservation order (TPO), therefore it will be protected against damage above and below ground. Planning will be adjusted to preserve this tree.

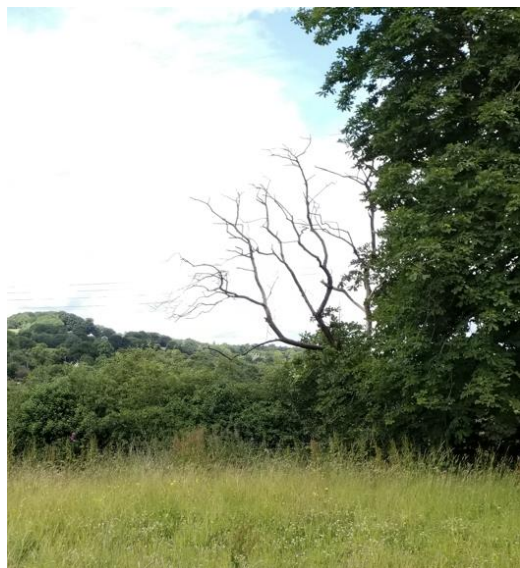
5.7: T3 Dead Sorbus Cat U. The tree is dead and should be removed regardless of development due to its location adjacent to the road.

Fig 5: T3 dead tree

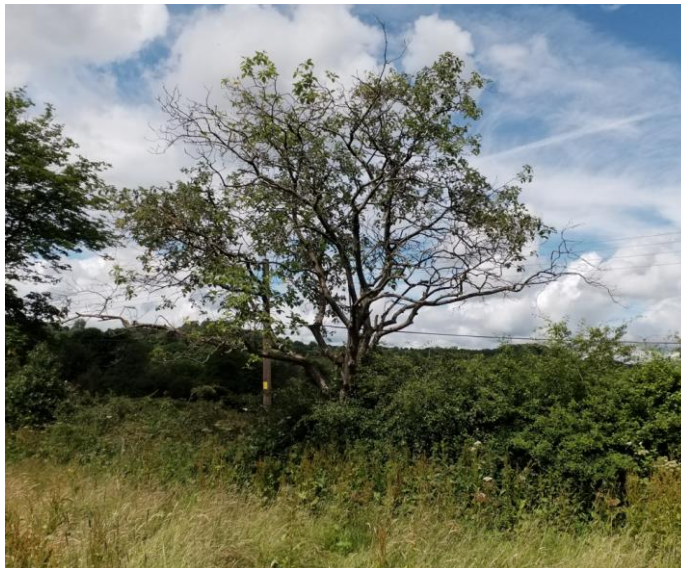
Fig 6: T4 a dying Sorbus adjacent to the road.

5.8: T4 Mature Sorbus Cat U. The tree is in severe decline being approximately half dead. The tree should be removed regardless of development due to its location adjacent to the road.

8.10: It is recommended to move the site access to the approximate area of T4 to prevent any damage to T2. Erect RPA barriers as shown in appendix 3.

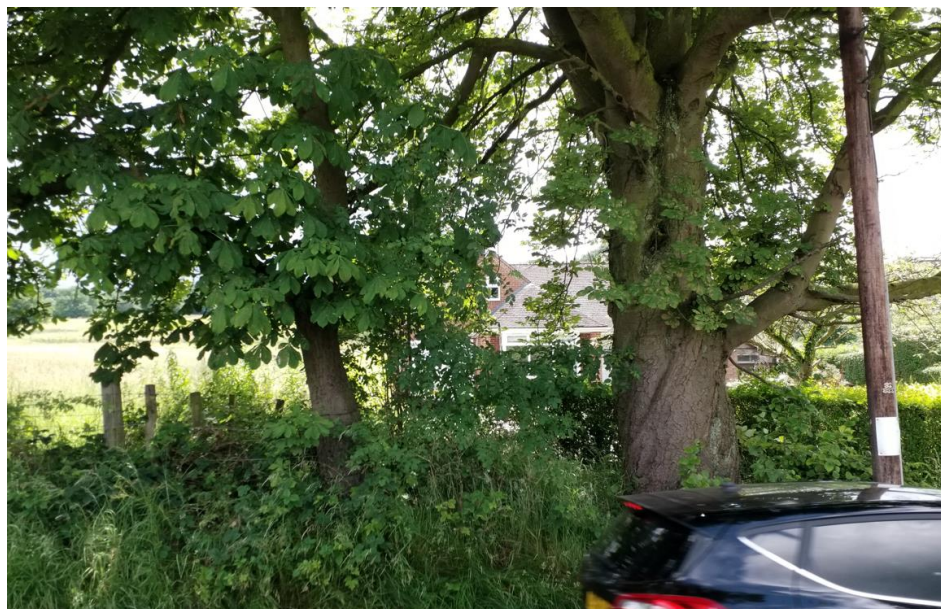
5.9: T5 Semi-mature Horse Chestnut Cat B. This tree is very one sided and has an unusual form due to suppression from T6. It has grown under the canopy of T6 and has now formed part of the canopy so that, from a distance they look like the same tree.

5.10: T6 Mature Horse Chestnut Cat B. This tree has good structure however it has a sparse crown with small foliage. There was no obvious signs of any fungal fruiting bodies or other reasons for this .

Fig 7: T5 & T6 Stems, T5 the smaller left hand stem. Notice the difference is leaf size, the larger, more normal Chestnut size leaves on T5 and the smaller leaves on T6.

8.4: T5 & T6 Horse Chestnut. These trees are not within the site boundary and T6 is under a TPO. They have grown as one tree and will be protected against damage above and below ground. Planning will be adjusted to preserve these trees.

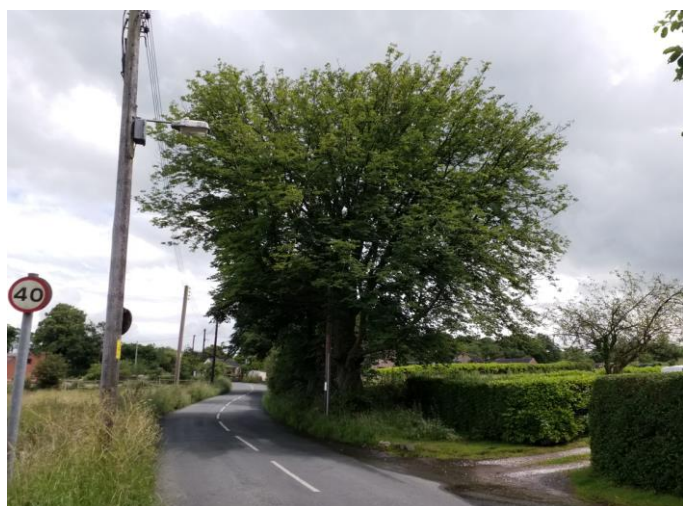
Fig 8: T6 from Stanley Road, looking east.

| Tree ID | Tree Type | Maturity | Height (m) | Height and direction of first significant branch (m) | Stem dia (MM) | Average crown spread (M) | Average canopy height (M) | Crown | Stem | Cat | Life Expectancy | Phys Condition | Action | Comment |
|---|---|---|---|---|---|---|---|---|---|---|---|---|---|---|
| T6 | Horse Chestnut | Mature | 16 | 2w | 1010 | 9 | 3 | Fair | Good | B | >10 yrs | Fair | Protect | Crown looks sparse with small foliage. No signs of ffb. |

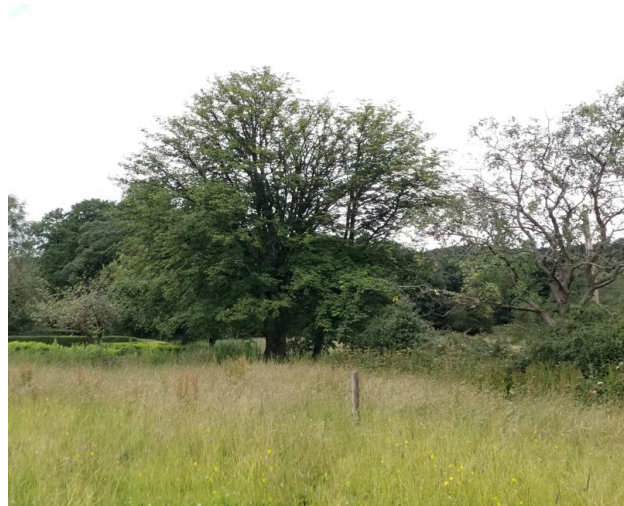
Fig 9: T6 looking northwest from the field.
