## BS5837 Tree Report

Land off Tenford Lane  
Upper Tean  
Staffordshire  
ST10 4EN

Report Ref: BALDS019-21  
Revision B  
Date: 14<sup>th</sup> July 2021

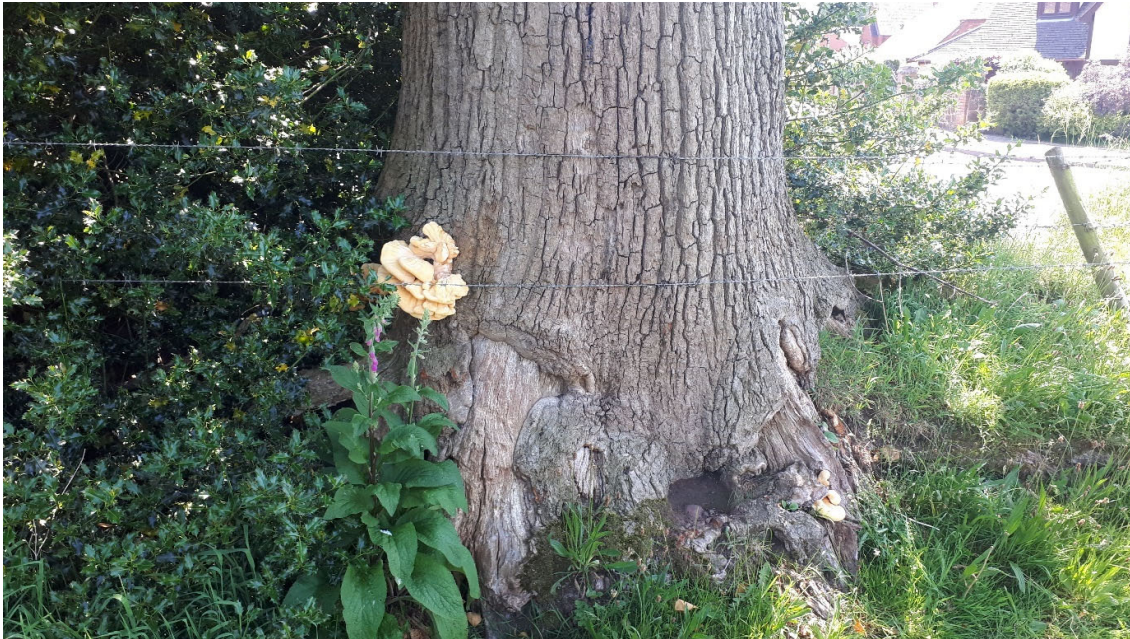
Tree T4541 is located on the western edge of group G2 on the southern site boundary. A fungal fruiting body of *Laetiporus sulphureus* is noted on the northern side of the trunk. There is a significant quantity of large dead limbs in the crown of the tree. This fungal species is noted for the failure of large limbs or even whole tree. A picture of the fungal fruiting body is shown on the following page.

Picture of *Laetiporus sulphureus* on base of tree T4541.

Tree T4541 is a mature Oak located on the southern boundary opposite Cavendish Road. This presents a fungal fruiting body of *Laetiporus sulphureus* which is a primary decay Fungi. The extent of dieback within the crown of the tree suggests that the tree is in severe decline and should be removed on the grounds of safety regardless of development taking place.

| Tree No. | Species (Common Name) | BS5837 Category | Recommended works |
|---|---|---|---|
| T4541 | English Oak | U | Remove due to poor condition, replacement planting required |
