# STRUCTURAL INSPECTION

**SHAWE FARM,  
SHAWE PARK  
ROAD,  
KINGSLEY  
HOLT,  
ST10 2DL**

31.07.21

| Survey details: | General Structural Inspection |

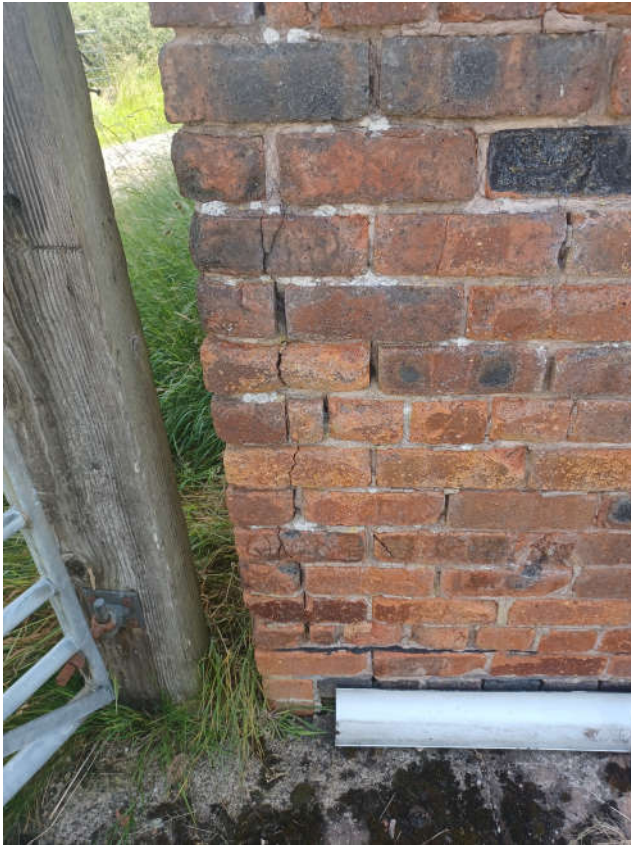
There was a vertical crack to the brickwork to the left hand corner. There was a bitumen DPC (photo 3).

Photo 3 Front elevation crack to brickwork

The cracks to the brickwork should be repaired by providing stainless steel anticrack bedjoint reinforcement embedded in the mortar beds, such as Helifix Helibars. This will prevent cracking re-occurring again. The detailed specification should be provided by a structural engineer.

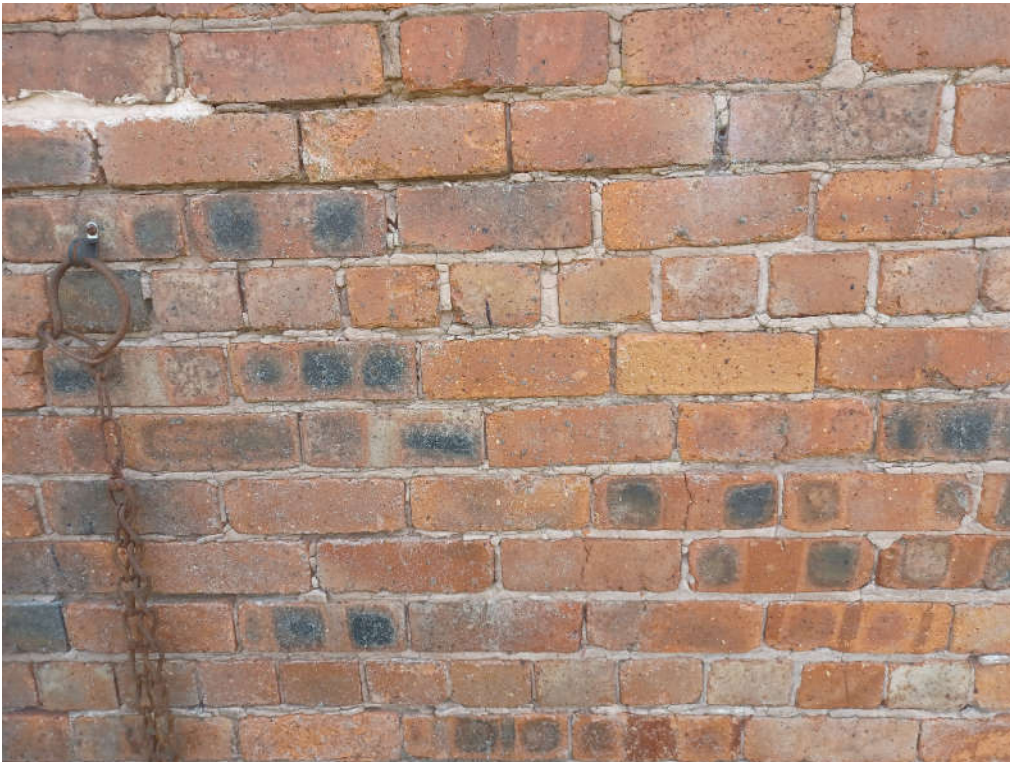
The brickwork was generally in reasonable condition with some spalling and minor cracking in places (photo 4).

The mortar was friable and missing in places. There was evidence of previous repointing. The original mortar may be lime mortar but this would need confirming by a specialist.

Photo 4 Front elevation brickwork

The brickwork to the walls is in reasonable condition and considered suitable for retention. In places there was spalled bricks and missing and friable mortar. It is considered however that appropriate brickwork repairs will resolve these issues. All cracked or spalled bricks should be replaced. All mortar joints should be raked out to a depth of 20mm and repointed to match existing. Where mortar is missing and brickwork loose, these areas should be carefully taken down and rebuilt.

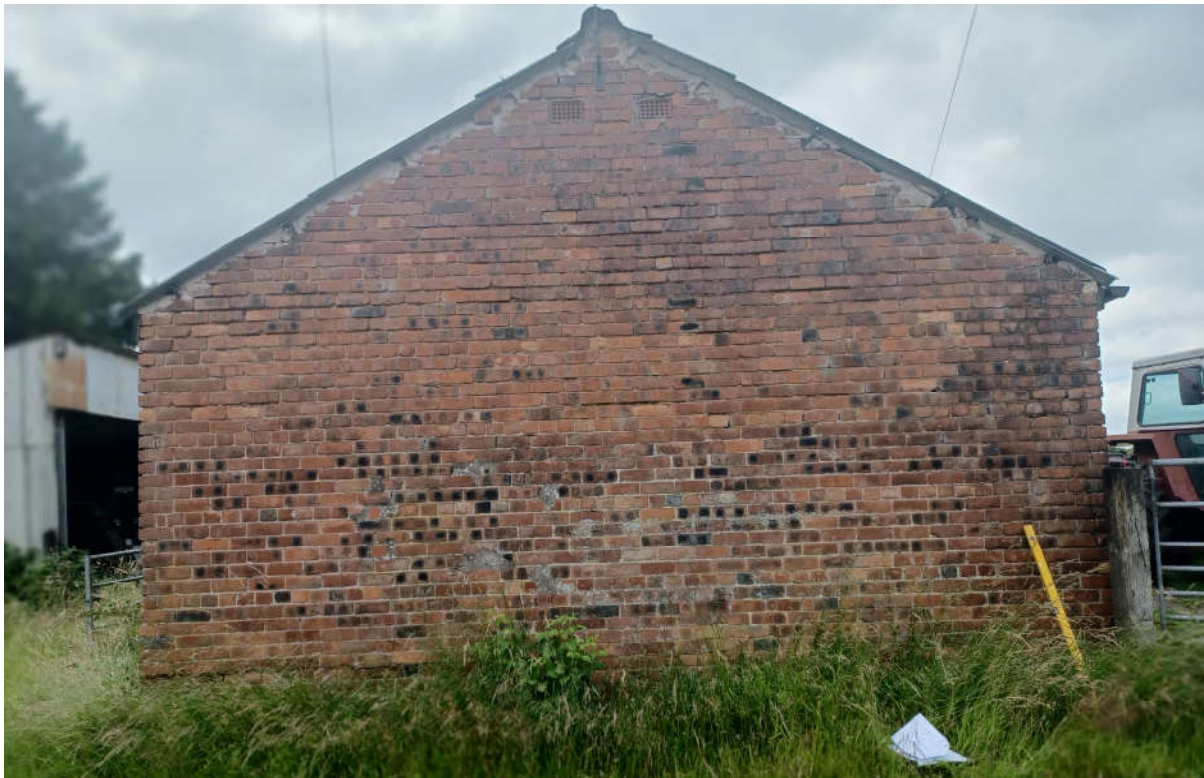
The gable (photo 5) was relatively plumb from ground level to the top of the window however the brickwork to the triangular gable below the ridge verge appeared to bow inwards.

Photo 5 Left hand gable

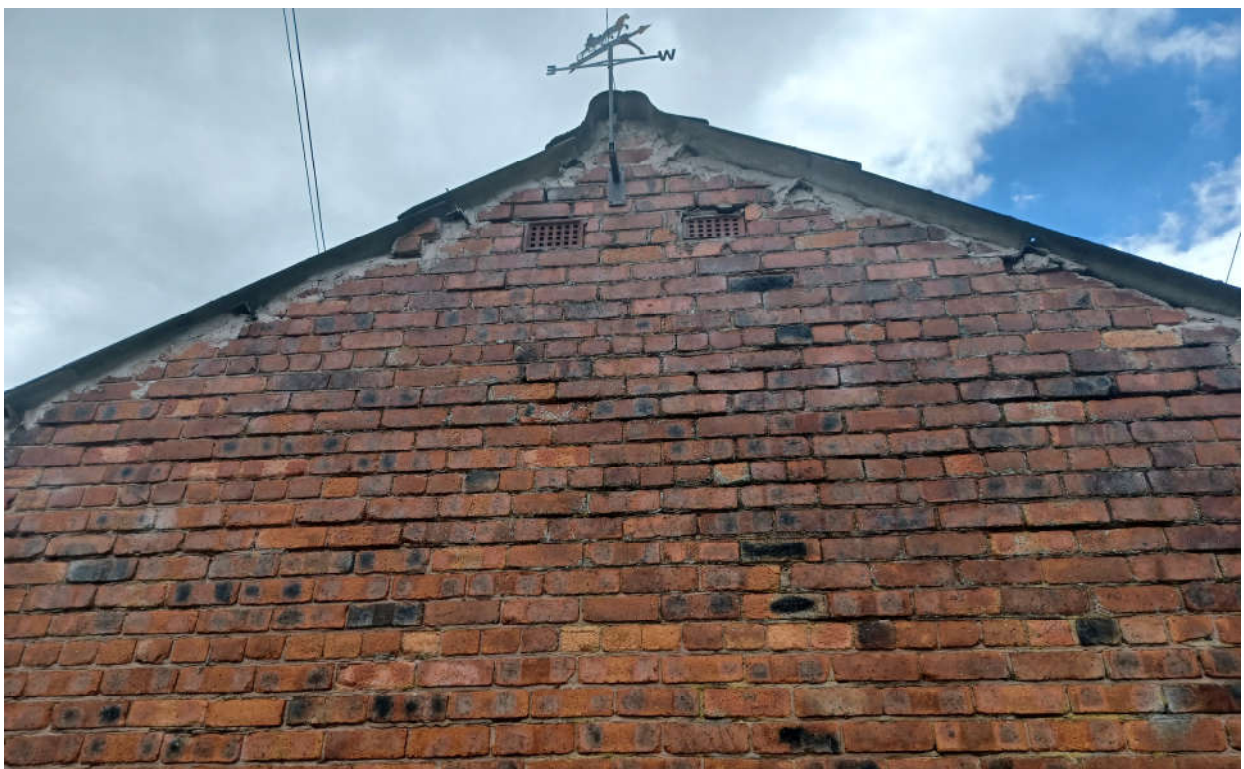
There was missing and defective mortar to the brickwork/roof sheeting junction along the verges (photo 6).

Photo 6 Verge to left hand gables

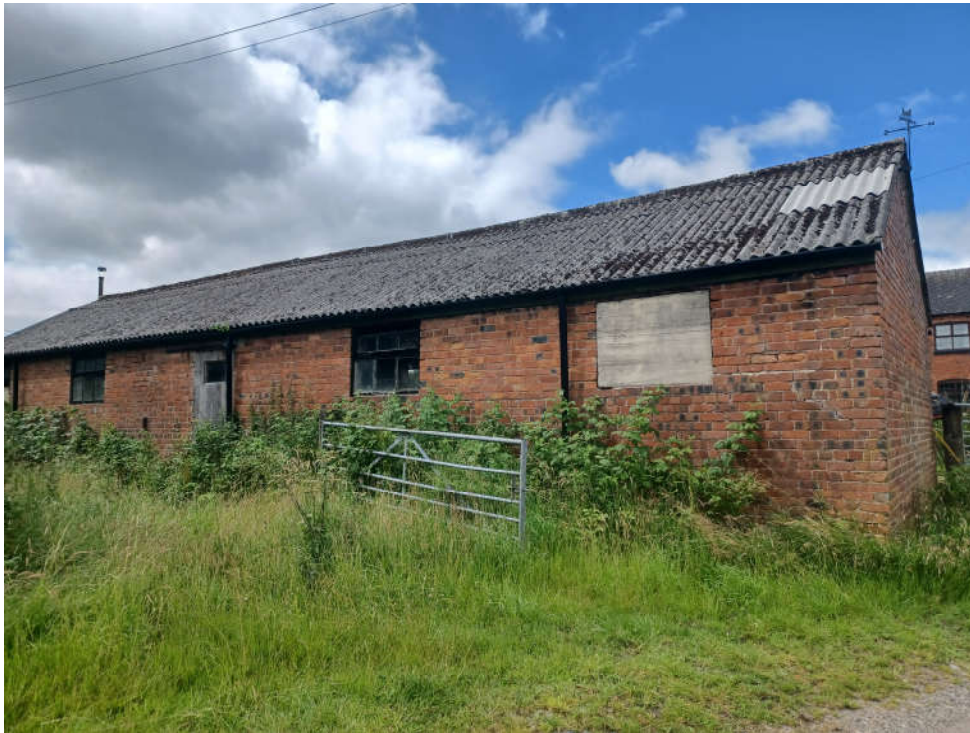
The rear elevation (photo 7) was partly obscured by vegetation so could not be fully inspected.

Photo 7 rear elevation

The brickwork to low level on the rear elevation (below DPC) had moss growth, suggesting damp ingress. All vegetation should be removed from next to the wall to allow a full inspection of the lower brickwork and for suitable repairs to be carried out.

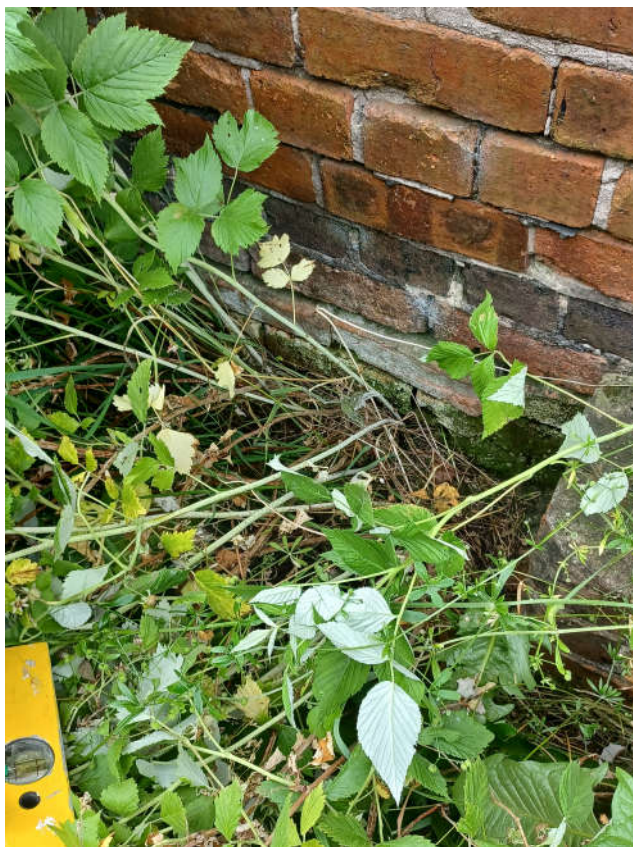
There was a bitumen DPC. The brickwork below the DOC was in poor condition, and showed signs of severe weathering and spalling. The mortar was defective and missing in places (photos 8).

The brickwork below the DOC to the right hand end had moss growth suggesting damp ingress into the brickwork.

Photo 8 defective brickwork below DOC to rear wall

There was evidence of a bitumen DPC. It is considered however that this may not be effective due to its age and condition therefore consideration should be given to providing a new remedial DPC, specified to suit the brickwork.

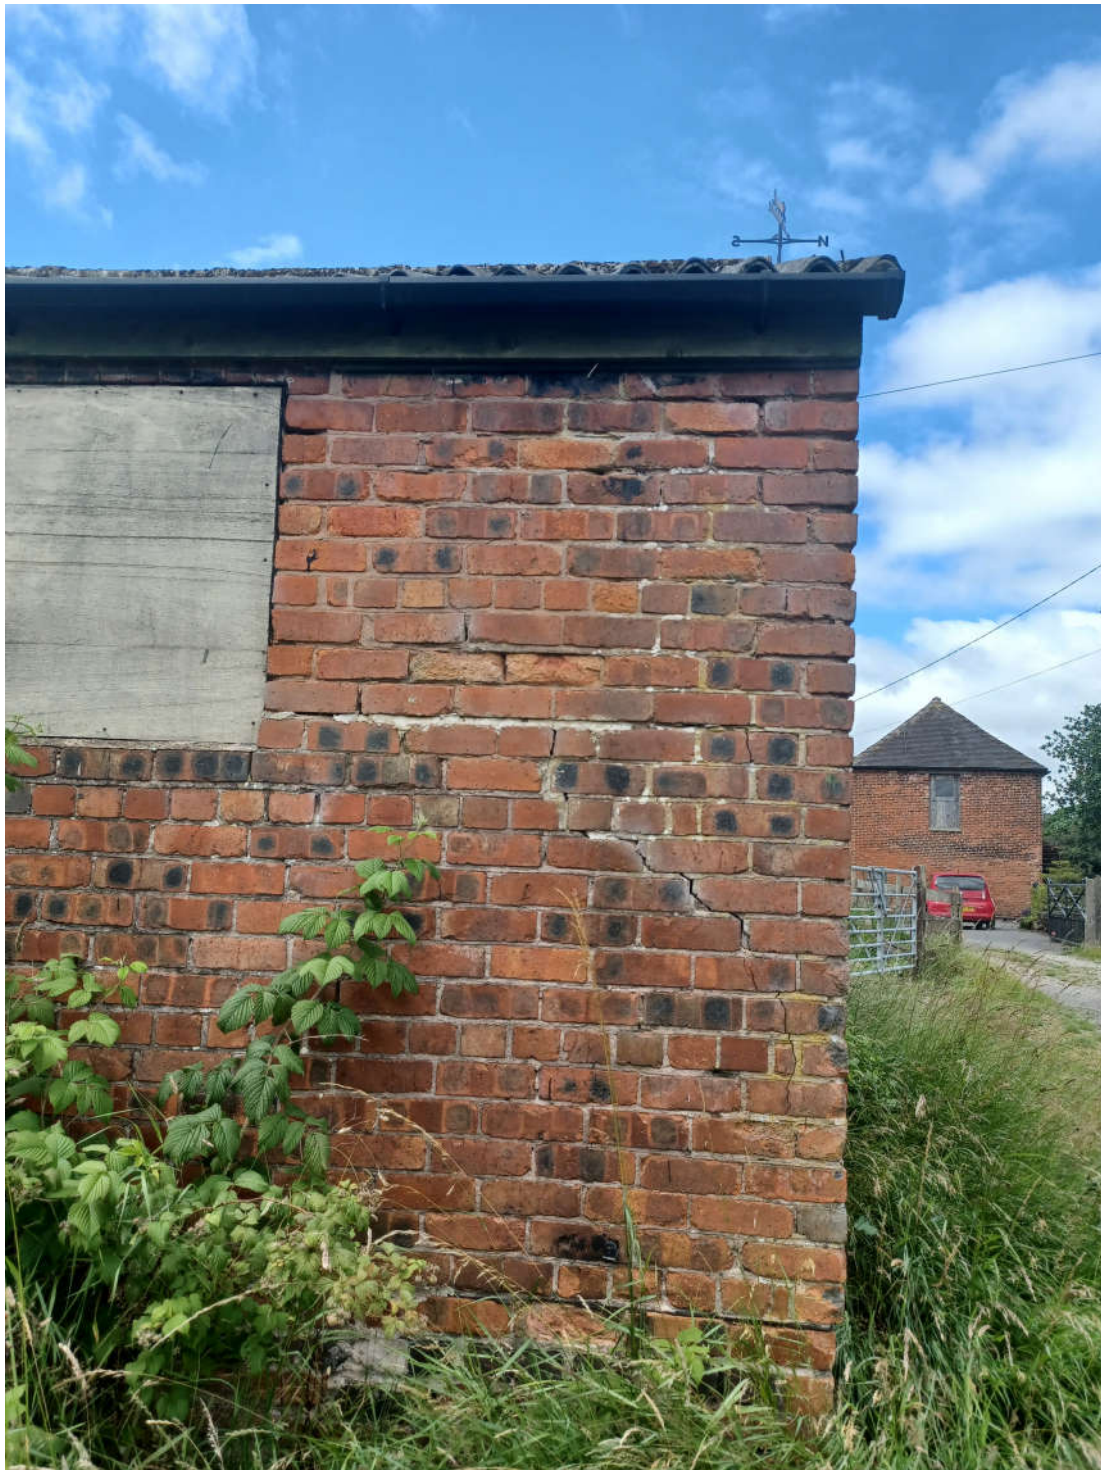
There was a stepped diagonal crack extending from DPC level at the left hand corner, upwards to the underside of the window cill of about 5m width (photo 9).

There was diagonal and vertical cracking to the rear left hand corner of the rear wall. The foundations could not be inspected so their condition could not be confirmed. It is considered a possibility that settlement of the foundations to the rear left hand corner could have caused the cracking.

Photo 9 crack to rear wall

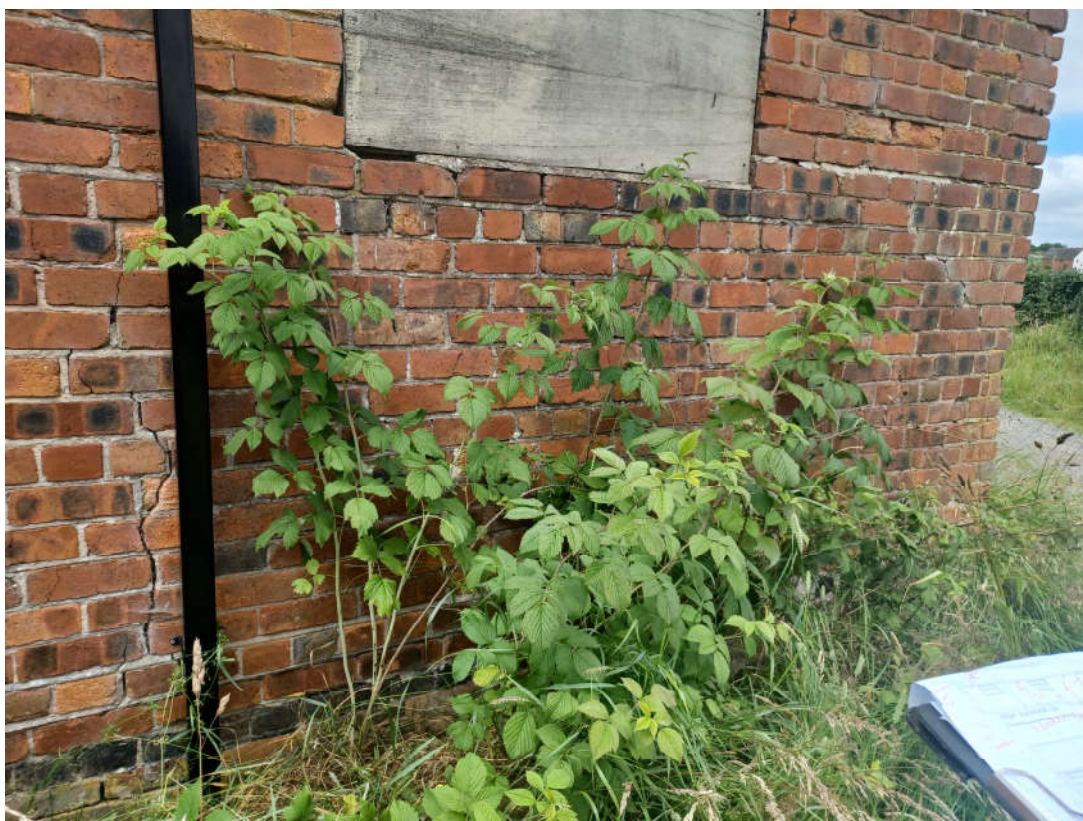
There was a vertical crack to the right of the left hand window about 5mm wide (photo 10).

Photo 10 Crack to rear wall

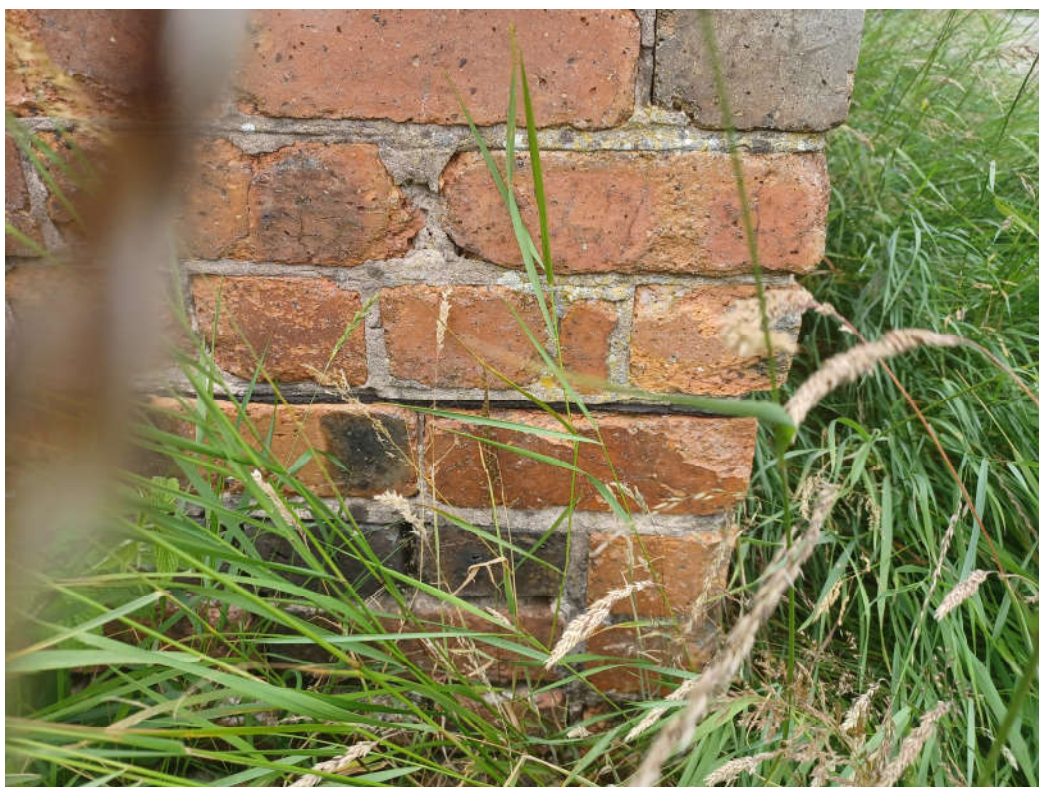
The brickwork above the DPC oversailed the DPC by up to 20mm along the full length of the rear wall (photo 11).

To the right hand side, the wall bulges outwards about 20mm above the DPC.

The walls to the rear bulged out and the front wall bulged in in places. It is considered that this is likely due to ineffective horizontal lateral restraint at eaves level. It is recommended that remedial lateral restraint is provided to the walls by strapping the new roof structure to the walls at ceiling level and along the verges.

Photo 11 Brickwork to right hand side of rear wall oversailing DPC

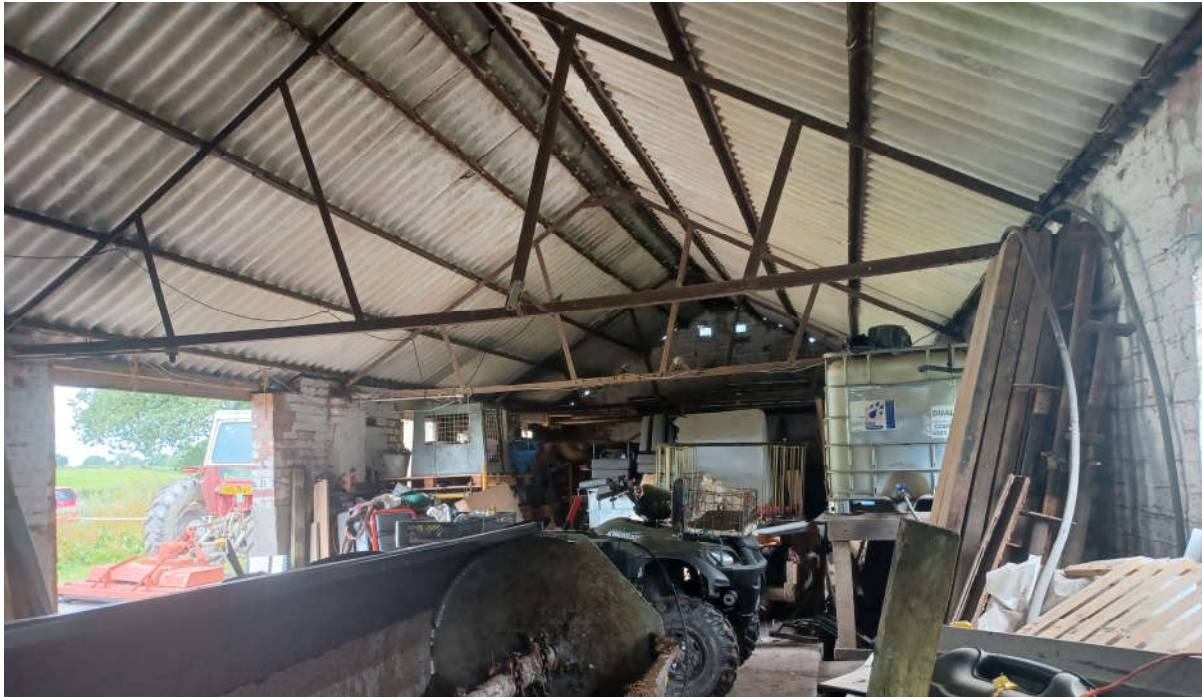
The roof was covered in lightweight corrugated sheeting which may contain asbestos.

The sheeting was supported on hot rolled steel angle sections which spanned between lightweight hot rolled steel trusses (photo 12).

Photo 12 roof structure

An asbestos survey should be carried out before any work is started.

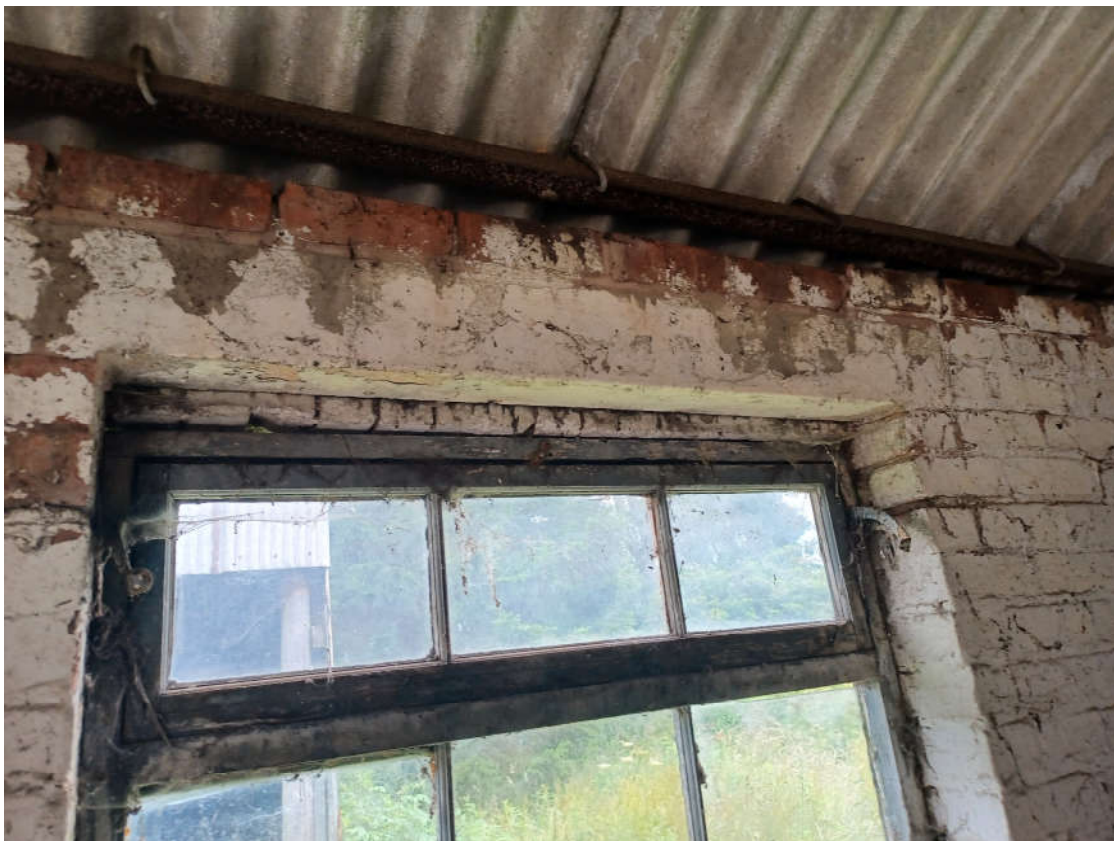
The inner 4 inch of brickwork was supported on what appeared to be concrete lintels (photo 13).

The outer 4 inch of brickwork appeared to be supported on the timber window frames with no proper lintel.

Photo 13 typical lintel to internal leaf of brickwork

The existing windows and doors did not appear to have suitable lintels to support the outer 4 inches of brickwork. New lintels should be provided over all new openings.

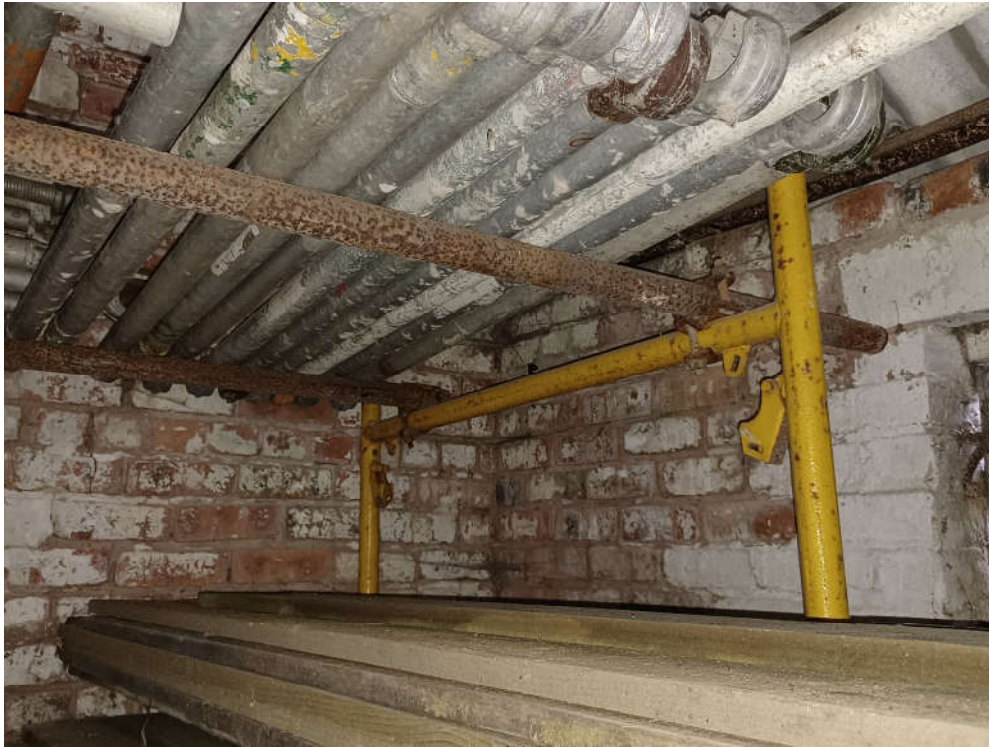
The brickwork internally was generally in reasonable condition with some localised areas of defects (photo 14).

Photo 14 Internal brickwork

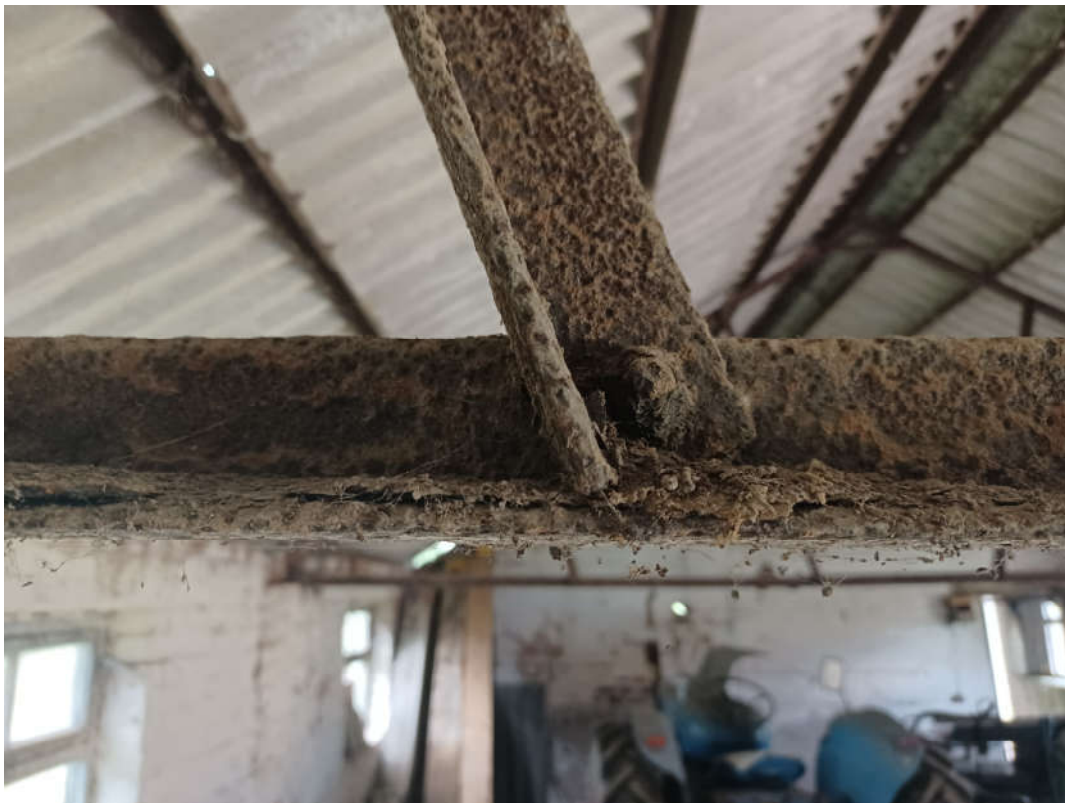
The hot rolled steel purlins and trusses had corroded (photo 15).

Photo 15 corroded hot rolled steel trusses and connections
