08 March 2021

**Preliminary Roost Assessment – Store Building at the Boat Inn, Bashford Bridge Lane, Staffordshire, ST13 7EQ**

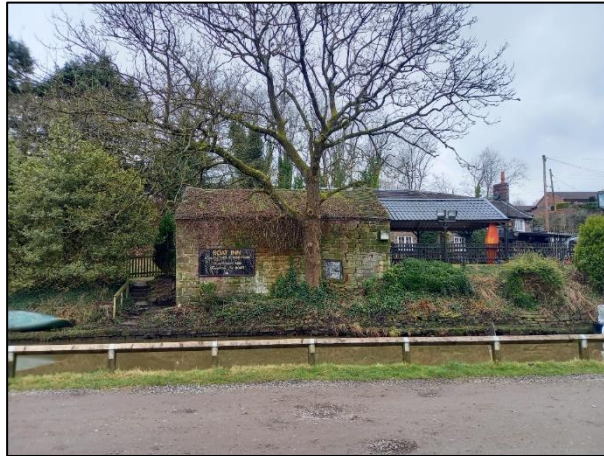
**Plate 1:** Showing a typical view of the store building at the Boat Inn. Photograph looking West.

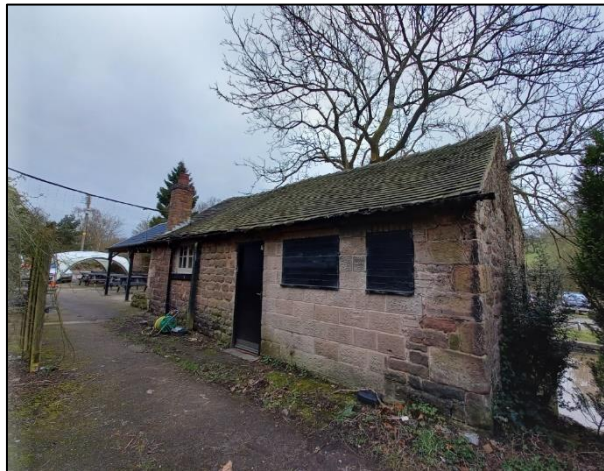
**Plate 2:** Showing a typical view of the store building at the Boat Inn. Photograph looking north-east.

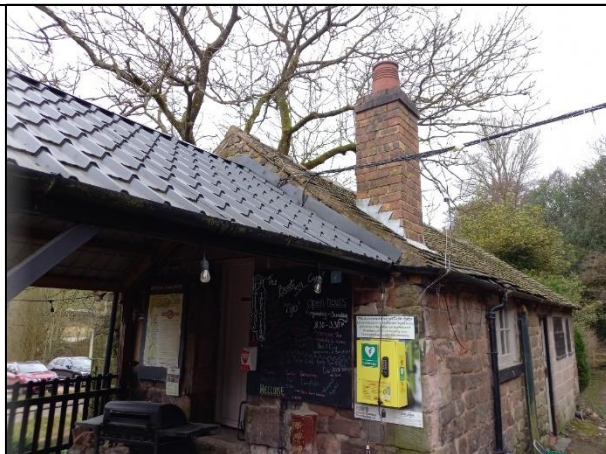
**Plate 3:** Showing a typical view of the store building at Boat Inn.  
Photograph looking south-east.

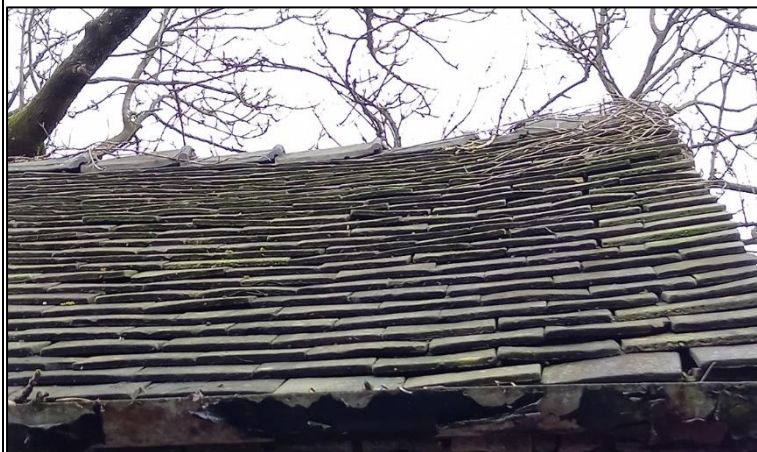
**Plate 4:** Photograph showing the lifted and warped slope and ridge tiles on the store building, Boat Inn.

The store building at the Boat Inn has multiple features suitable for roosting bats – both void-dwelling (e.g. brown long-eared) and crevice-dwelling species (e.g. common and soprano pipistrelle). The gaps under slope and ridge tiles, as well as between the tiles and the wall top provide good access into the building for void-dwelling bats. Additionally, the old stone walls in declining condition provide numerous of cracks and crevices suitable for crevice-dwelling bats. Although no signs of bat roosting activity were recorded, the rugged nature of the floor means these could easily have been hidden and therefore missed. Furthermore, the recent pruning of ivy from around the building means bat droppings could have been displaced during the works. The location of the store building directly adjacent to the canal, close to the River Churnet and surrounded by deciduous woodland and mature trees makes it prime habitat for a wide range of bat species. Multiple bats have been recorded foraging and commuting over

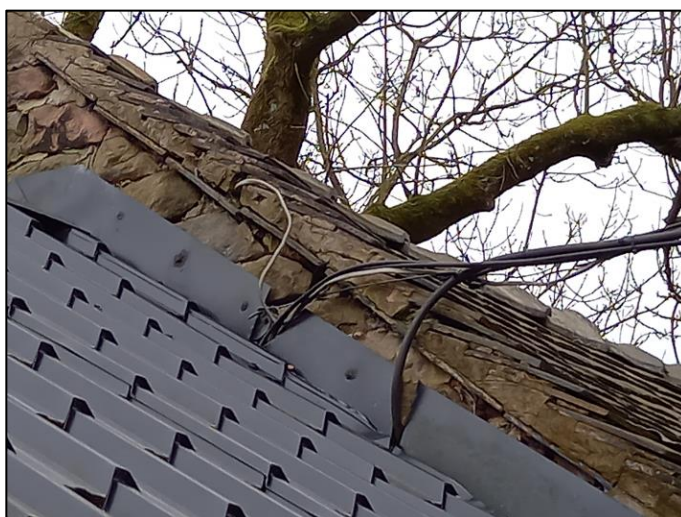
**Plate 5:** Photograph showing the gaps between the tiles and the wall top on the southern gable end.

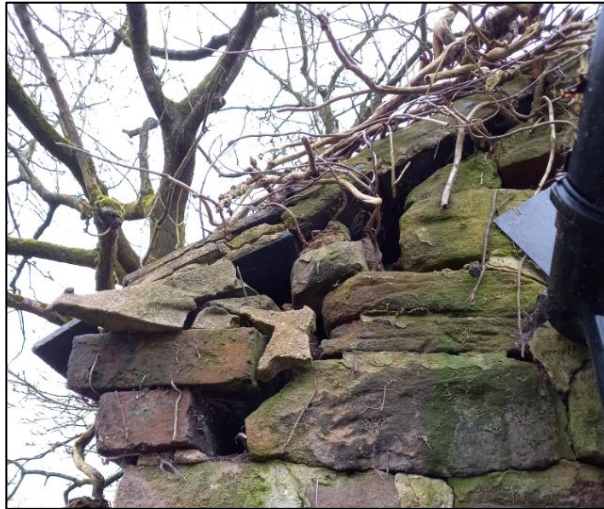
**Plate 6:** Photograph showing the large cracks within the brickwork on the north-east gable end.

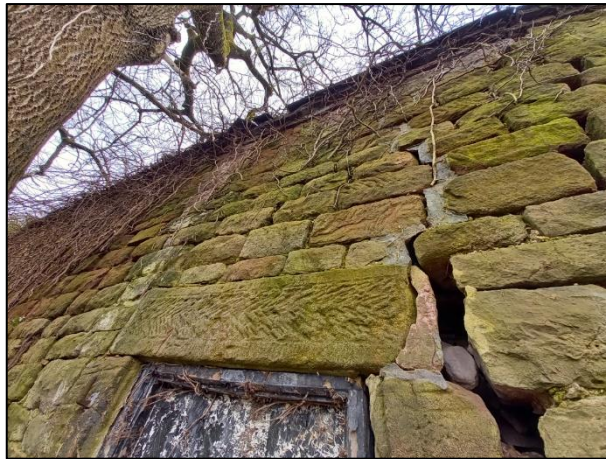
**Plate 7:** Photograph showing the large crack on the eastern elevation of the building.

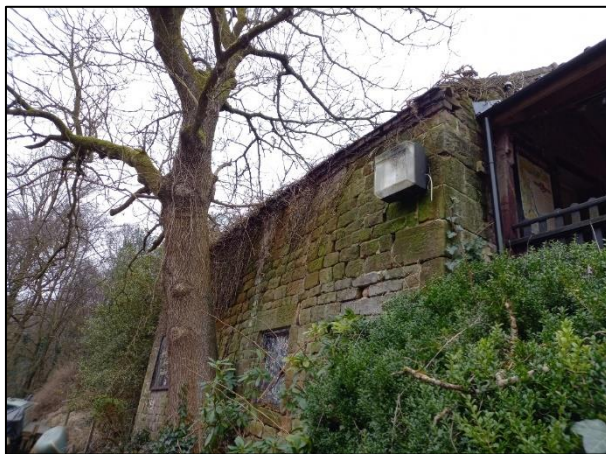
A mature oak tree (Tree 1) is present next to the building and the canal. Although the pruning wounds on the tree appear to have healed over, crevices may still be present around the edges which cannot be seen from ground level. Due to the presence of potential roosting features within the tree as well as its prime location alongside the water, this tree has been assessed as having a 'low' potential for roosting bats (with reference to Collins, 2019). Therefore, if this tree were to be removed or subject to significant arboricultural works then a precautionary approach, outlined below, should be followed.

**Plate 8:** Photograph showing the mature oak tree along the eastern elevation of the building. Photograph facing north-west.

3. Where removal is required, the oak tree (Tree 1) adjacent to the building must be soft felled (e.g. cutting the tree in sections, and gently lowering the sections to the ground). The cut sections should be examined immediately prior to removal. If cavities are evident in the trunk or elsewhere, it is important that these are brought down intact (rather than sawn through).

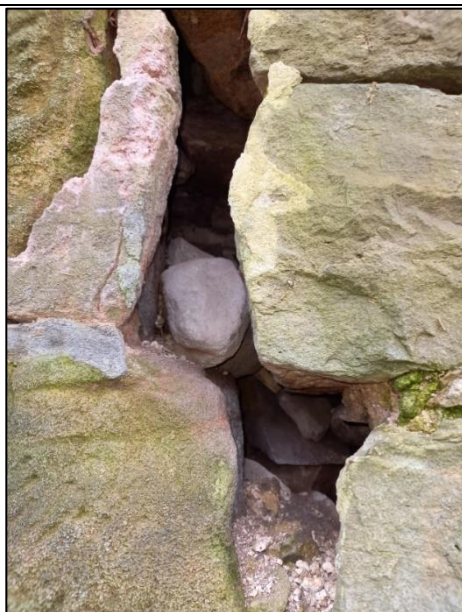
**Plate 9:** Photograph showing the depth of one of the cracks present on the eastern elevation.

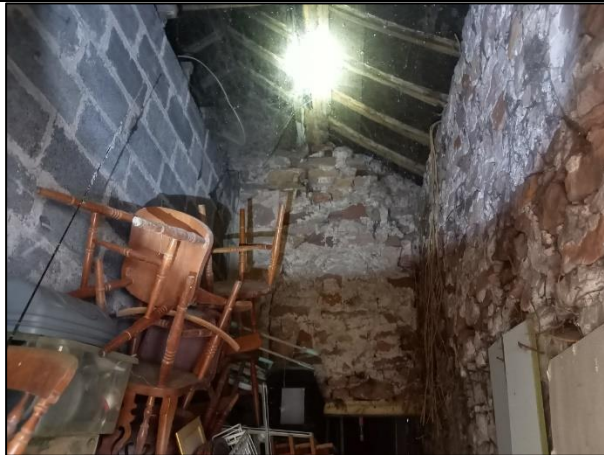
**Plate 10:** Photograph showing the eastern section of the store building. Photograph facing north.

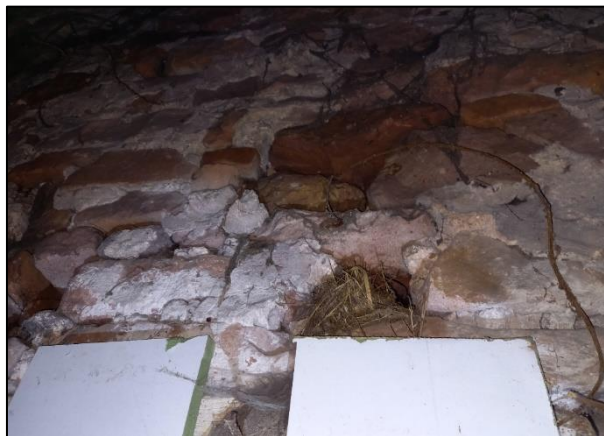
**Plate 11:** Photograph showing some of the cracks internally on the eastern elevation, including one containing bird nesting material.

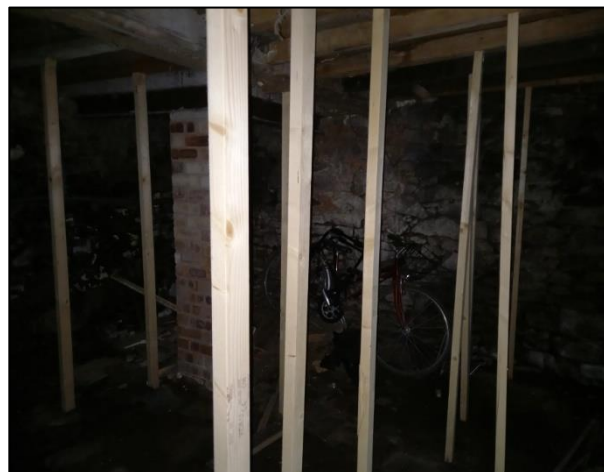
**Plate 12:** Photograph showing the far end of the eastern elevation with wooden ceiling and boards. Photograph facing north-west.

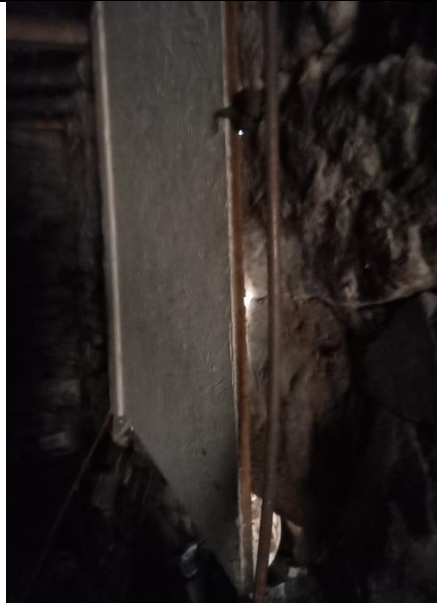
**Plate 13:** Photograph showing the light coming through the boarded window. Photograph facing north-east.

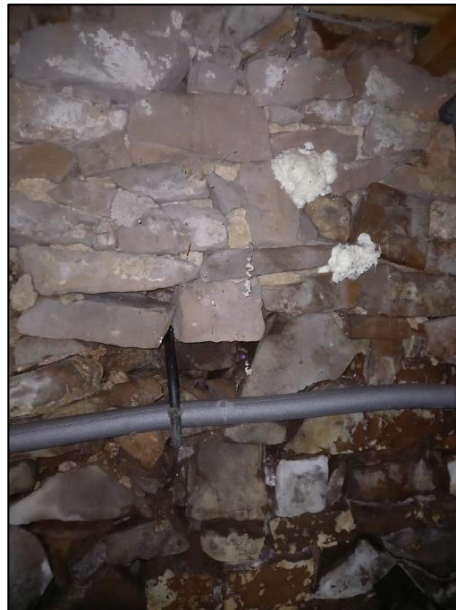
**Plate 14:** Photograph showing a typical view of the internal stone walls within the northern-most section of the building.
