Our Ref. PC/SMC/2029/1

04 December 2020

**Boat Inn**  
**Basford Bridge Lane, Cheddleton, Leek, ST13 7EQ**

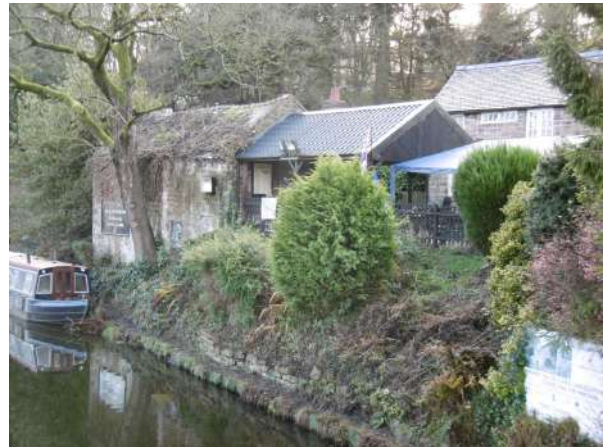
Canal side elevation of outbuilding  
and leaning tree

There was a large tree growing tight alongside the wall about midway along.

The tree maybe an Elm and about 20 m high. It leans out towards the canal and is likely to topple over at any time but most likely in a summer storm when it is in full leaf.

The tree should be removed and the adjacent wall rebuilt as necessary.

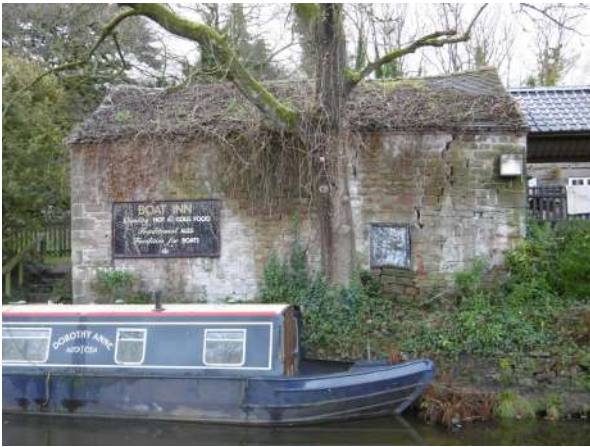
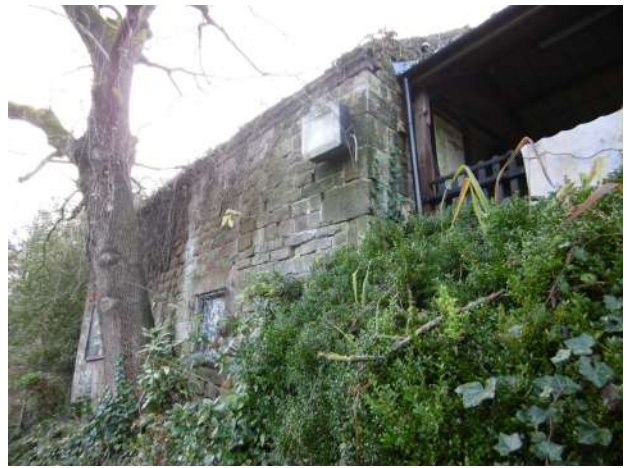
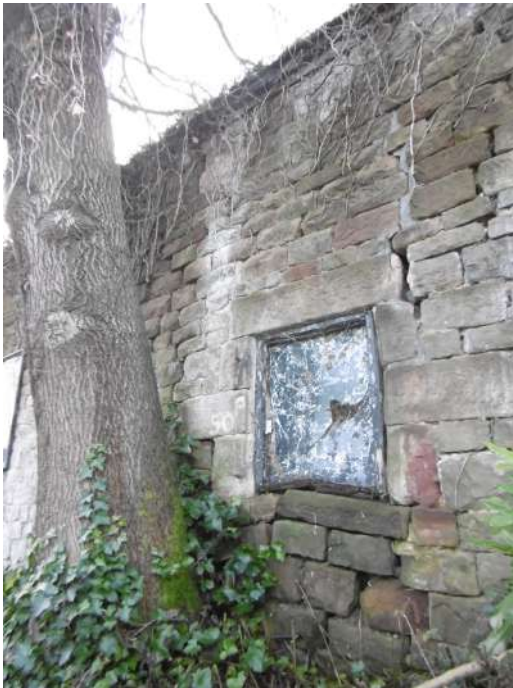
The tree has damaged the wall foundations and distorted the lower coursing and instigated severe vertical cracking below and above the small basement window opening.

The tree roots have severely damaged the integrity of the canal side wall and foundations. The tree is liable to fall into the canal at any time probably during a summer storm when it is in full leaf. When this happens, it will probably bring down much of the canal side wall north gable wall and roof structure together with it into the canal.

Eastern canal side wall with tree causing severe cracking to wall and foundations

Allowance should be made for at least half of the canal side wall to be taken down from eaves level to ground level. This will require scaffold along the canal bank which should be tied back to the internal birdcage scaffold.

The tree and all roots should then be removed.

The canal side wall should then be rebuilt solid and as original in lime mortar off new foundations.

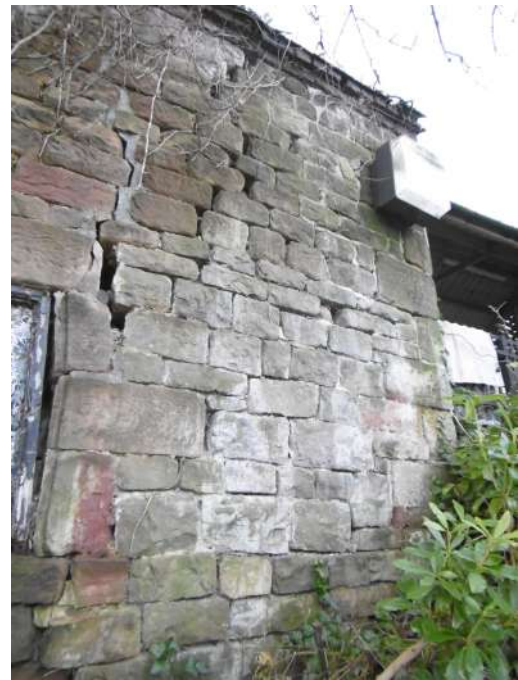
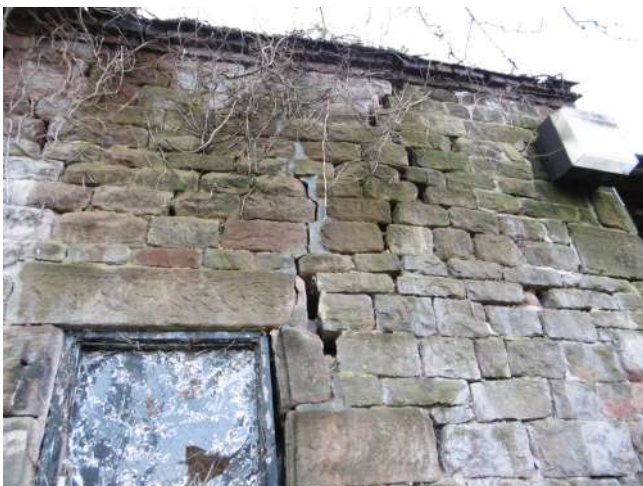
Some previous repointing work has since re-cracked indicating continuing movement.

Severe cracking to wall above window having been repointed and since re-cracked

All areas of defective pointing should be made good externally and internally.

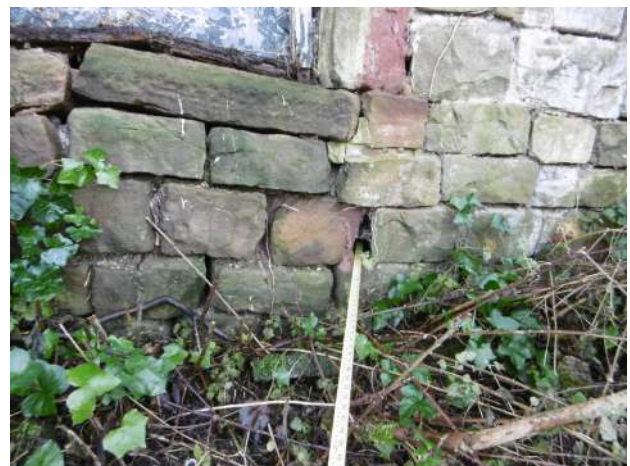
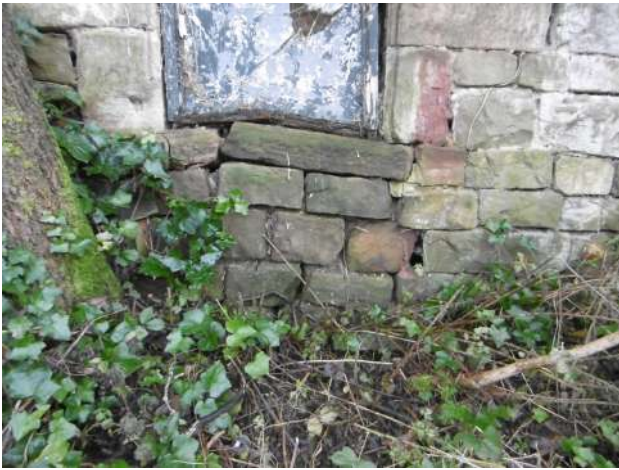
Distorted and cracked wall under window

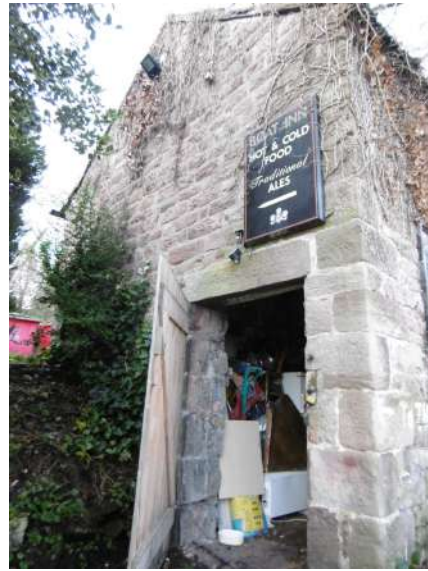
South gable with entrance to basement  
at canal side

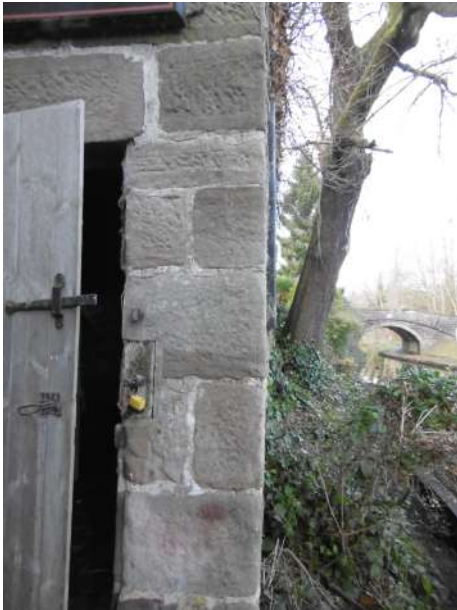
The wall is of coursed stonework recently repointed about 450 mm thick. The stone lintel over the doorway has minimal bearing and the rusting inset iron door hinges are damaging the stonework.

Basement door with poorly supported  
lintel and leaning tree alongside canal

Any inadequately bearing stone lintels should be resupported with at least 100 mm end bearing, if there is any movement present in the walls adjacent or over.

Embedded rusting iron brackets and hinges should be replaced with corrosion resistant surface fixings.

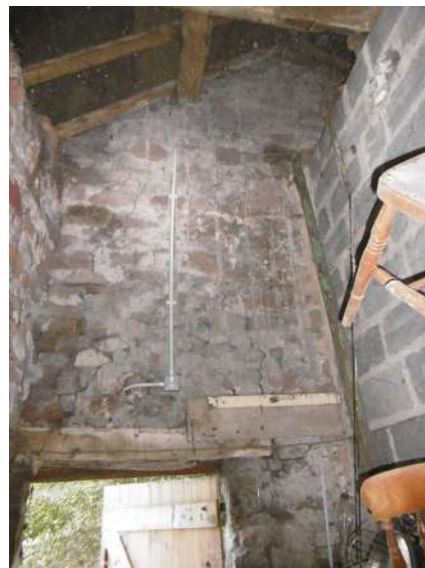
A block wall has been built halfway along the gable from floor to eaves level to enclose the kitchen area above. There is a vertical crack internally above the doorway on the right-hand side.

Internal wall over basement door with cracking  
over right hand side of timber lintel

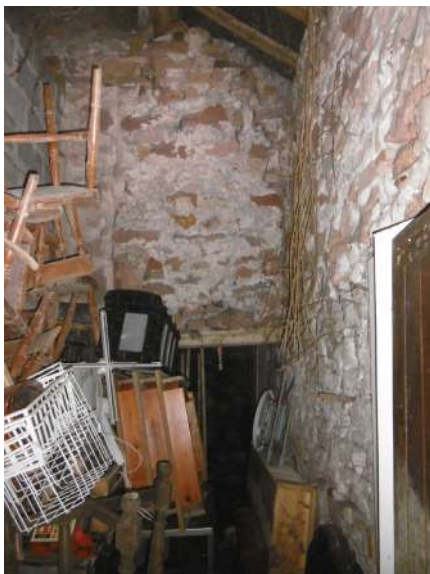
An original stone wall splits the basement into two rooms with the far room ceiling providing the timber floor under the cafe room. Timber lintels over the opening have wood worm damage. This floor is of shallow timber joists spanning onto a central timber beam and has also been provided with a forest of small timber struts placed under the joists to stiffen them. There is also a roughly central brick pier supporting the timber joists and the chimney above.

Internal passage with opening to rear basement  
with defective timber lintel supporting stone wall

The woodworm infested timber lintels should be replaced.

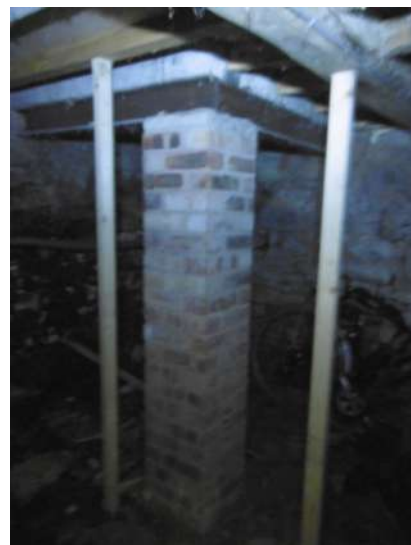
Brick pier in rear basement and  
timber props supporting cafe floor

The cafe floor should be strengthened with additional joists and beams placed alongside existing.

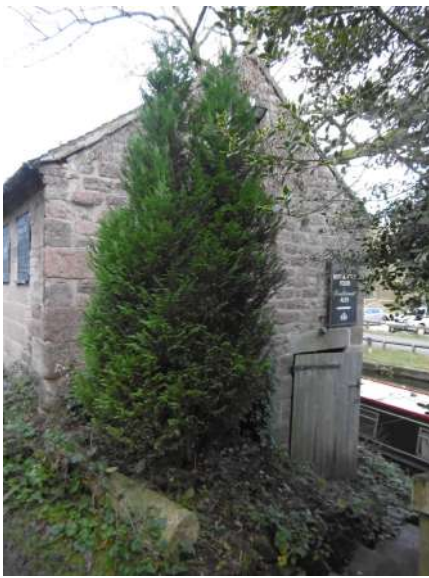
South gable wall with basement entrance alongside canal

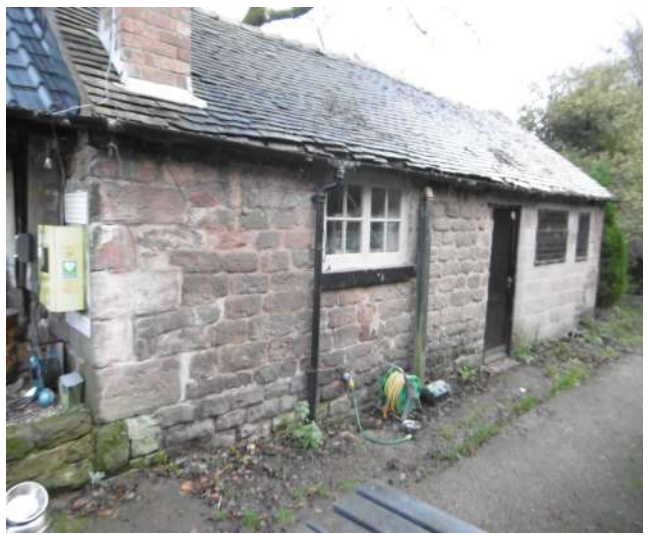
Some repointing has been carried out to the original stonework but further pointing is required especially at lower levels on this and above and to the right-hand side of the rebuilt wall.

West side elevation with showing original and rebuilt stone walls

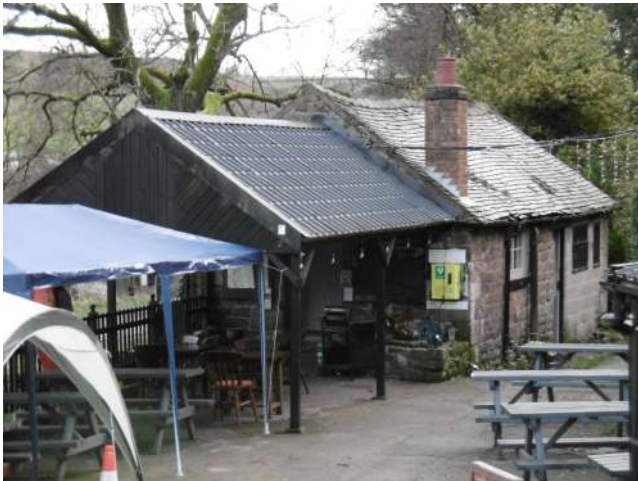
The roof slopes and ridge have dips and undulations from gable end to gable end.

North elevation showing roof undulations and veranda

The roof should be stiffened with additional purlins, rafters and ceiling ties.

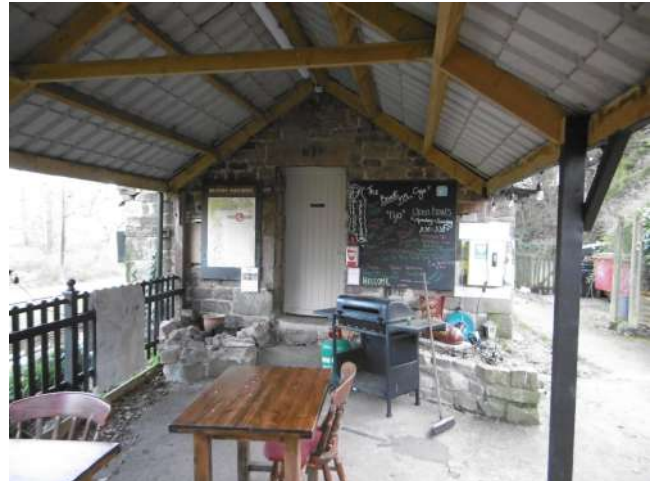
North gable elevation with veranda roof over

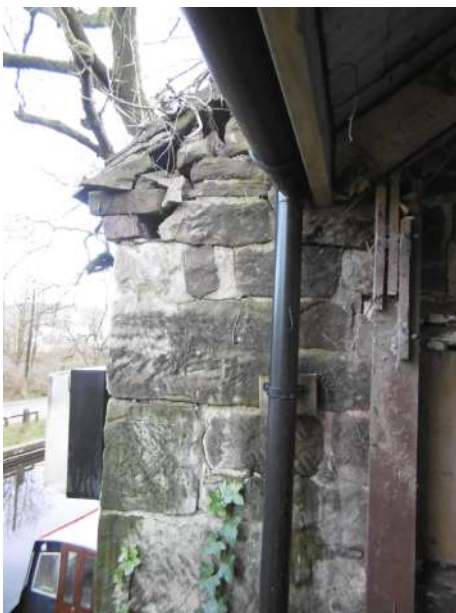
The north gable wall is single storey and has a central doorway with two steps up from the adjacent veranda floor level. The stonework is largely obscured by signage and the veranda with a duo pitch tiled roof but cracking and loose stonework is present at eaves level.

North elevation gable showing loose stonework at eaves

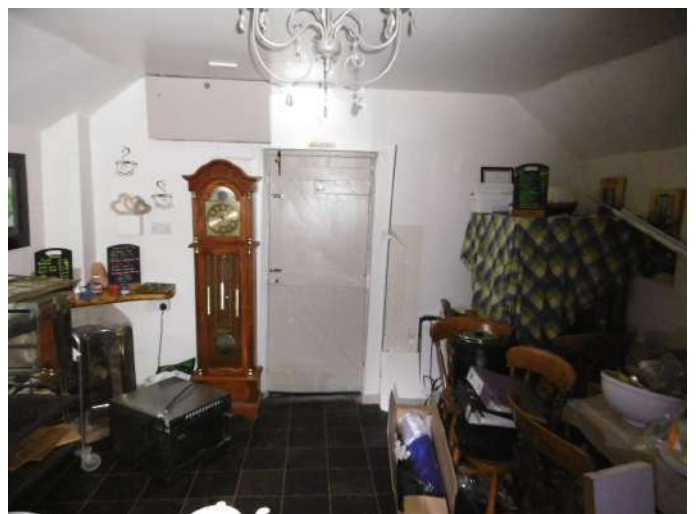
Internal view of north gable dry lined cafe walls
