# **Bat Survey Report 2021**

## **Building Inspection Report**

Location: **BRADLEY ELMS FARM, ALTON ROAD, THREAPWOOD, Cheadle, Stoke-on-Trent, ST10 4RB**

Date of inspection: **20<sup>th</sup> May 2021**

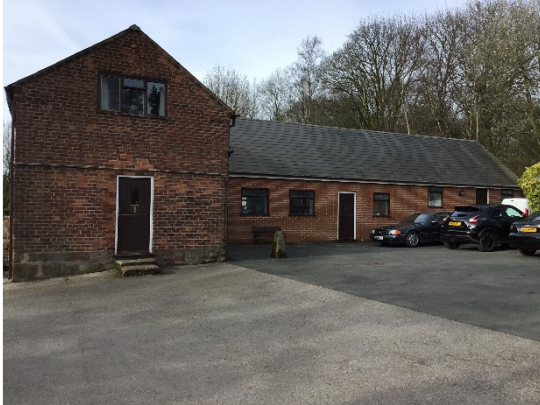
| <p>1. <i>Building A</i></p> | <p>2. <i>Building B</i></p> |

- 5.2. Externally, as is evident from the photographs no's 1-4, Buildings A, B and C appear to be in good condition; the mortar appears sound and in place and the roof tiles are tight. There were no visible entry points apart from two possible small gaps beneath the ridge tiles on the southern elevation of Building A. Building D is a portal frame building with a long axis from north to south, open at the southern end, and with a wide entry opening at the northern end. No evidence of bats was found on the outside of any of the buildings.

- 5.4. There are two roof spaces in Building A; one in the two-storey part of the building and one at the western end of the single-storey part. Both were inspected using a torch. Both have glass fibre laid between the floor joists and a breathable roof membrane beneath the tiles. The latter is unsuitable for bats because their feet can get easily tangled in the membrane. No light could be seen penetrating the darkness. No sign of bats – dropping or stains - was found in either roof space.

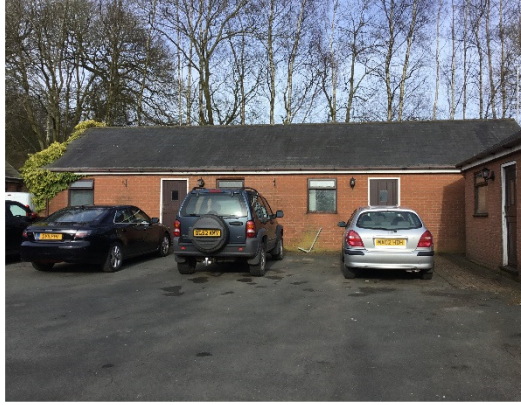
- 5.5. No sign of bats was found in the loft in Building B which has clean glass fibre between the floor joists and breathable roof membrane (BRM) beneath the tiles. The ridge height is about 2.5 to 3 metres and no light percolation was detected. The floor of the roof space is lined with glass fibre and no droppings could be found. The roof is felted with plastic-coated BRM (breathable roof-membrane) which is unsuitable for bats. The roof space stretches from across the full width and the full length of the building. With the torch switched off no light penetrated the space indicating that there were no visible entry points into the space. No shredding of the BRM could be seen which is something that often happens when bats hang from breathable roof membranes.

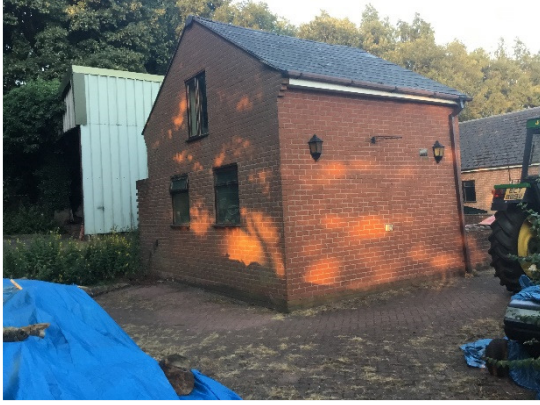
| <p>3. <i>Building C</i></p> | <p>4. <i>Building D</i></p> |

- 5.6. There is no accessible roof space in Building C. The external inspection of the building revealed no potential access points into the roof space.

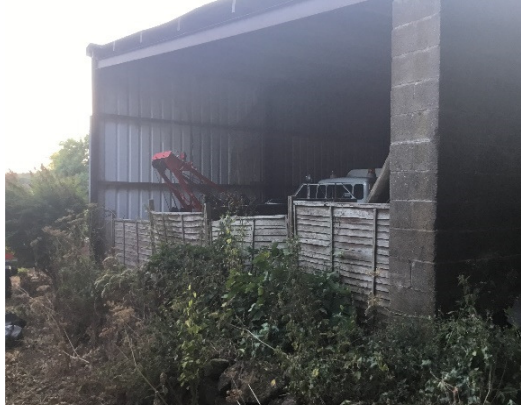
- 5.7. Building D is open to the roof and but bats can access through the doorways on the north and south of the barn. No bat droppings or other sign of bats was found in the building.
