White Shaw Farm  
Heaton  
Rushton Spencer  
SK11 0SR

19th Feb 2021

**Re: Structural survey of Barns at Grenway Hall Farm**

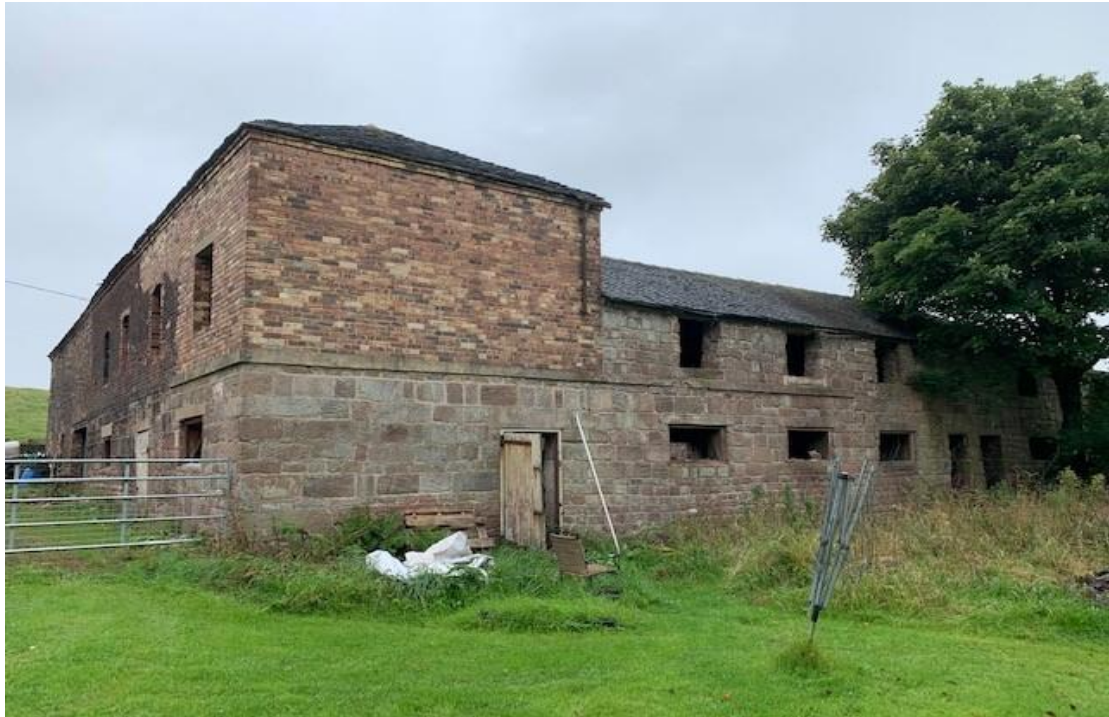
General view of barns.

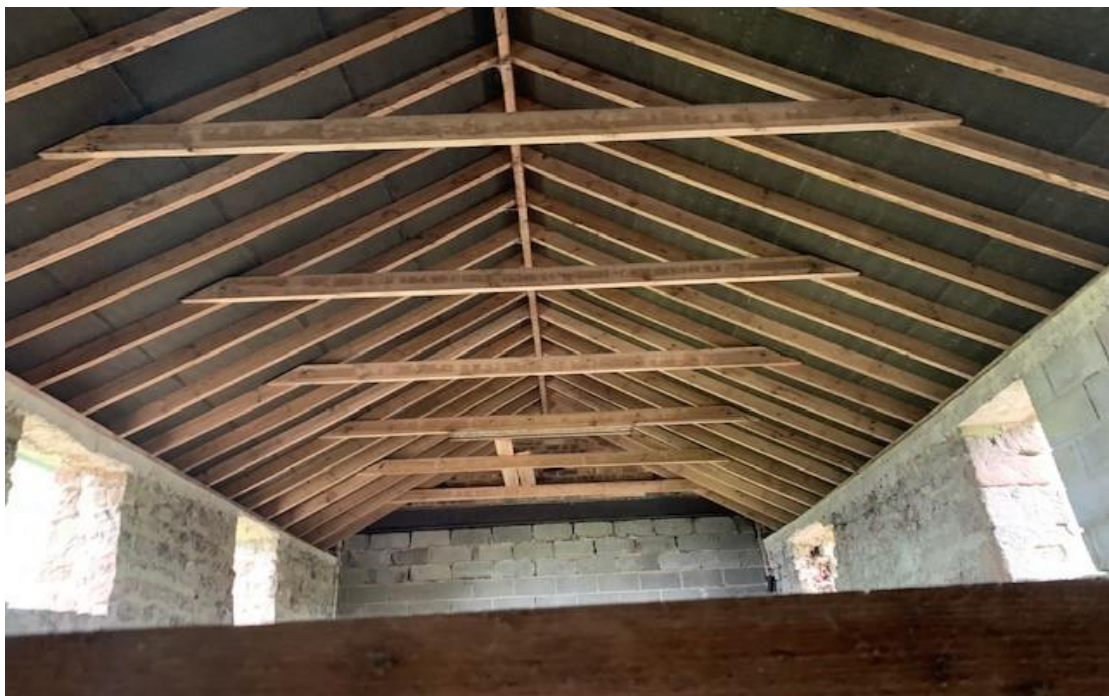
The roofs are finished with Staffordshire blue tiles, which is generally in fair condition with some broken and missing tiles. The roof to the north east section has been re-roofed in the past with new timbers and roofing felt and is in good condition. The timber rafters and trusses within the south east section are in reasonable condition with only very minor localised signs of rotten elements and distortion and most of the timbers remain in good structural condition.

General view of relatively new roof to north east section, will require some minor strengthening for domestic conversion.

- 6) New rainwater goods to the south east section connected in to a suitable underground drainage system.
- 7) The roof within the north east section, although relatively new, will need to be strengthened slightly to allow for conversion for domestic loads associated with insulation and plasterboard etc.

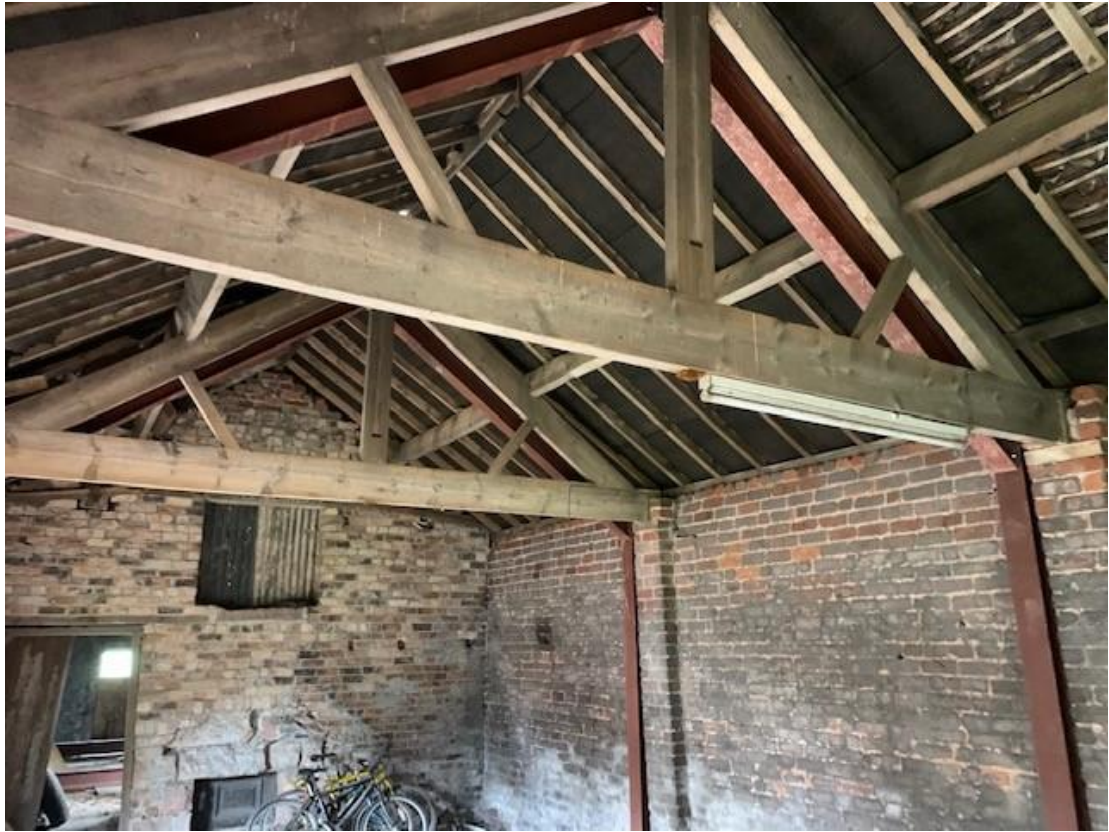
The stone walls at ground floor level of the south east section appear to be reasonably plumb and free from any significant historic or ongoing structural movement. The first-floor walls are showing signs of historic lateral movement both vertically and laterally, however, strengthening works have been carried out in the past in the form of steel portal frames providing lateral stability to the structure. The external wall has pulled away from the internal buttress wall over the years due to a lack of structural continuity.

Typical internal view of first floor south east section – note previously installed steel portal frames providing lateral stability.

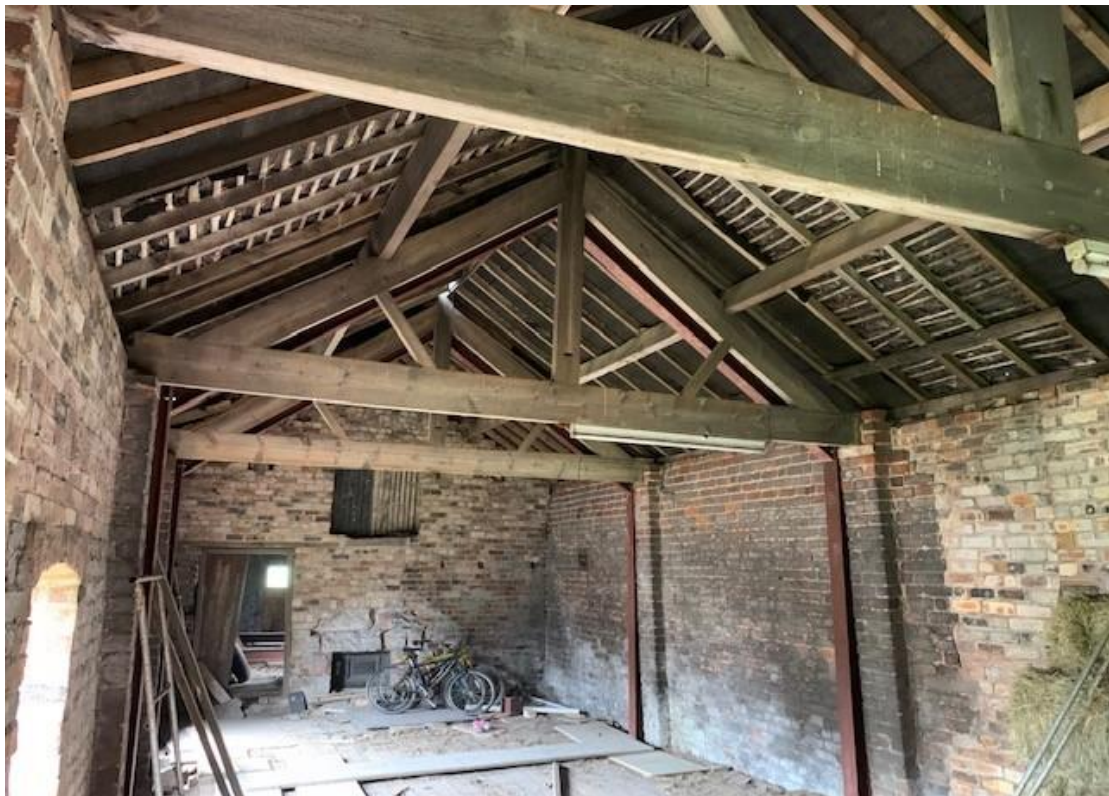
Another internal first floor view of north east section – note timber trusses, purlins and rafters generally in good condition.

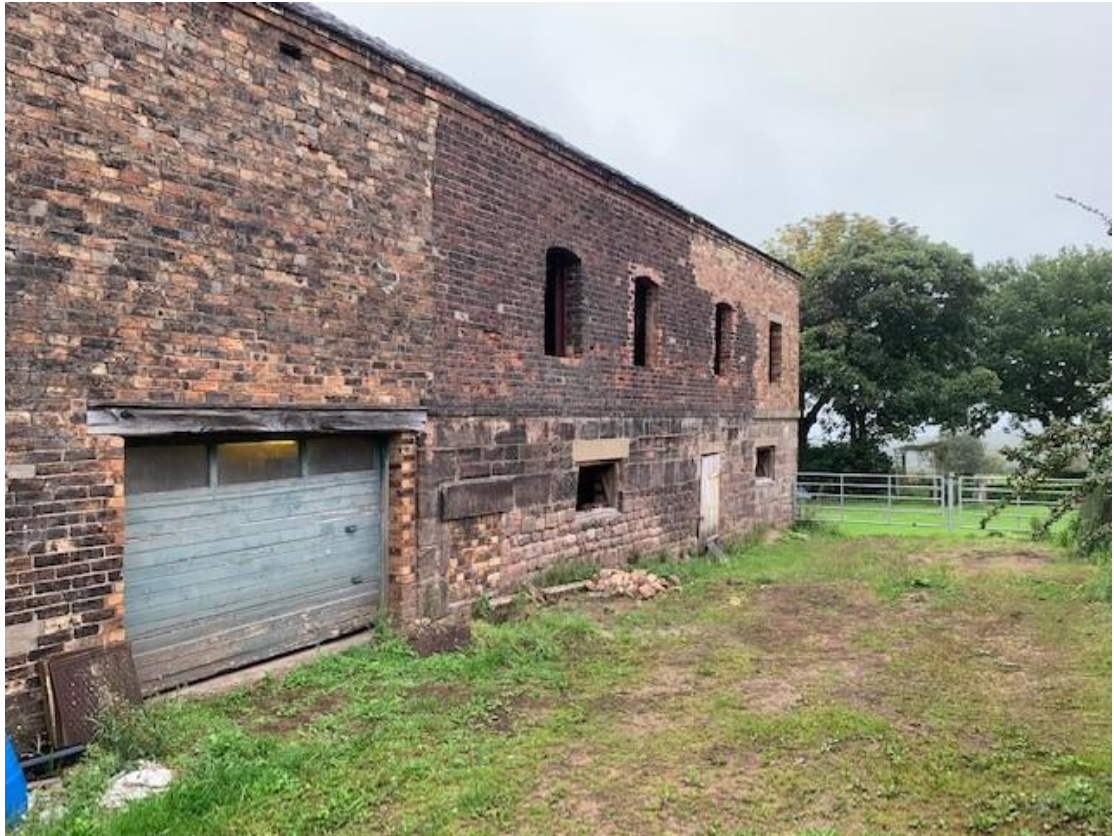
The barns are constructed with a mixture of materials, the north east element is constructed with stonework and the south east element is predominantly stonework at ground floor level and brick work masonry at first floor.

External view of south east barn showing stonework at ground floor level and brick work masonry at first floor.

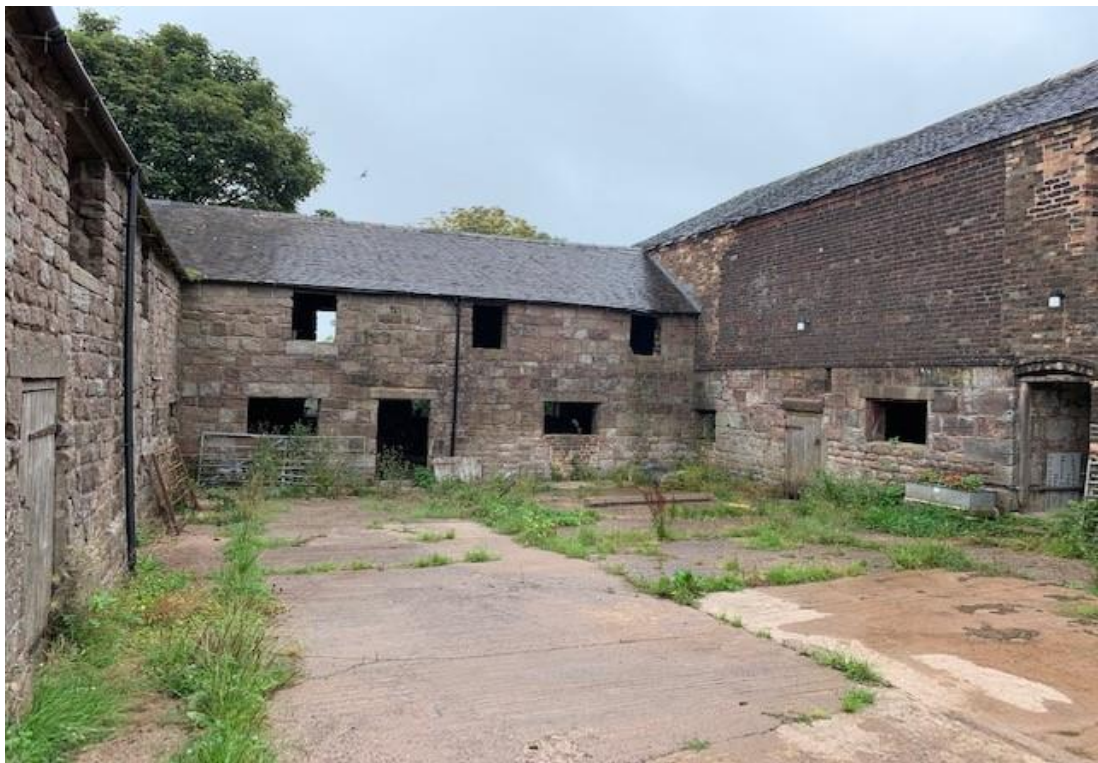
The walls to the north east section of the barn are in good condition and exhibit extensive re-pointing and localised re-building, the walls remain undulating and out of plumb in places due to historic movement, however, this is considered normal for the age and type of construction and is not of structural concern.

Stone work and roof of north east section in good condition.

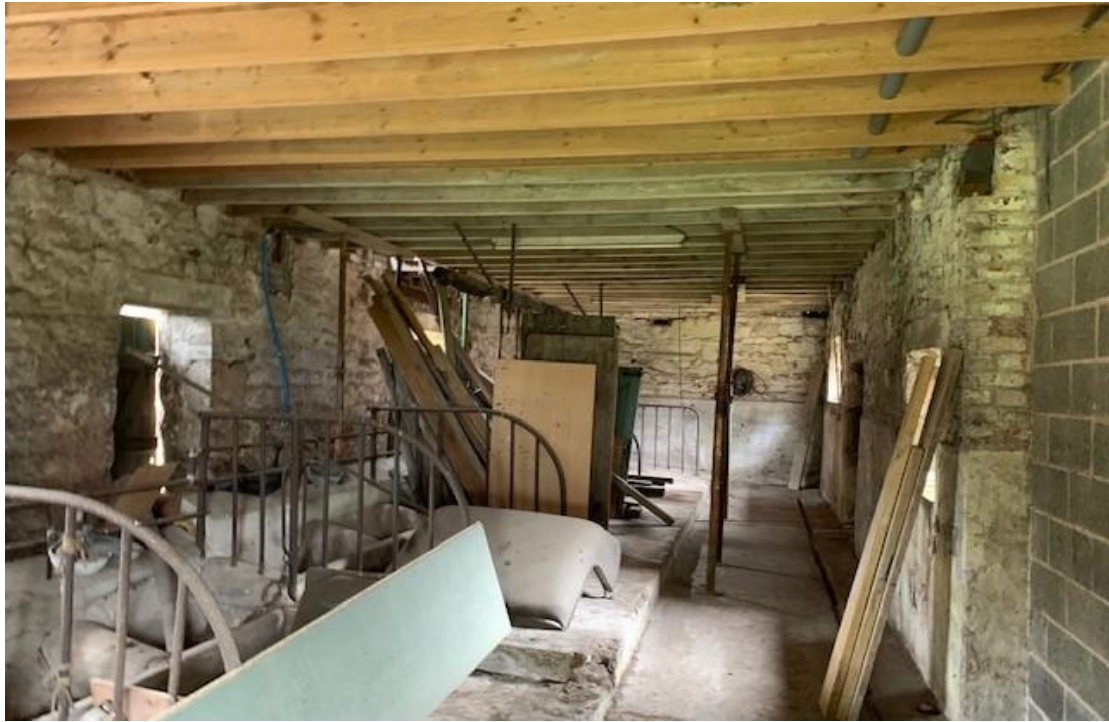
The first-floor timbers within the north east section have been extensively replaced and are all in good condition. The first-floor timber joists within the south east element appear satisfactory for the most part, however, some elements are unsafe to walk on due to rotten and or missing boards and rotten joists.

Timber first floor with south east section – note acro props supporting defective floor sections.

- 3) Isolated elements of the first-floor joists and boards should be completely removed and replaced within the south east section; any new floor structure should be sufficiently strapped to the external walls to meet current building regulations.
