## **STRUCTURAL REPORT**

**FAIRCLOUGH**  
**CONSULTING STRUCTURAL ENGINEERS**  
The Old Stables, Potts Lane, Ollerton. WA16 8SF  
Tel: 01565 653768

**Ref No:** 180602

**PROPOSED ECO SELF BUILD RESIDENTIAL DEVELOPMENT**  
**THORNCLIFFE LANE, LEEK, STAFFS**

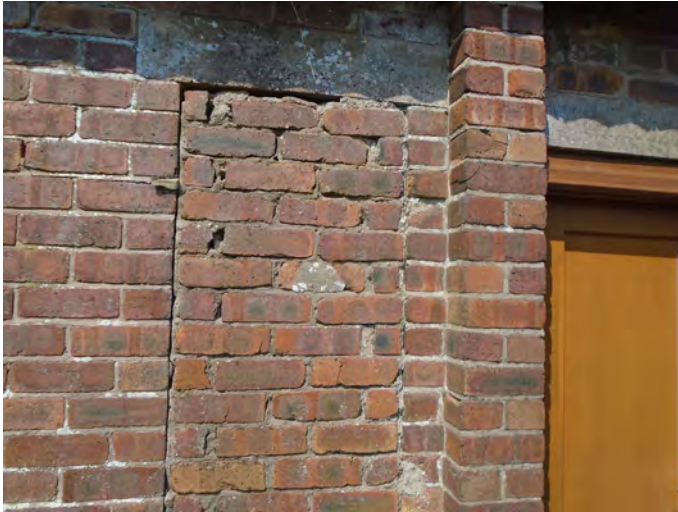
4. The elevations are plumb within normal tolerances. Horizontal lines are level within normal tolerances. There are no signs of structurally significant or recent foundation movement. One of the concrete lintels is cracked. There are some relatively minor cracks, mainly at or above lintel height. On the West elevation at the right hand end there are small pieces of steel embedded into the brickwork at the two end windows – the steel is corroding and the rust expansion is cracking the brickwork. The brick infill to the windows

is not properly bonded to the adjoining brickwork. The lintel to the opening on the south gable is missing.

*Building A. Infilled window detail - typical of all buildings.*

8. To avoid potential problems with reinforcement corrosion in the future I recommend that the lintels are replaced with new. It would therefore be sensible to re-build the small amount of brickwork above the lintels and that would deal with the majority of the brickwork cracks. All embedded steel in the elevations should be removed. All other cracks should be raked-out and re-pointed. The brick infill panels to the windows should be removed or re-pointed as required by the proposed conversion scheme.

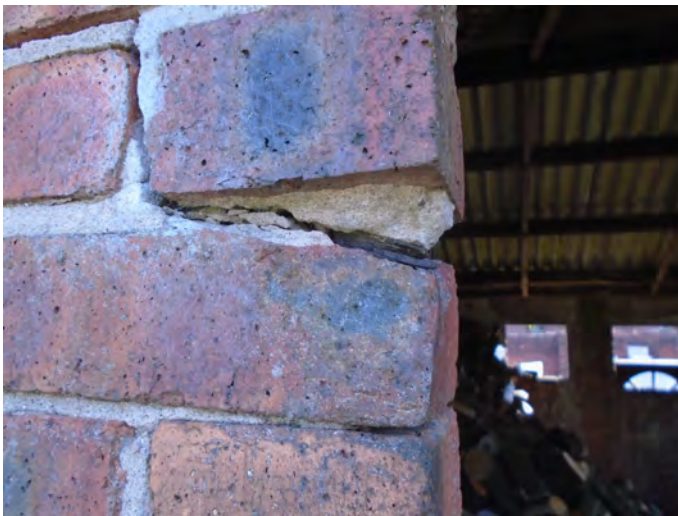
*Building A. Corroding embedded metal causing cracks to brickwork.*

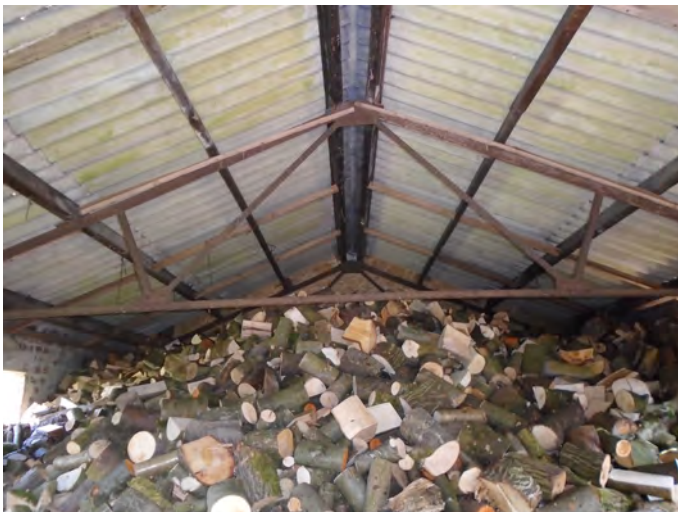
5. The roof structure consists of steel trusses supporting timber purlins. The roof covering is corrugated asbestos sheeting. The trusses are very light-weight by current standards and will not be strong enough to support increased roof loads (for example from insulation, plasterboard, etc).

*Building A. Truss detail – typical of buildings A, B, C.*

9. A new roof structure will be required to support the increased loads from a domestic roof.

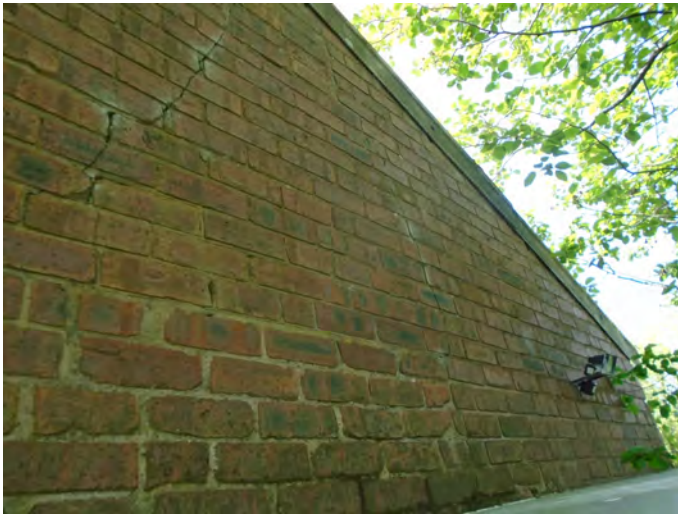
12. The elevations are plumb within normal tolerances. Horizontal lines are level within normal tolerances. There are no signs of structurally significant or recent foundation movement. One of the concrete lintels is cracked. There are more cracks in this building than building A but they do not represent an overall structural defect with the building. There are some horizontal cracks at window head level, and cracks to both gable elevations. There are some stepped diagonal cracks adjacent to windows at the ends of both side elevations. All of these cracks are old. The brick infill to the windows is not properly bonded to the adjoining brickwork. There is a tree in close proximity to the North gable. Lintels to the South gable opening and to internal walls are missing.

*Building B. Cracks to gable.*

16. To avoid potential problems with reinforcement corrosion in the future I recommend that the lintels are replaced with new. It would therefore be sensible to re-build the small amount of brickwork above the lintels and that would deal with the majority of the brickwork cracks. All embedded steel in the elevations should be removed. All other cracks should be raked-out and re-pointed. The brick infill panels to the windows should be removed or re-pointed as required by the proposed conversion scheme.

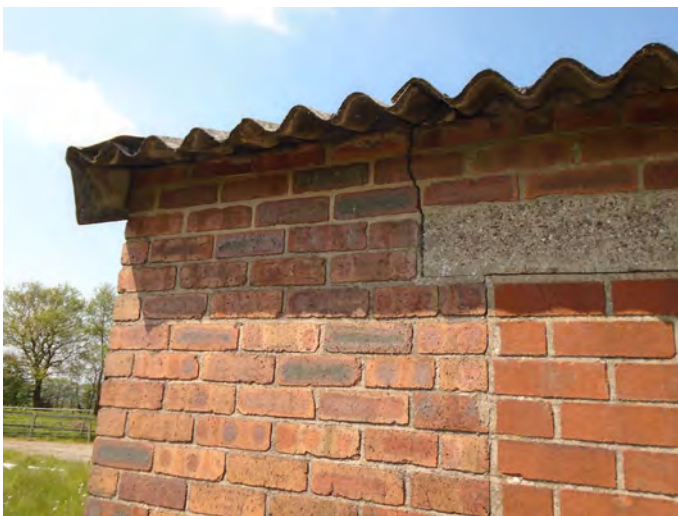
*Building B. Minor cracks to brickwork – typical of all buildings.*

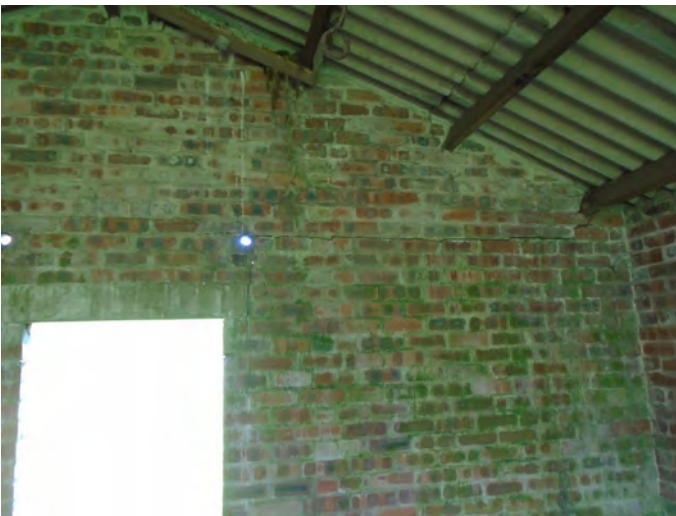
20. The elevations are plumb within normal tolerances. Horizontal lines are level within normal tolerances. There are no signs of structurally significant or recent foundation movement. The lintel to the South gable elevation is very slender and should be replaced. There are some cracks, mainly at or above lintel height. The brick infill to the windows is not properly bonded to the adjoining brickwork. There are significant cracks to the North gable elevation caused by rust expansion of embedded steel.

*Building C. Cracks from corroding embedded metal (tubes).*

24. To avoid potential problems with reinforcement corrosion in the future I recommend that the lintels are replaced with new. It would therefore be sensible to re-build the small amount of brickwork above the lintels and that would deal with the majority of the brickwork cracks. All embedded steel in the elevations should be removed. All other cracks should be raked-out and re-pointed. The brick infill panels to the windows should be removed or re-pointed as required by the proposed conversion scheme.

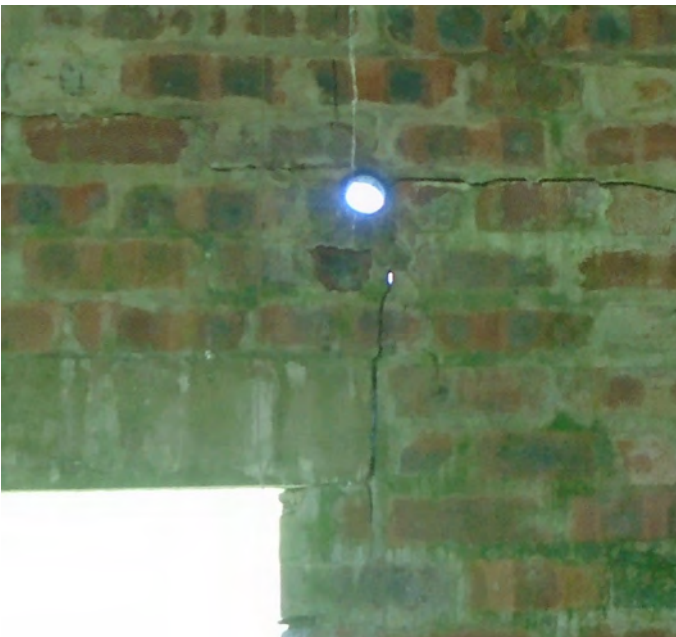
*Building C. Close-up of cracks from embedded metal.*

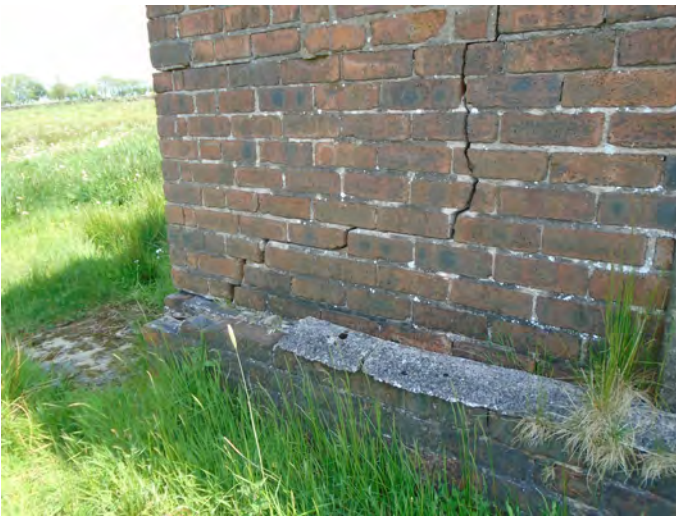
28. The elevations are plumb within normal tolerances. Horizontal lines are level within normal tolerances. There are some significant cracks to the North end of the West elevation but they do not appear to have been caused by foundation movement and they are clearly very old. The brick infill to the windows is not properly bonded to the adjoining brickwork. The lintel to the opening on the south gable is missing.

*Building D. Significant cracks – North end of the West elevation.*

33. The area of significantly cracked brickwork at the North end of the West elevation should be re-built. These cracks do not appear to be the result of foundation movement but this should be investigated further during construction and an allowance made for some localised underpinning at this corner.

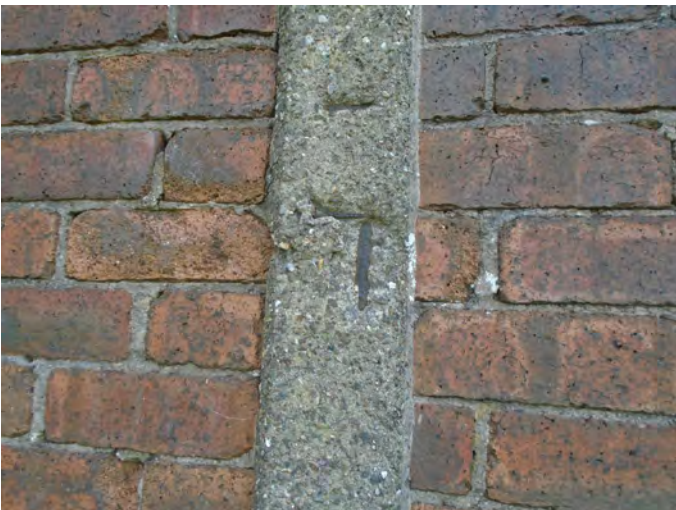
27. The side elevations consist of half-brick panels between the reinforced concrete portal frame columns. The outer and inner faces of the concrete columns are exposed. There are cracks, exposed reinforcement, and reinforcement corrosion to both the outer and inner faces. Regularly spaced windows have concrete lintels. The lower parts of the windows have been in-filled with brickwork. The gable elevations are of half brick construction. There is an exposed and corroding steel lintel to the opening in the South gable elevation.

*Building D. External exposed reinforcement to columns.*

34. The reinforced concrete portal frames would not be adequate to support increased roof loads even if they were un-damaged but the damage from reinforcement corrosion to the columns has significantly weakened them further. The portal rafters should be unbolted and replaced with a new roof structure. The haunches (attached to the tops of the columns) should be cut off.

35. The reinforced concrete portal columns will continue to corrode unless they are encapsulated in a permanently dry environment. Continued corrosion would cause significant rust expansion and cause cracking and disruption not only to the columns themselves but also to the adjacent brickwork. To prevent this there are 3 Options: -

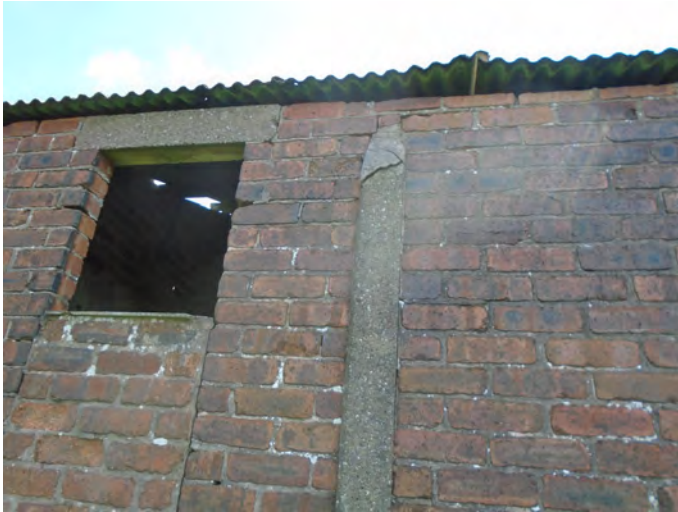
*Building D. External cracks to columns.*

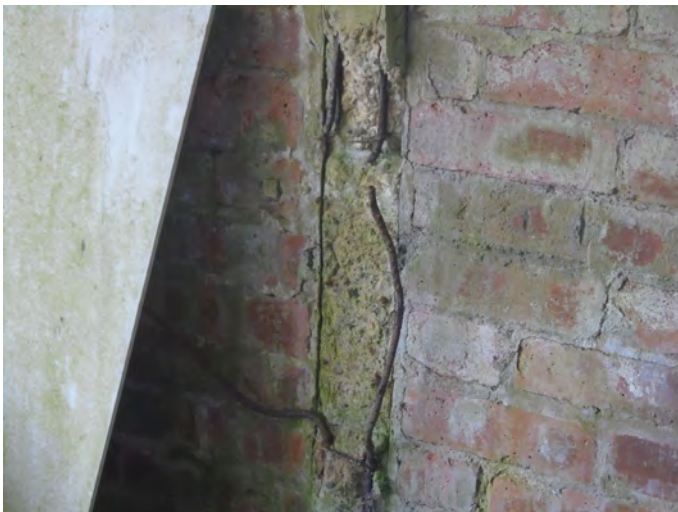
*Building D. Internal cracked concrete and exposed reinforcement.*
