**80/82 PRINCE GEORGE STREET**  
**CHEADLE**  
**STOKE ON TRENT**  
**ST10 1HX**

**STRUCTURAL APPRAISAL**

A REPORT  
ON A  
STRUCTURAL APPRAISAL

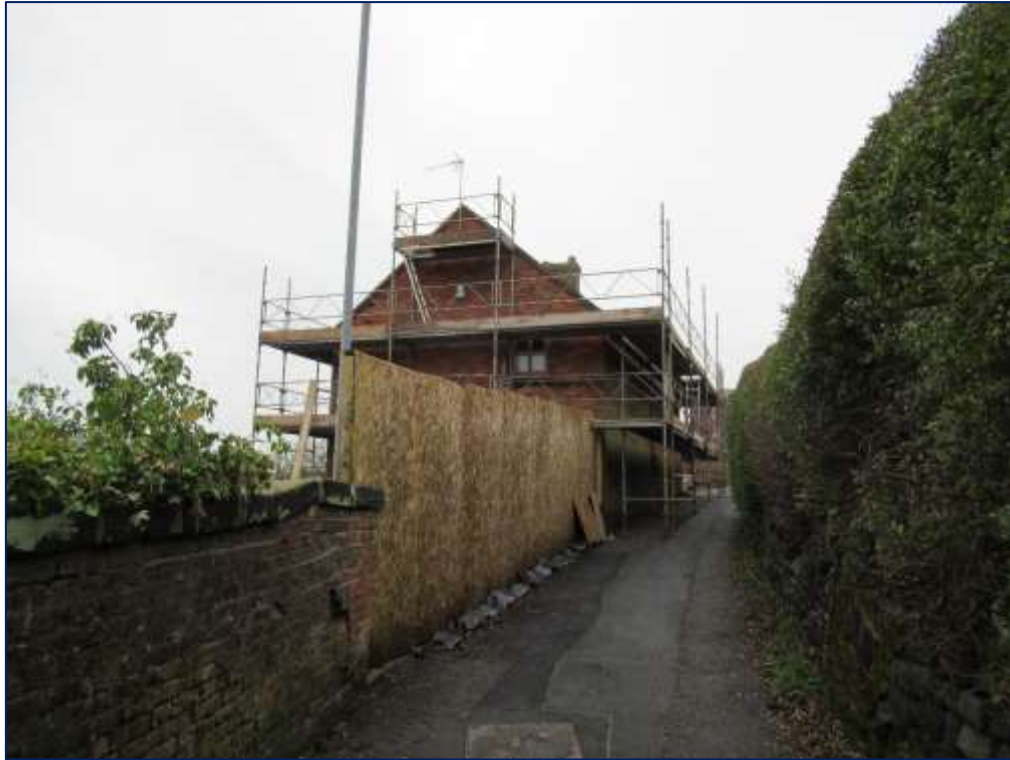
On the left-hand gable, which includes the entrance to number 82, there is no evidence of any cracking or movement.

1. View looking at the left-hand gable from Prince George Street.

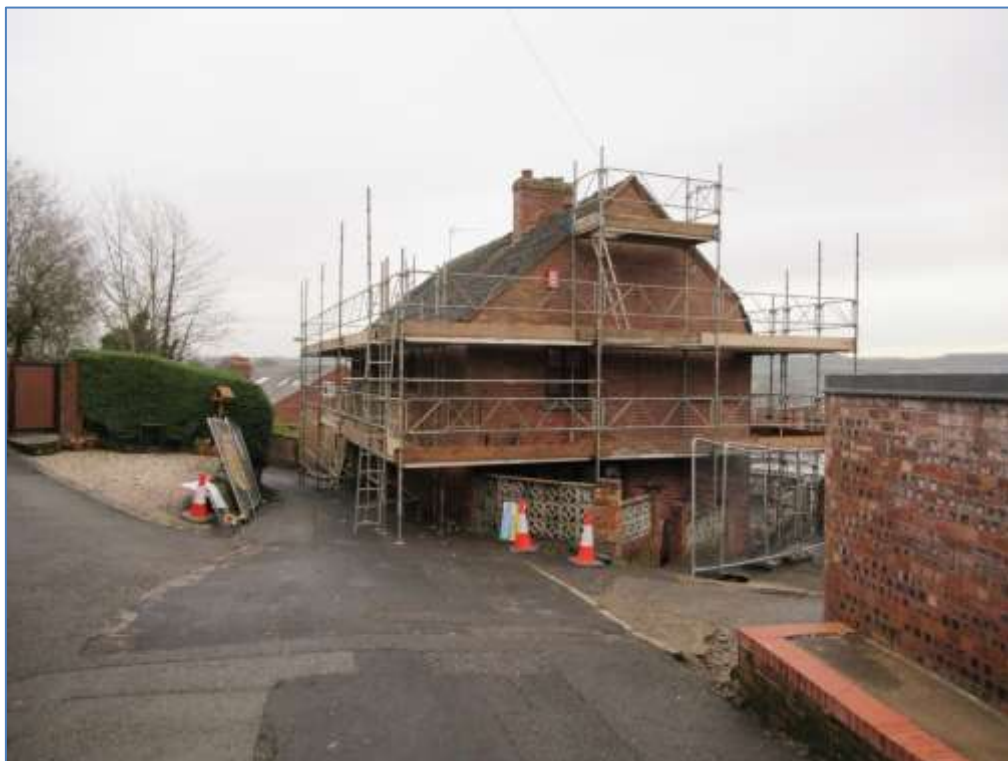
4. General from looking at the right-hand gable to number 80.

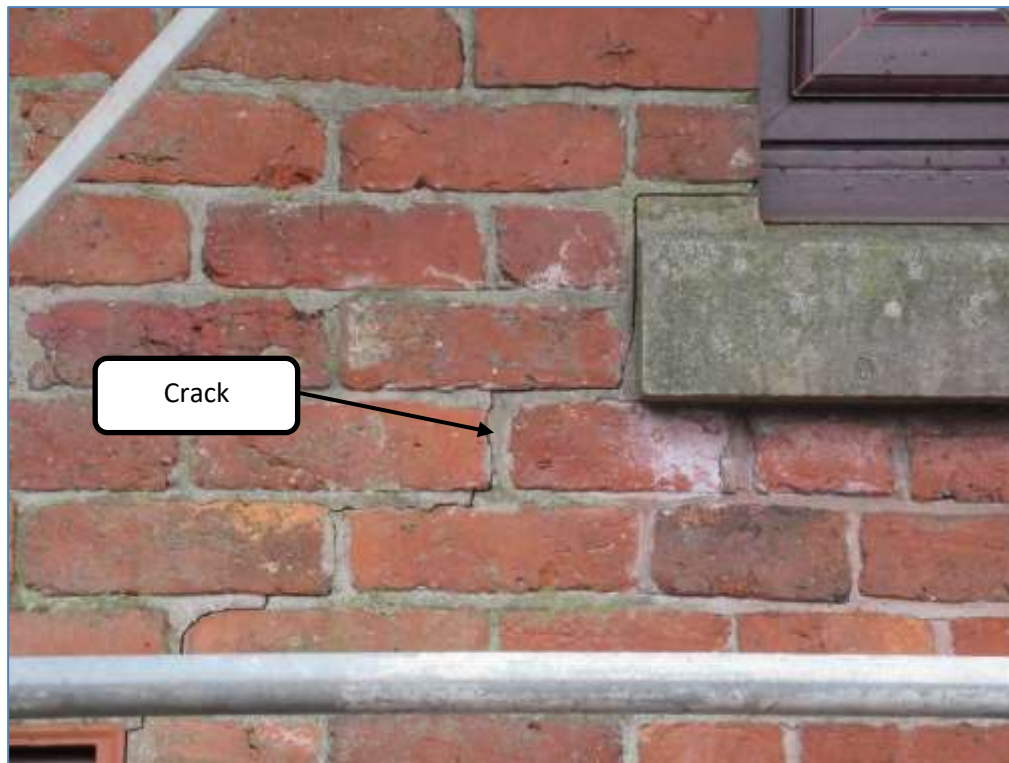
On the right-hand gable, which includes the entrance to number 80, above the head of the entrance door is a raking 1mm wide crack running up to the bedroom window. Beneath the lounge window to this elevation is a raking 0.5mm wide crack.

5. Shows cracking running from the head of the entrance door.

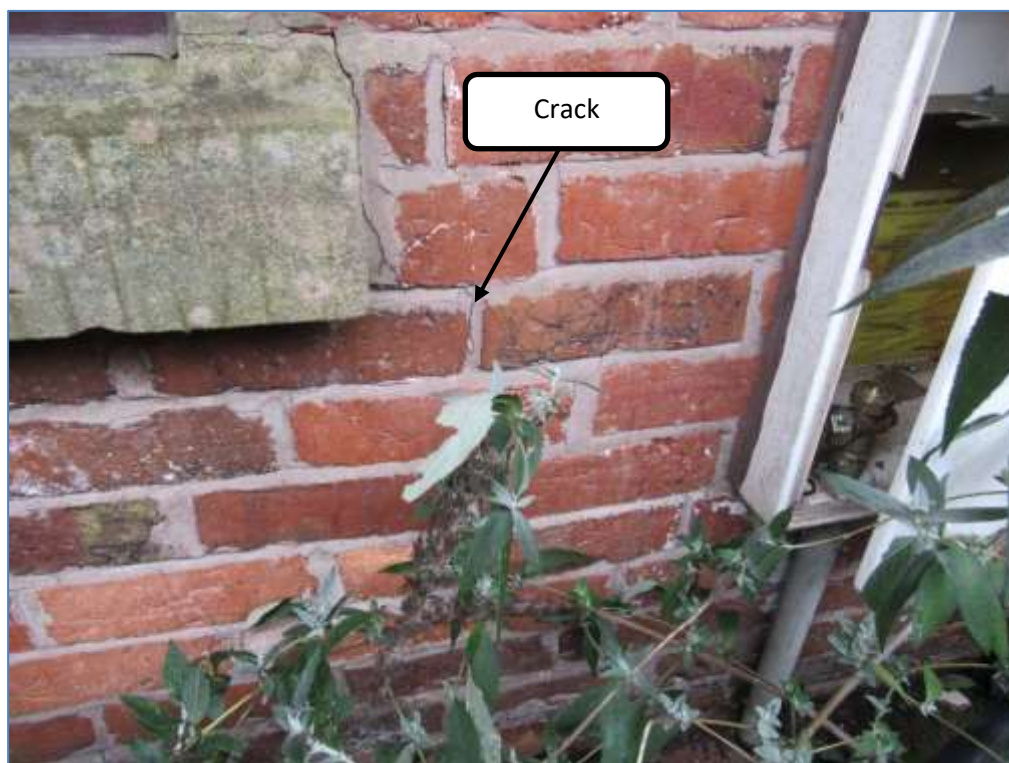
6. Shows cracking running below the window to the lounge.

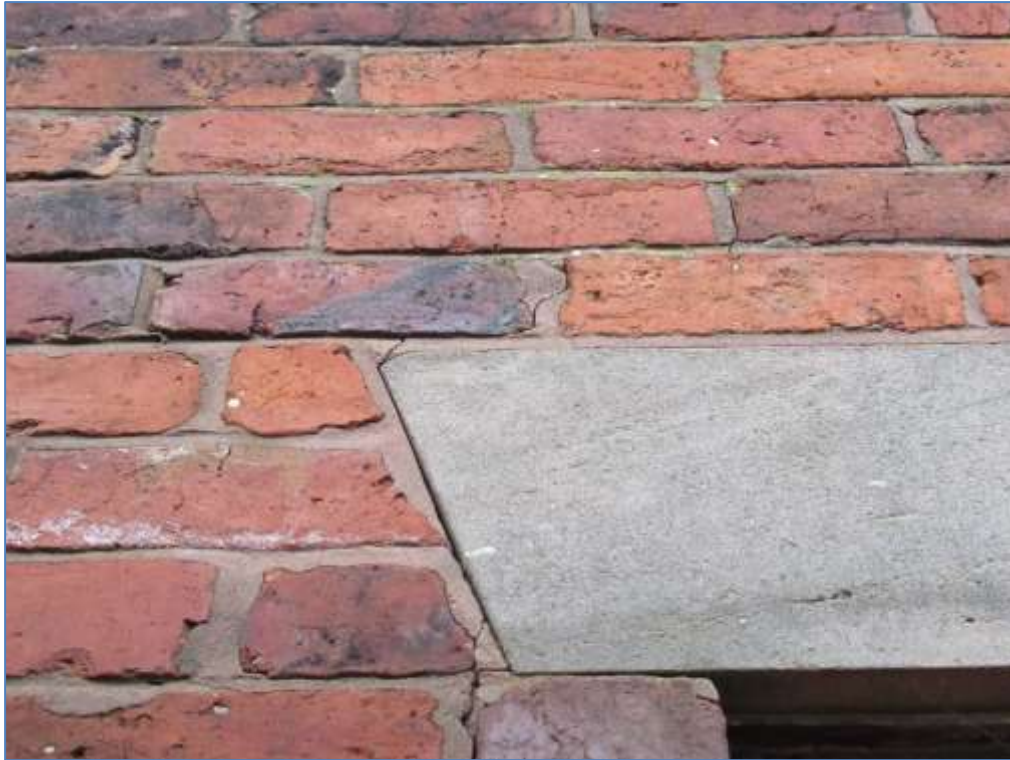
On the rear elevation to both properties, there is no evidence of any cracking or movement of structural significance. Emanating from around all of the feature lintels above the ground floor patio doors and windows are raking 0.5mm to 1mm wide cracks.

9. Shows cracking at the end of the lintel over the ground floor windows to number 82.

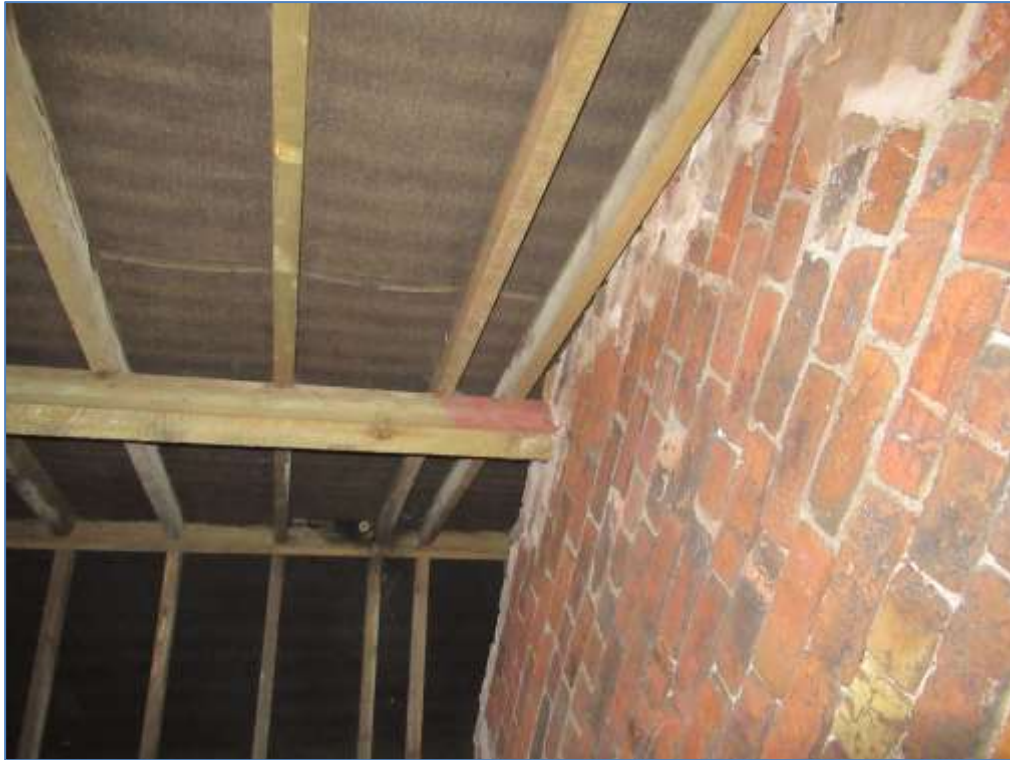
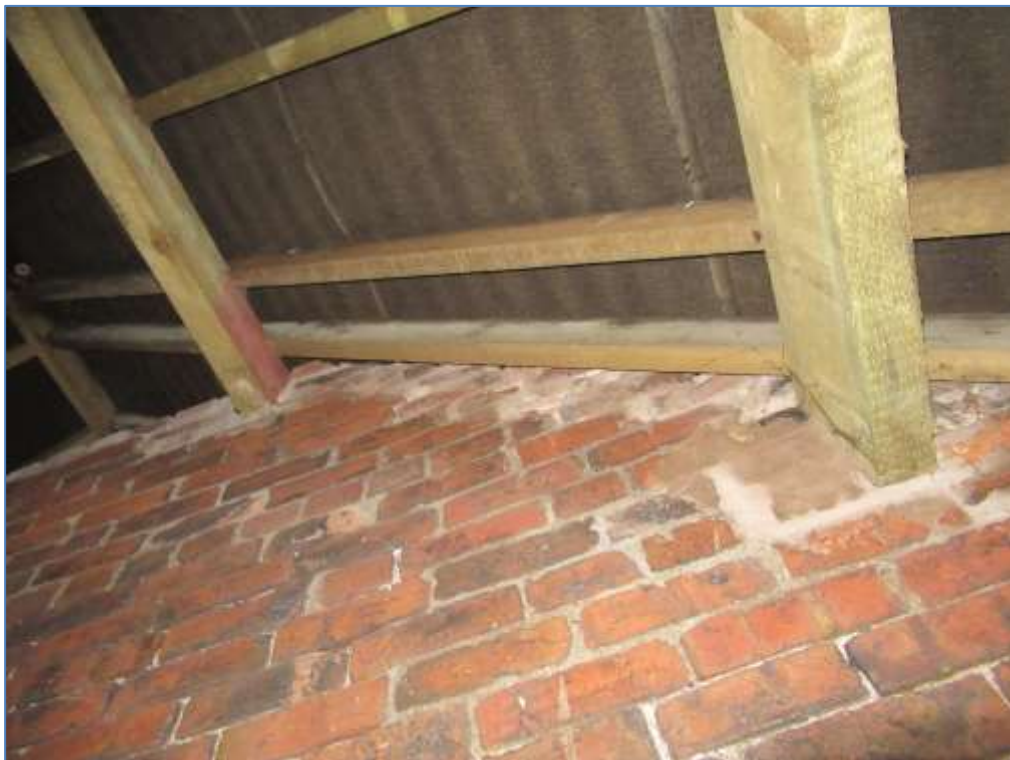
Observations internally through the loft hatch show that the roofs to the properties are constructed from a cut timber roof from modern timbers. There is no evidence of any distress to the roof structure.

25. Shows modern cut timber roof to the properties.

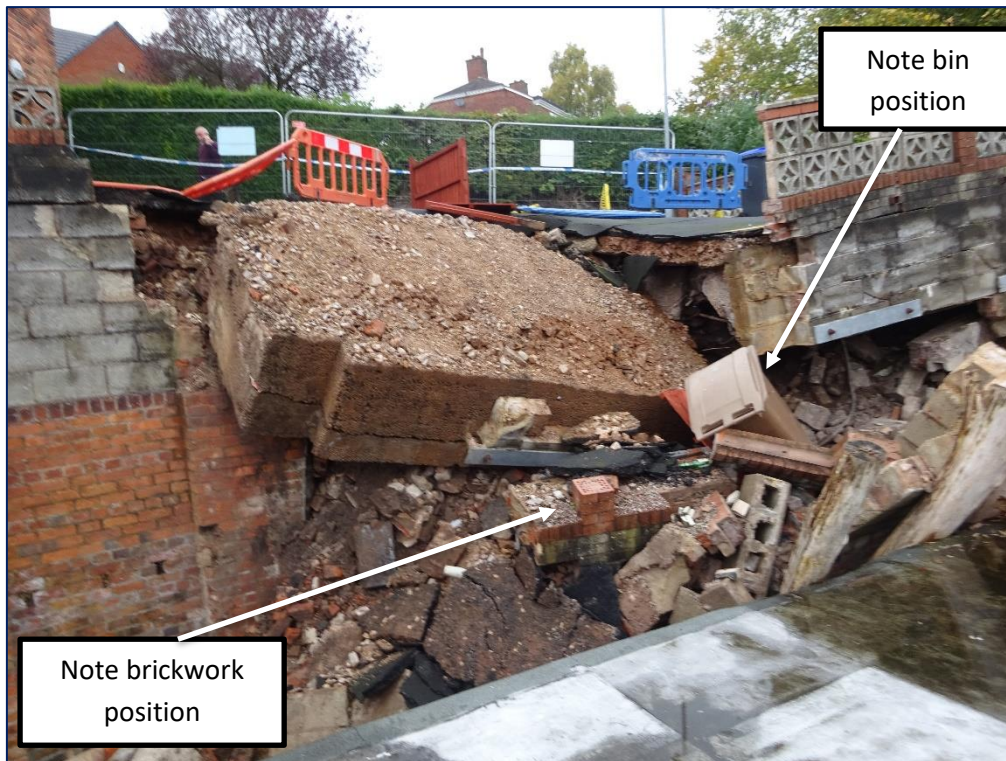
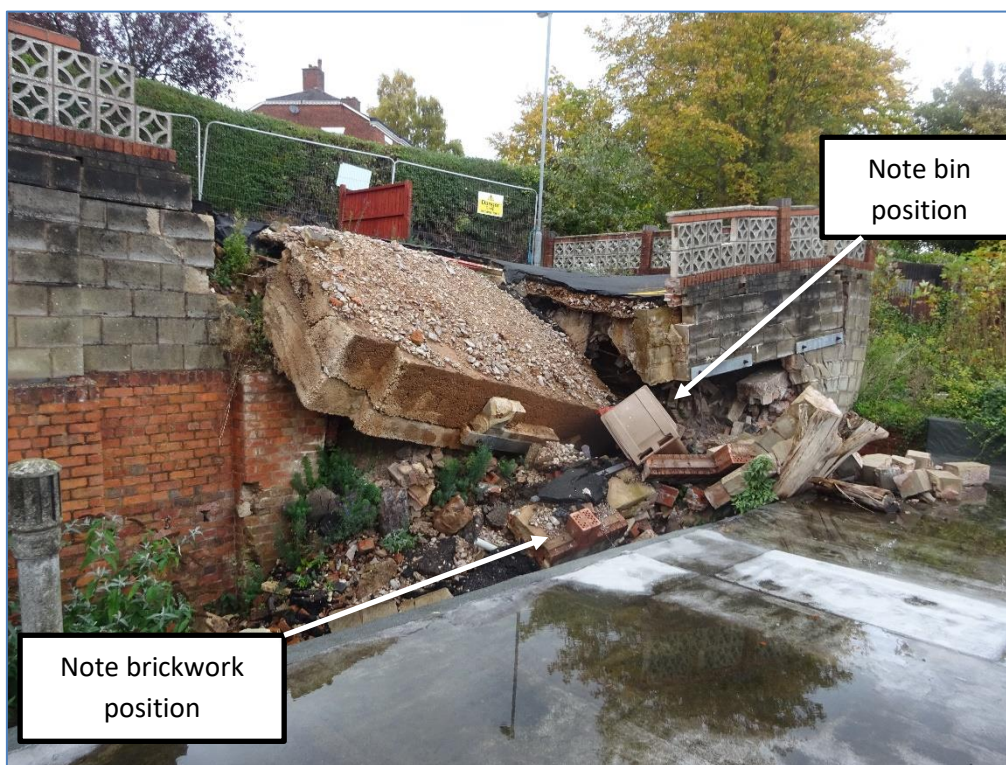
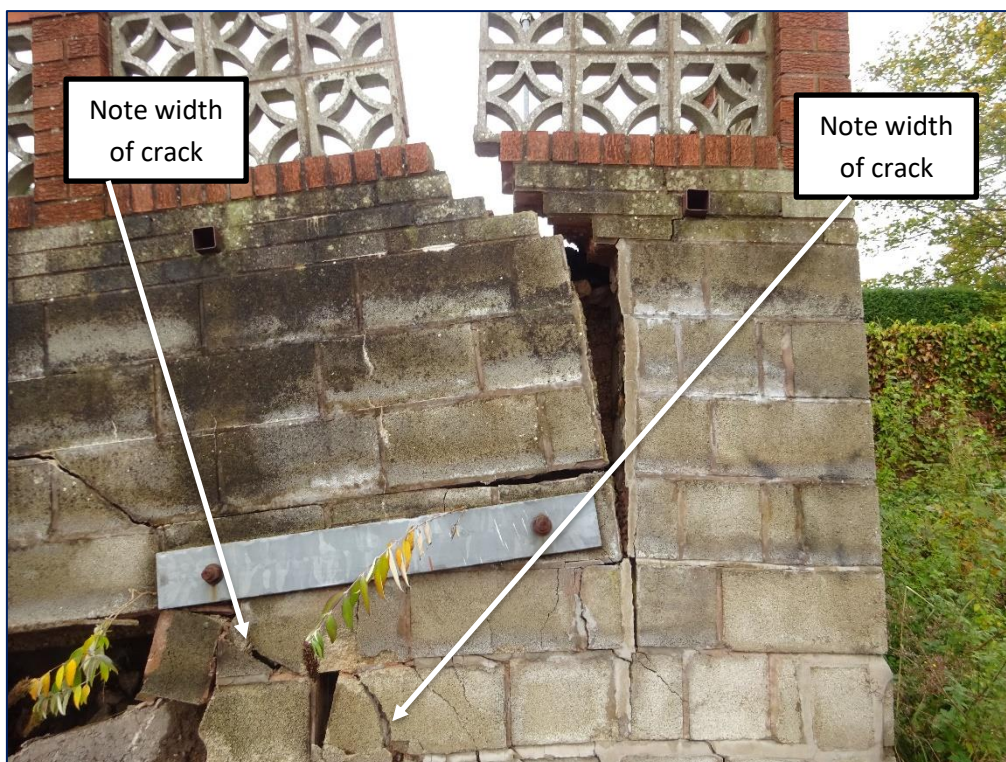
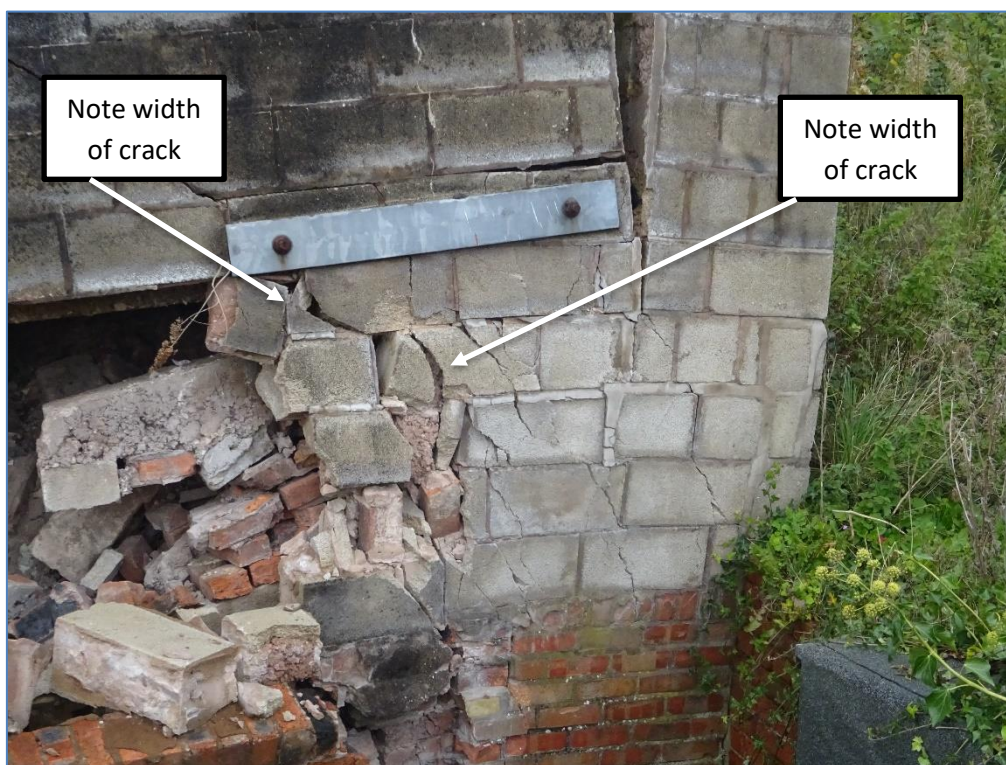
Observations of the retaining wall are limited due to the lack of safe access. Based on the observations possible, the original brick retaining wall along the rear of these properties has been raised in height by around 3m to 4m and it is believed the overall height of the retaining wall is now of the order of 10m.

The section of retaining wall supporting the car parking area, to the left of the properties, has collapsed against the rear wall of the shops on the High Street.

In the section of retaining wall across the rear of the properties, there is evidence of lateral displacement of the blockwork at low level.

The retaining wall across the rear of the properties which supports the fill on which the properties are founded has failed in structural terms.

The section of retaining wall to the rear of the car parking area has already totally collapsed causing damage to the adjacent properties. The remaining section is at high risk of collapse at any time with the risk of further consequence damage to the properties on the High Street.

In order to mitigate the risk of further catastrophic collapse of the retaining wall and the two properties, the retaining wall across the rear needs to be made safe. A number of options for making this area safe have been investigated with specialist contractors including erection of specialist propping through the shops and filling the void with foam. All of these have practical difficulties and following discussion with multiple parties, it has been agreed the only way to make the area absolutely safe is to take the section of wall down.

Therefore, demolition of the properties is required in order to make the area safe.

With the retaining wall taken down and the area made safe, a bored pile retaining wall can be installed to stabilise the ground and prevent further loss of ground undermining the highway.
