STRUCTURAL APPRAISAL REPORT BARN CONVERSION

**Wragg Hall Farm,
Biddulph Park Road,
Biddulph Moor,
ST8 7SJ**

Wagg Hall Farm– Structural Appraisal

Project No: 2012

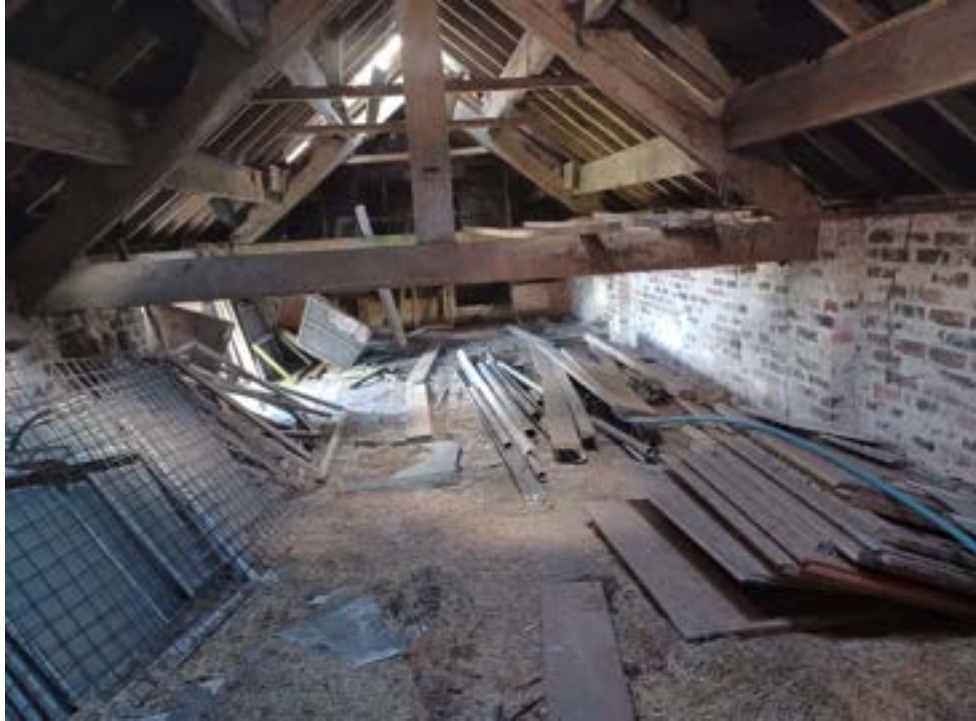
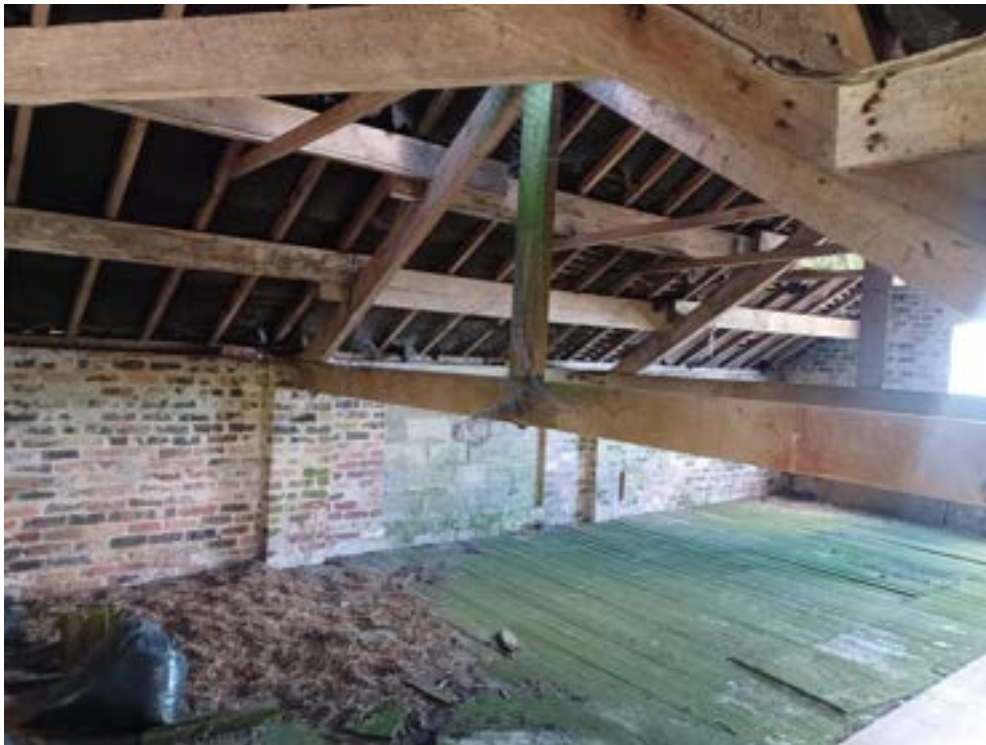
The rafters are in a good condition.

2 No purlins are present each side of the roof, all the purlins are in a good condition.

4 No king post trusses are present in the barn, again these are in a good condition.

Photo 1 – Looking at the Roof structure

Photo 2 – Looking at the Roof structure

The roof is to be repaired where holes are present and a new lining insulation will be required.

The main members of the roof: rafters, purlins and trusses are in a condition where minimal repair work would be required upon altering the barn to a domestic property. New felting, insulation and to ensure any holes are infilled and sealed would be required but the main structure to the roof including the tiles could remain. The guttering and downpipes will need replacing and connecting into a suitable drainage system.

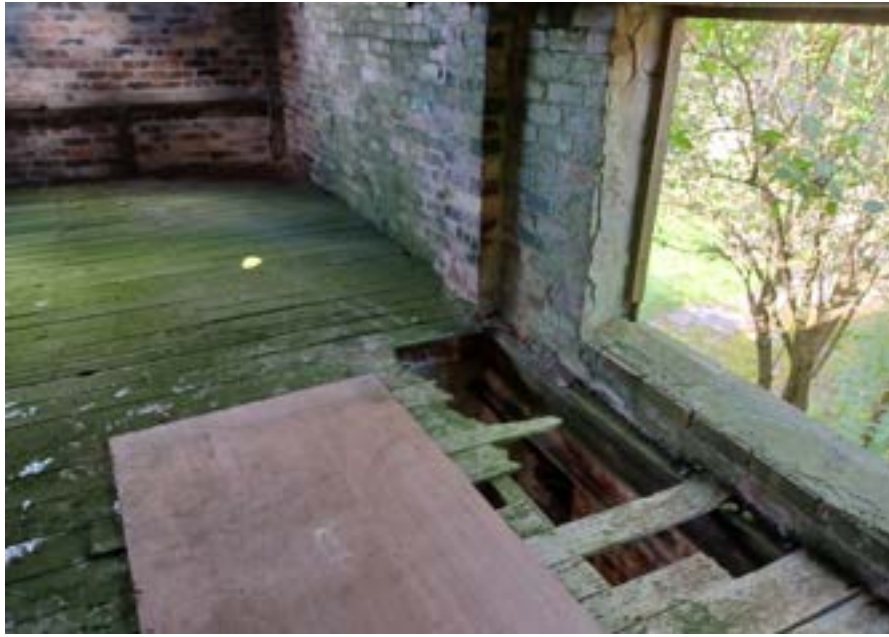
A timber floor is present throughout which is all at the same level. The floor consists of timber boards over timber joists. A number of the boards are broken, missing or rotten and should be replaced. The joists are typical 60x220mm at 600mm ctrs, some areas of joists are showing early signs of rot and should be treated if to remain.

Photo 3 – Showing area of broken floor boards

The existing 1st floor would require all the boards to be replaced but a large number of the floor joists could remain (subject to calculations been undertaken to check the loadings). Some areas of floor joists would need to be replaced or undertake wood treatment.

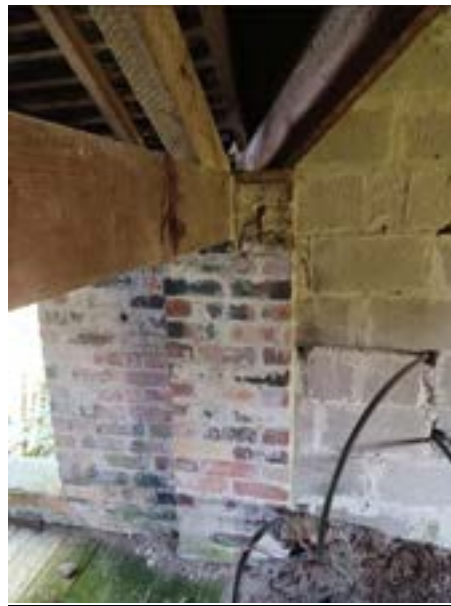
The kingpost trusses sit onto 440mm wide brickwork pillars, these pillars are in a relatively good condition but do require some attention to the top 2 courses.

Photo 4 – Showing truss onto brick pillar

The masonry (brick / block) internal walls and piers are in a good condition with only a couple of areas requiring strengthening or some sections of piers rebuilding near the top.

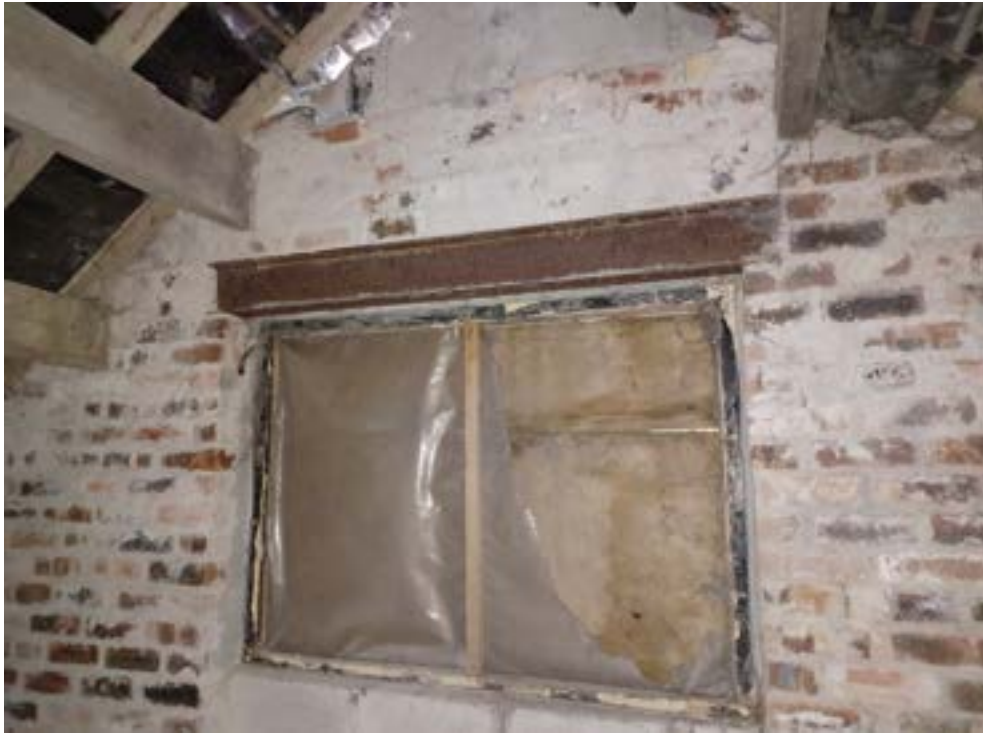
Photo 5 – Gable (retaining side) steel lintel to be treated

Where steel beam lintels are present, these need to be treated to remove the surface rust and repainted or replace with a new steel or concrete lintel.

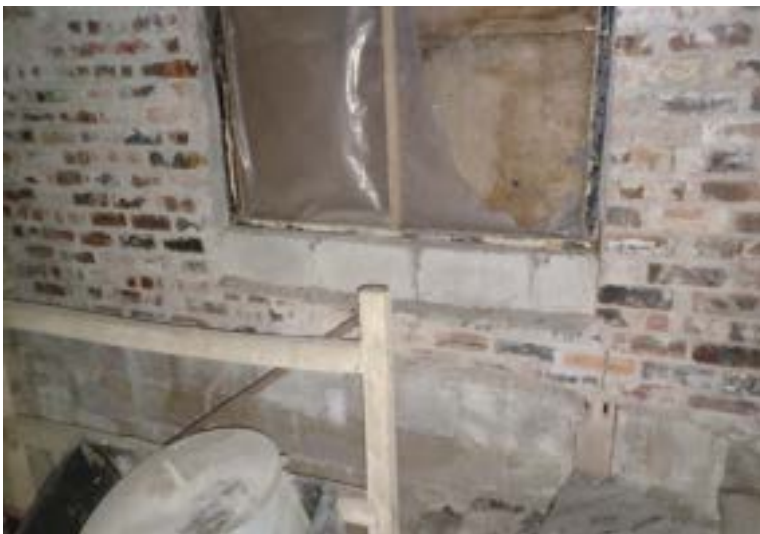
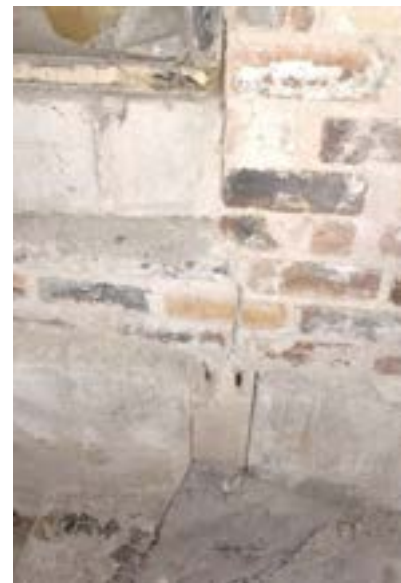
The gable end that is retaining has a vertical crack present below the 1st floor window. This wall needs to be further investigated and probably strengthening to ensure its suitability as a retaining structure with a habitable space. Damp proofing will also be required.

Photo 6 & 7 – Gable (retaining side) showing vertical crack below window

The main area of work to ensure the barn can be converted into a habitable space is the side wall (left) and rear wall below storage slab level, which will require further investigation and calculations undertaken to assess the suitability of a retaining wall. It is likely additional work will be required, which would consist of building a reinforced concrete or reinforced block wall with concrete behind the existing walls. These areas will also require tanking to current standards with drainage to enable the space to be deemed habitable.

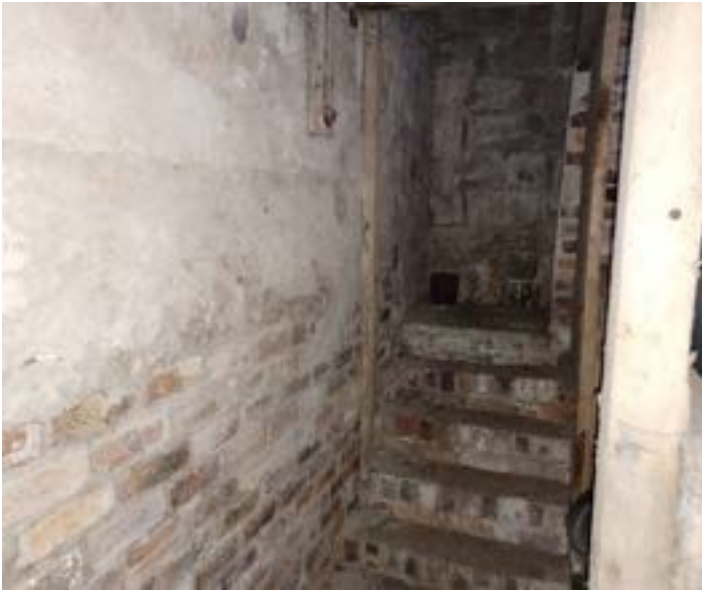
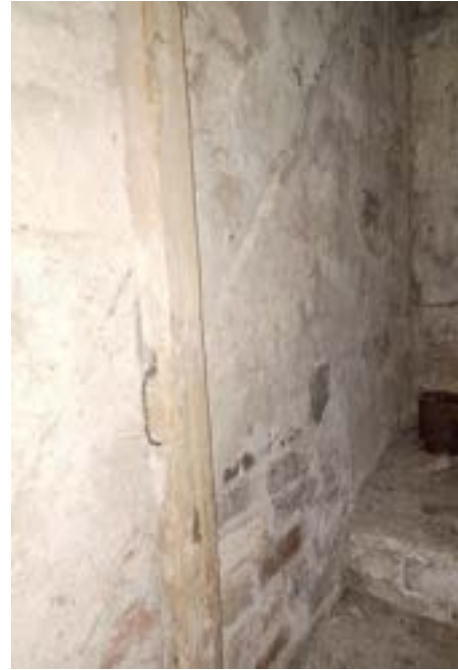
Photo 8&9 – 550mm brick external wall & internal stairs

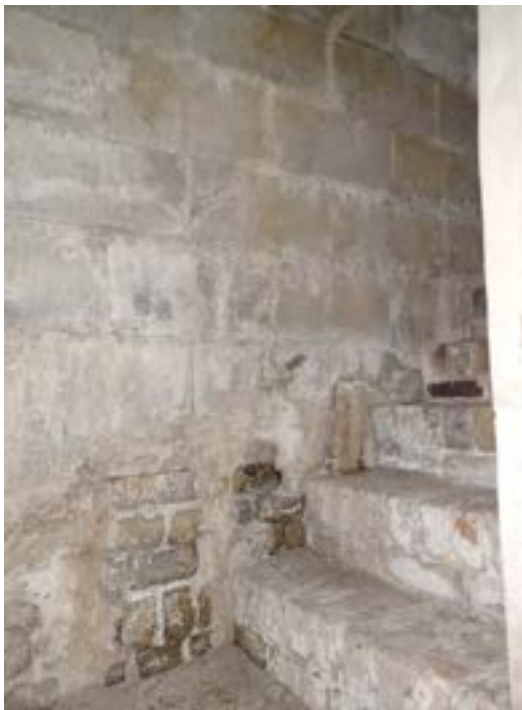
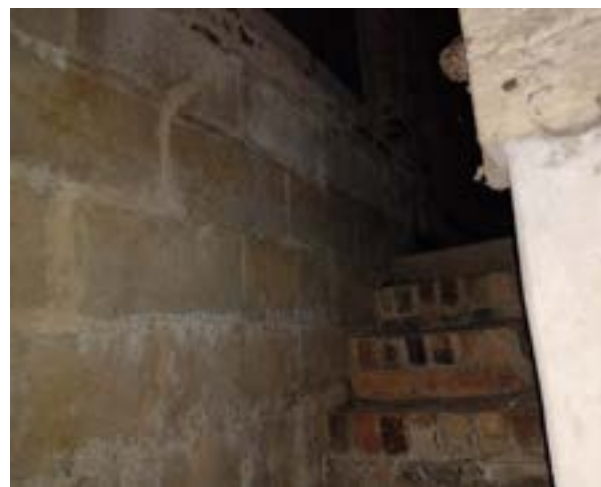
Photo 10 & 11 – Gable (Retaining wall) & internal stairs

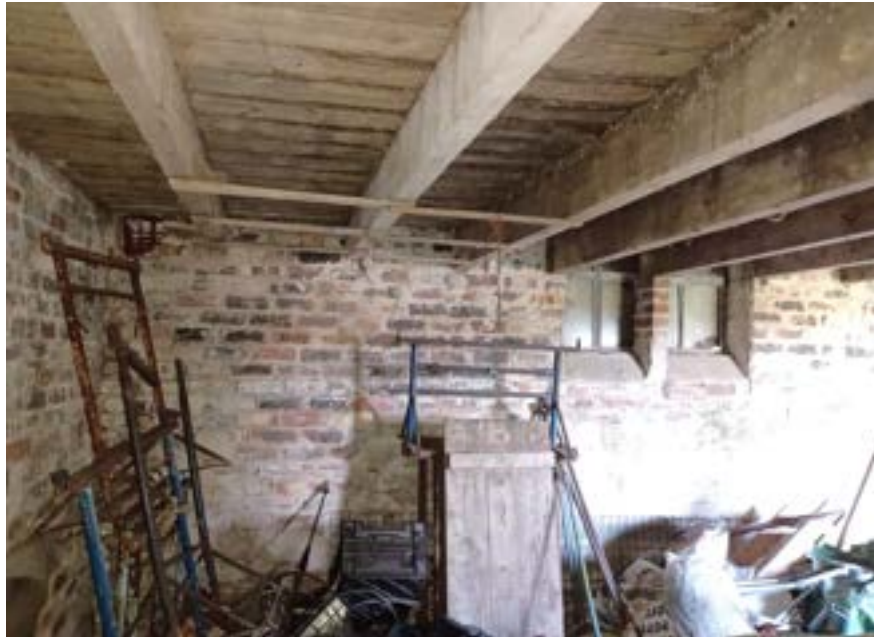
Photo 12 – Ground Floor room (by stairs looking to rear wall)

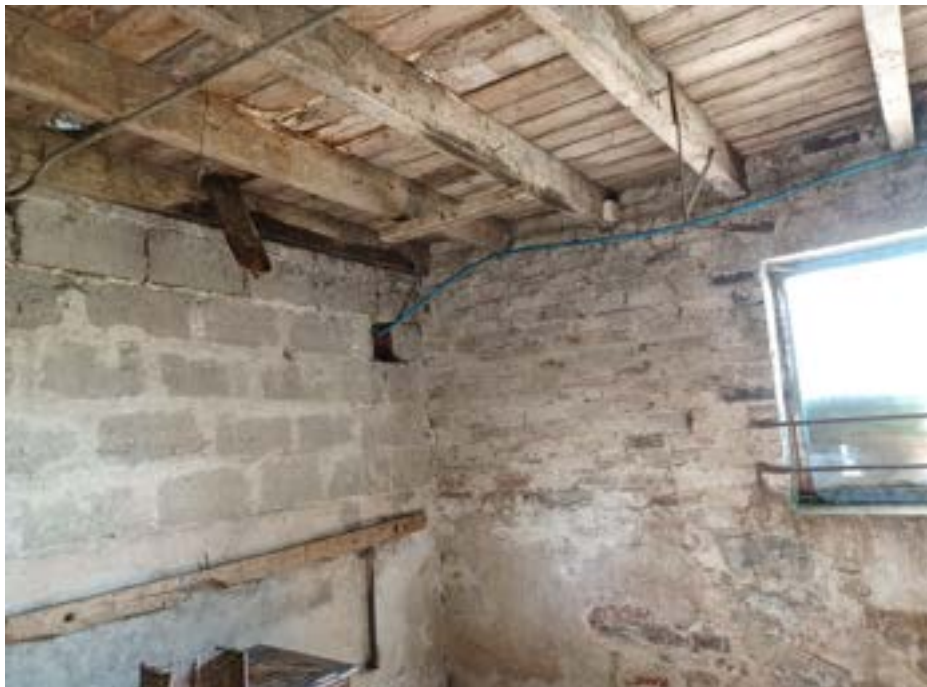
Photo 13 – Ground Floor room (looking to rear wall)

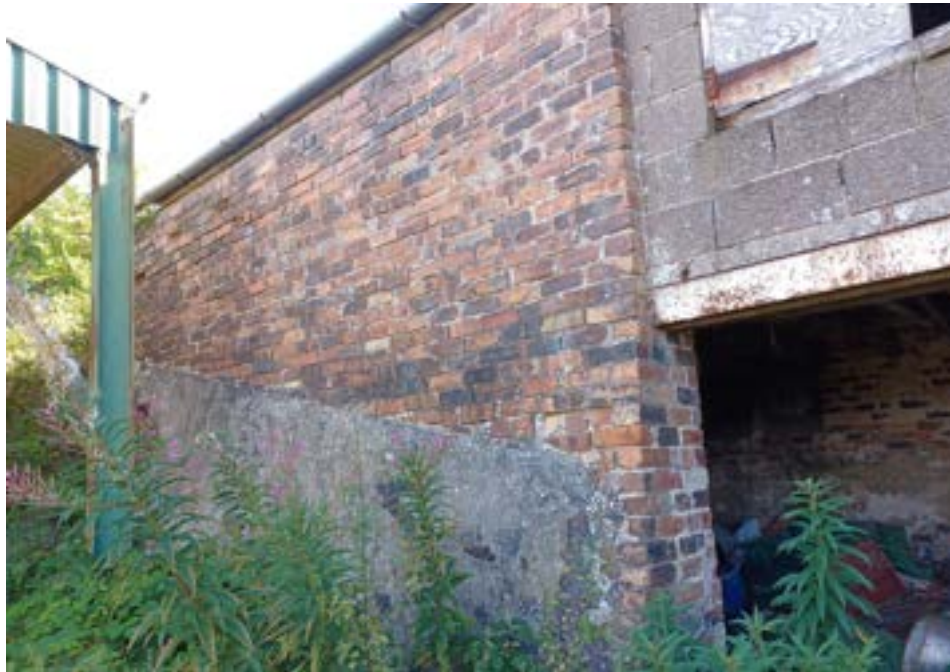
Photo 14 – Part front elevation (masonry wall /looking towards retaining side)

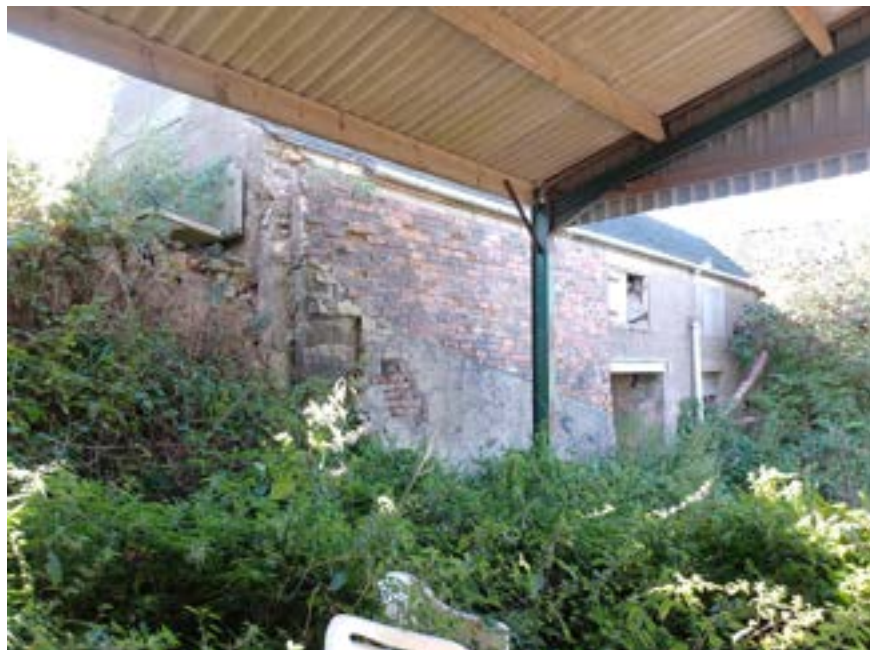
Photo 15 – Front elevation / gable (retaining side)

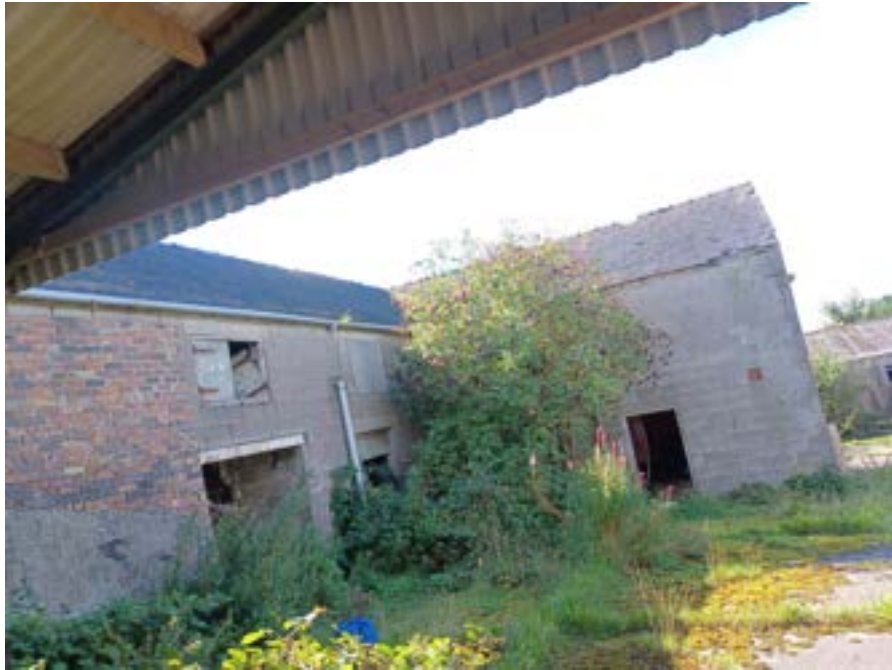
Photo 16 – Front elevation / side wall

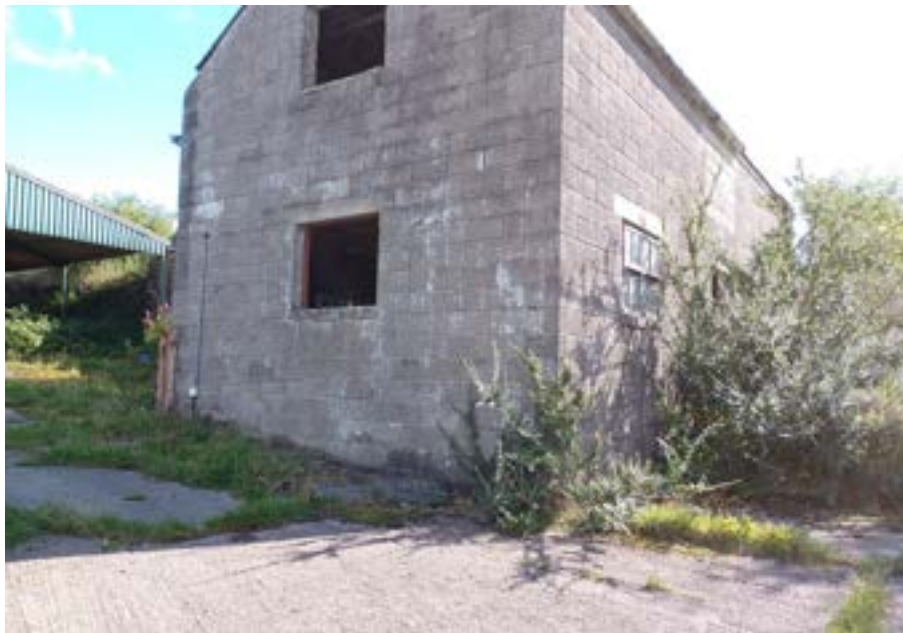
Photo 17 – Gable wall / track side elevation

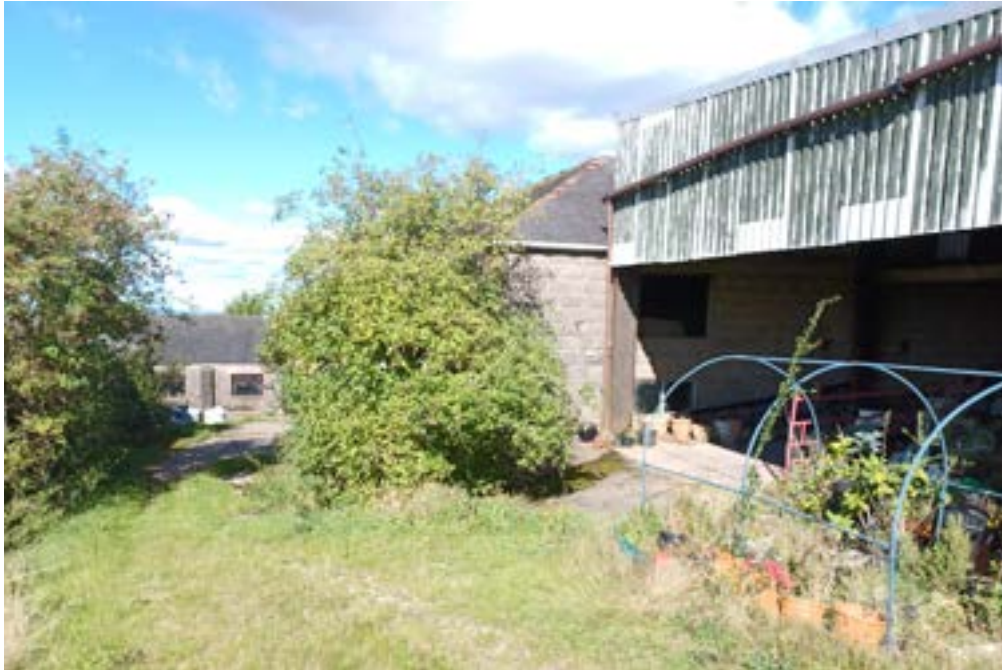
Photo 18 – looking from top of track towards the rear /side elevation
(Showing covered slab)
