# Asbestos Demolition Survey Report

Job Ref No: **543458**, Account Ref No: **25719**, Contract Ref No: **86323**

## Blakeley' Rudyard Lake Leek SK11 0RA

**Title:** Asbestos demolition survey to 'Blakeley' Rudyard Lake

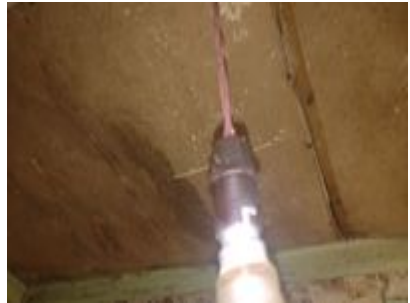
| Building | Level | Location | Item / Product Examined | Sample No. | Material Description | Fibre Type | Material Score | Extent | Risk Level Assessment | Initial Control Recommendation | Photograph |
|---|---|---|---|---|---|---|---|---|---|---|---|
| Blakeley' Rudyard Lake Reacliffe rd Leek ST138RS | 0 | 001/ bedroom and toilet | Light fitting | | Asbestos-containing composite | Presume Amosite | 5 | 1 No. | R3 | Remove if likely to be disturbed by proposed works | |

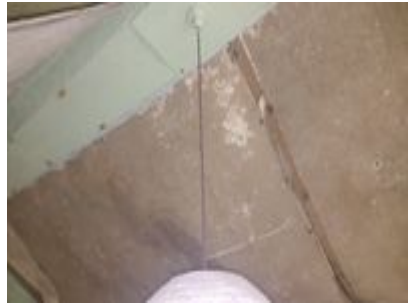
| Building | Level | Location | Item / Product Examined | Sample No. | Material Description | Fibre Type | Material Score | Extent | Risk Level Assessment | Initial Control Recommendation | Photograph |
|---|---|---|---|---|---|---|---|---|---|---|---|
| Blakeley' Rudyard Lake Reacliffe rd Leek ST138RS | 0 | 001/ bedroom and toilet | Light fitting cable | | Asbestos-containing woven product | Presume Chrysotile | 5 | 1 No. | R3 | Remove if likely to be disturbed by proposed works | |

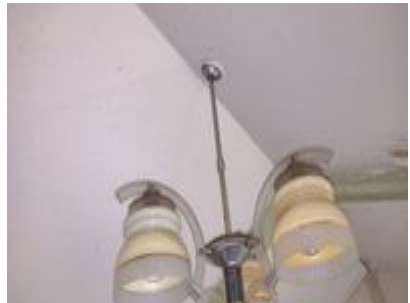
| Building | Level | Location | Item / Product Examined | Sample No. | Material Description | Fibre Type | Material Score | Extent | Risk Level Assessment | Initial Control Recommendation | Photograph |
|---|---|---|---|---|---|---|---|---|---|---|---|
| Blakeley' Rudyard Lake Reacliffe rd Leek ST138RS | 0 | 002/Living room | Light fitting cable | | Asbestos-containing woven product | Presume Chrysotile | 5 | 1 No. | R3 | Remove if likely to be disturbed by proposed works | |

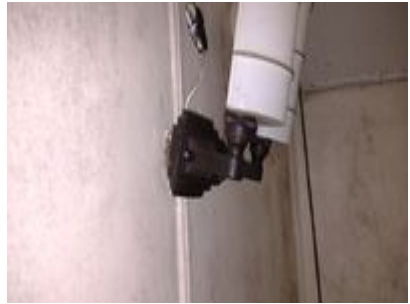
| Building | Level | Location | Item / Product Examined | Sample No. | Material Description | Fibre Type | Material Score | Extent | Risk Level Assessment | Initial Control Recommendation | Photograph |
|---|---|---|---|---|---|---|---|---|---|---|---|
| Blakeley' Rudyard Lake Reacliffe rd Leek ST138RS | 0 | 002/Living room | Wall light fitting | | Asbestos-containing composite | Presume Amosite | 4 | 1 No. | R3 | Remove if likely to be disturbed by proposed works | |

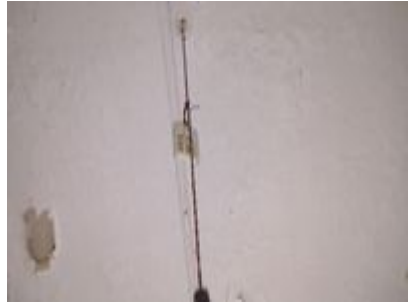
| Building | Level | Location | Item / Product Examined | Sample No. | Material Description | Fibre Type | Material Score | Extent | Risk Level Assessment | Initial Control Recommendation | Photograph |
|---|---|---|---|---|---|---|---|---|---|---|---|
| Blakeley' Rudyard Lake Reacliffe rd Leek ST138RS | 0 | 003/ kitchen | Light fitting cable | | Asbestos-containing woven product | Presume Chrysotile | 5 | 1 No. | R3 | Remove if likely to be disturbed by proposed works | |

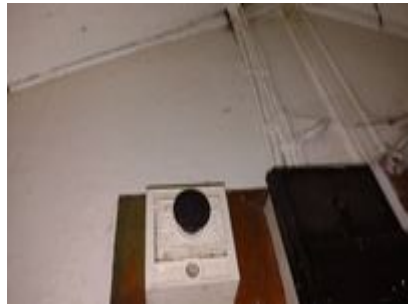
| Building | Level | Location | Item / Product Examined | Sample No. | Material Description | Fibre Type | Material Score | Extent | Risk Level Assessment | Initial Control Recommendation | Photograph |
|---|---|---|---|---|---|---|---|---|---|---|---|
| Blakeley' Rudyard Lake Reacliffe rd Leek ST138RS | 0 | 003/ kitchen | Mem fuse box | | Asbestos-containing composite | Presume Chrysotile | 3 | 1 No. | R3 | Remove if likely to be disturbed by proposed works | |

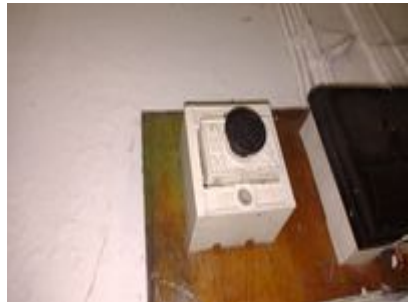
| Building | Level | Location | Item / Product Examined | Sample No. | Material Description | Fibre Type | Material Score | Extent | Risk Level Assessment | Initial Control Recommendation | Photograph |
|---|---|---|---|---|---|---|---|---|---|---|---|
| Blakeley' Rudyard Lake Reacliffe rd Leek ST138RS | 0 | 003/ kitchen | Within mem fuse box | | Asbestos-containing woven product | Presume Chrysotile | 5 | 1 No. | R3 | Remove if likely to be disturbed by proposed works | |

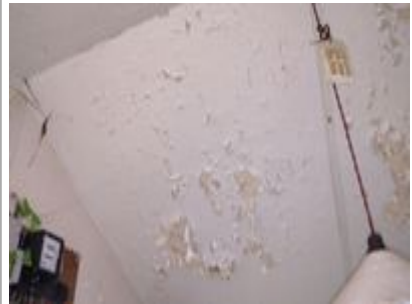
| Building | Level | Location | Item / Product Examined | Sample No. | Material Description | Fibre Type | Material Score | Extent | Risk Level Assessment | Initial Control Recommendation | Photograph |
|---|---|---|---|---|---|---|---|---|---|---|---|
| Blakeley' Rudyard Lake<br>Reacliffe rd Leek<br>ST138RS | 0 | 003/<br>kitchen | Ceiling panels | 543458-5 | Asbestos-containing cement | Chrysotile | 5 | 8 m2 | R3 | Remove if likely to be disturbed by proposed works | |

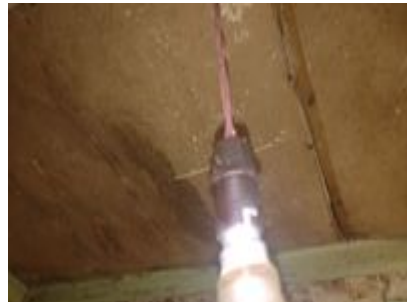
| Building | Level | Location | Item / Product Examined | Accessibility | Surveyor Additional Comments At Time Of Survey | Photograph |
|---|---|---|---|---|---|---|
| Blakeley' Rudyard Lake Reacliffe<br>rd Leek ST138RS | 0 | 001/bedroom<br>and toilet | Light fitting | No Access | Live service supply | |
| | | | | 💬 No isolation certificates or evidence of electrical not being live. | | |

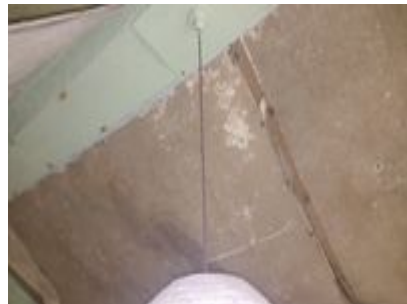
| Building | Level | Location | Item / Product Examined | Accessibility | Surveyor Additional Comments At Time Of Survey | Photograph |
|---|---|---|---|---|---|---|
| Blakeley' Rudyard Lake Reacliffe<br>rd Leek ST138RS | 0 | 001/bedroom<br>and toilet | Light fitting cable | Limited Access | Live service supply | |
| | | | | 💬 No isolation certificates or evidence of electrical not being live. | | |

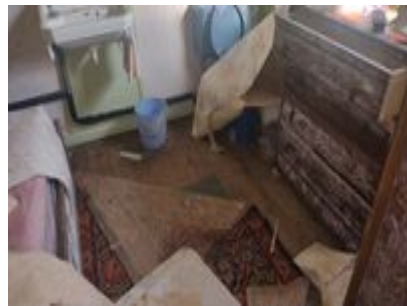
| Building | Level | Location | Item / Product Examined | Accessibility | Surveyor Additional Comments At Time Of Survey | Photograph |
|---|---|---|---|---|---|---|
| Blakeley' Rudyard Lake Reacliffe rd Leek ST138RS | 0 | 001/bedroom and toilet | Floor void | No Access | Structural instability due to building state | |

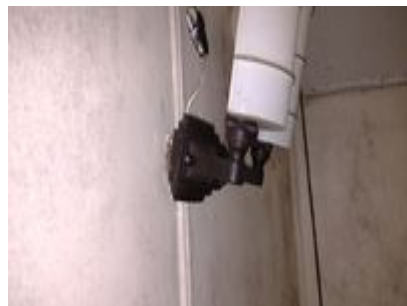
| Building | Level | Location | Item / Product Examined | Accessibility | Surveyor Additional Comments At Time Of Survey | Photograph |
|---|---|---|---|---|---|---|
| Blakeley' Rudyard Lake Reacliffe rd Leek ST138RS | 0 | 002/Living room | Wall light fitting | No Access | Live service supply | |
| | | | | 💬 No isolation certificates or evidence of electrical not being live. | | |

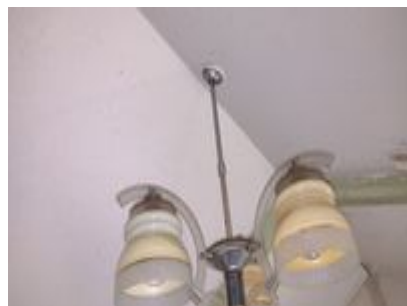
| Building | Level | Location | Item / Product Examined | Accessibility | Surveyor Additional Comments At Time Of Survey | Photograph |
|---|---|---|---|---|---|---|
| Blakeley' Rudyard Lake Reacliffe rd Leek ST138RS | 0 | 002/Living room | Light fitting cable | Limited Access | Live service supply | |
| | | | | 💬 No access within light fitting presumed within. | | |

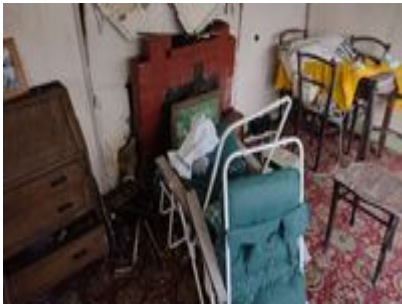
| Building | Level | Location | Item / Product Examined | Accessibility | Surveyor Additional Comments At Time Of Survey | Photograph |
|---|---|---|---|---|---|---|
| Blakeley' Rudyard Lake Reacliffe rd Leek ST138RS | 0 | 002/Living room | Floor void | No Access | Structural instability due to building state | |

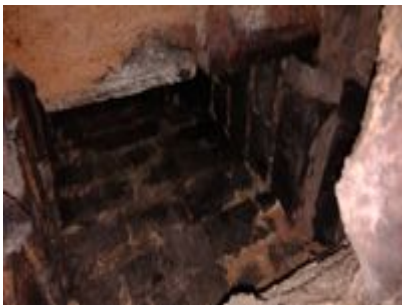
| Building | Level | Location | Item / Product Examined | Accessibility | Surveyor Additional Comments At Time Of Survey | Photograph |
|---|---|---|---|---|---|---|
| Blakeley' Rudyard Lake Reacliffe rd Leek ST138RS | 0 | 002/Living room | Chimney void | Limited Access | Structural instability due to building | |

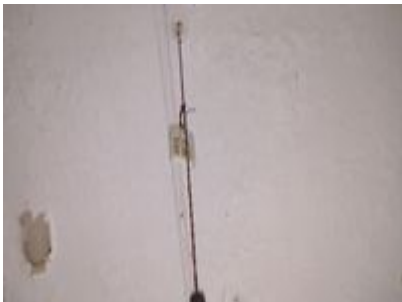
| Building | Level | Location | Item / Product Examined | Accessibility | Surveyor Additional Comments At Time Of Survey | Photograph |
|---|---|---|---|---|---|---|
| Blakeley' Rudyard Lake Reacliffe rd Leek ST138RS | 0 | 003/kitchen | Light fitting cable | Limited Access | Live service supply | |
| | | | | 🗨️ No isolation certificates or evidence of electrical not being live. | | |

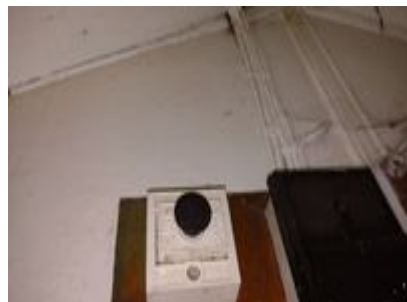
| Building | Level | Location | Item / Product Examined | Accessibility | Surveyor Additional Comments At Time Of Survey | Photograph |
|---|---|---|---|---|---|---|
| Blakeley' Rudyard Lake Reacliffe rd Leek ST138RS | 0 | 003/kitchen | Mem fuse box | No Access | Live service supply | |

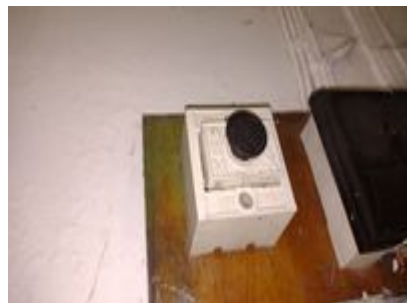
| Building | Level | Location | Item / Product Examined | Accessibility | Surveyor Additional Comments At Time Of Survey | Photograph |
|---|---|---|---|---|---|---|
| Blakeley' Rudyard Lake Reacliffe rd Leek ST138RS | 0 | 003/kitchen | Within mem fuse box | No Access | Live service supply | |

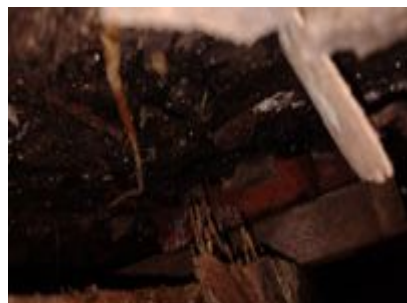
| Building | Level | Location | Item / Product Examined | Accessibility | Surveyor Additional Comments At Time Of Survey | Photograph |
|---|---|---|---|---|---|---|
| Blakeley' Rudyard Lake Reacliffe rd Leek ST138RS | 0 | 003/kitchen | Floor void | Limited Access | Structural instability due to building state | |

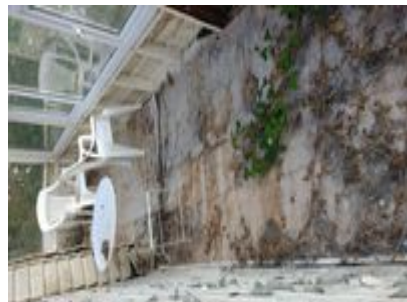
| Building | Level | Location | Item / Product Examined | Accessibility | Surveyor Additional Comments At Time Of Survey | Photograph |
|---|---|---|---|---|---|---|
| Blakeley' Rudyard Lake Reacliffe rd Leek ST138RS | 0 | 004/ conservatory | Floor void | No Access | Structural instability due to building state | |

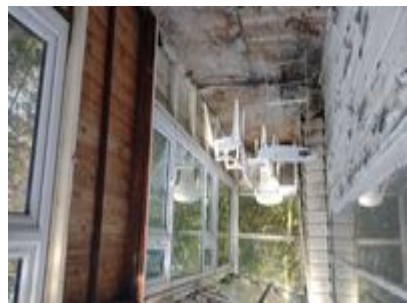
| Building | Level | Location | Item / Product Examined | Accessibility | Surveyor Additional Comments At Time Of Survey | Photograph |
|---|---|---|---|---|---|---|
| Blakeley' Rudyard Lake Reacliffe rd Leek ST138RS | 0 | 004/ conservatory | Entire Location | Limited Access | structural instability due to building state | |

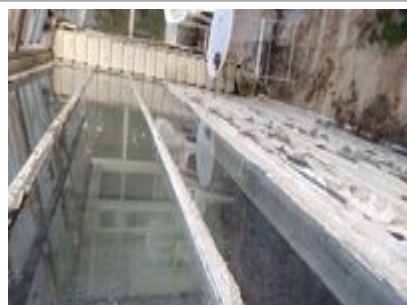
| Building | Level | Location | Item / Product Examined | Accessibility | Surveyor Additional Comments At Time Of Survey | Photograph |
|---|---|---|---|---|---|---|
| Blakeley' Rudyard Lake Reacliffe rd Leek ST138RS | 0 | 004/ conservatory | Window frame glazing putty | Limited Access | | |
| | | | | 🗨 Sampled via externals 9/999 visually similar no access within the conservatory due to structural instability of the building. | | |
