## Refurbishment Survey

Former New Inn Pub  
Denford Road  
Longsdon  
Staffordshire  
ST9 9QF

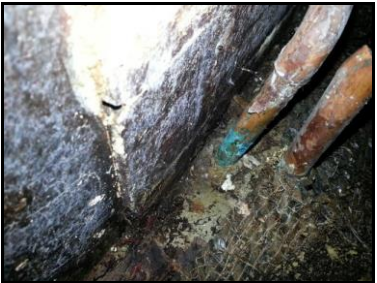
| | Product type | Condition | Surface Treatment | Asbestos type |
| | - | - | - | - |
| <b>Surveyor comments</b> | The pipework passes through the solid concrete floor and into the cellar below which was not accessed at the time of the survey due to unsafe construction of the stairs. | | | |

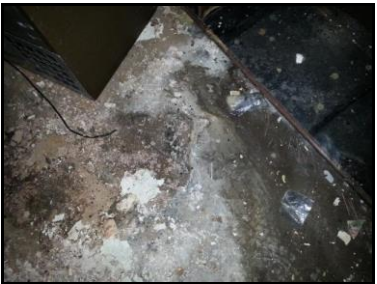
| | Product type | Condition | Surface Treatment | Asbestos type |
| | - | - | - | - |
| <b>Surveyor comments</b> | Inspection revealed the original plaster ceiling and timber beams, inspection to the timber header boxing above the bar revealed a metal RSJ. Solid brick and plaster walls behind the ceramic wall tiles and bar shelves, solid concrete floor below the sampled vinyl. Inspection to the foam insulation pipework revealed that these passed through a ceramic pipe to the basement area. Limited inspection to the wall mounted electrics for safety reasons. | | | |

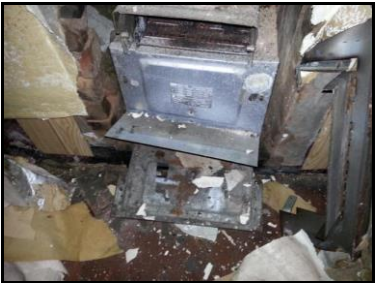
| | Product type | Condition | Surface Treatment | Asbestos type |
| | - | - | - | - |
| <b>Surveyor comments</b> | Inspection revealed the original plaster ceiling and timber beams, the sampled wall panels, solid concrete under the ceramic floor tiles, solid brickwork under the timber window boards, timber panels to the stair case where accessible. Limited inspection to the heater and chimney due to the sampled insulation board revealed MMMF insulation to a metal flue. | | | |

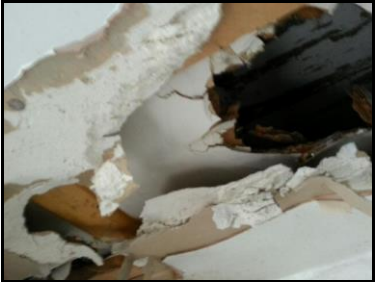
| | Product type | Condition | Surface Treatment | Asbestos type |
| | - | - | - | - |
| Surveyor comments | Inspection revealed a plaster ceiling with the sampled ceiling panels above, inspection from a previous damaged area revealed a timber ceiling above. Limited inspection to the metal ventilation ducting due to the sampled panels and metal panels which are riveted shut revealed a metal ventilation and fan. | | | |

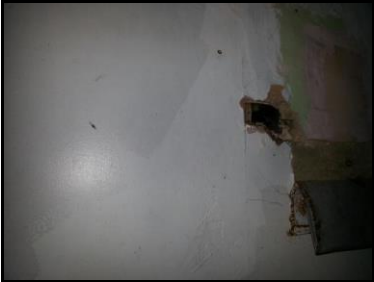
| | Sample No | Building | Floor | Analysis |
|---|---|---|---|---|
| | P-184906/010 | Former New Inn Pub | Ground Floor | No asbestos detected |

| | Product type | Condition | Surface Treatment | Asbestos type |
| | - | - | - | - |
| Surveyor comments | The sampled insulation is present within the wall cavity where previous pipework has run. | | | |

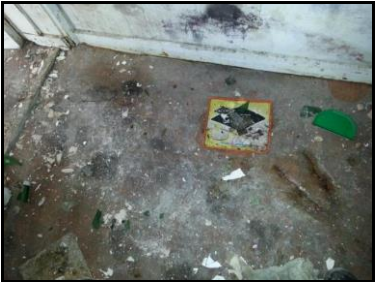
| | Product type | Condition | Surface Treatment | Asbestos type |
| | - | - | - | - |
| Surveyor comments | Inspection revealed a plaster ceiling, solid brick and plaster walls with MMMF insulation, solid concrete floor. Limited inspection to the roof void revealed a timber construction and MMMF blanket insulation. | | | |

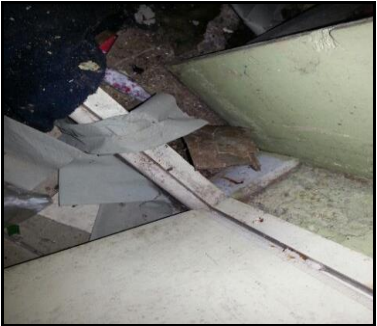
| | Sample No | Building | Floor | Analysis |
|---|---|---|---|---|
| | P-184906/012 | Former New Inn Pub | Ground Floor | No asbestos detected |

| | Product type | Condition | Surface Treatment | Asbestos type |
| | - | - | - | - |
| Surveyor comments | The sampled debris is present within the store cupboard. | | | |

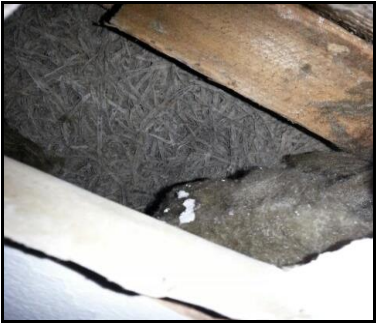
| | Sample No | Building | Floor | Analysis |
|---|---|---|---|---|
| | P-184906/013 | Former New Inn Pub | Ground Floor | No asbestos detected |

| | Product type | Condition | Surface Treatment | Asbestos type |
| | - | - | - | - |
| <b>Surveyor comments</b> | The sampled ceiling panels are above the plasterboard ceiling. | | | |

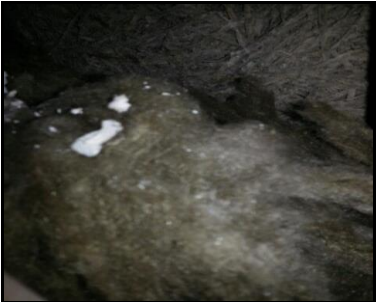
| | Product type | Condition | Surface Treatment | Asbestos type |
| | - | - | - | - |
| <b>Surveyor comments</b> | Inspection revealed a plasterboard ceiling with the sampled panels above, solid brick and plaster behind the ceramic wall tiles, plasterboard infills with empty cavities above the doors, solid floor below the ceramic floor tiles, ceramic cistern and plastic waste pipe. Limited inspection to the skylight due to been covered by a metal grid revealed plasterboard surroundings. Inspection within the timber boxing revealed a metal waste pipe and hessian insulated pipework. | | | |

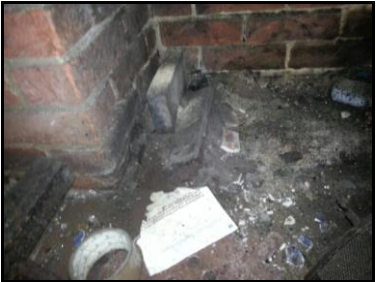
| | Product type | Condition | Surface Treatment | Asbestos type |
| | - | - | - | - |
| <b>Surveyor comments</b> | Inspection revealed a plaster and the original plaster ceiling, original timber beams, solid brick and plaster walls with polystyrene insulation, solid brick and plaster columns, concrete floors under the ceramic floor tiles, inspection below the timber floorboards revealed and empty cavities and general building debris, solid brickwork below the timber window boards. Limited inspection to the fire places revealed solid brick and quarry tiled construction, brick work within the chimney. Most of the pipework had been removed in this area prior to the survey. Non suspect white stair nosing. | | | |

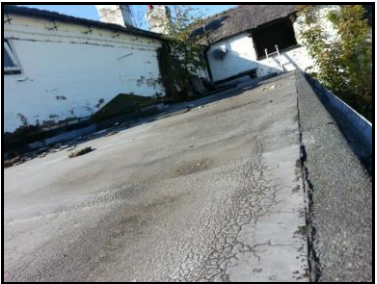
| | Product type | Condition | Surface Treatment | Asbestos type |
| | - | - | - | - |
| <b>Surveyor comments</b> | Inspection from ground level revealed slate roof tiles, clay ridge tiles, timber fascias and soffits with empty cavities above where accessible, metal and plastic rainwater goods, metal and plastic waste pipes. Metal and clay chimney pots and cowls. | | | |

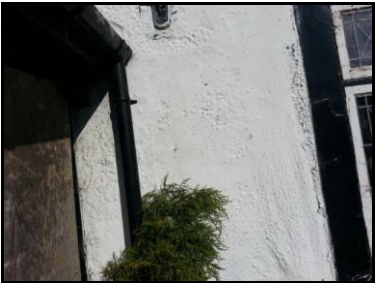
| | Sample No | Building | Floor | Analysis |
|---|---|---|---|---|
| | P-184906/029 | Former New Inn Pub | External | No asbestos detected |

| | Product type | Condition | Surface Treatment | Asbestos type |
| | - | - | - | - |
| <b>Surveyor comments</b> | The sampled was taken from different locations. The sampled textured coating is present as debris to the ground. | | | |

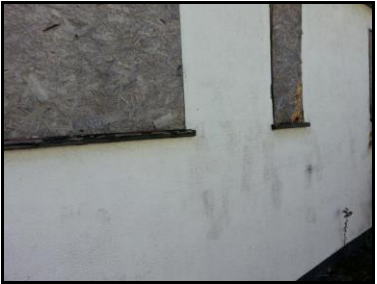
| | Sample No | Building | Floor | Analysis |
|---|---|---|---|---|
| | P-184906/030 | Former New Inn Pub | External | No asbestos detected |

| | Product type | Condition | Surface Treatment | Asbestos type |
| | - | - | - | - |
| <b>Surveyor comments</b> | The sampled was taken from different locations. The sampled textured coating is present as debris to the ground. | | | |

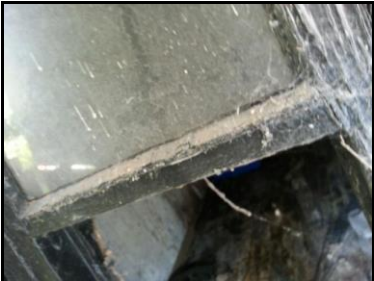
| | Product type | Condition | Surface Treatment | Asbestos type |
| | - | - | - | - |
| <b>Surveyor comments</b> | Limited inspection to the boarded out roof area revealed a redundant timber water tank. Timber construction to the roof, solid brick walls, timber partition walls between the areas. | | | |

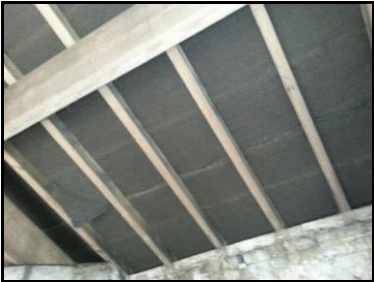
| | Product type | Condition | Surface Treatment | Asbestos type |
| | - | - | - | - |
| <b>Surveyor comments</b> | Inspection revealed a metal roof, timber construction and timber beams, solid brick walls and solid concrete and brick floor. Limited inspection to stored items. | | | |

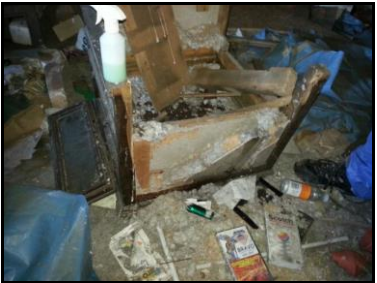
| | Sample No | Building | Floor | Analysis |
|---|---|---|---|---|
| | P-184906/035 | Former New Inn Pub | External | Chrysotile |

| | Sample No | Building | Floor | Analysis |
|---|---|---|---|---|
| <b>Surveyor comments</b> | The boxing is in poor condition with broken debris present to the floor area. | | | |

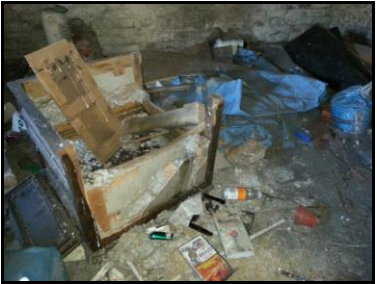
| | Sample No | Building | Floor | Analysis |
|---|---|---|---|---|
| | P-184906/036 | Former New Inn Pub | External | No asbestos detected |

| | Product type | Condition | Surface Treatment | Asbestos type |
| | - | - | - | - |
| <b>Surveyor comments</b> | The sampled insulation is in poor condition with broken debris present to the floor area. | | | |

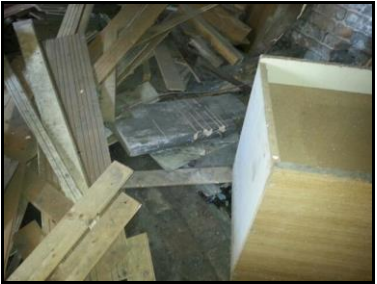
| | Sample No | Building | Floor | Analysis |
|---|---|---|---|---|
| | P-184906/038 | Former New Inn Pub | External | Amosite |

| | Sample No | Building | Floor | Analysis |
|---|---|---|---|---|
| <b>Surveyor comments</b> | The redundant panels are under a pile of wood panels. | | | |

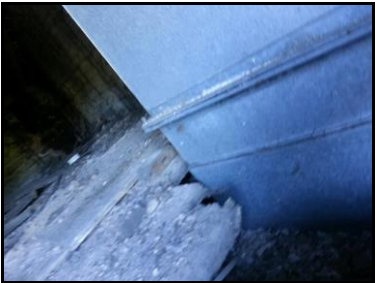
| | Product type | Condition | Surface Treatment | Asbestos type |
| | - | - | - | - |
| <b>Surveyor comments</b> | Limited inspection from the side hatch only revealed a timber construction, slate roof tiles, timber floorboards. Uninsulated electric cables, uninsulated metal ducting passing through the sampled ceiling and brick wall. | | | |

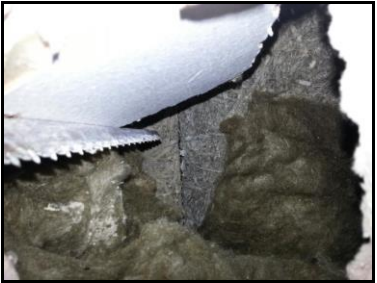
| | Sample No | Building | Floor | Analysis |
|---|---|---|---|---|
| | P-184906/As 013 | Former New Inn Pub | Ground Floor | Strongly presumed: No asbestos detected |

| | Product type | Condition | Surface Treatment | Asbestos type |
| | - | - | - | - |
| Surveyor comments | The sampled ceiling panels are above the plasterboard ceiling. | | | |

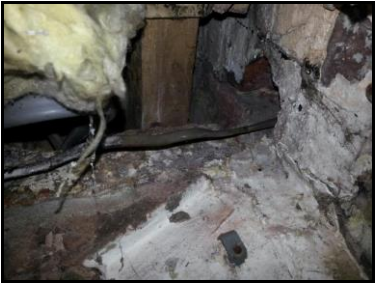
| | Sample No | Building | Floor | Analysis |
|---|---|---|---|---|
| | P-184906/As 013 | Former New Inn Pub | Ground Floor | Strongly presumed: No asbestos detected |

| | Product type | Condition | Surface Treatment | Asbestos type |
| | - | - | - | - |
| <b>Surveyor comments</b> | The sampled ceiling panels are above the plasterboard ceiling. | | | |

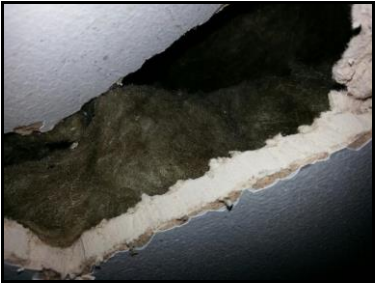
| | Product type | Condition | Surface Treatment | Asbestos type |
| | - | - | - | - |
| <b>Surveyor comments</b> | Inspection revealed a plasterboard ceiling with the sampled panels above, solid brick and plaster behind the ceramic wall tiles, solid floor under the quarry tiles, solid brickwork below the multiple layers of ceramic window board tiles. Ceramic cistern and plastic waste pipe. | | | |

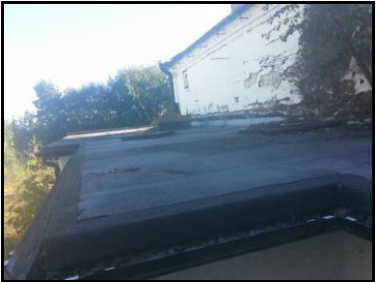
| | Sample No | Building | Floor | Analysis |
|---|---|---|---|---|
| | P-184906/P001 | Former New Inn Pub | External | Presumed to contain asbestos |

| Building | Floor | Item | Location | Sample Ref | Recommendations |
|---|---|---|---|---|---|
| Former New Inn Pub | External | seal to skylight | 021 - External | P001 | Remove if likely to be disturbed by the refurbishment, otherwise monitor condition. |
