Green Farm  
Rudyard Manor  
Green Lane  
Rudyard

16th<sup>th</sup> October 2023

**Re: Structural inspection of Green Farm, Rudyard Manor, Green Lane, Rudyard**

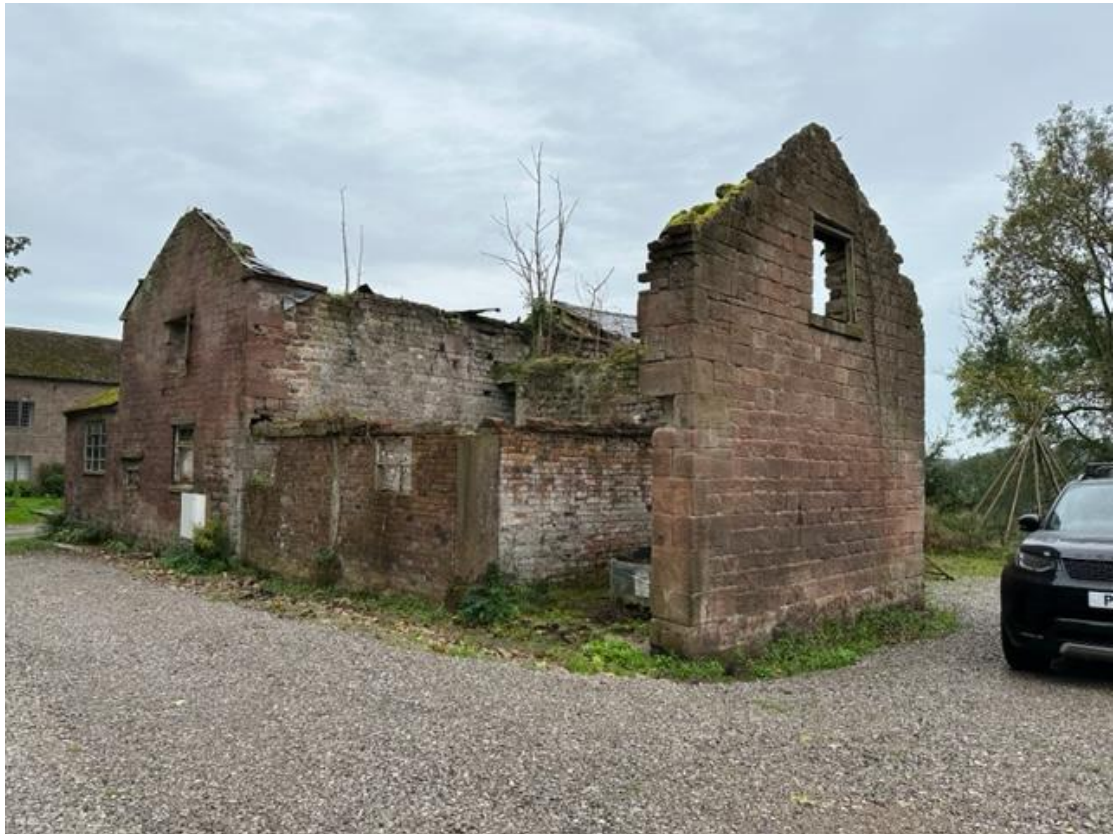
General view from North

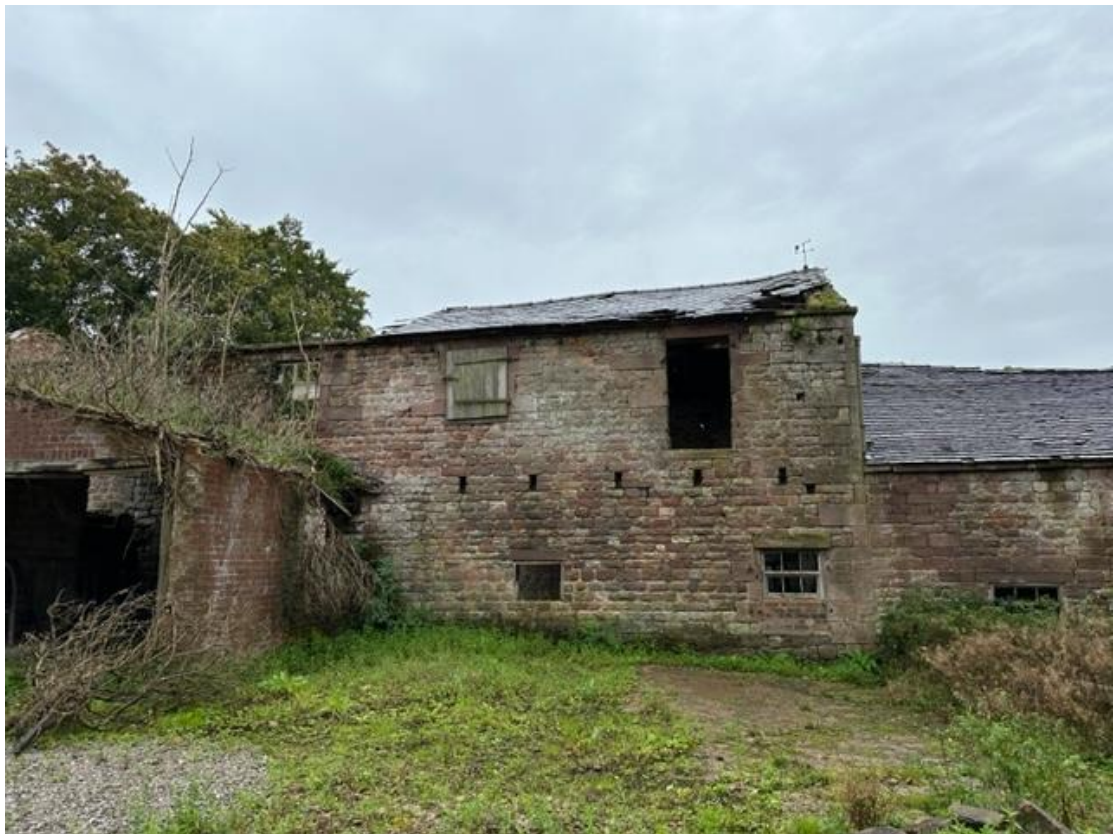
General view from the north west.

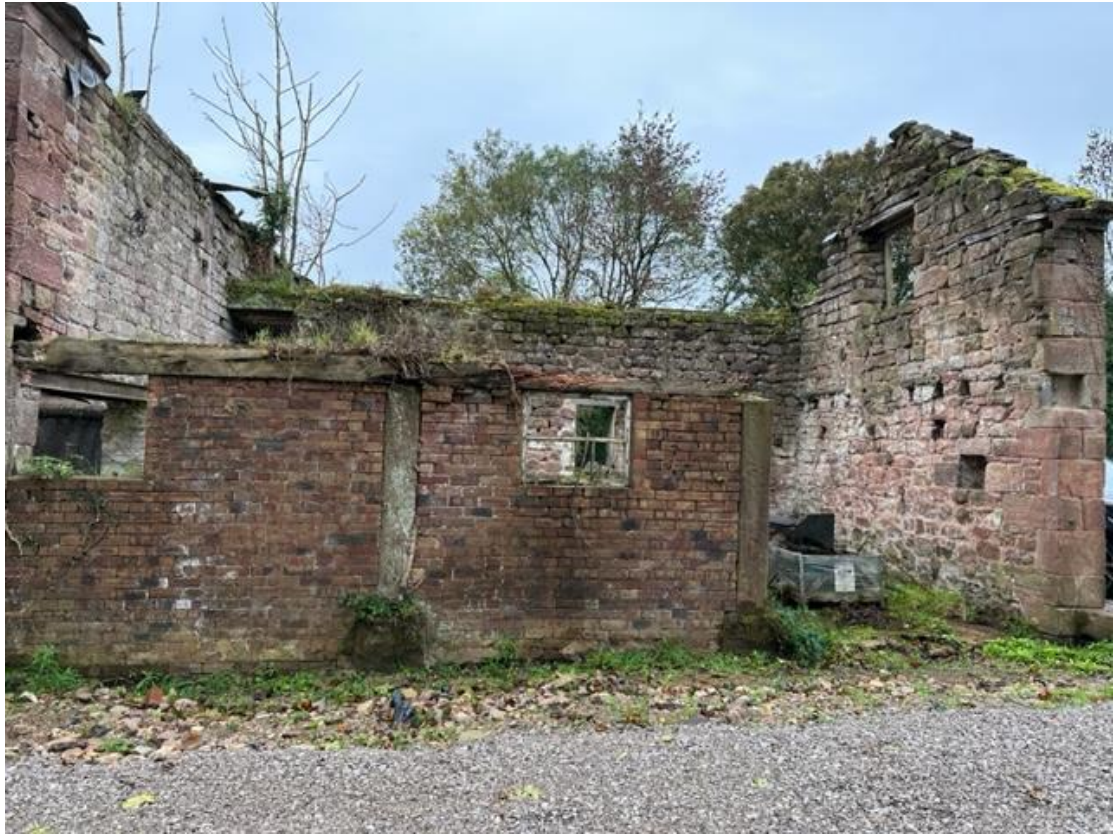
General view from the North east looking at the former cart shed – later brick infill panels with original stone pillars between.

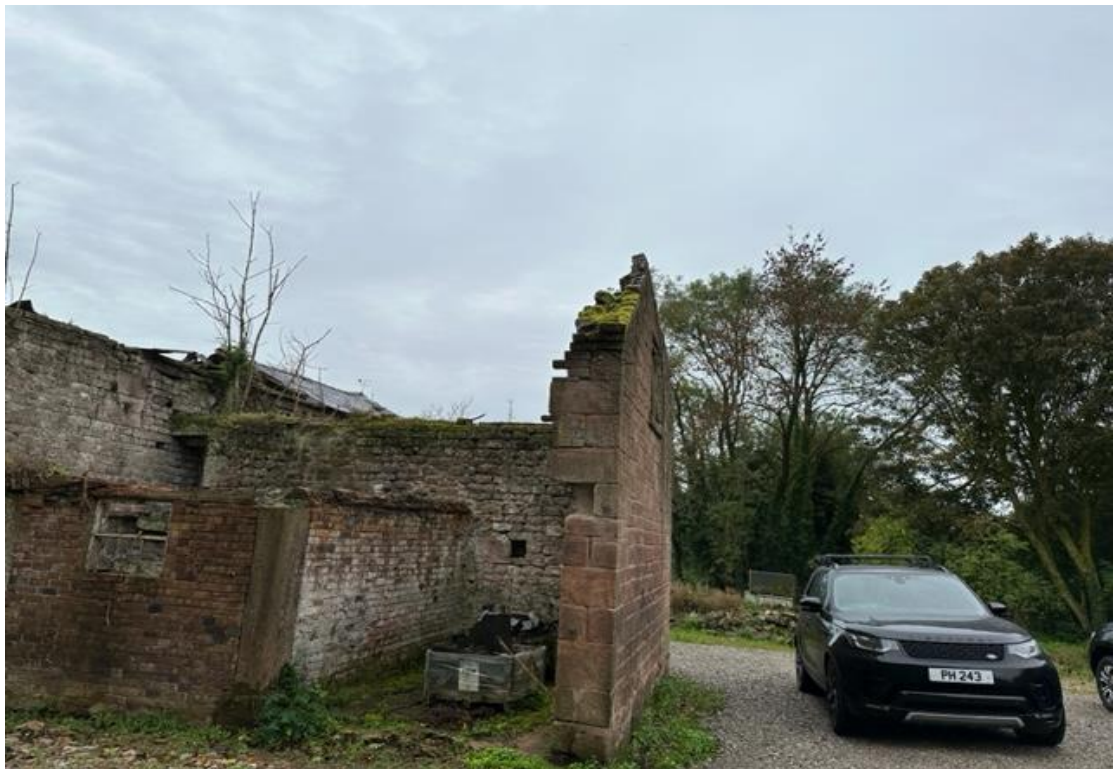
View of north west gable wall – note wall is plumb apart from a small section at the ridge line.

generally and the top say 1.0m of the gable wall to the top section of the north west gable wall to the former cart shed. Some of the primary structural timber members that remain could be saved, ie the queen post trusses and purlins subject to some minor strengthening and replacement of rotten sections. The secondary roof elements and floor structures will need to be new construction, however, this normally required during any renovation of a heritage building to ensure it complies with modern building regulation standards.

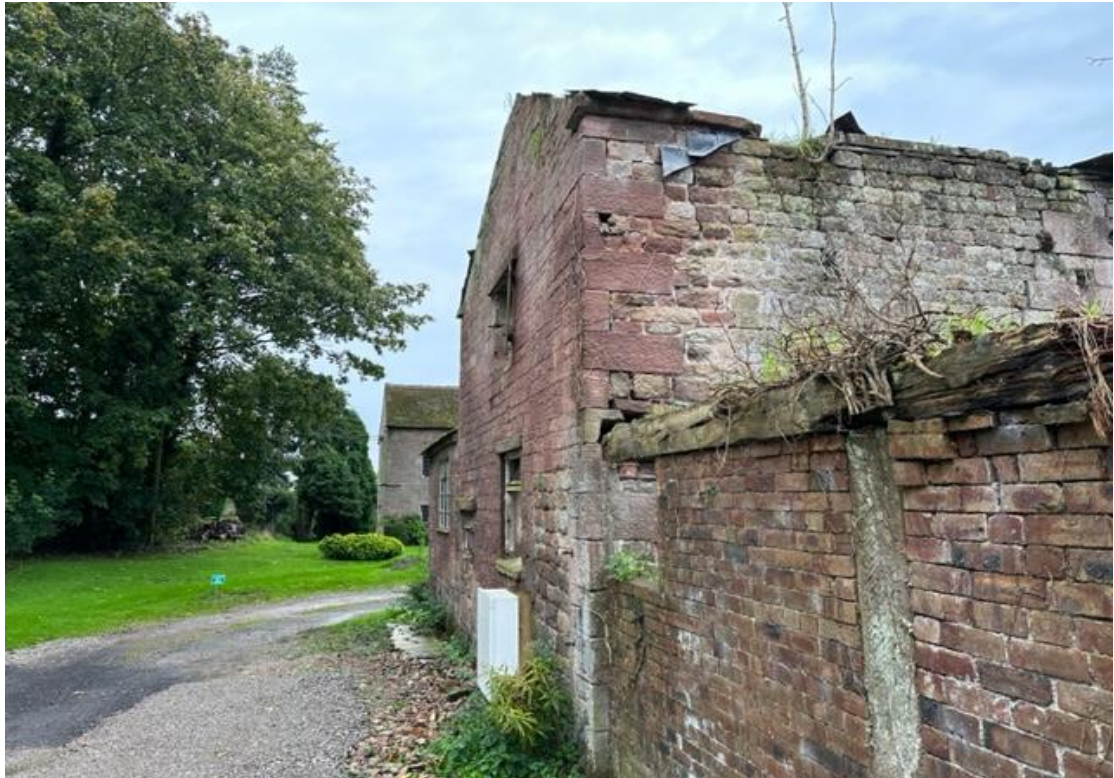
View of north east gable wall, cart shed in foreground and single storey outrigger in the background – note quality of stone work and plumb walls

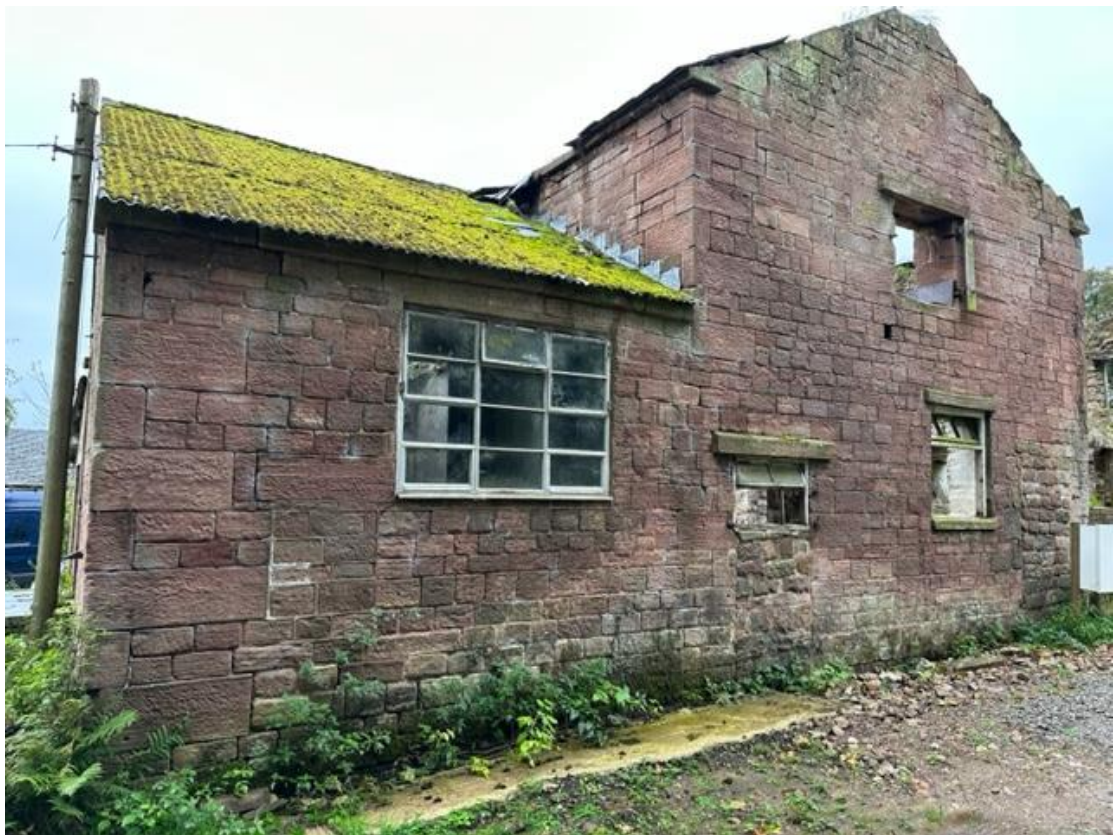
Further view of north east gable and single storey outrigger – note stone work in good condition and plumb, also note stone lintels in good condition.

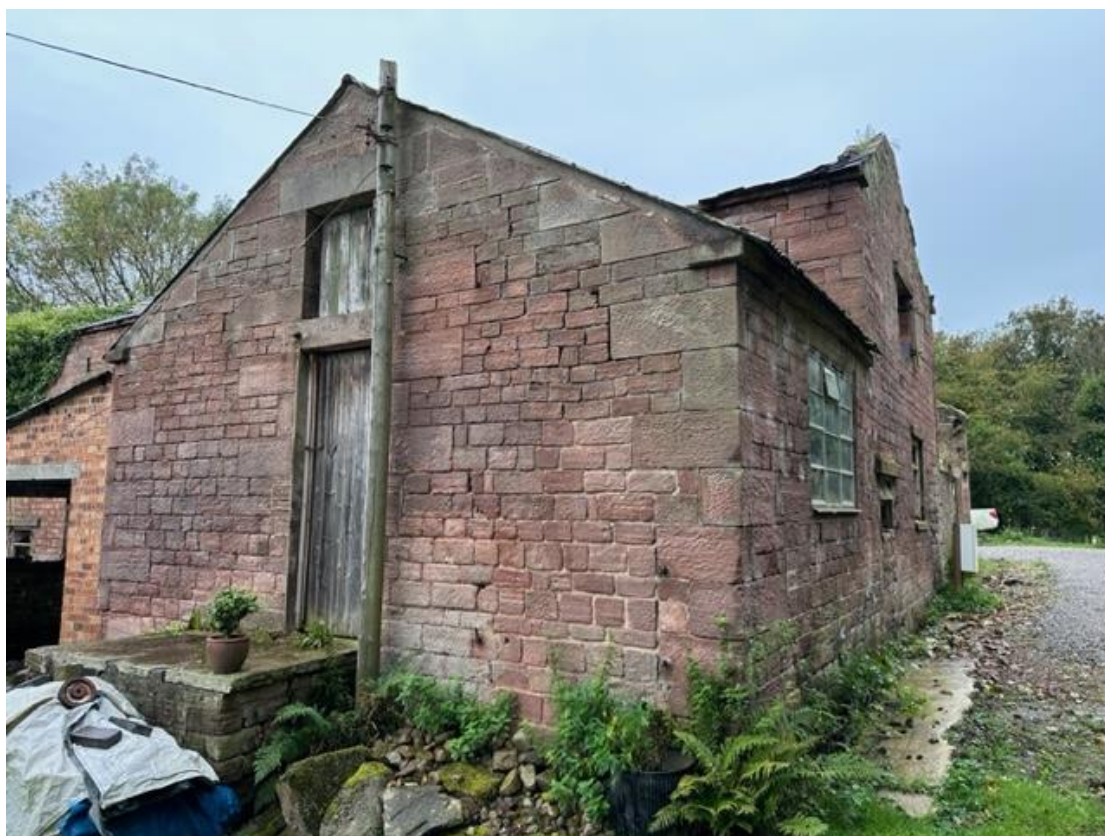
View of stone work to outrigger – Stone work in good condition and plumb.

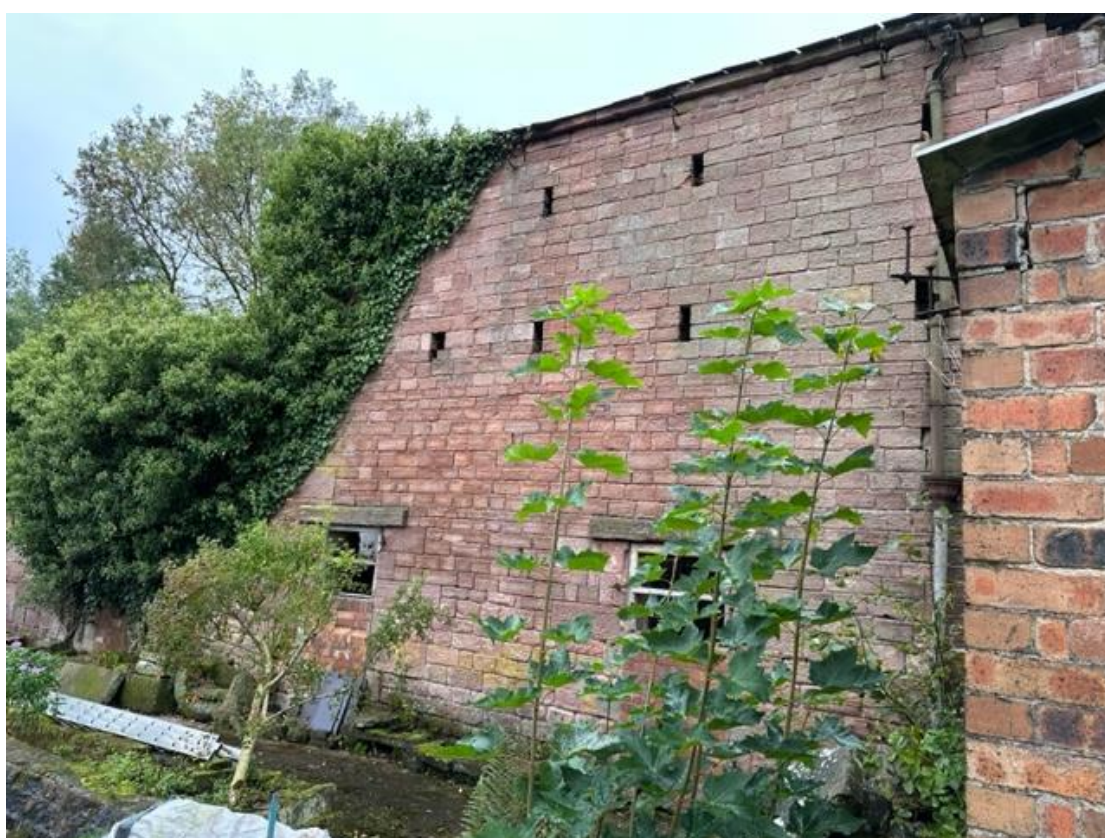
General view of south east elevation – stonework and lintels in good condition.

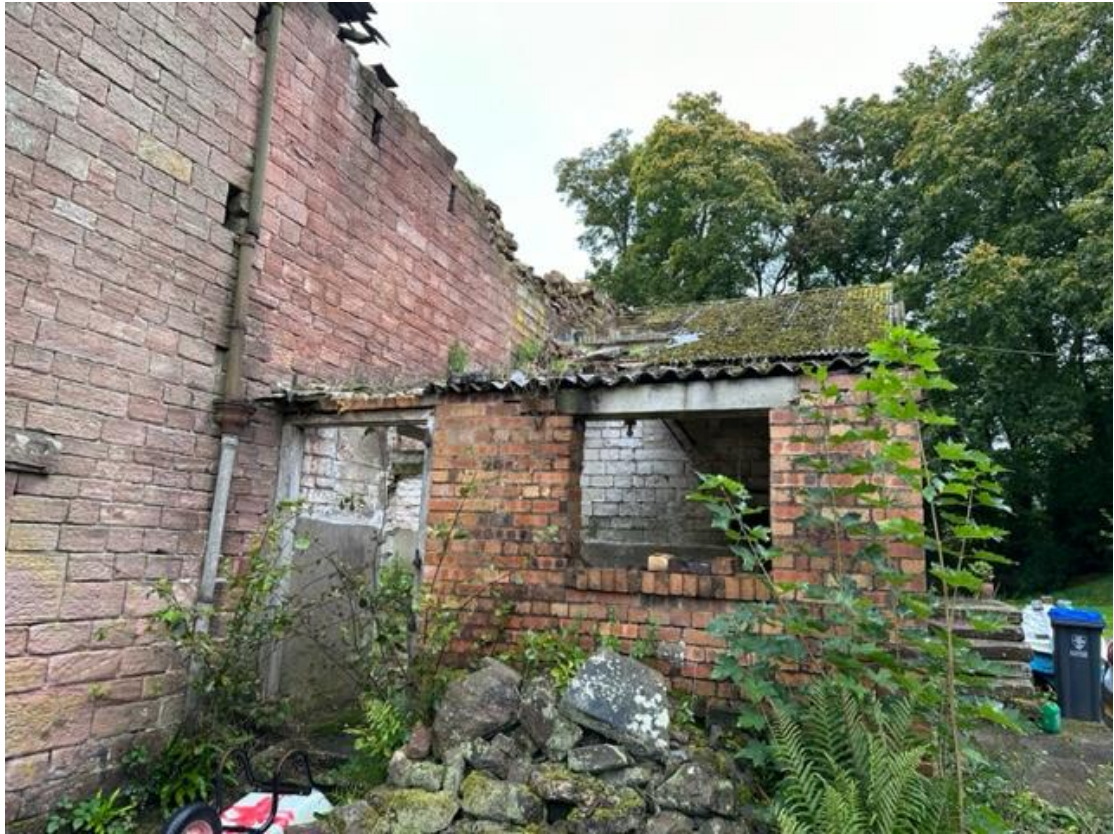
Small poor-quality brick-built structure to be demolished as part of the renovation.

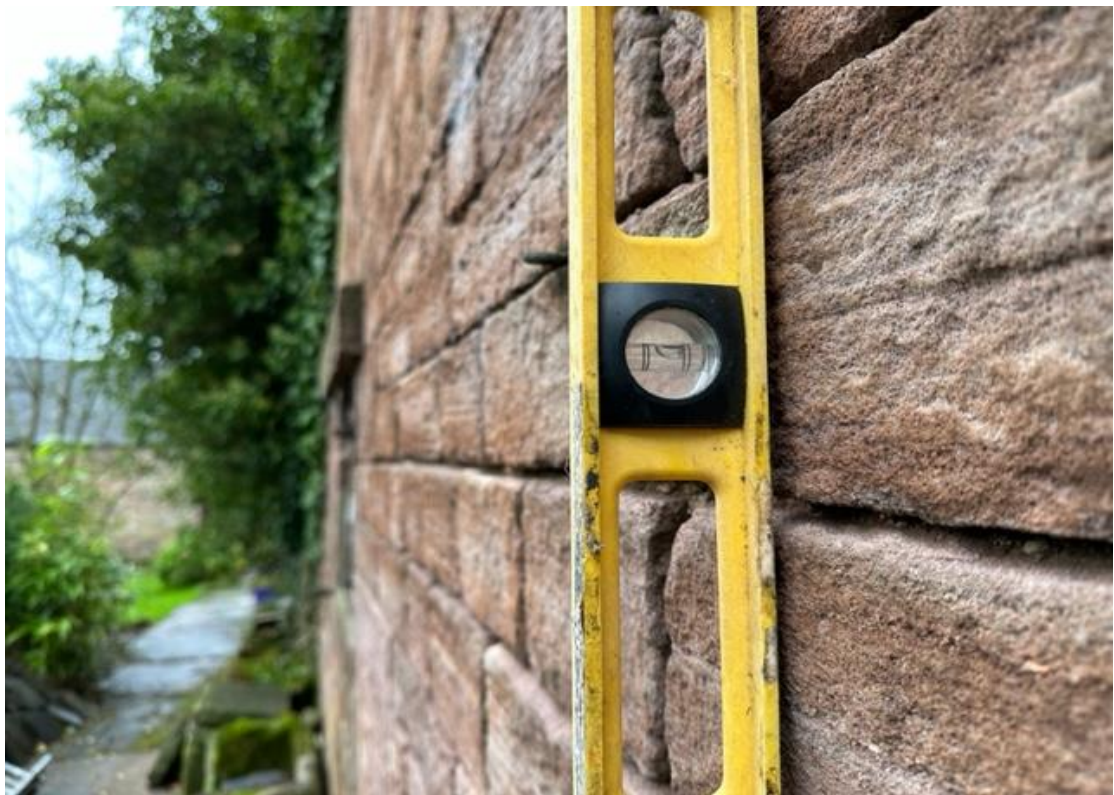
Close up of walls showing quality of stone and plumbness of walls

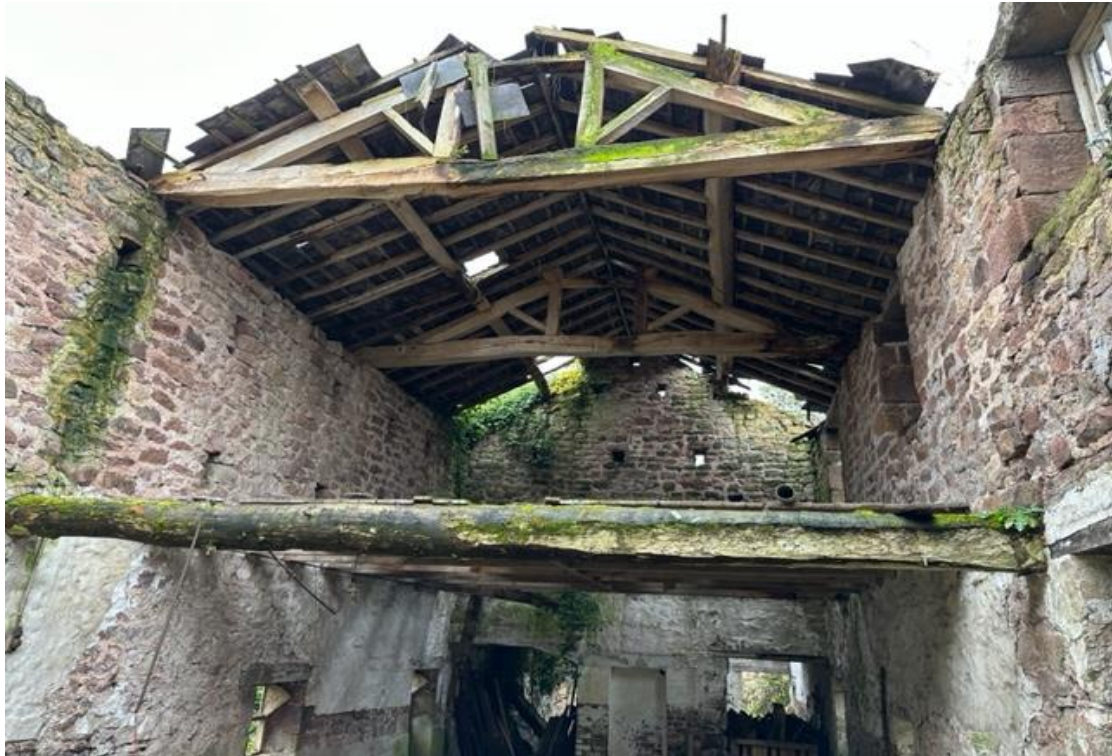
Typical internal view of southern wing of buildings – Stone work generally in good condition. Original remaining queen post trusses and purlins could be saved with minimal structural intervention.

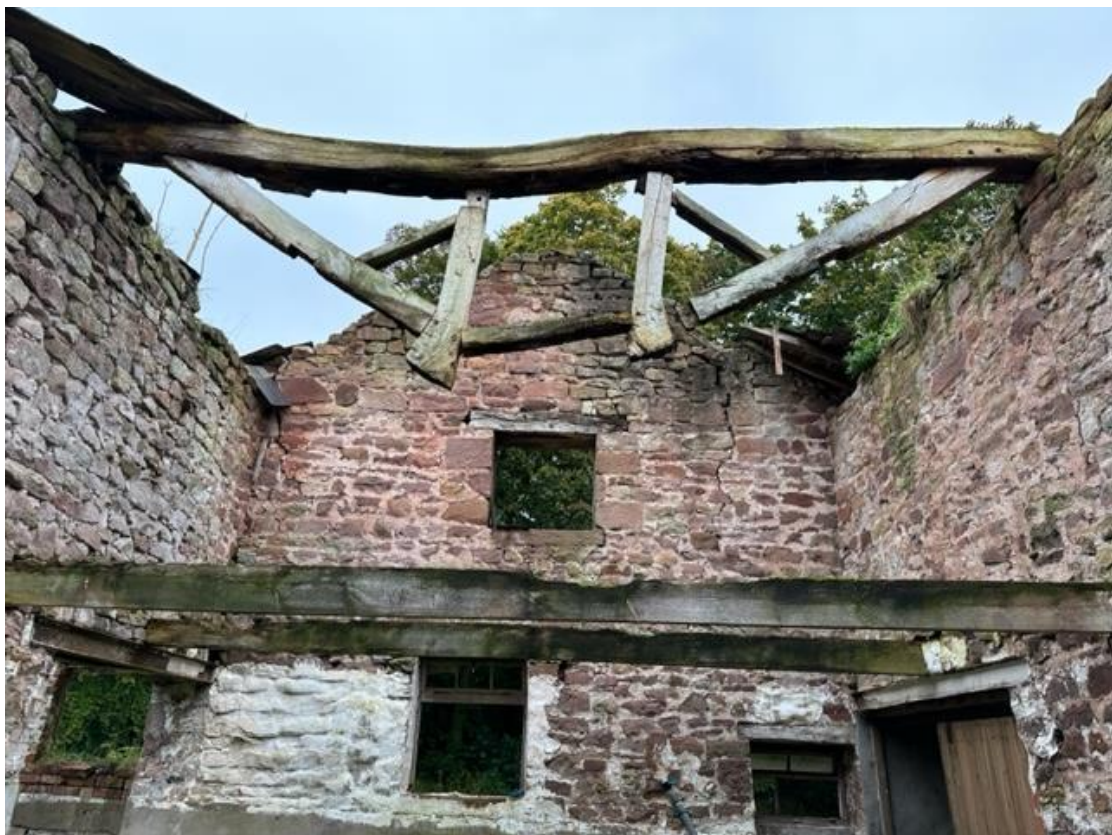
Original roof and floor structure is largely missing – however, this would ordinarily be replaced as part of any renovation to meet modern building regulation standards.
