# IGN Structures

## Barn Survey & Structural Assessment

Endon Bank Farm, Church Lane, Endon

**Reference:** 22-092R\_001

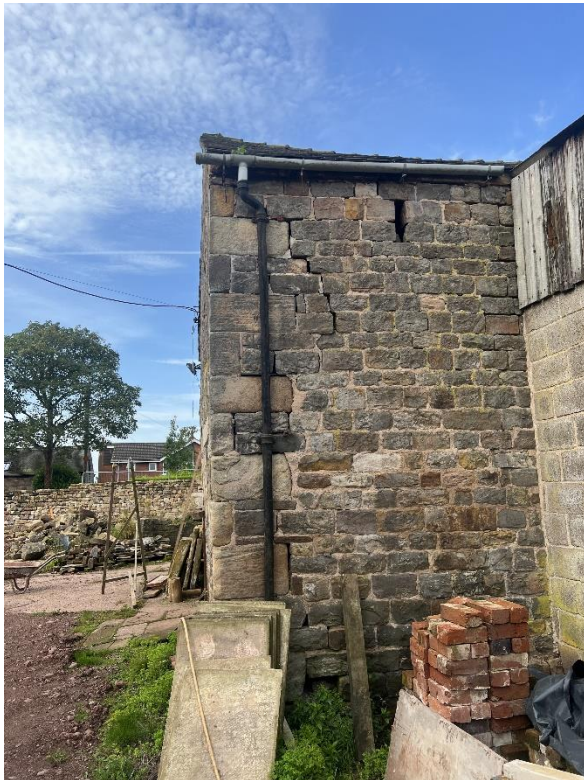
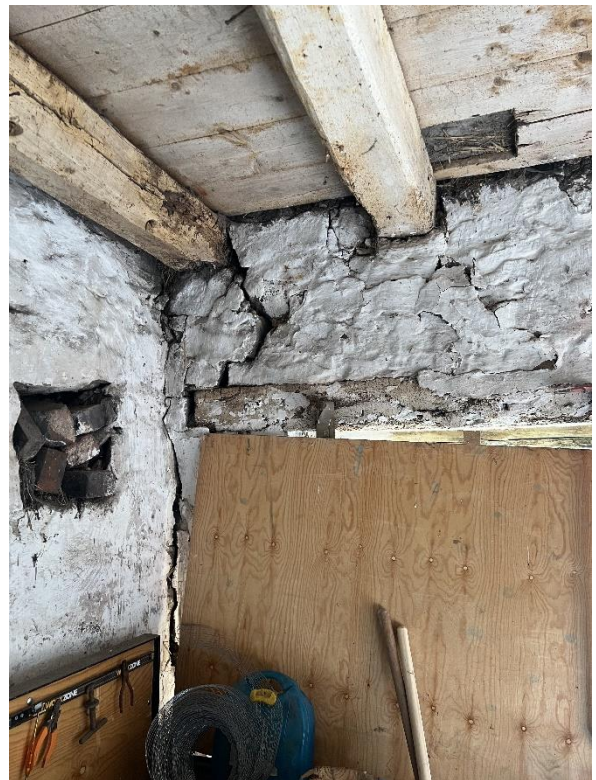
- 4.4 The timber kingpost system appeared to be in a satisfactory condition and no major structural distress was noted.
- 4.5 Some movement was noted to the corner of the Southern Gable end wall (Section A). Where vertical cracks had formed externally and internally. Foundations in this area should be exposed and allowance should be made for localised underpinning / rebuilding this section of wall. This work is required irrespective of any conversion works to maintain the building in a serviceable condition.

Movement to Southern gable end wall

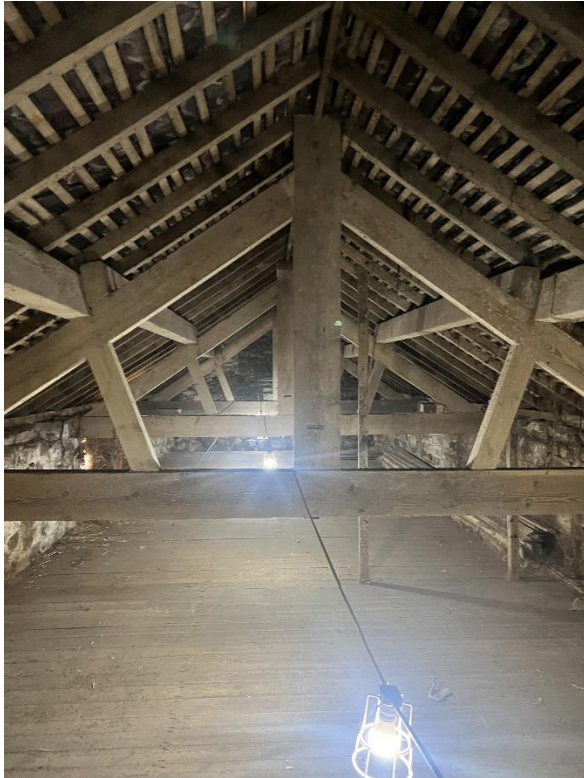
Timber Kingpost Truss

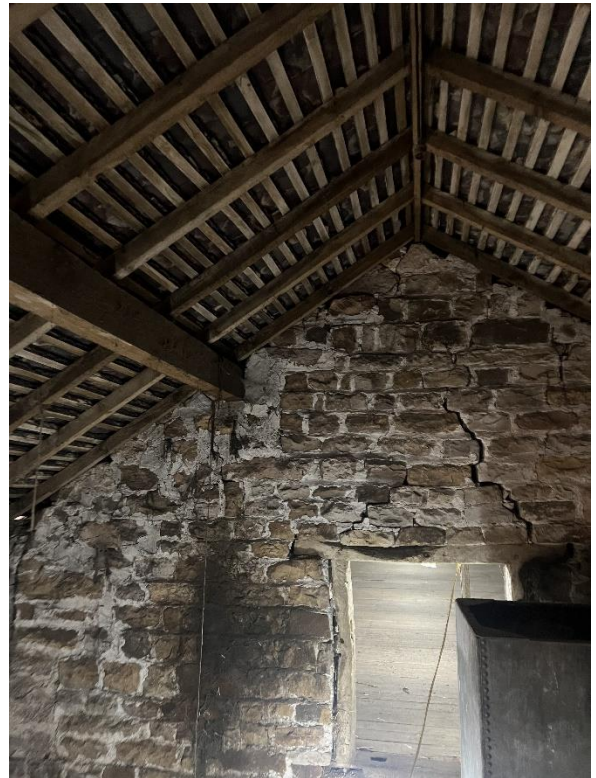
- 4.7 Timber lintel failure was noted at first floor between Sections B & C, where cracks had formed in the stone cross wall. Lintel should be replaced, and stone cross wall made good.

Lintel Failure Sections B & C

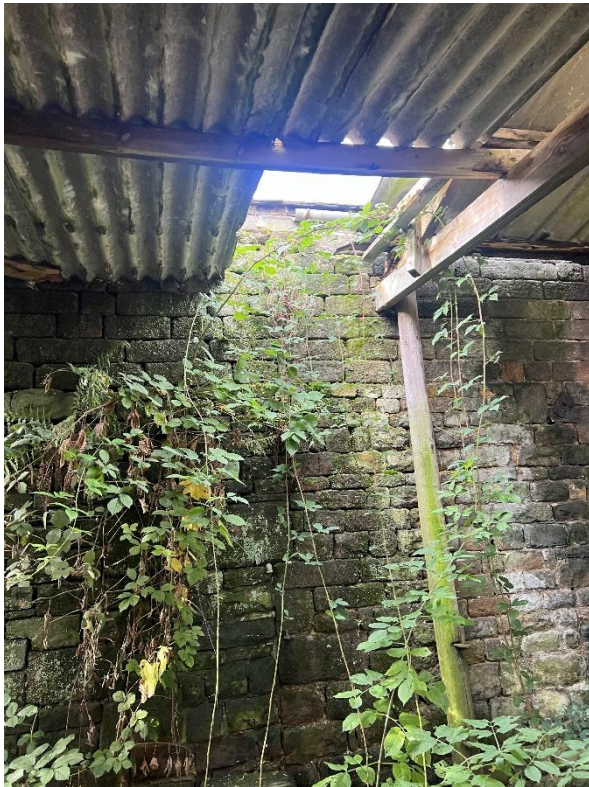
- 4.8 The rainwater goods are generally in a poor condition to the rear flank wall with many sections of guttering either missing or significantly distorted, rendering them ineffective. The rainwater goods ideally require replacement in their entirety.

- 4.9 Generally external walls to the rear flank wall of the barn had been exposed to a degree of weathering over time, resulting in a loss of mortar and foliage growth. Removal of foliage growth and raking out and repointing joints will assist in restoring integrity. This work is required irrespective of any conversion works to maintain the building in a serviceable condition.

Foliage / Rainwater goods rear flank wall.
