**Middlecliff Farm– Structural Appraisal (Class Q)**

Project No: 2476

## **STRUCTURAL APPRAISAL REPORT BARN CONVERSIONS (Class Q)**

**Middlecliff Farm,  
Middlecliff,  
Bradnop,  
Leek,  
ST13 7NB**

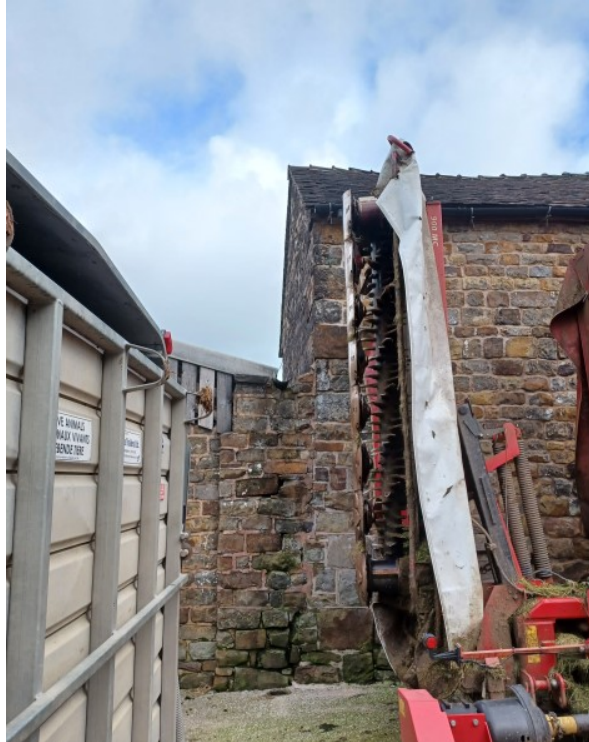
**Photo 1: Front elevation showing the side gable with the cattle shed.**

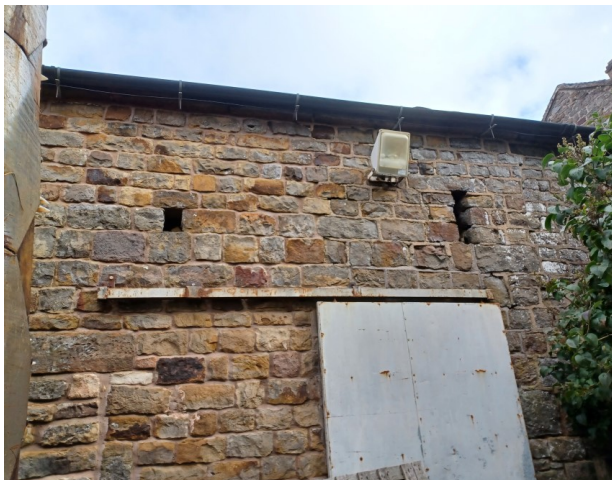
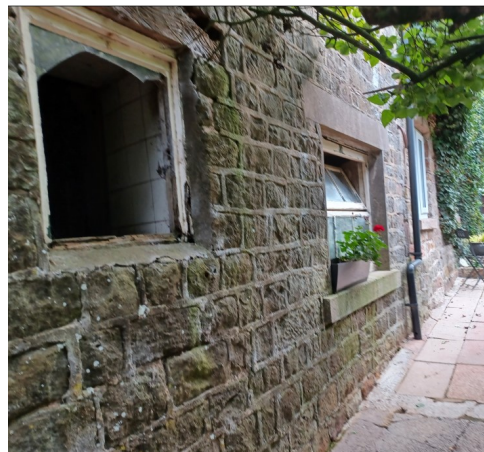
The elevation comprises of a 2-storey stone wall with 1 door opening at ground floor and 2 small windows to the left of the door. No windows are present at 1<sup>st</sup> floor but 3No small slots are present within the stonework.

A second door was present at ground floor, but this has been stoned up.

The smaller window has a timber lintel, and the slightly large window has a stone outer lintel with timber on the inner section.

**Photo 2 & 3: Part front elevation**

The walls are generally in a good condition with one small area requiring attention (small section of rebuilding to the top middle section of the front wall and tying the wall to the roof / floor elements. Lintels will need to be addressed during the construction stage, ensuring that the lintels meet current standards, the lintels aren't currently causing any issues with the structure.

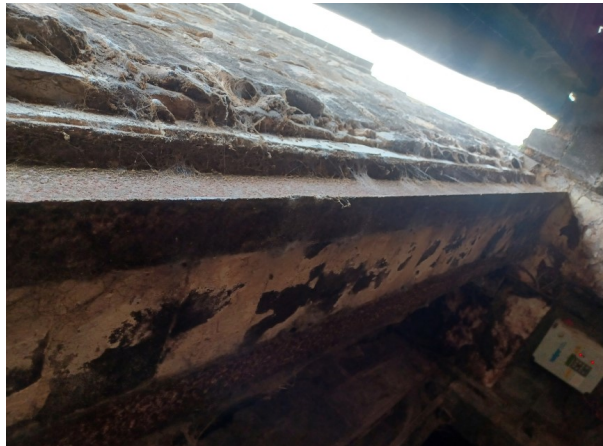
The barn has been separated into 2 areas with a block wall. Within the block wall is the chicken store with access from the outside front wall door. The milking parlour is accessed through the cattle shed building with the ground floor gable wall removed and a 225mm solid blockwall built back up in the middle. The gable over is supported by 2No 254x146 UB steels. These steels have surface rust but are showing no other signs of failure.

The ground floor wall has been removed and replaced in part with blockwork and steel beams. Over the steel beams is a newer blockwork inner section with stone outer faces.

**Photo 6: Gable wall with cattle shed showing steel supports**

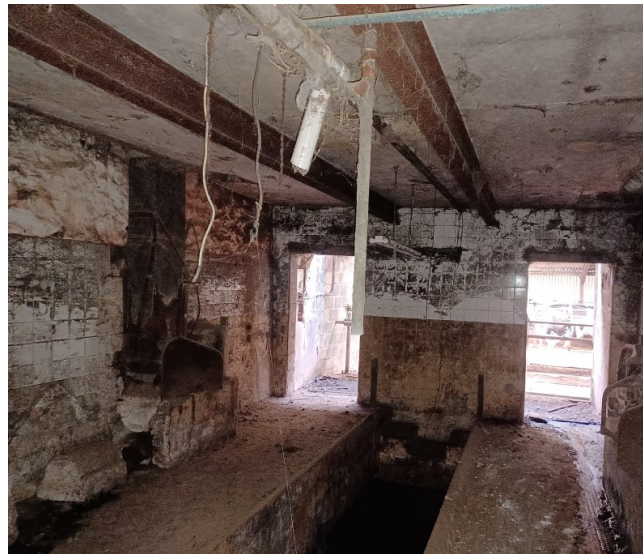
Over the milking parlour are 2No 203x133 UB steels at 1/3 span running from the chicken store wall into the replaced blockwork gable wall. Again, these steels have surface rust but show no other signs of failure. 225x75mm timber floor joists are present over, spanning between the front and rear walls. The joists are generally in a good condition, but a couple have come away from the wall at the bearing.

**Photo 7: Ground floor milking parlour**

The 1<sup>st</sup> floor is in a relatively good condition but would need a couple of joists replacing where the bearing is compromised.

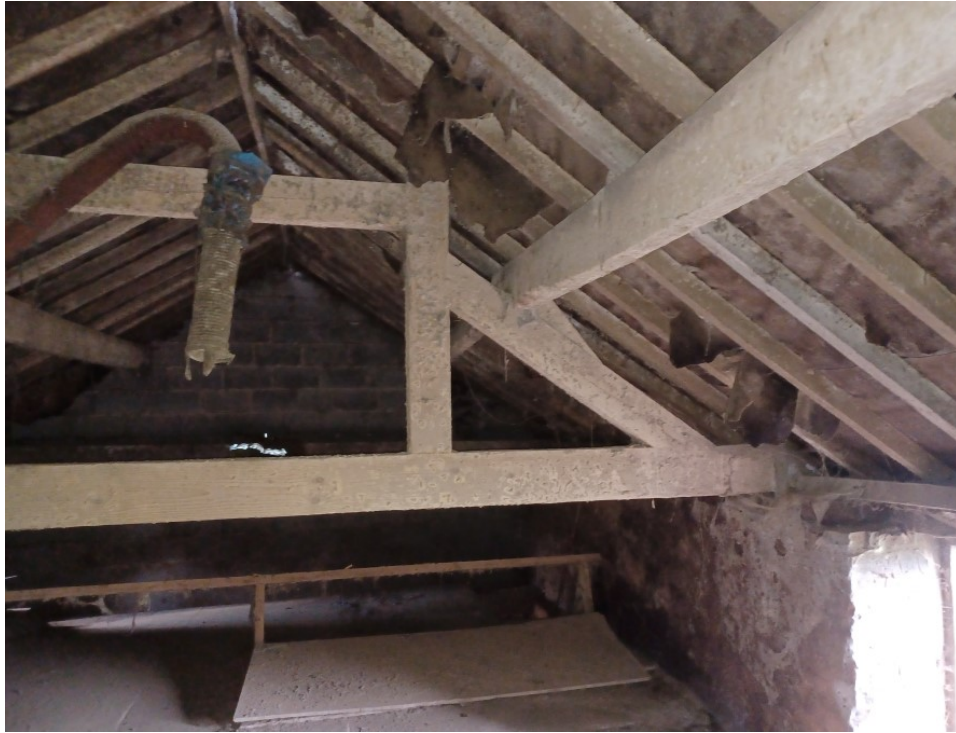
**Photo 8: First floor showing the roof construction**

The roof structure is in a good condition, therefore suitable for the proposed conversion. Providing the proposed roof materials don't exceed the load of the existing materials, no further structural checks would be required.
