## STRUCTURAL ENGINEERS REPORT

C14703

Barn at Stanley Farm, Dial Lane,  
Congleton SK11 0RU

31 January 2024

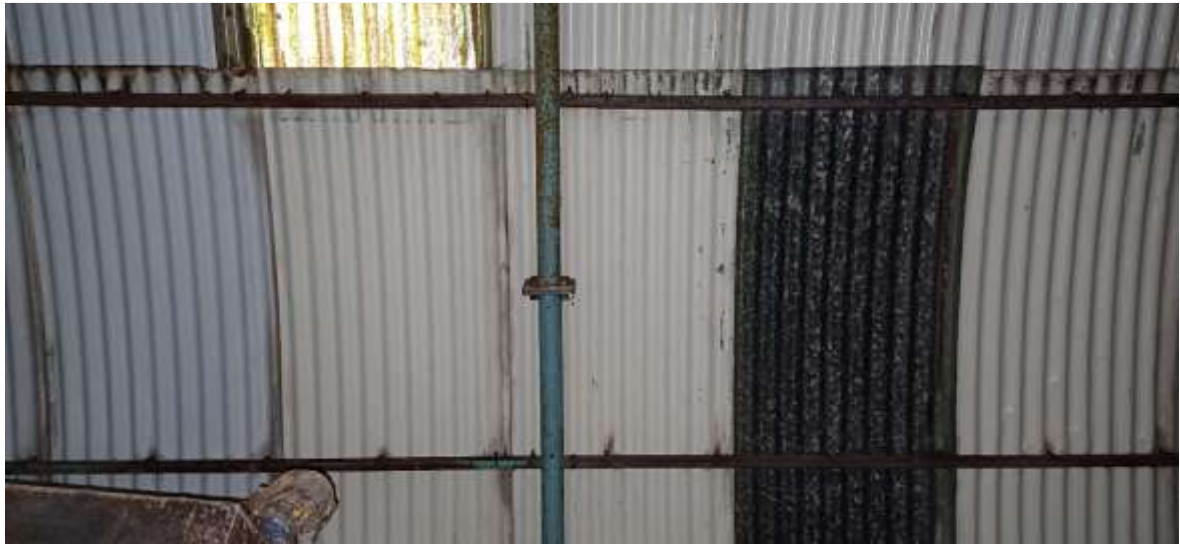
*Figure 1 – Joint in steel frame*

This is a single space. The structure can be seen and consists of circular steel sections forming frames at regular centres, approximately 2.5m. The left to right dimension is just less than 11m and the front to rear around 15m. Steel angle purlins support the cladding and are doubled-up near the ridge. Roof lights are set in the cladding. The front bay has diagonal steel bracing using small steel angles.

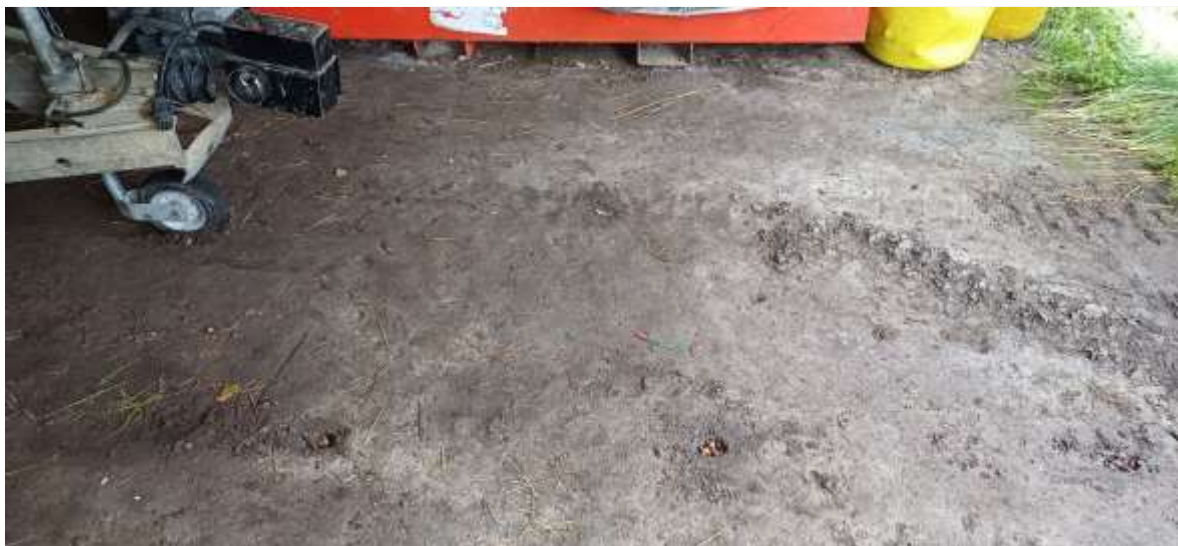
*Figure 4 – Ground 'floor'*

There does not appear to be a floor slab.

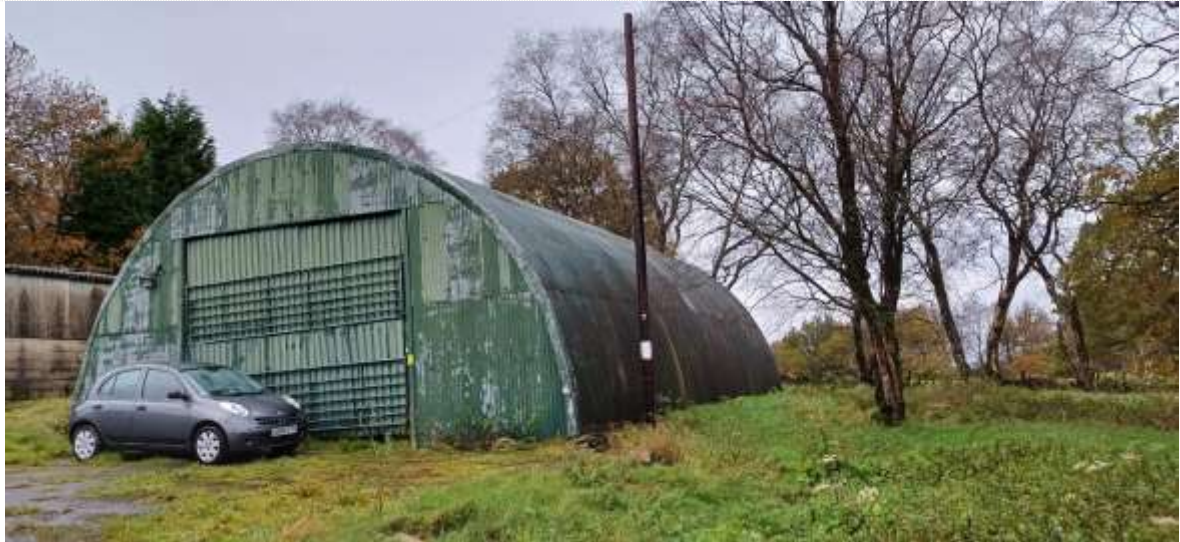
*Figure 5 – Front elevation*

This elevation is a corrugated clad, semi-circle. To the centre is a rectangular door opening which occupies around half of the area of this elevation.

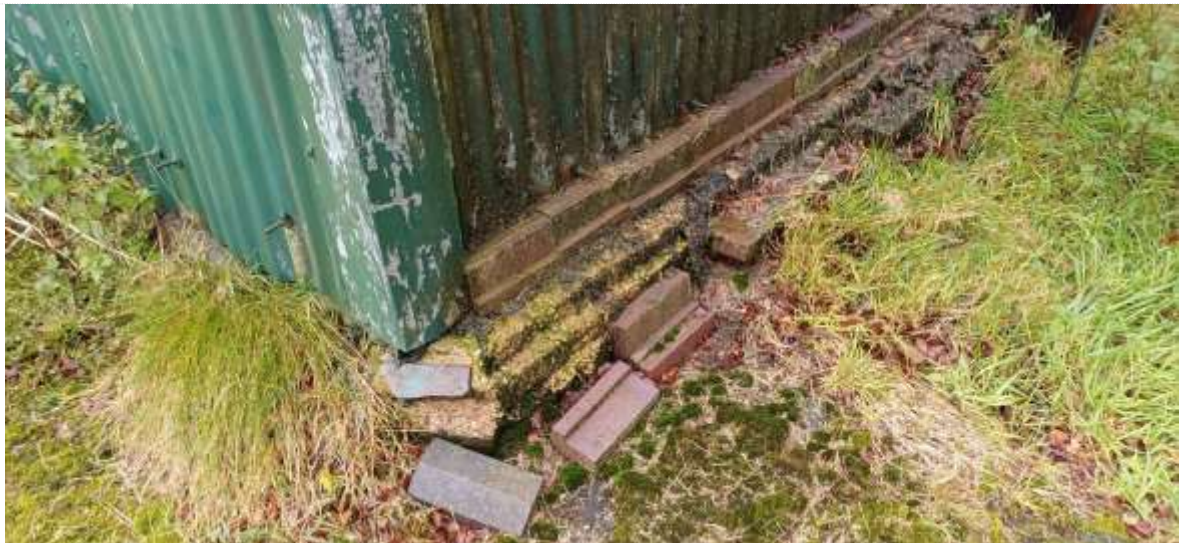
*Figure 6 – Front right corner*

This is curved, corrugated clad, elevation, with the curve running away from the base of this elevation. There is a row of brickwork at the base of the cladding and a stepped concrete detail runs below the brickwork.

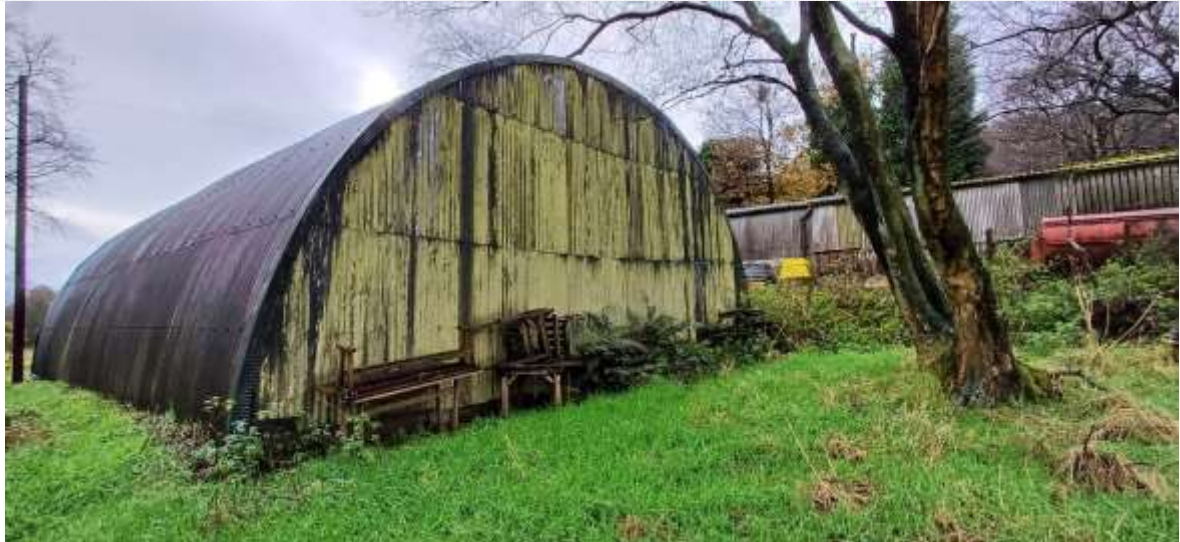
*Figure 7 – Rear & right elevation*

This is the corrugated clad semi-circle, similar to the front elevation but with no openings. The plot slopes up to the left.

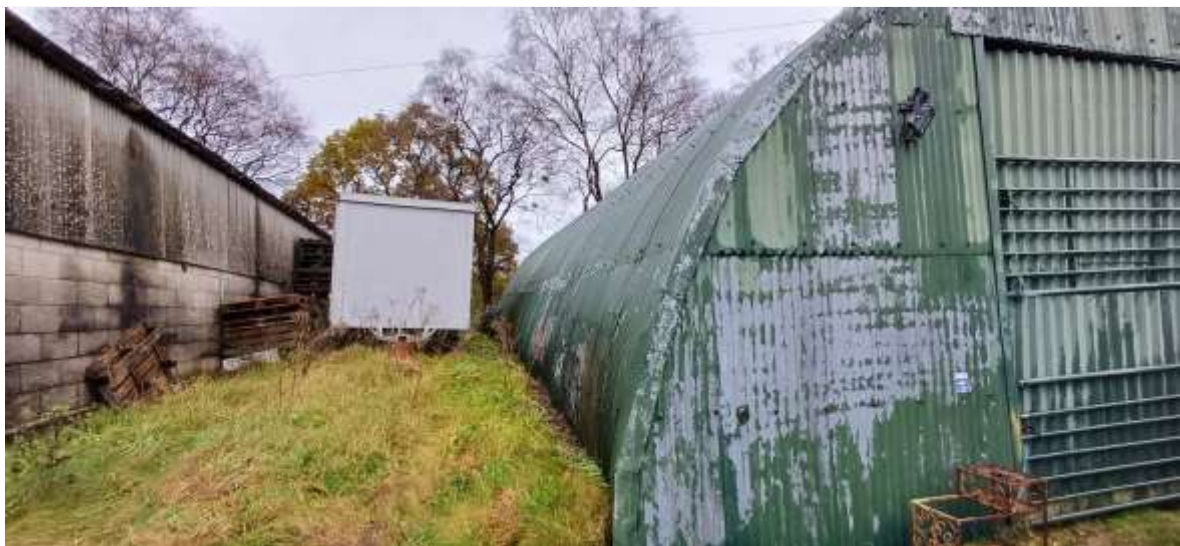
*Figure 8 – Left elevation*

This is a corrugated clad elevation which curves away to the right. The ground level is raised slightly against this elevation.
