Ref: PJL/418040let26

Date: 21 July 2014

**Groundwater and 'V' Notch Monitoring at Moneystone Quarry, Oakamoor,  
Staffordshire.**

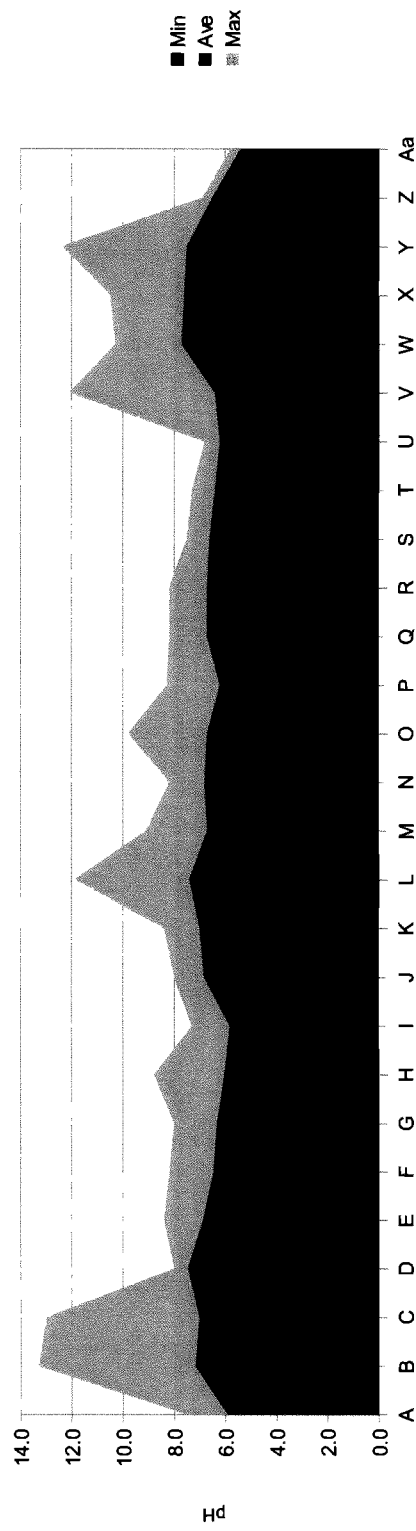
**Fig 3**

Where accessible, the pH of surface water bodies and seepages were recorded (including lagoons and the River Churnet). The pH values are noted from previous visits to be highly variable. See Table 2 and Fig 3. The average pH across the site has remained relatively constant around pH 6.5 although small scale variations have been introduced by sampling regimes.

During the July 2014 monitoring visit the variability had reduced with the range of values recorded being between 5.2 and 5.8. It might be suggested that the variability in pH is influenced in part by the preceding weather conditions. As the warmer drier weather approaches, reduced precipitation could cause a reduction in pH due to decreased dilution.

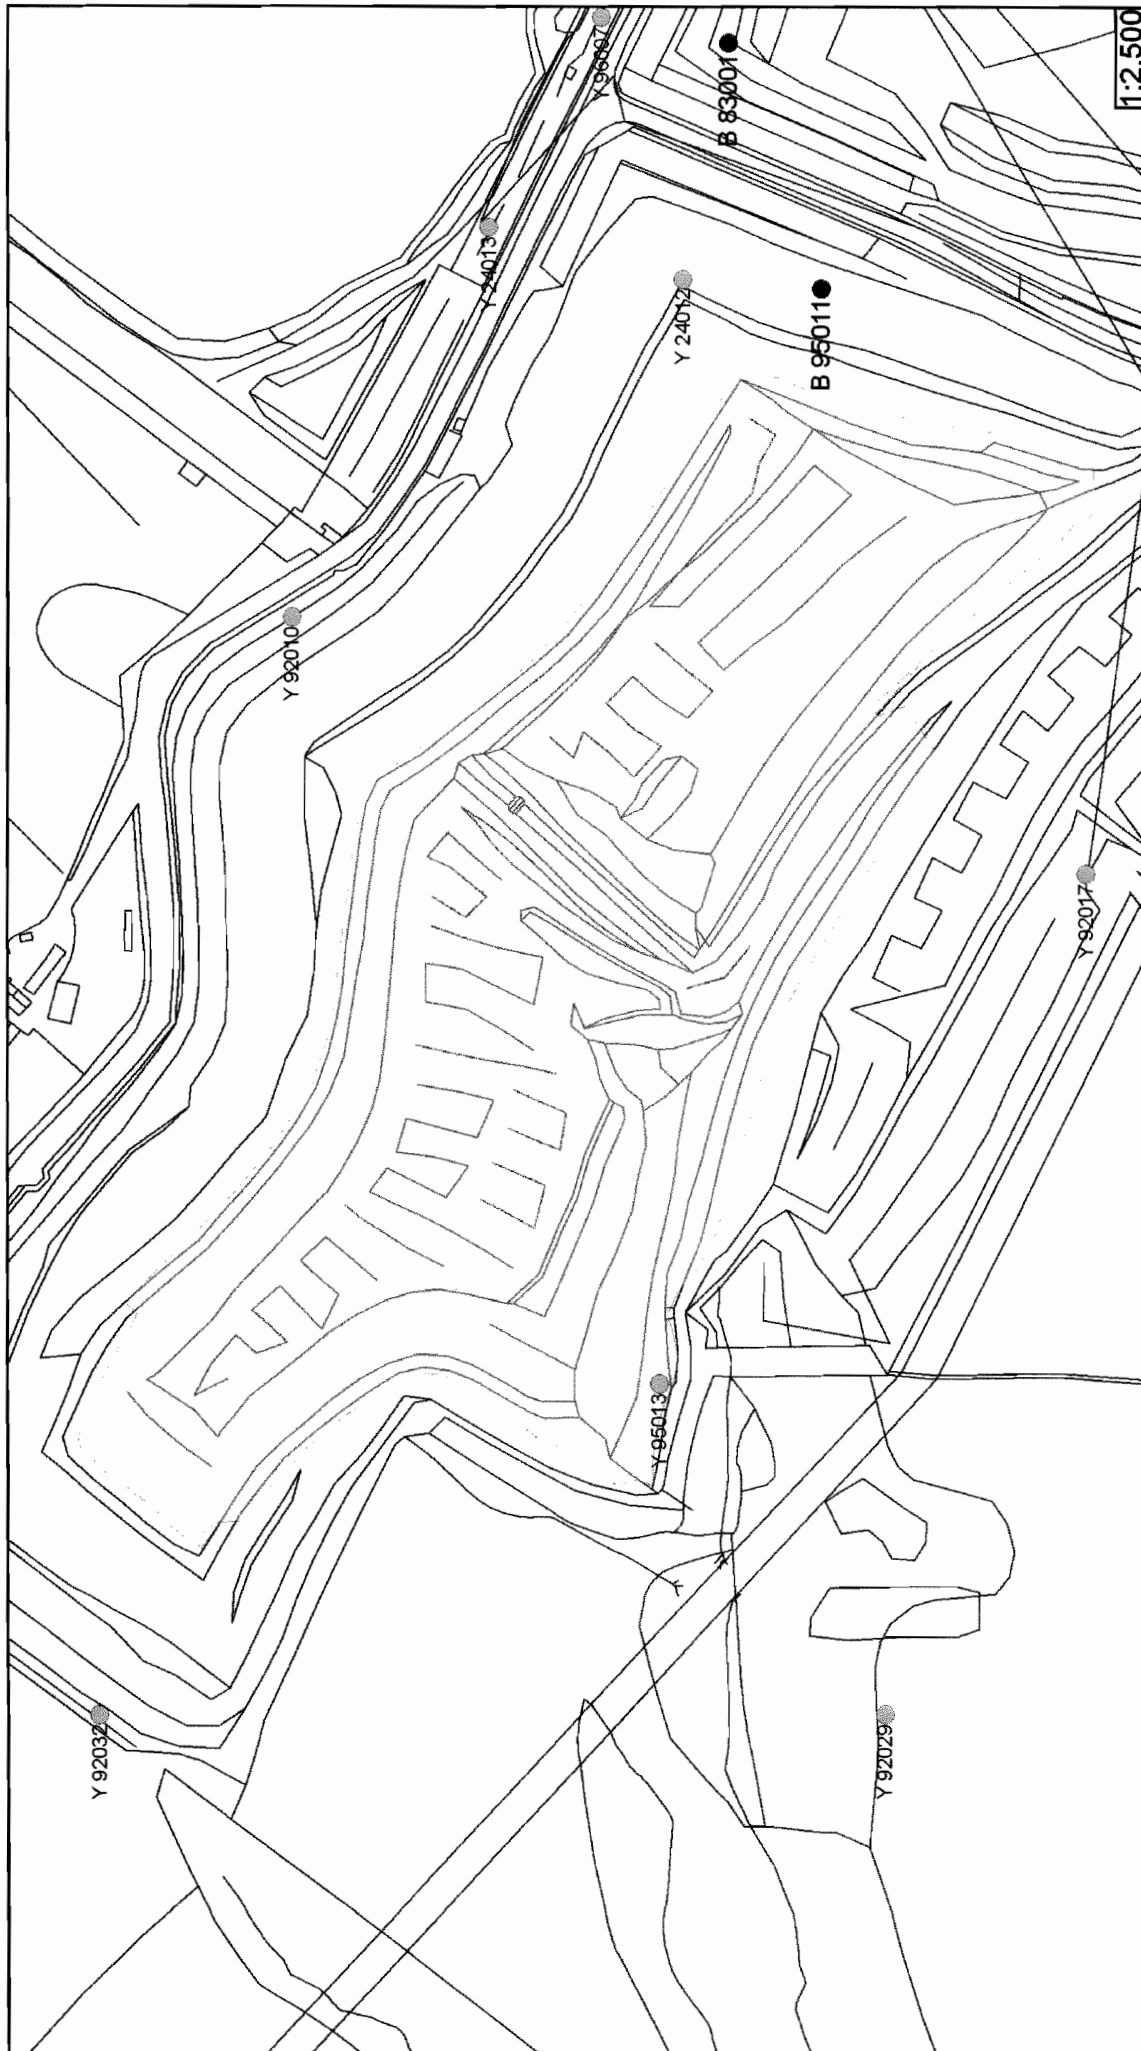
**Fig 4**

The Q3 lake level has been monitored by ABEC on previous visits. See Table 3. Our most recent visit on 8 July 2014 recorded a water level of approximately 158.3m AOD, around 700mm below the level of the spillway. It is noted that following the January 2014 visit, which appeared to show an equilibrium level had been reached around 156.91m AOD, lake levels have again begun to rise at a seemingly increasing rate. The lake level rise has obscured the former beach line that was observed on previous visits (ABEC Ref: 418040Let24) and has now overtopped BH95013. The small water course previously recorded on the north face of the quarry was noted to be dry during the latest visit. The lake level had now reached the boundary between the sandstone and the overlying coal measures strata on the southern face of Q3. The slopes on the southern edge of Q3 above the water line showed large desiccation cracks between 20mm to 40mm wide suggesting that the water level rise is not due to precipitation. Currently the bench surrounding Q3 is completely submerged with the exception of the western end which stands a maximum of 1.5m above the lake level. See Fig 4. The slopes within Q3 continue to be monitored for signs of instability.

## Area of Q3 water coverage

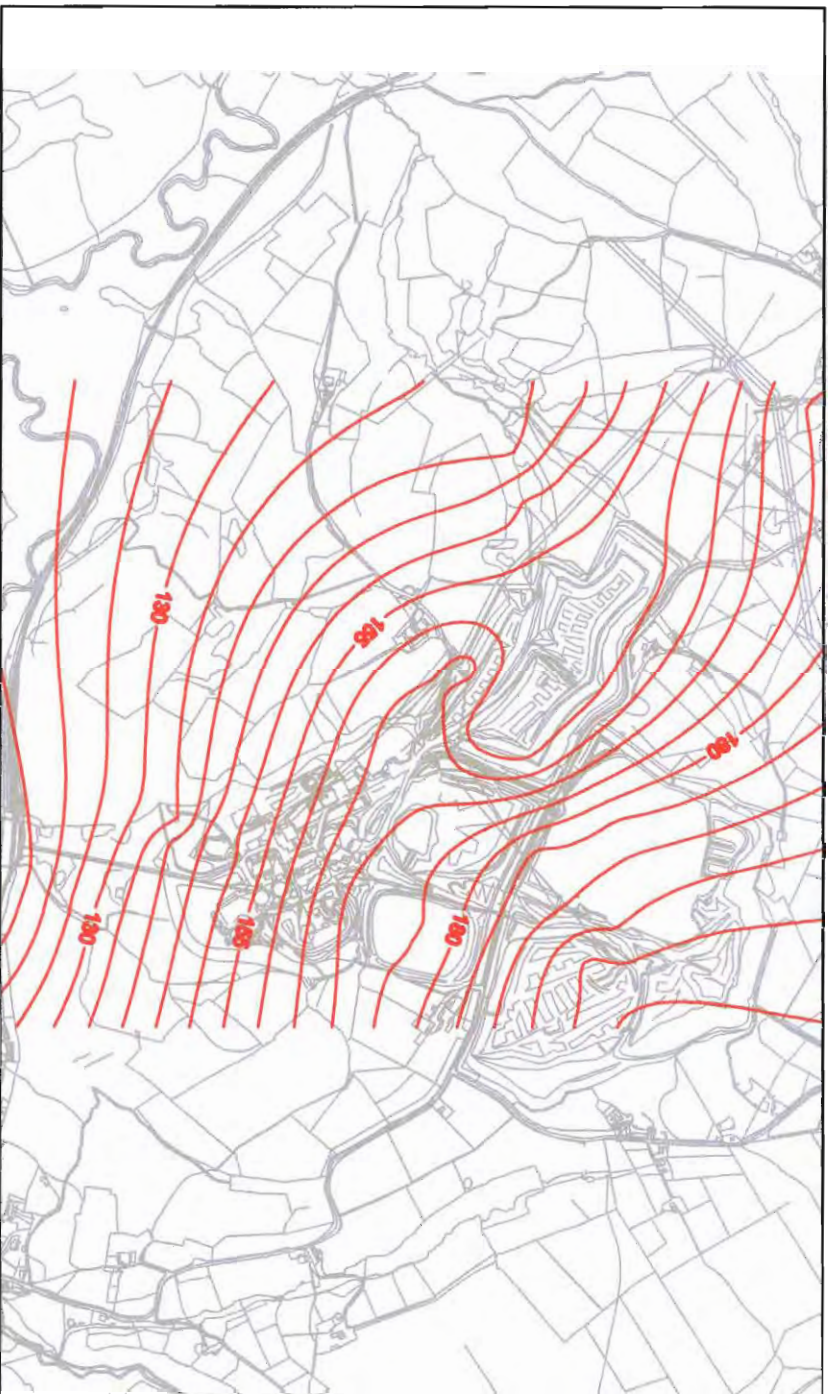
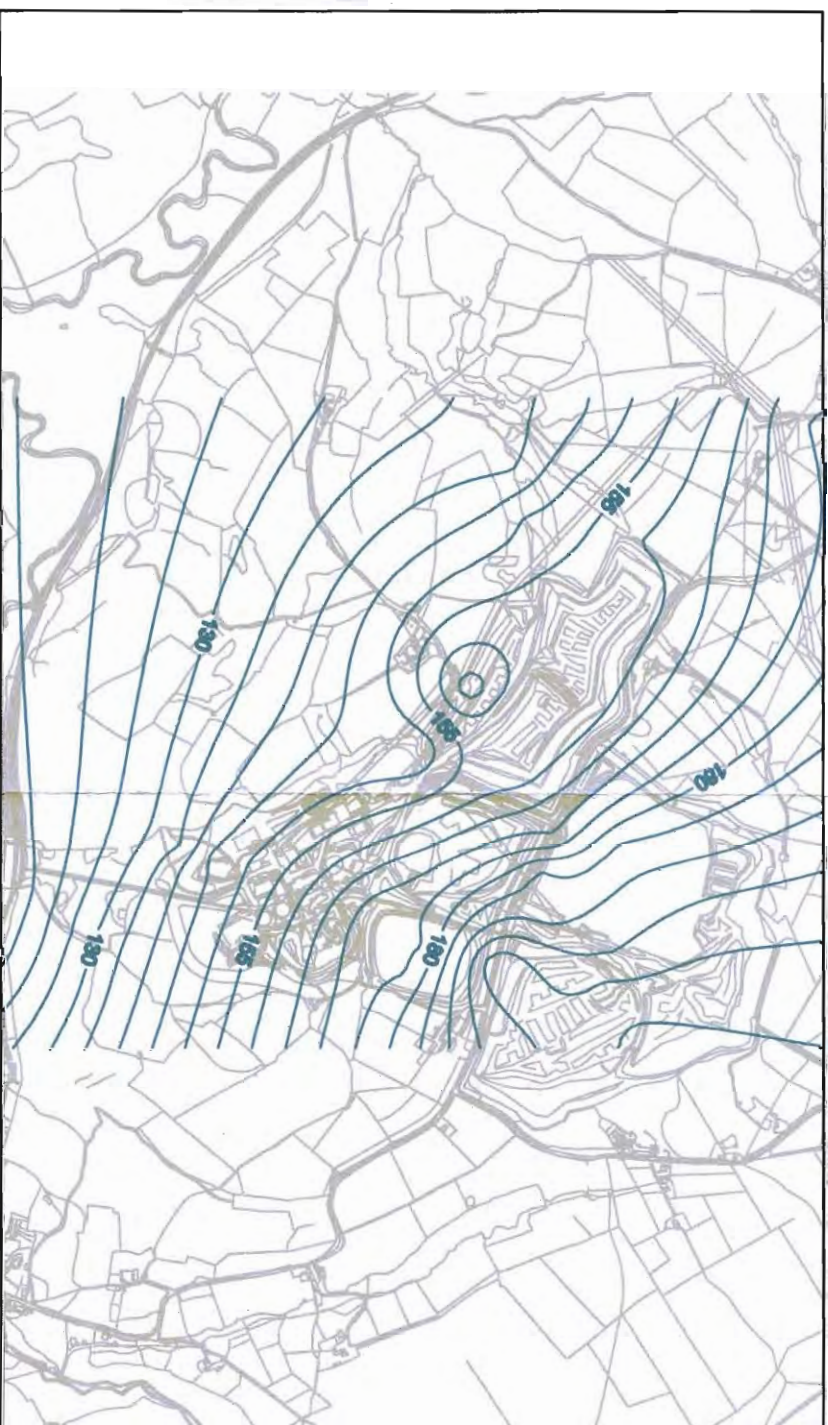
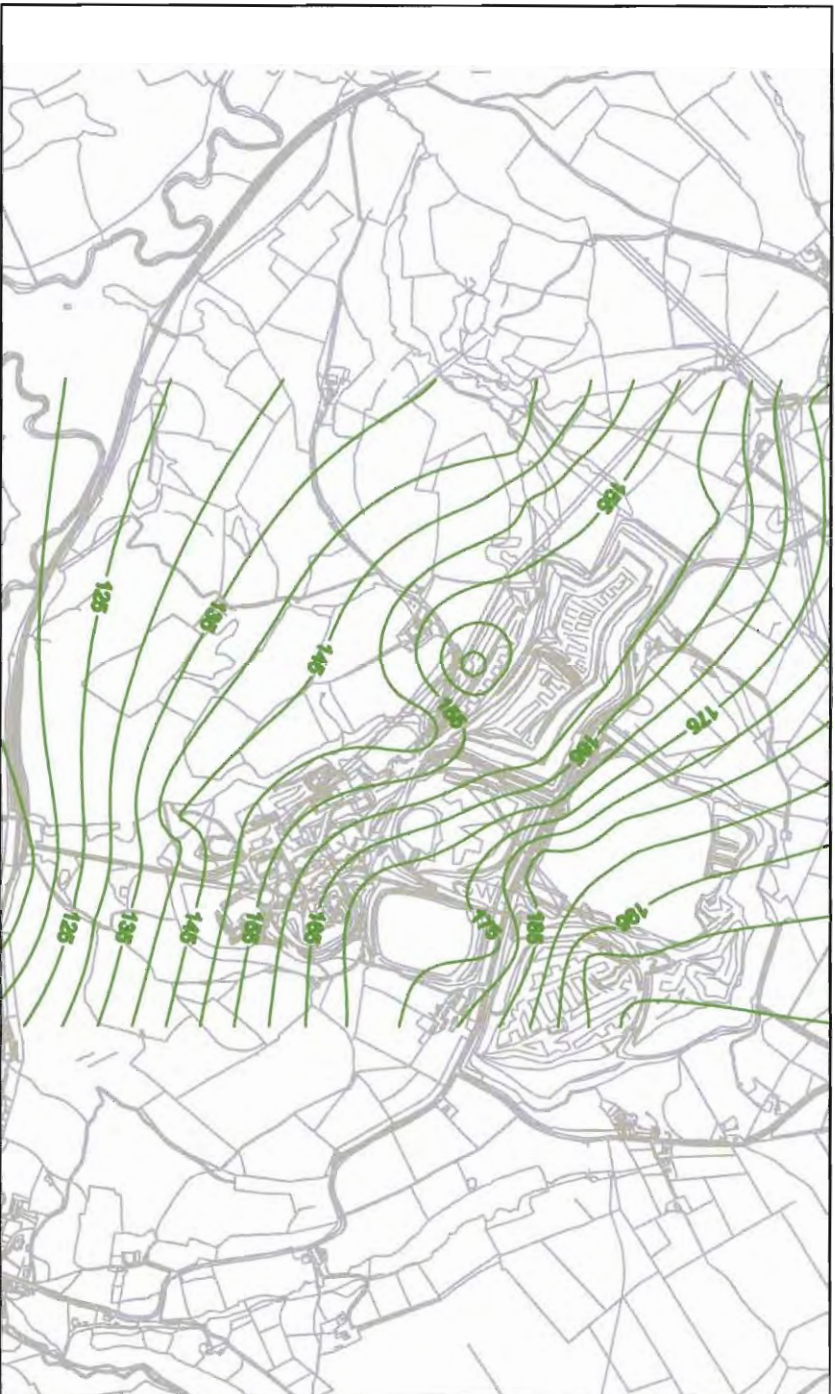
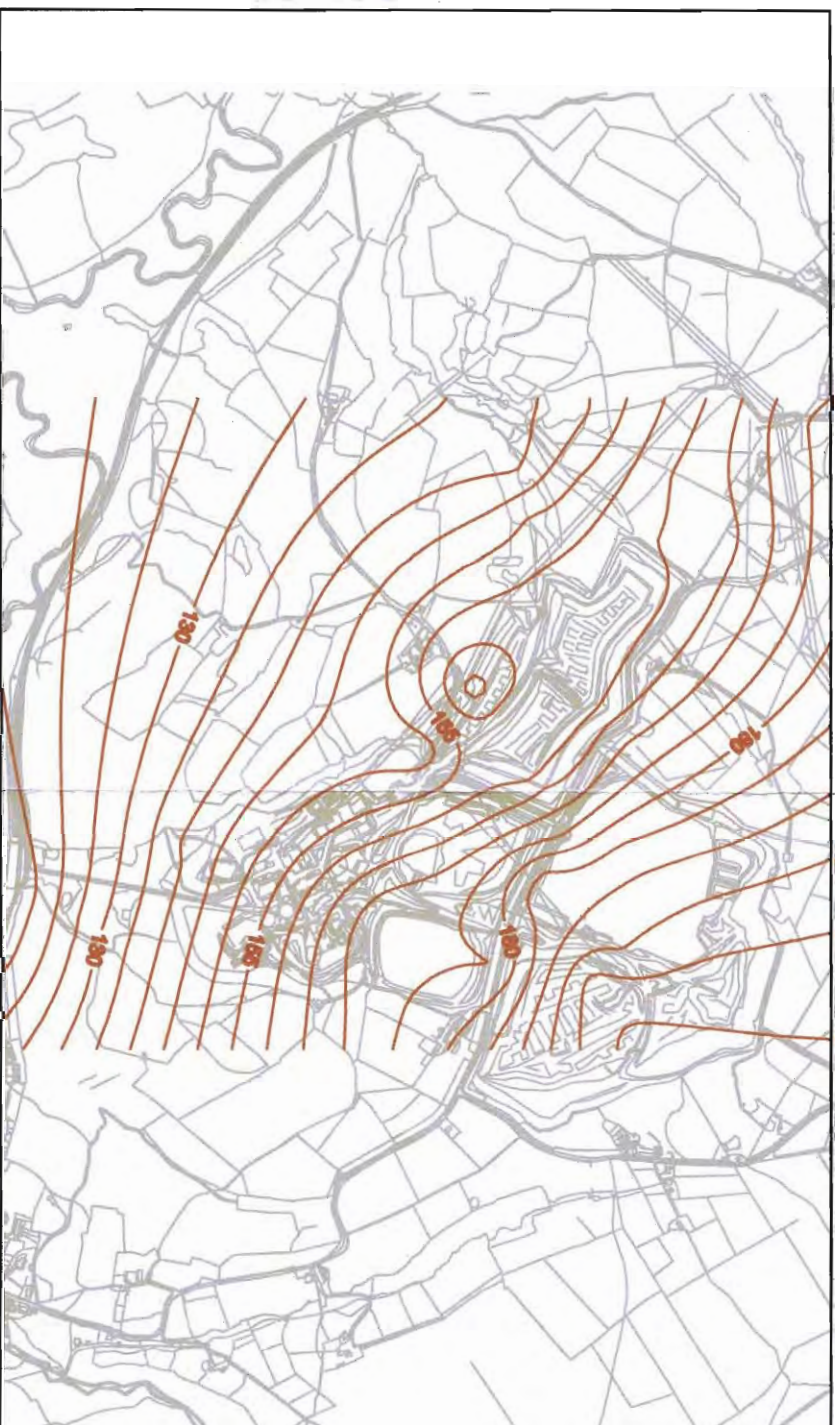
Fig. 5g

# Groundwater July 2013 to Apr 2014

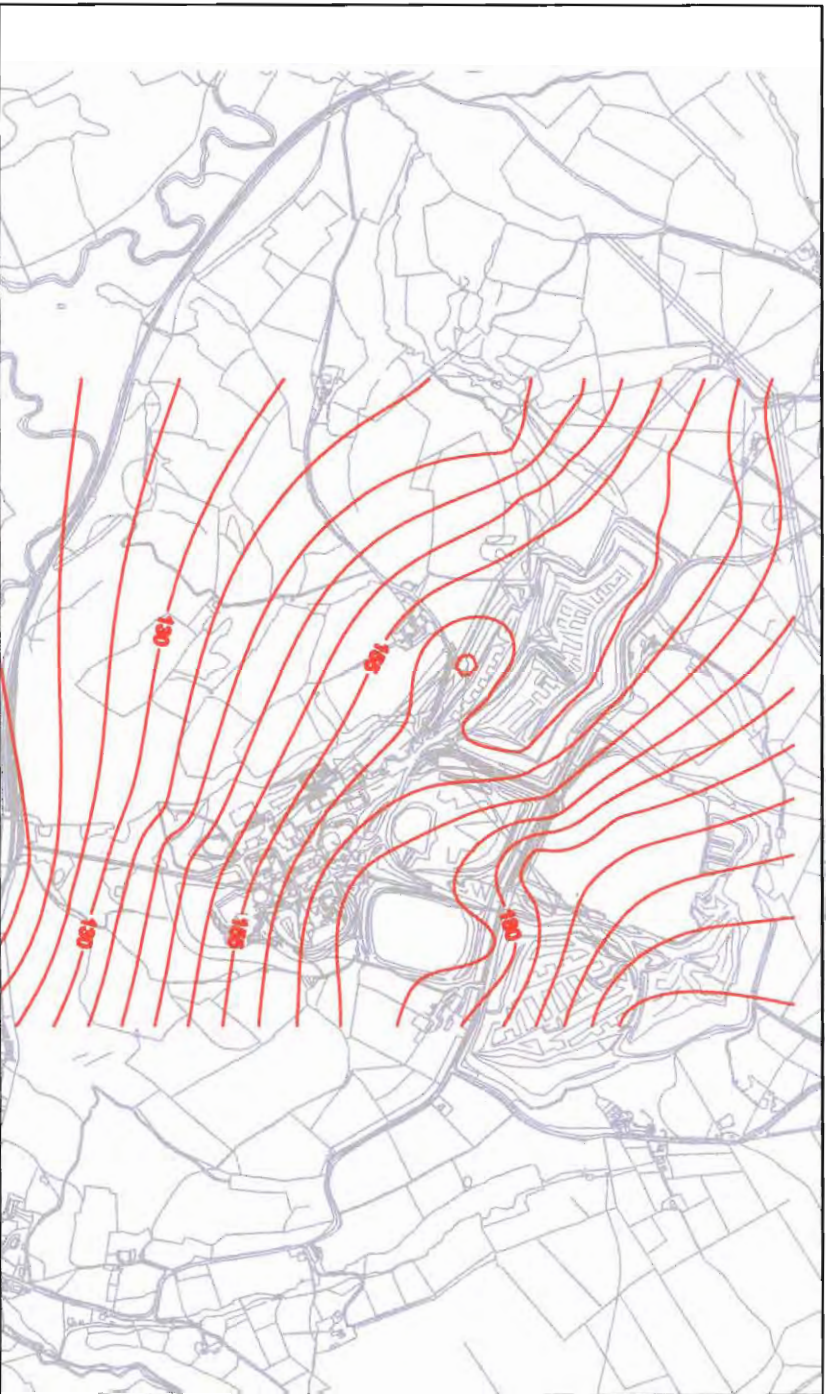
**Fig. 5h**

The boreholes have shown varying rates of change throughout the monitoring period. During the July 2014 visit, all boreholes have shown slight decreases in groundwater levels of between 2.3m to 0.3m from the April 2014 visit. The exception of which is BH 122 and BH 92029, which record increases. See Table 1 and Fig 6. Over the course of the monitoring period an overall steady rise in water level has been recorded in BH 92029 with BH 122 remaining relatively constant. It is considered that the decreases in groundwater levels will be due in part to the reduced rainfall and infiltration from increased evaporation. The increased levels of Q3 would therefore not be expected. The Q3 level rise may be due to delayed draining out of groundwater in the sandstone, accumulated last winter.

**Groundwater July 2014**
