# W03

| DRAWING No. | TITLE<br>CH COTTAGE W03 E/P | DRAWN by<br>Paul Statham | | |

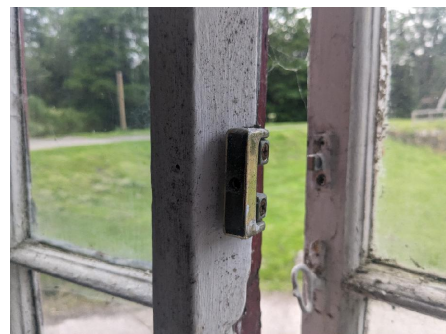
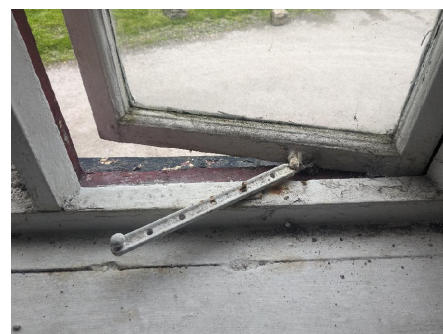
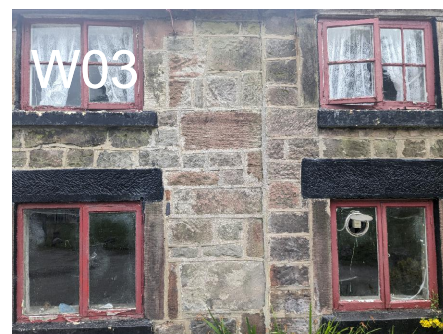
MUNTIN PROFILE TO MATCH EXISTING HORIZONTAL ELEMENTS
