White Shaw Farm  
Heaton  
Rushton Spencer  
SK11 0SR

22<sup>nd</sup> July 2022

**Re: Structural survey of Barn at Cloud Park Farm**

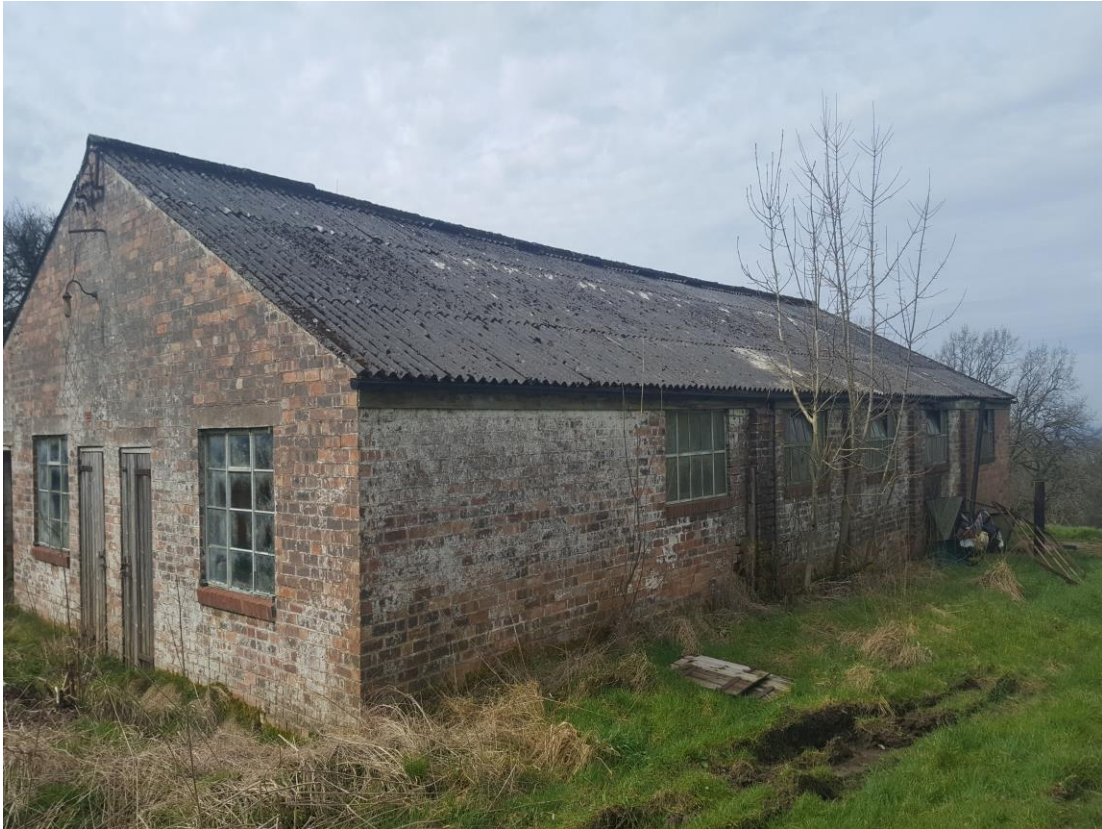
The external roof construction is generally in good condition, with no sign of any distress or structural movement, likewise the walls externally appear to be in good condition with no signs of foundation movement or distress, it was noted that there is some significant tree and vegetation growth very close to the building and some of the external ground levels require rationalising to ensure they remain below internal floor level.

General view of side elevation of barn

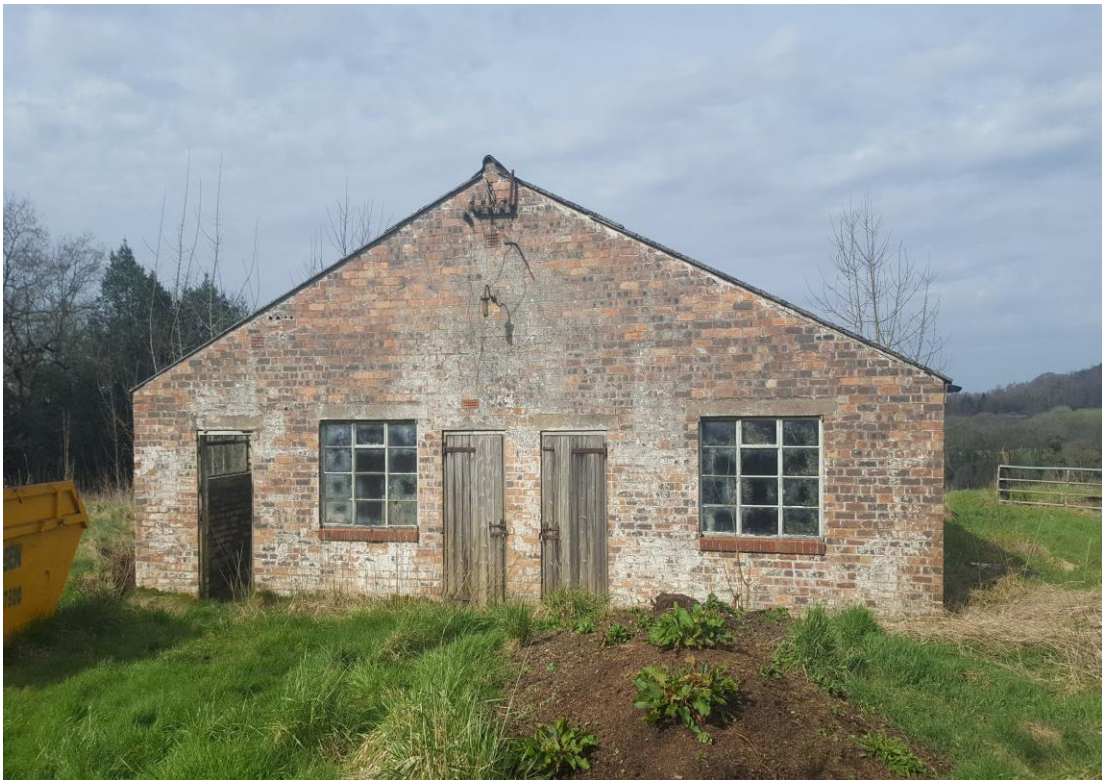
General view of gable elevation

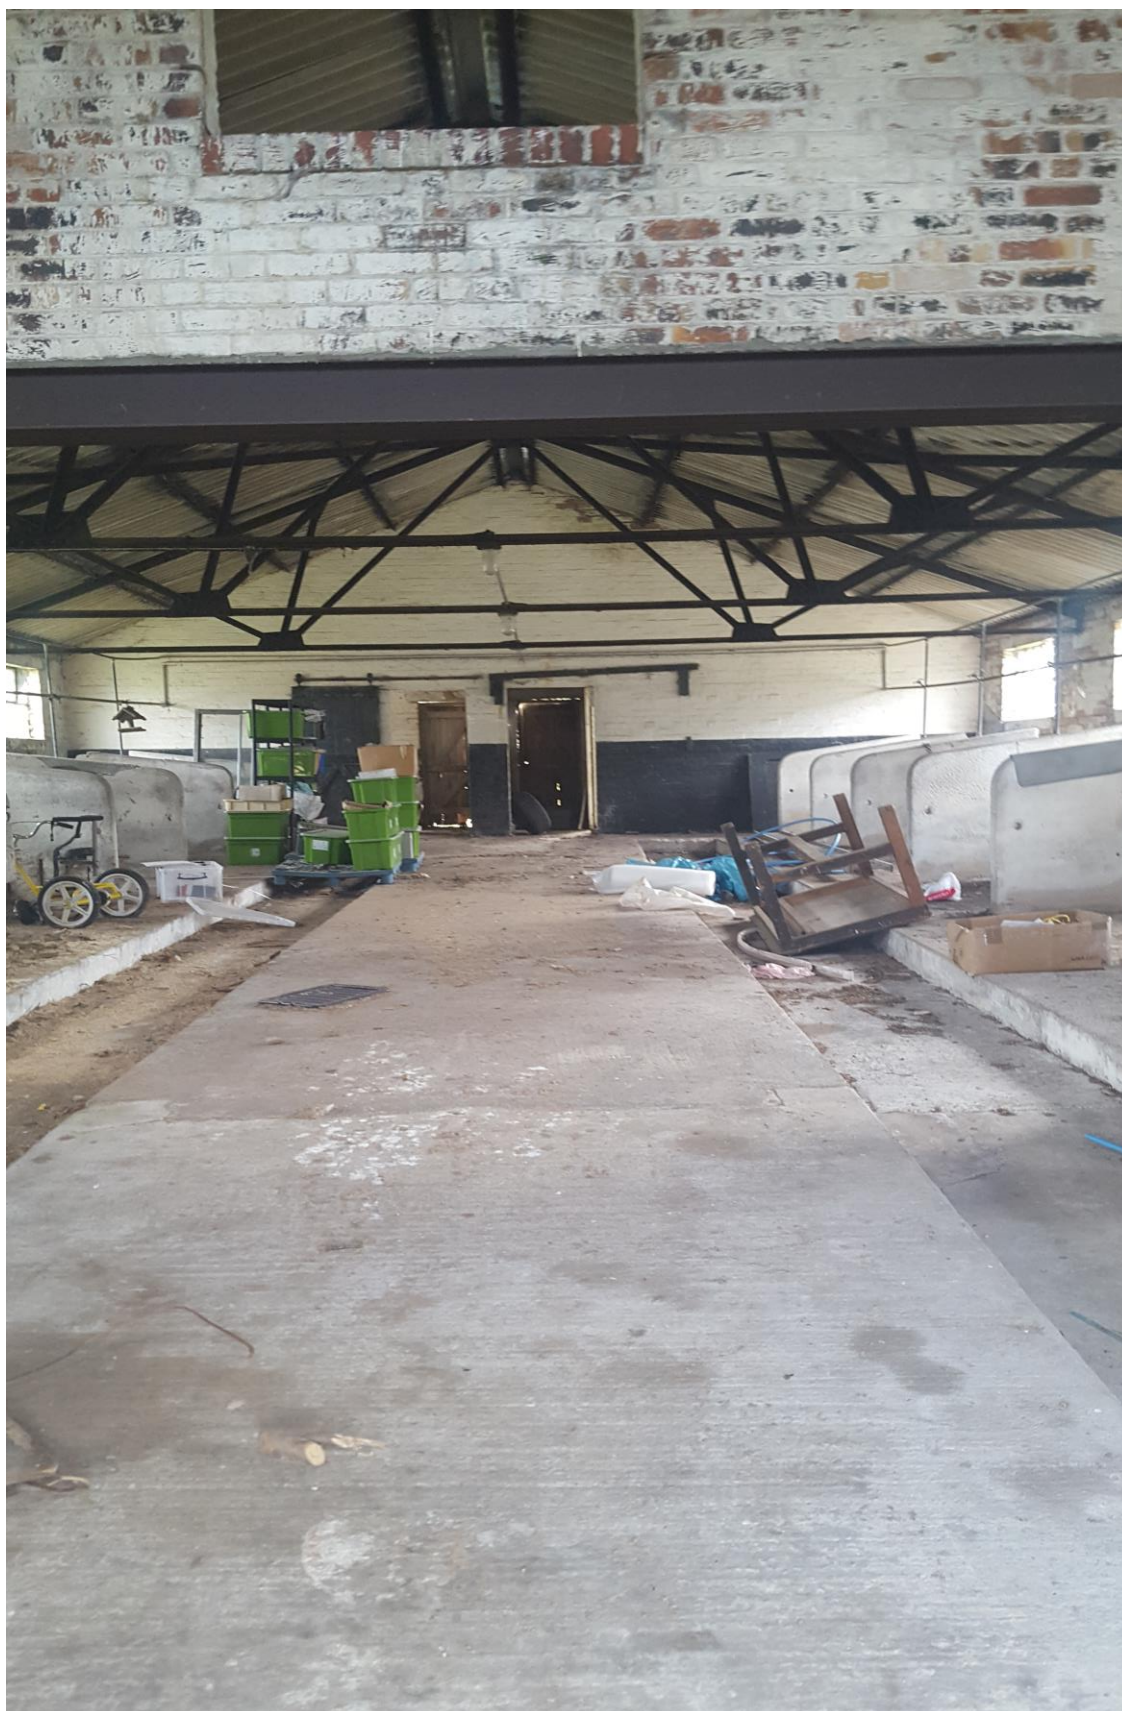
Internally the roof structure appeared to be in good order, the steel elements exhibiting only minor surface corrosion. There were no signs of structural distress or movement to the steel trusses, the internal steel beam supporting the wall appears to be performing satisfactorily.

General internal view.
