# **BAT SURVEY REPORT DERBY STREET, LEEK**

EE-2435-001-REP-001  
JULY 2024

**Prepared For** Andrew Carter  
**Site** Derby Street, Leek  
**Document Title** Bat Survey Report  
**Document Ref** EE-2435-001-REP-001  
**Date** July 2024

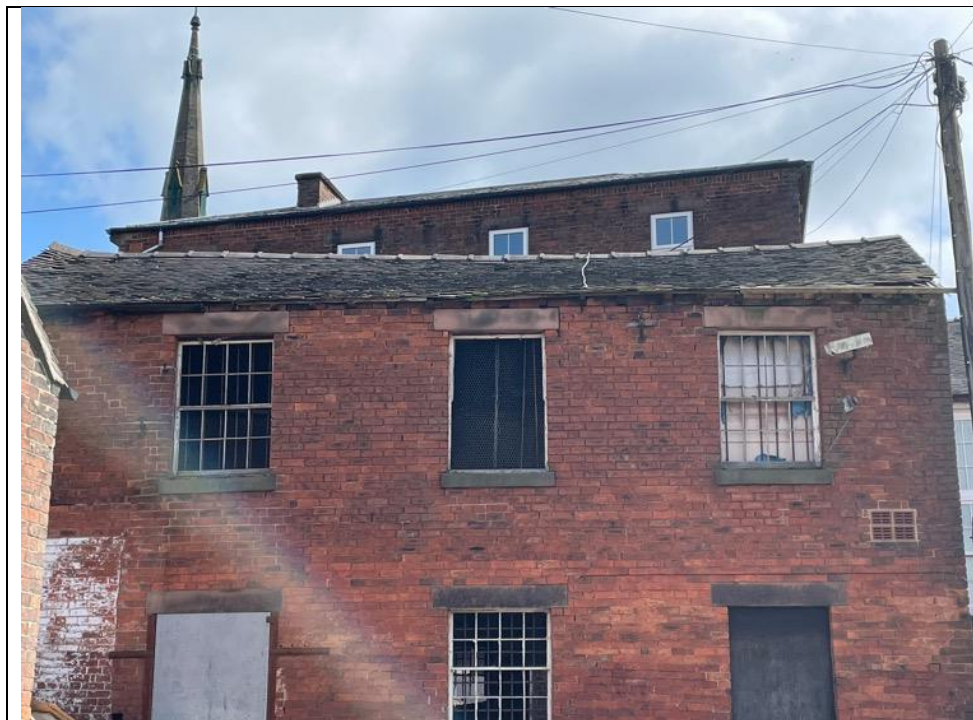
- 3.2.4. Generally the brickwork of Area A is sound, although a significant bow in the west facing wall will require it to be rebuilt on a like-for-like basis. Some small sections of brickwork are missing or broken along the top of the walls on the west and south facing aspects. The soffits, bargeboards and fascia, located along the western, southern and eastern facing aspects of Area A are all wooden in construction and show signs of severe decay and are absent in several locations.

Photograph 1: West facing aspect of Area A (bow in wall)

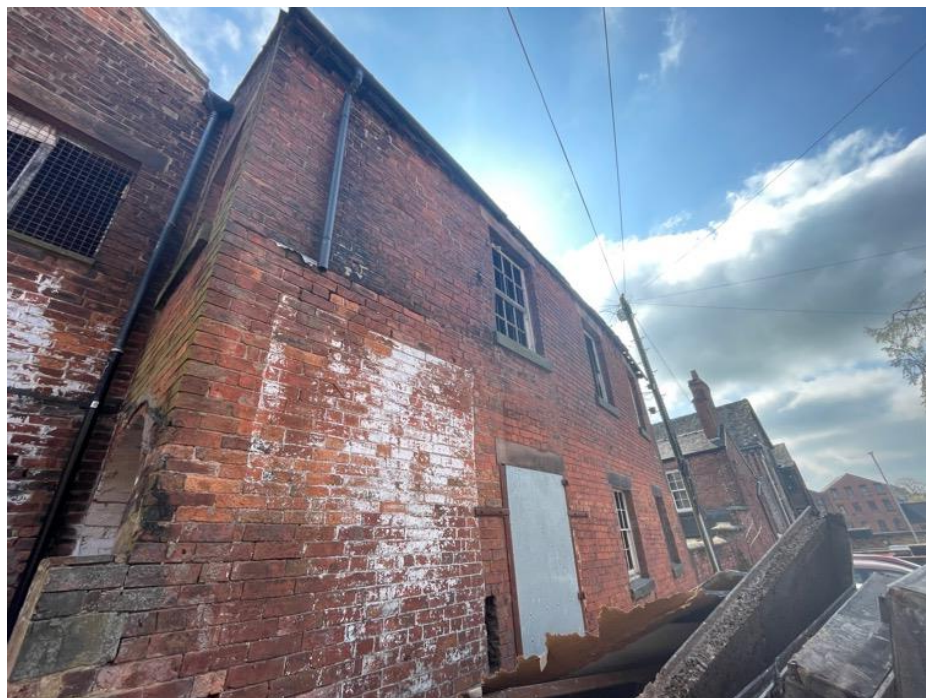
Photograph 3: West facing aspect of Area A (bow in wall)

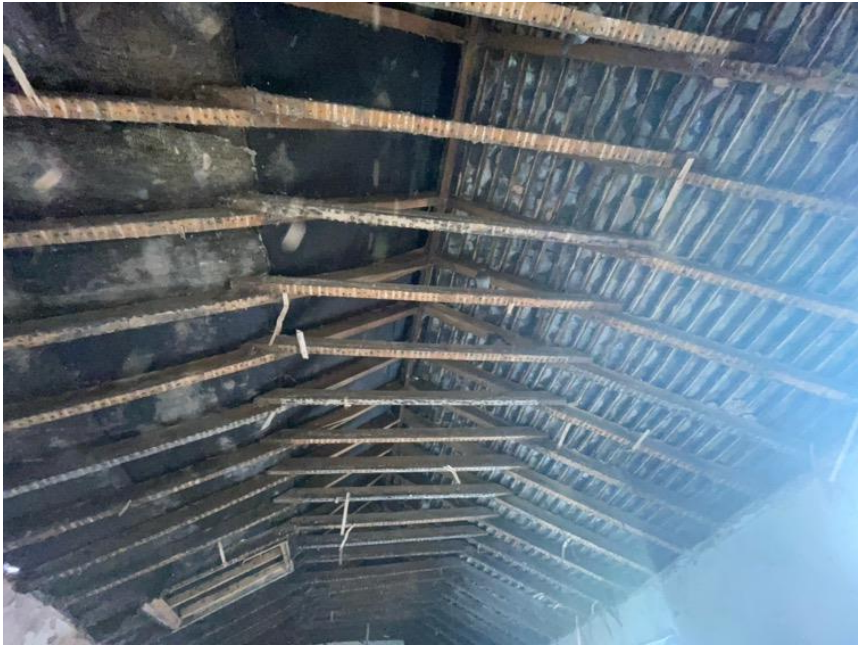
- 3.2.9. The ground floor of Area A has a temporary plywood flooring. The first floor has recently had its floor covering removed and the lath and plaster ceiling has also recently been removed. The first floor is therefore open to the tiled roof. No roof lining (i.e. felt) is present.

Photograph 8: Removed ceiling showing tile covering (Area A)

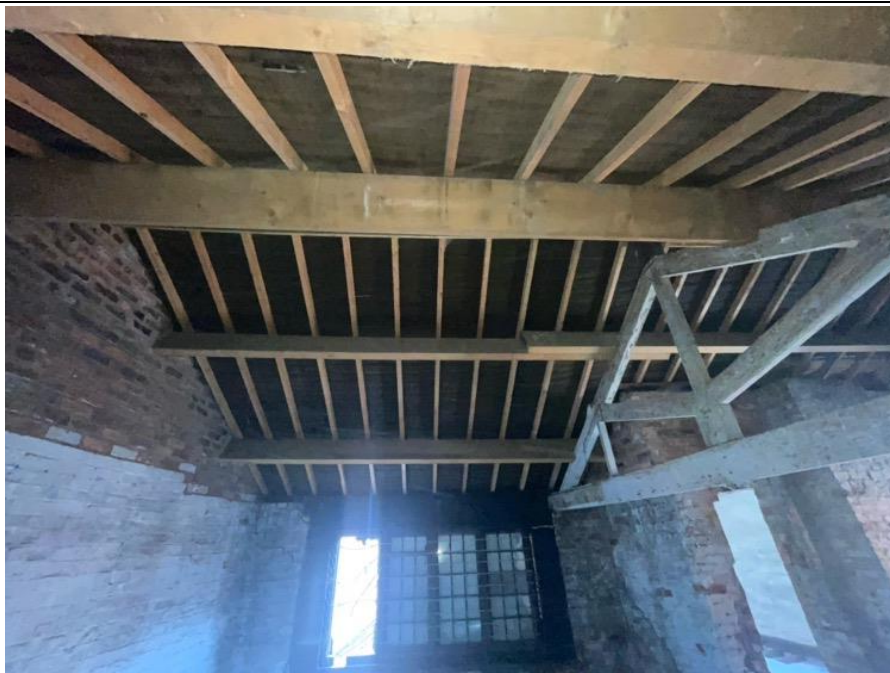
- 3.2.10. The first floor of Area B is open to the roof, with no ceiling in place. Recent repair works included the installation of new roofing felt to the underside of the tiled roof.

Photograph 9: Recently replaced roof of Area B

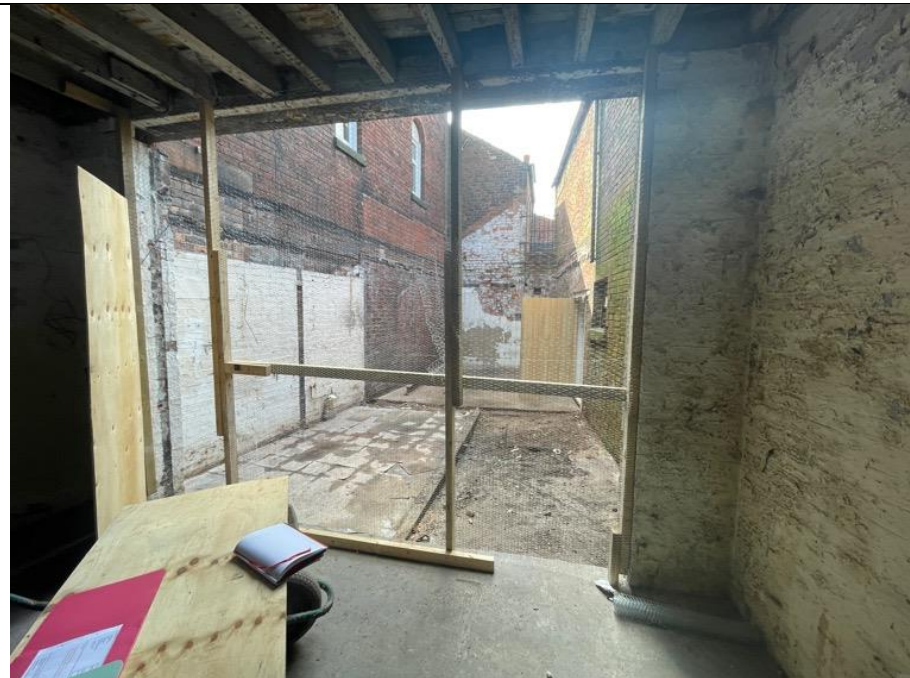
- 3.2.6. Area B is comprised of a brick built building with a single pitched and tiled roof. There is a large opening (currently sealed with mesh) on the ground floor of the south facing aspect, with a smaller meshed window on the first floor. Access to this area is made via a doorway on its western end. There is also a small (meshed) window on the western end of Area B. The northern and eastern aspects of Area B abut to adjoining (off-site) buildings.

Photograph 10: Opening in Area B to small courtyard.
