# GEOSHIELD Verification Report

GEO101290

Eaton Grange

AREA SURVEYED: Roadside Wing & Plant Room

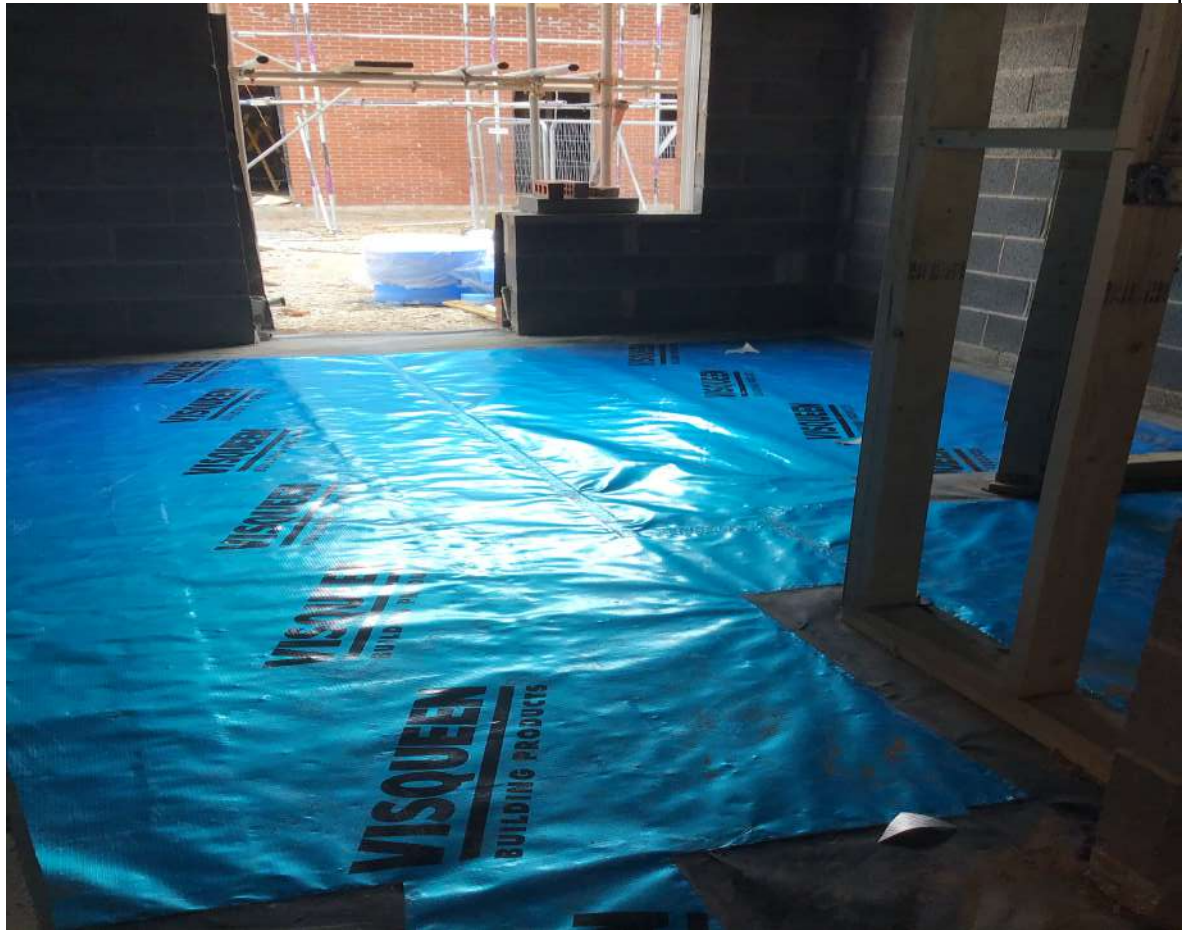
Overview photo looking into a completed room, all sealed using the

Visqueen standard gas barrier over block beam flooring.

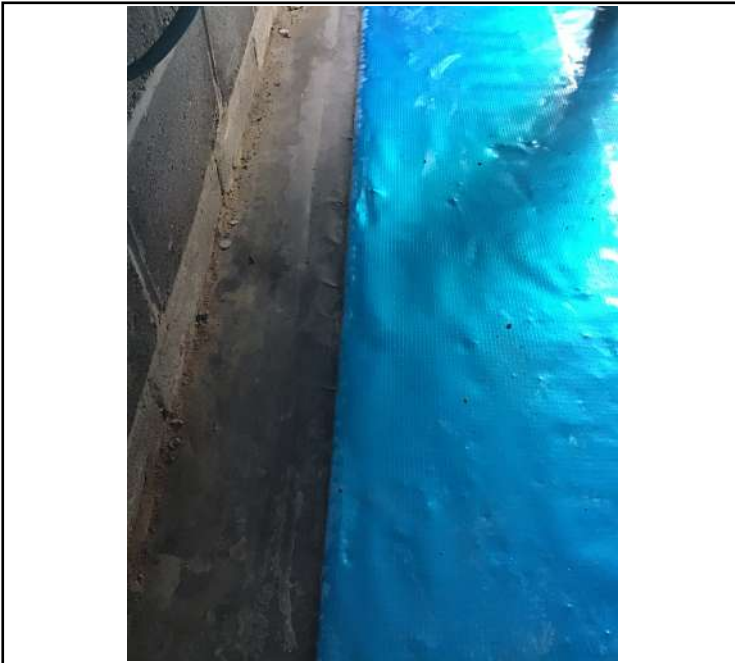
Picture one: is overlooking where the Installers have attached the Visqueen Standard gas barrier to the GR DPC, the installers have hand welded this by using the leister gun.

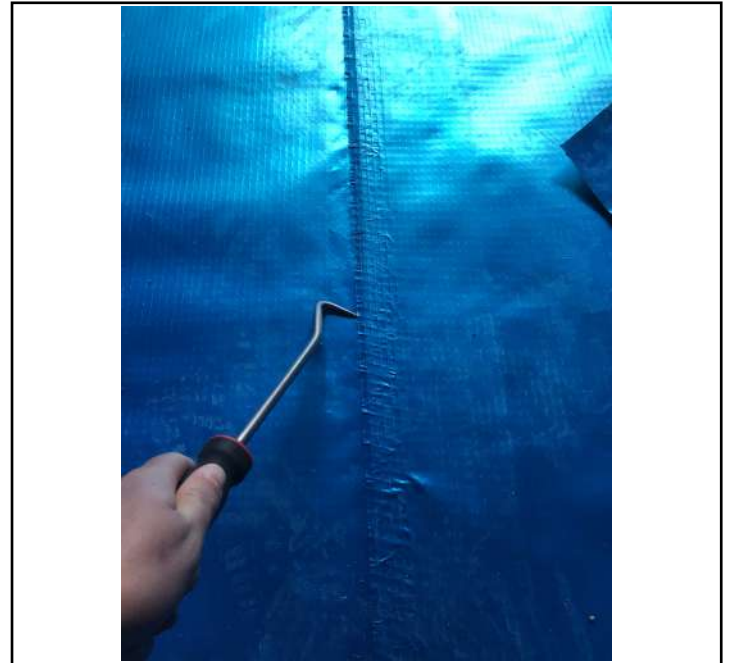
Picture two: is showing that pick probe testing was carried out to the welded lap joint,

No faults were detected.

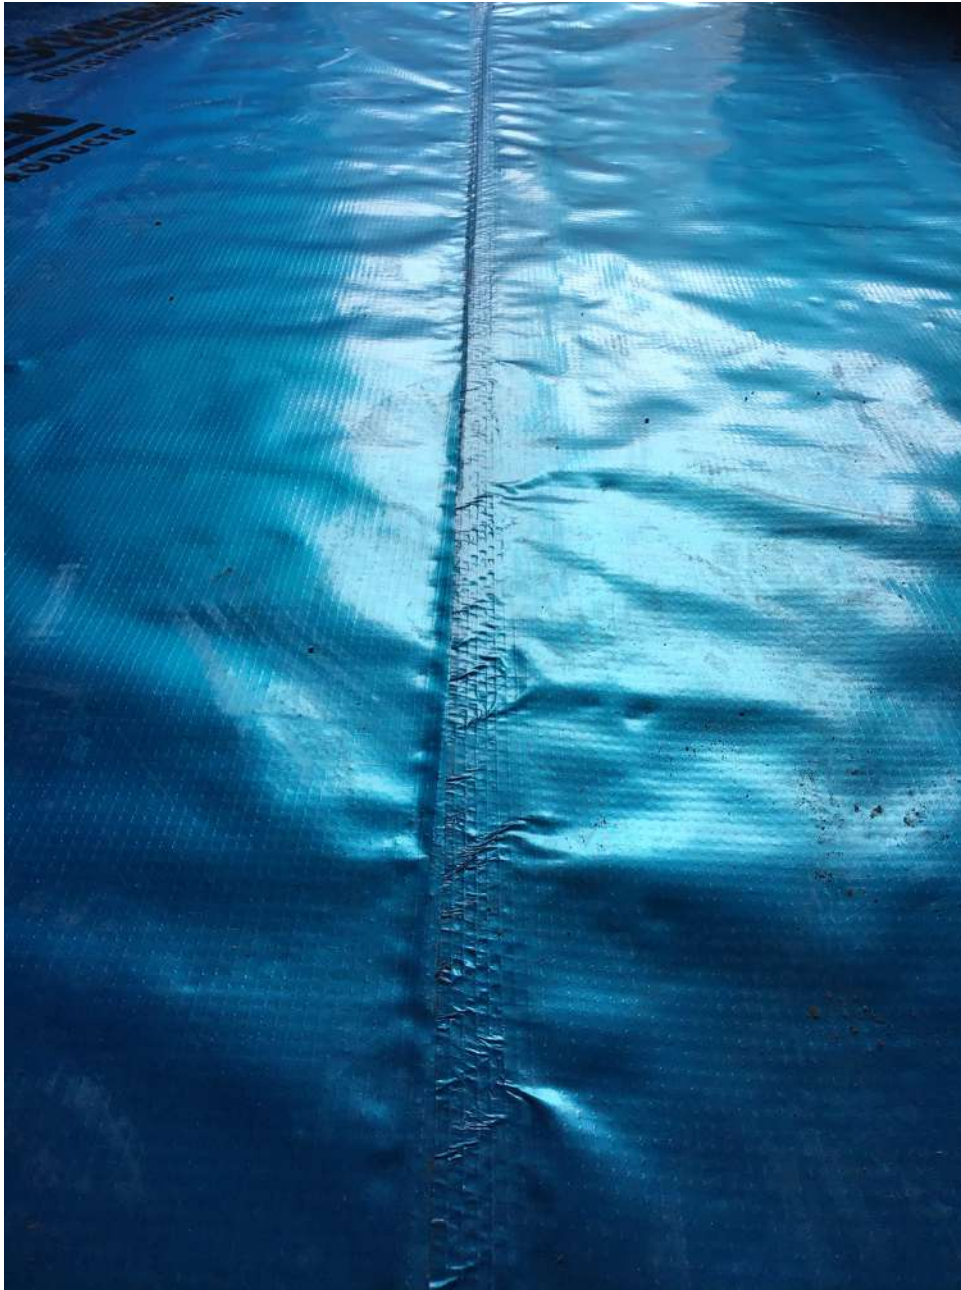
The above photo is an overview looking down a welded lap joint, the installers have maintained a consistent 40mm weld joint.

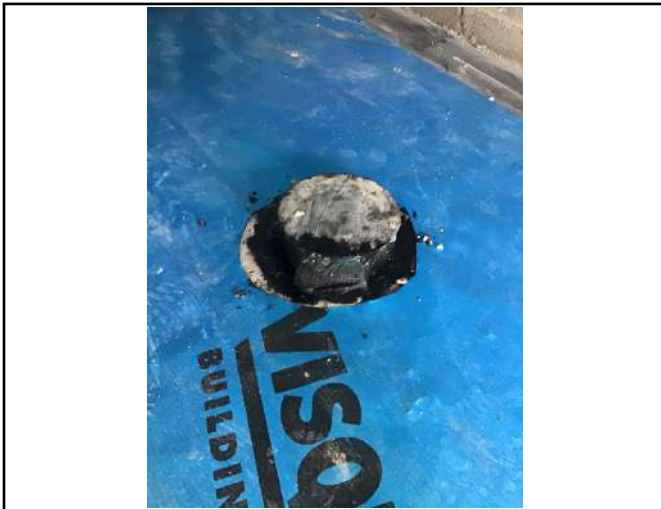
Picture one: is showing that the installers have applied the Visqueen standard

Gas barrier around this pipe detail and HP primer has been coated around the  
pipe.

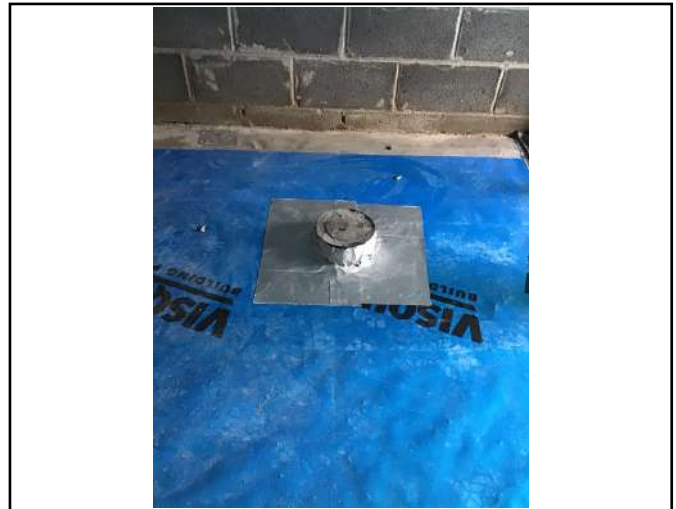
Picture two: is showing a fully completed pipe penetration detail, the

installers have applied the GRSAM all around this detail, all heated down with

the leister gun.

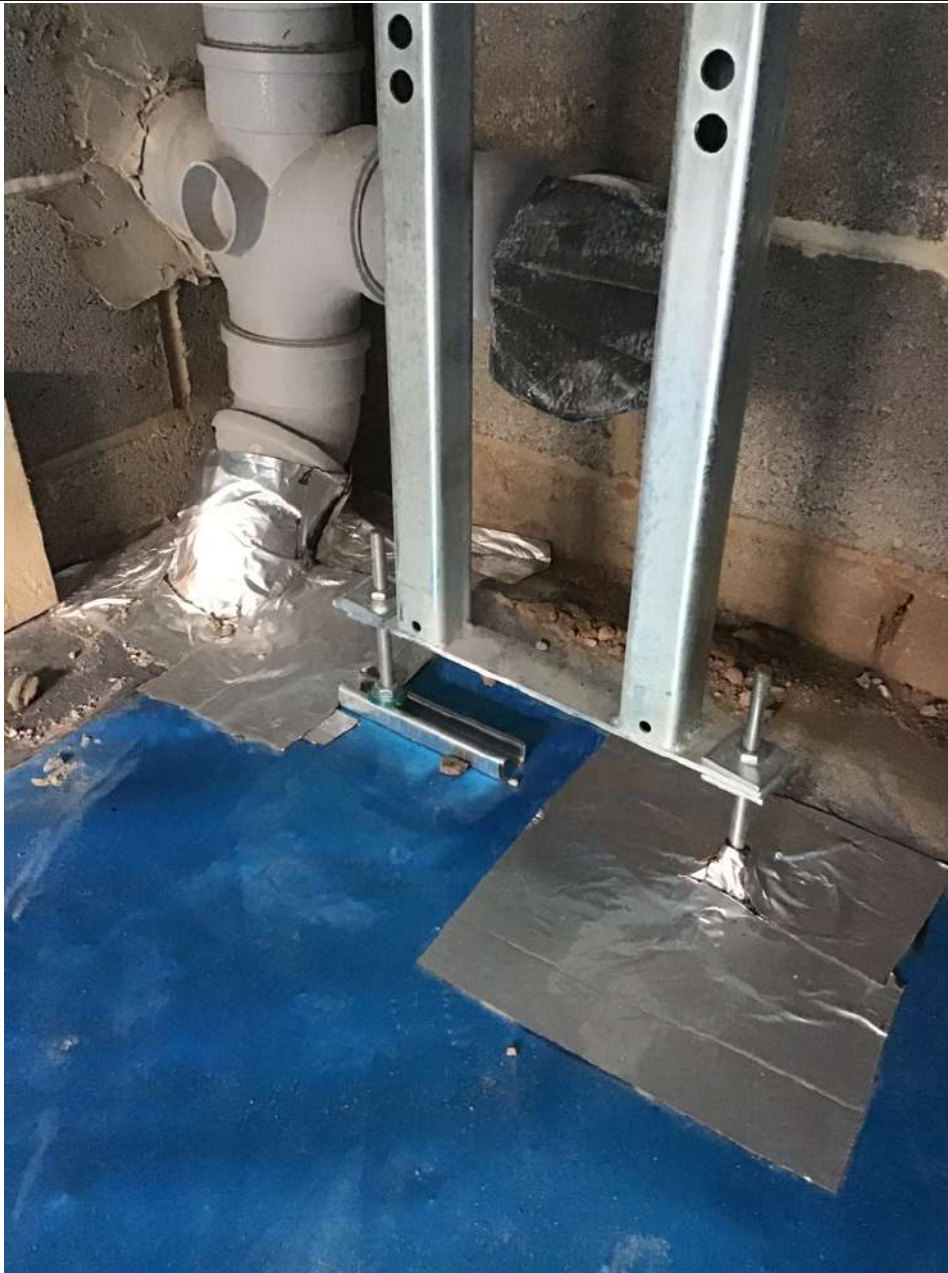
The above photo is showing a completed pipe penetration detail,

All areas have been fully sealed and heated down.

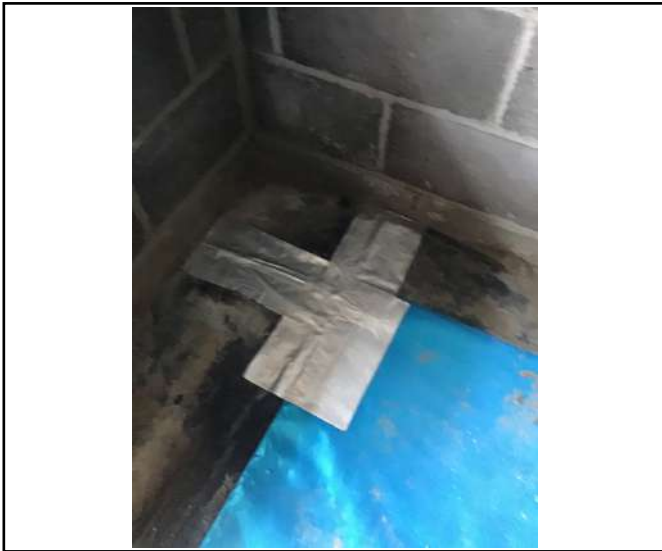
GRSAM applied to the DPC.

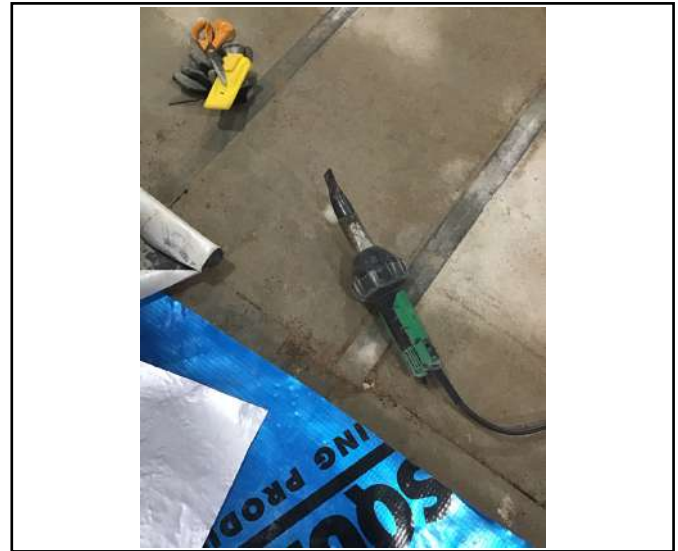
Heat source being used.

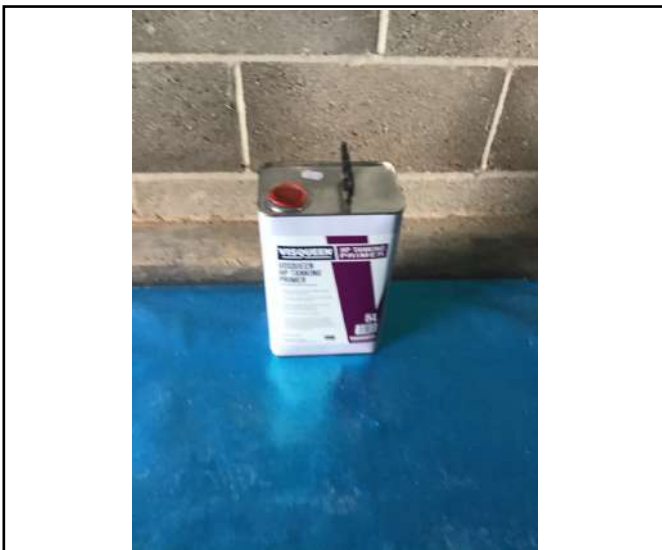
Visqueen HP Primer used.

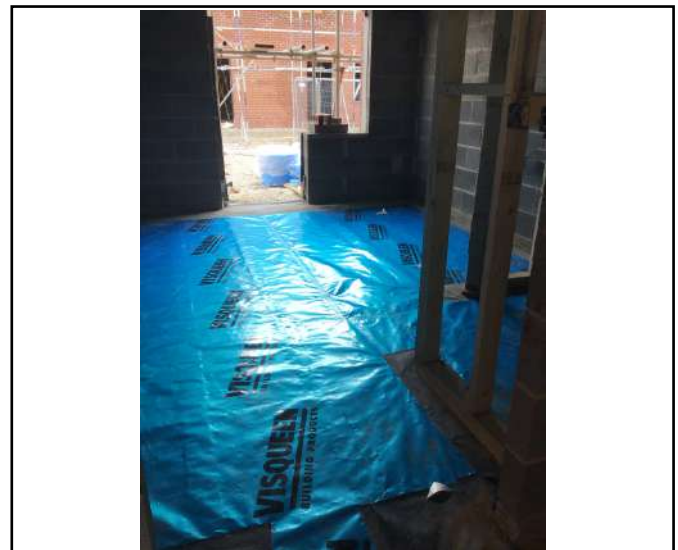
Overview photo of a completed.
