## Verification Report

GEO101290

002

Eaton Grange

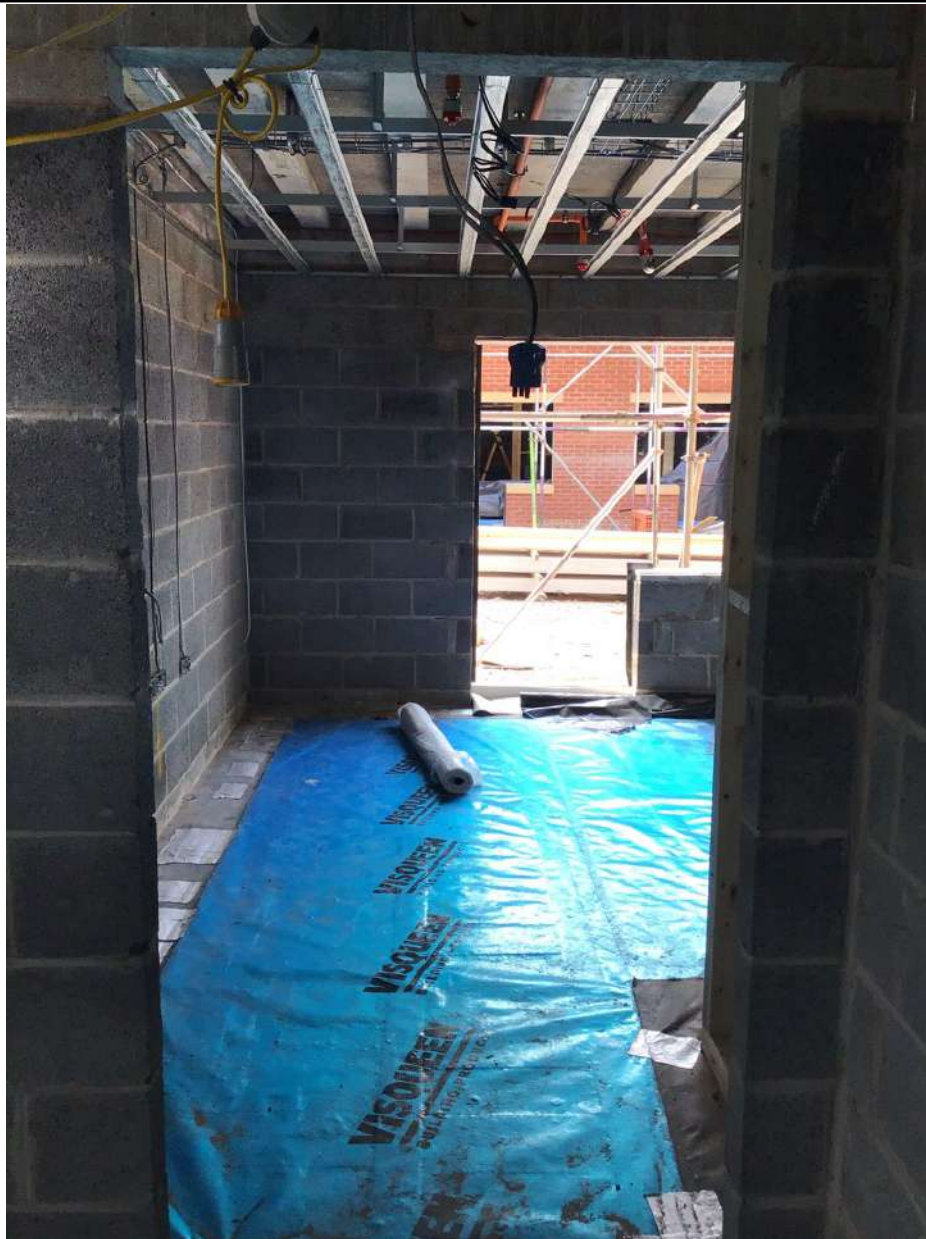
Overview photo looking into a completed room, sealed with Visqueen Standard

Gas Barrier

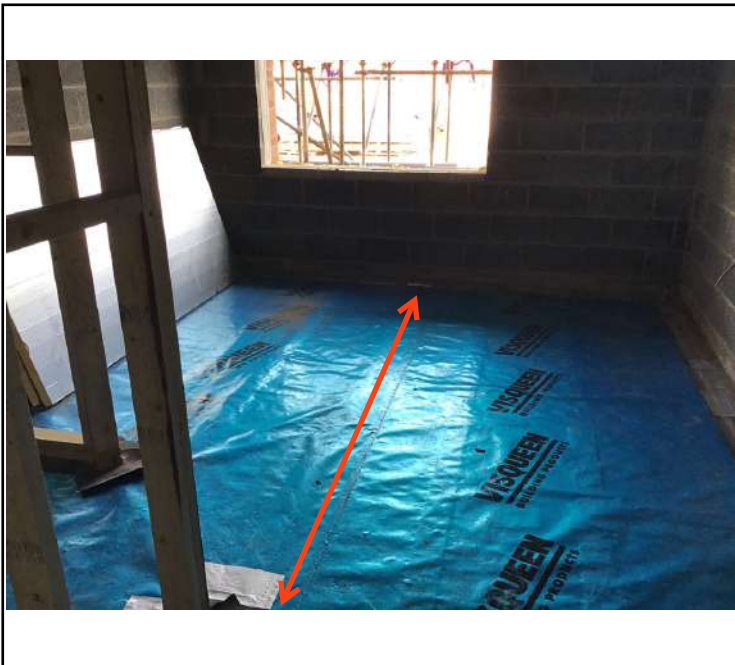
NOTES: Welded lap joints.

Visqueen Standard Gas Barrier has been installed through out the verified area. Overlaps have been created and sealed using a leister. The membrane has also been sealed to the GR DPC using a leister.

Left photo) overview of room, red arrow shows welded lap joint

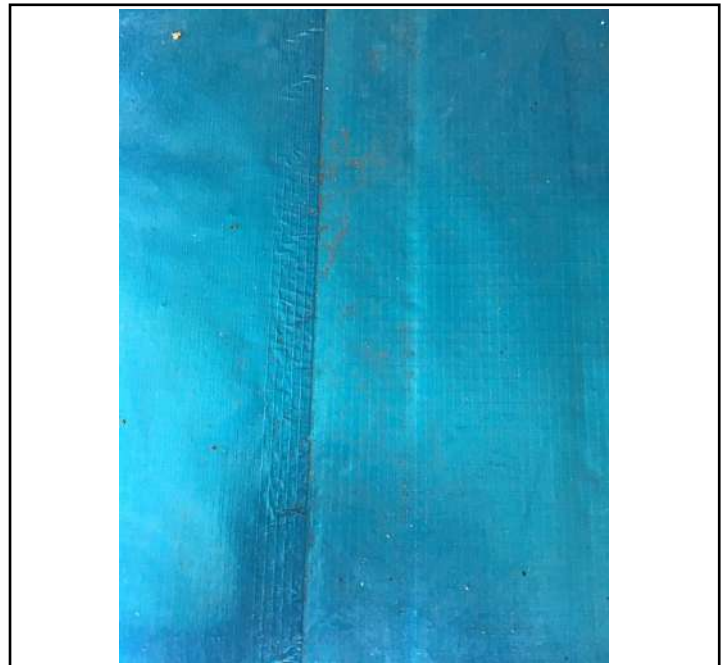
Red photo) close up of welded lap joint

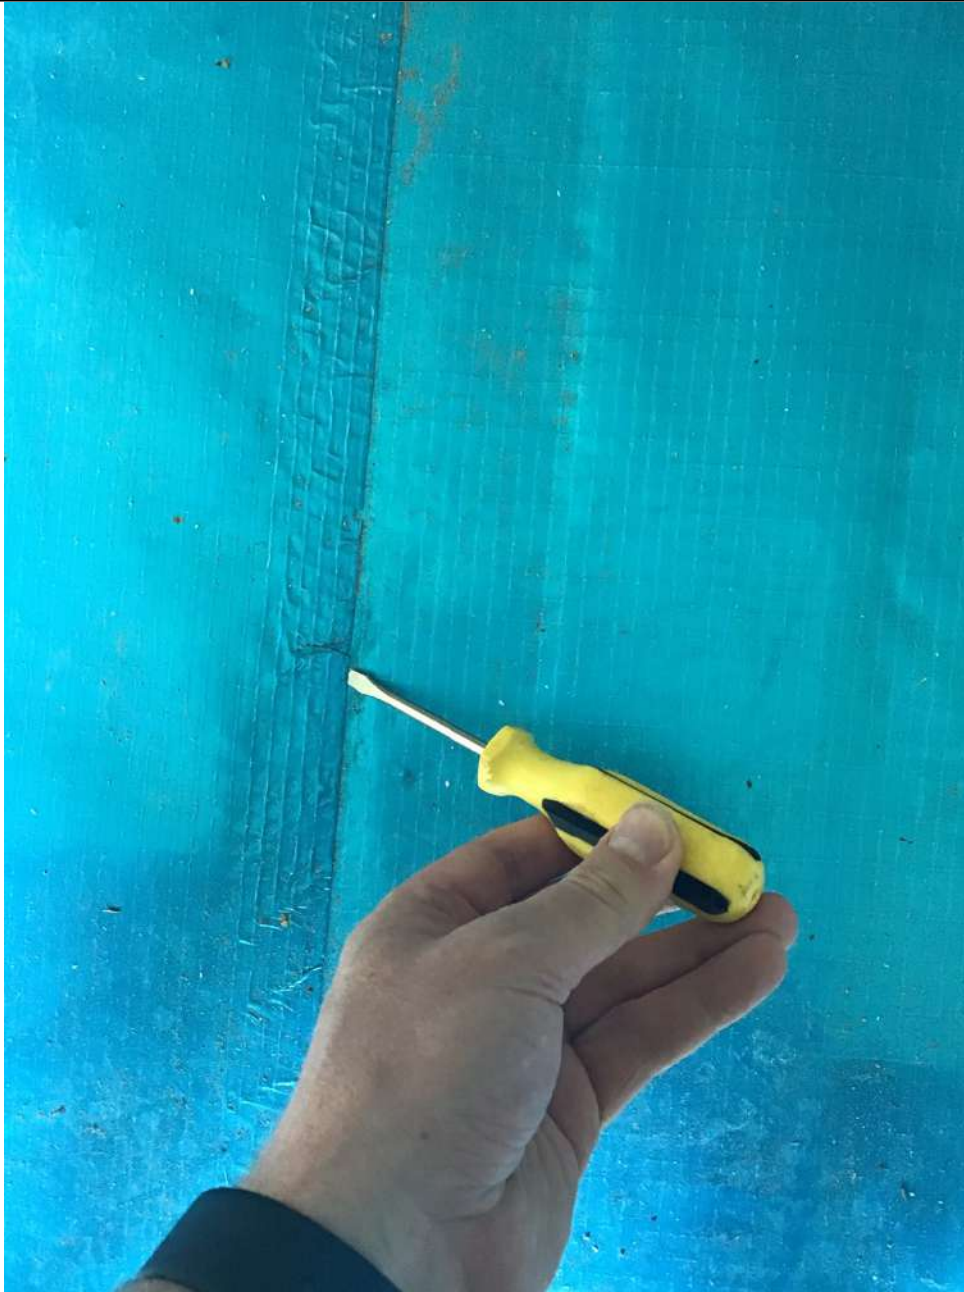
Above photo) this shows a pick and probe test carried out on the welded lap joints

of Visqueen Standard Gas Barrier.

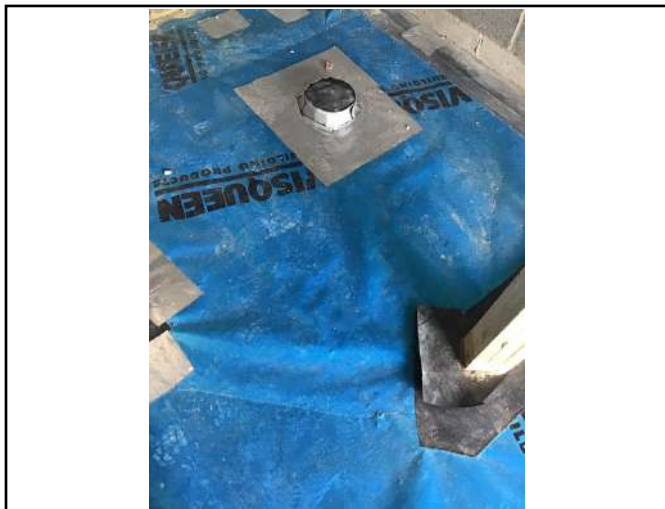
NOTES: Pipe penetrations.

Pipe penetrations have been sealed using Gas Resistant Self Adhesive Membrane, the bitumen sided has been heated using a leister for it to be activated. It has then been applied to the pipe.

Left photo) overview of pipe penetration, sealed with Gas Resistant Self Adhesive Membrane. Visqueen Standard Gas Barrier sealed to GR DPC also visible.

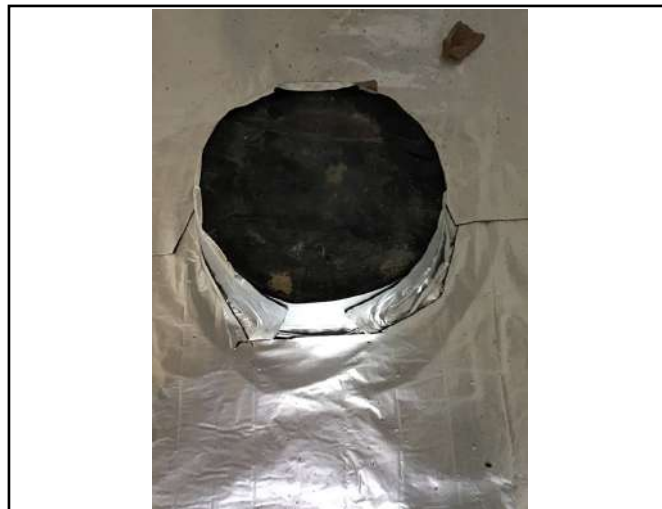
Right photo) close up of sealed pipe penetration

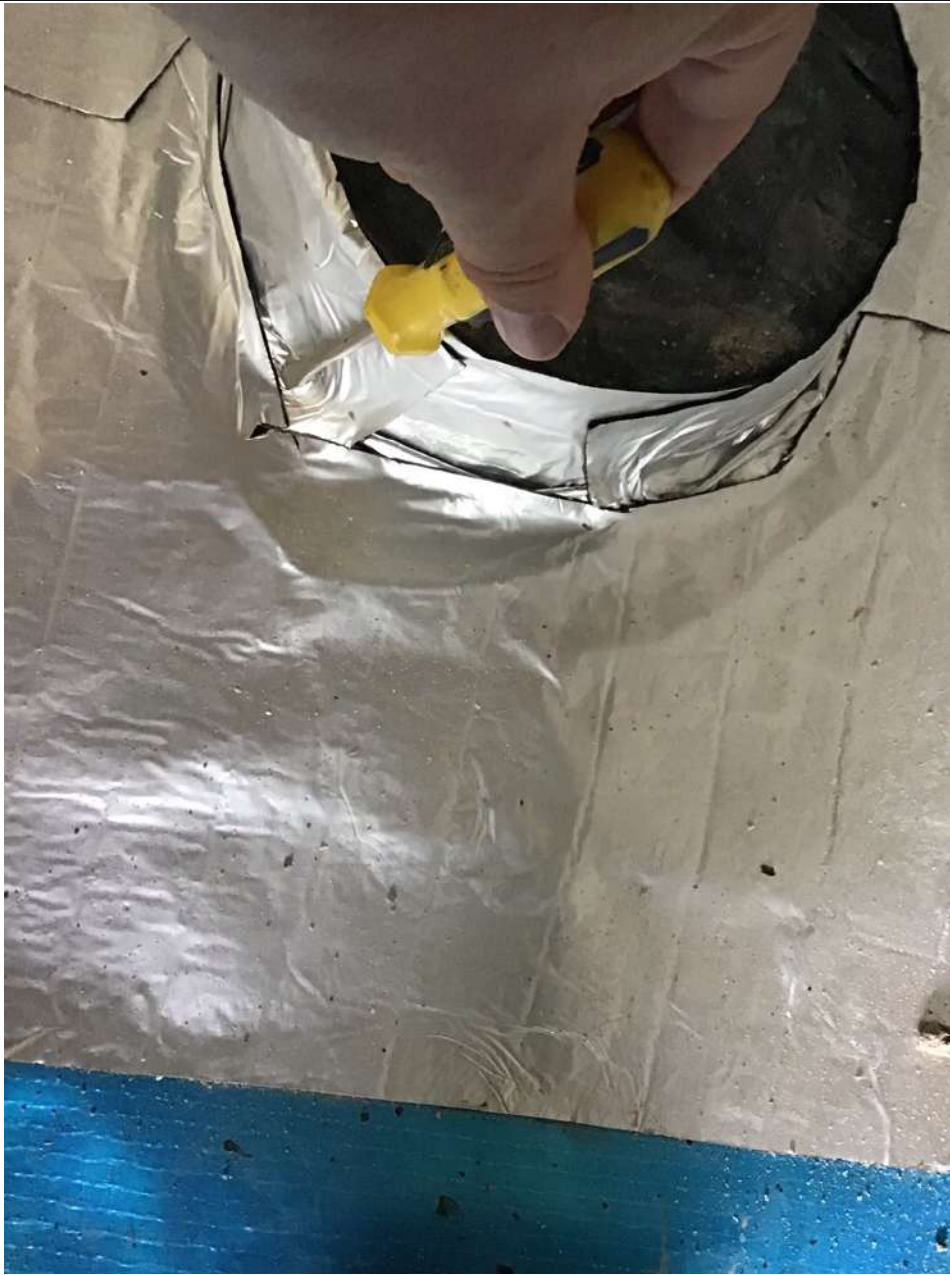
Above photo) a pick and probe test was carried out on the sealed pipe penetration

to ensure that a strong seal was created.

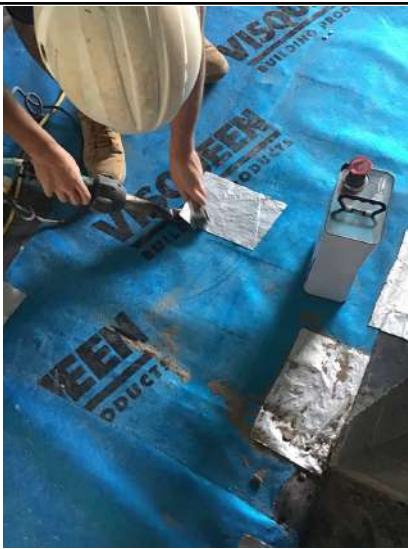
Hole found remediated on site

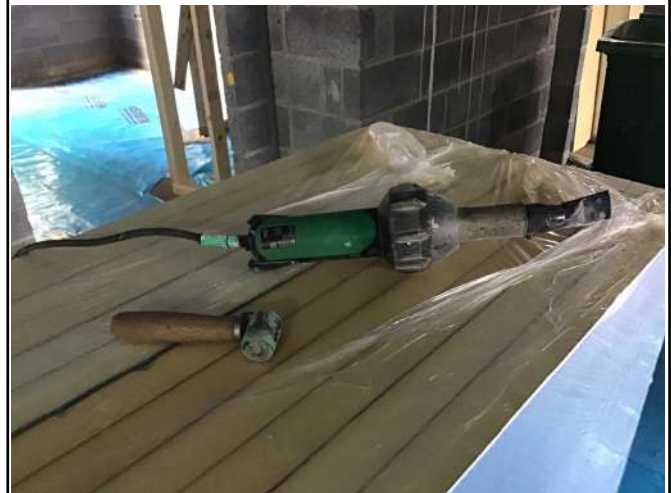
Heat source being used.

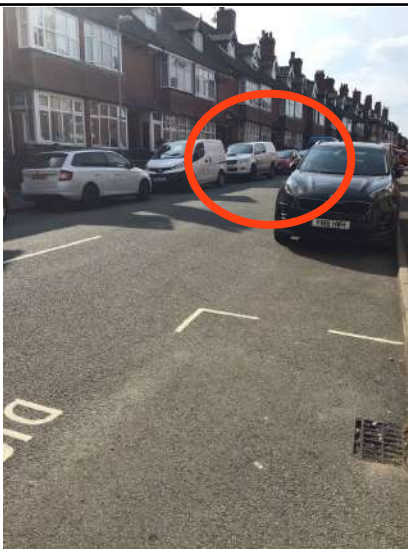
Air lancing not possible
