**Holly House– Structural Appraisal (Class Q)**

Project No: 2477

## **STRUCTURAL APPRAISAL REPORT STABLE CONVERSIONS (Class Q)**

**Holly House,  
Cheddleton,  
Staffs,  
ST13 7BH**

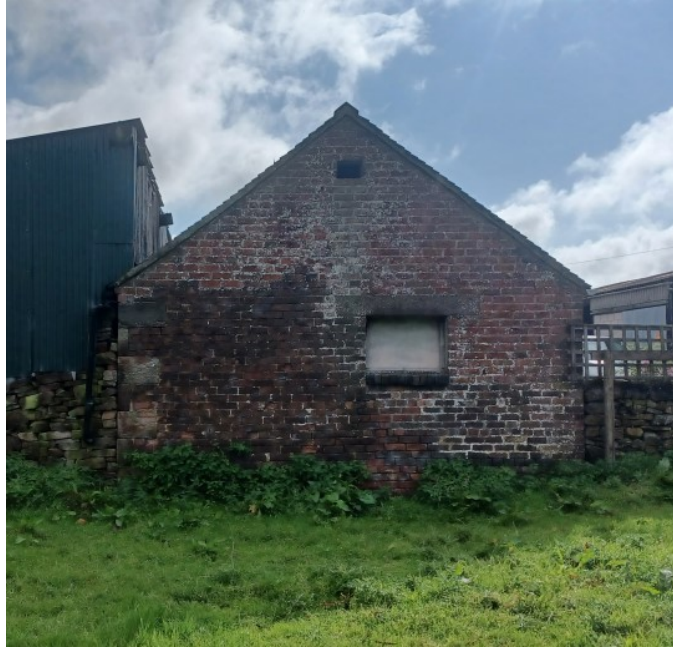
**Photo 1: West Elevation**

A 225mm brick single storey gabled masonry wall is present with a stone corner on the north junction. This wall has become weathered and will require repointing and replace a small number of spalled bricks. The internal drain within the concrete slab, exits the building in the middle of this elevation, which has caused the majority of the issues to the brickwork. 1 window is present to the elevation which has been boarded up, but, it has a 250mm deep concrete lintel over.

The ground across the elevation slopes away from the yard towards the covered timber store. All the ground along this elevation is lower than elsewhere, and is below the internal slab finish level.

The walls are generally in a good condition, with minor repairs required to one corner where the stonework meets the brickwork, and the west elevation that has become weathered.

The discharge of water out this elevation should be prevented.

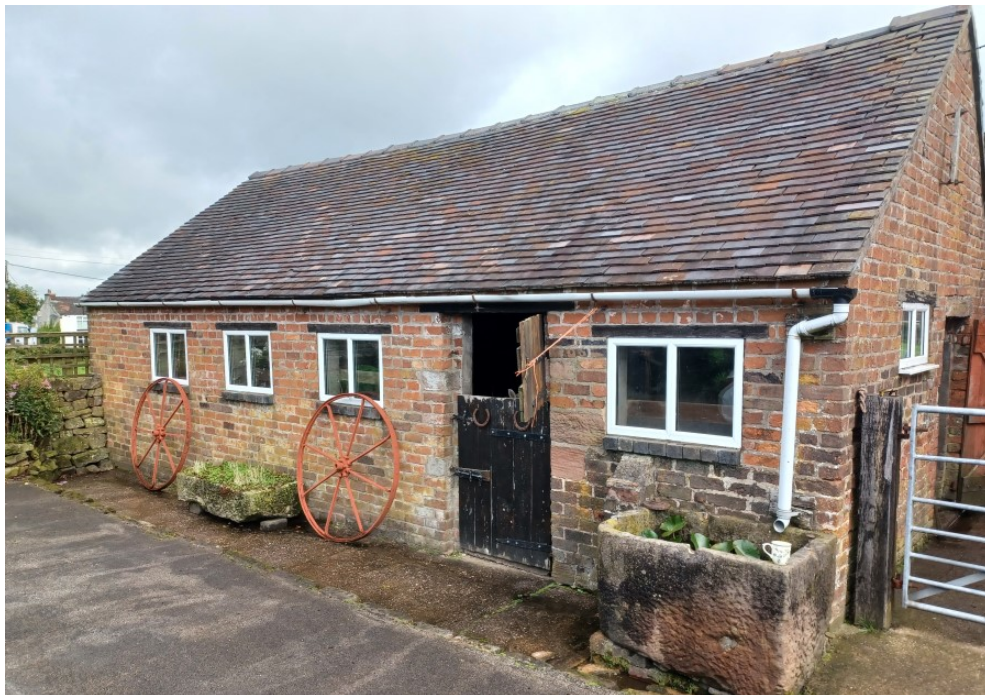
A 225mm brick single storey masonry wall with a tiled pitch roof over. The masonry is in a reasonable condition and has a small buttress to the right of the door where a concrete water butt is situated. No structural issues are present to the wall or roof.

1 door and 4 windows are present, all with timber lintels over.

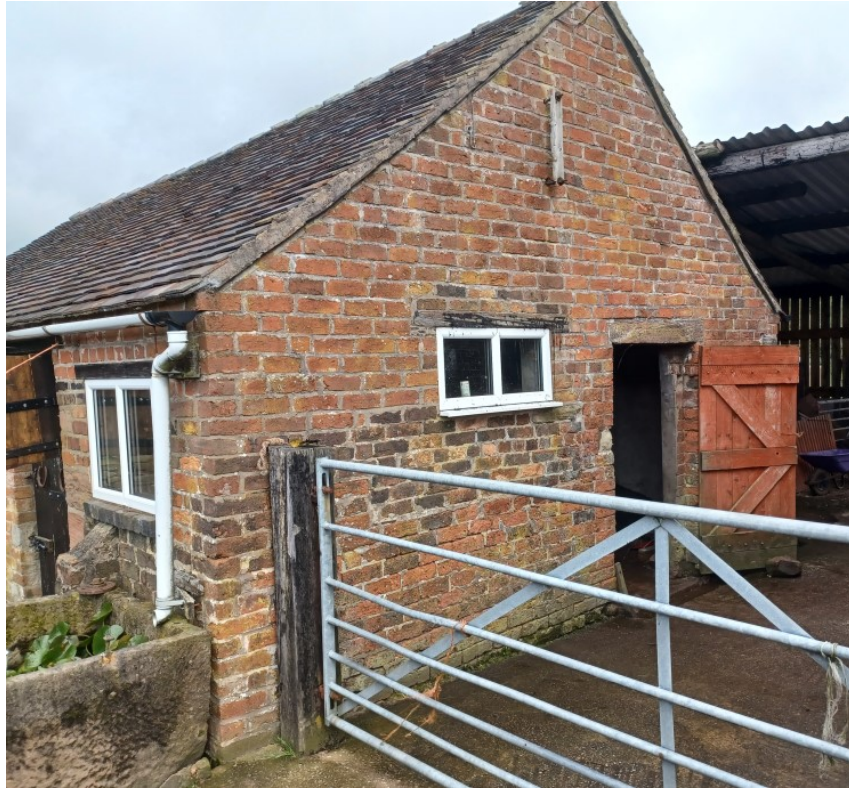
**Photo 3: East Elevation**

A 225mm brick single storey gabled masonry wall is present with a stone corner on the north junction. The top section of the stone/brickwork has a small crack within the mortar.

1 door and 1 window are present to the elevation with a timber lintel over the window and a 170mm deep concrete lintel over the door.

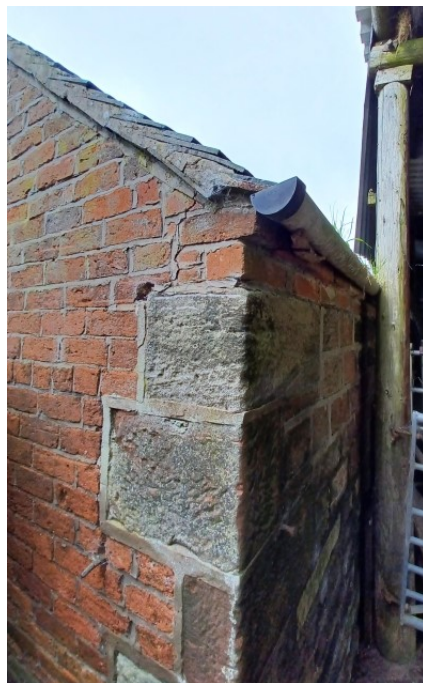
**Photo 4: East / North Elevation showing corner (crack to mortar)**

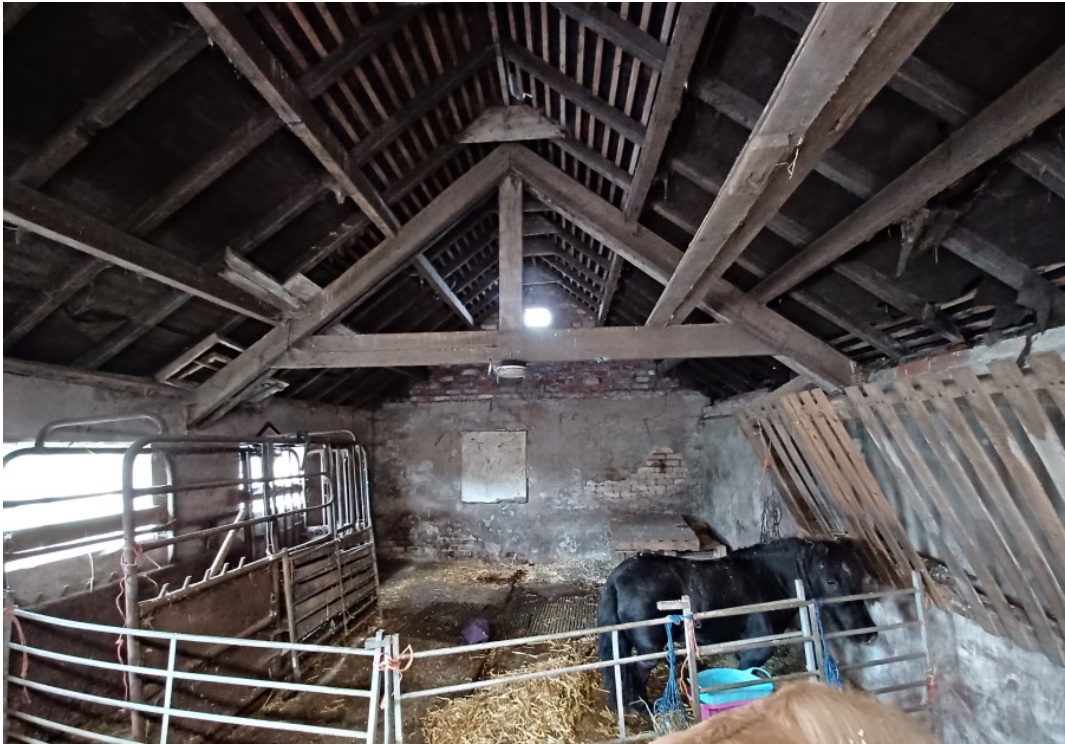
**Photo 5: Internal**

The walls appear to be 225mm solid brickwork on all sides with a plastered finish applied to the majority of the inside. A timber wall plate is present to the outer section of the south and north walls. The middle section of the wall plate on the north side wall is missing / broken and will need to be replaced with the rafters fixed over.

A concrete ground floor slab is present which slopes gently towards a middle channel that is cast within the slab.

The stable concrete slab, which is not an integral part of the structure, would not meet modern standards. This would require insulation and a dpm. This individual element will need to be taken out or upgraded.

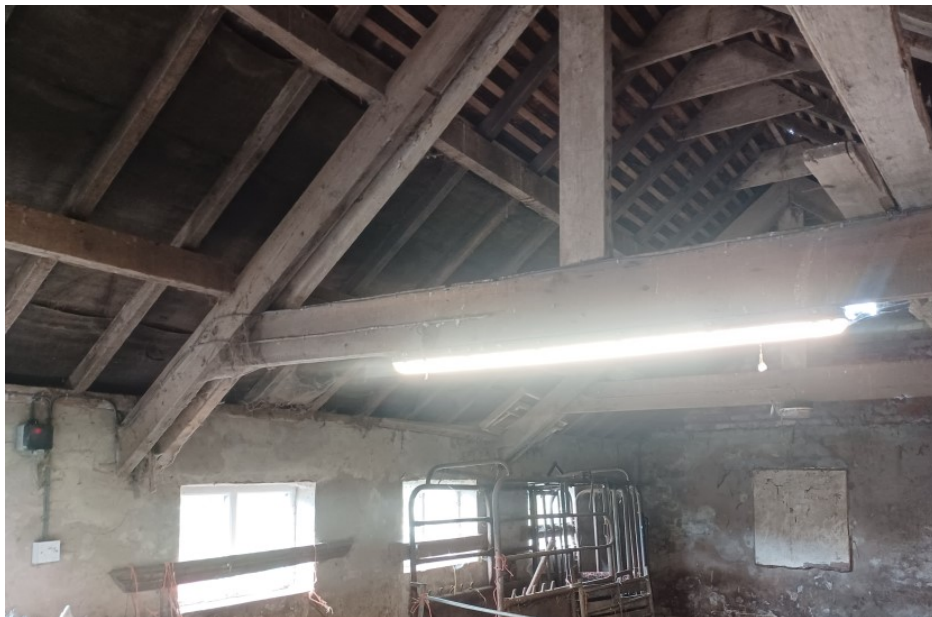
The stable roof is constructed from 75x63mm timber rafters at 450mm ctrs with 2 No 125x75mm timber purlins each side of the roof slope. 2No king post trusses are then present at 1/3 spans, the trusses are made up from 2No 175x63mm timber rafters with a central 220x63mm timber bottom boom and 150x63mm middle vertical post. All the structural roof members are in a reasonable condition.

**Photo 6: View of truss**

The roof structure is in a good condition, therefore suitable for the proposed conversion. Providing the proposed roof materials don't exceed the load of the existing materials, no further structural checks would be required. The section of wallplate to the north elevation should be replaced.

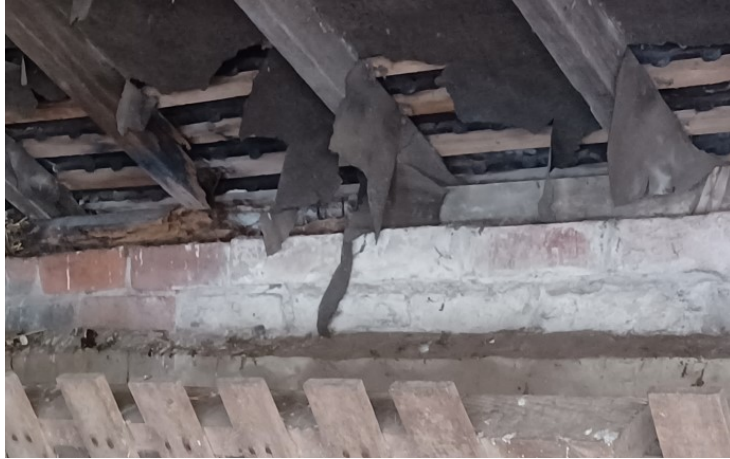
**Photo 7: Damaged wallplate**
