## **Structural Inspection Report**

Barns A & B  
Marshfield Gate Farm  
Marshfield Lane  
Gillow Heath  
Staffordshire  
ST8 6RG

**Date of inspection: 26<sup>th</sup> May 2023**

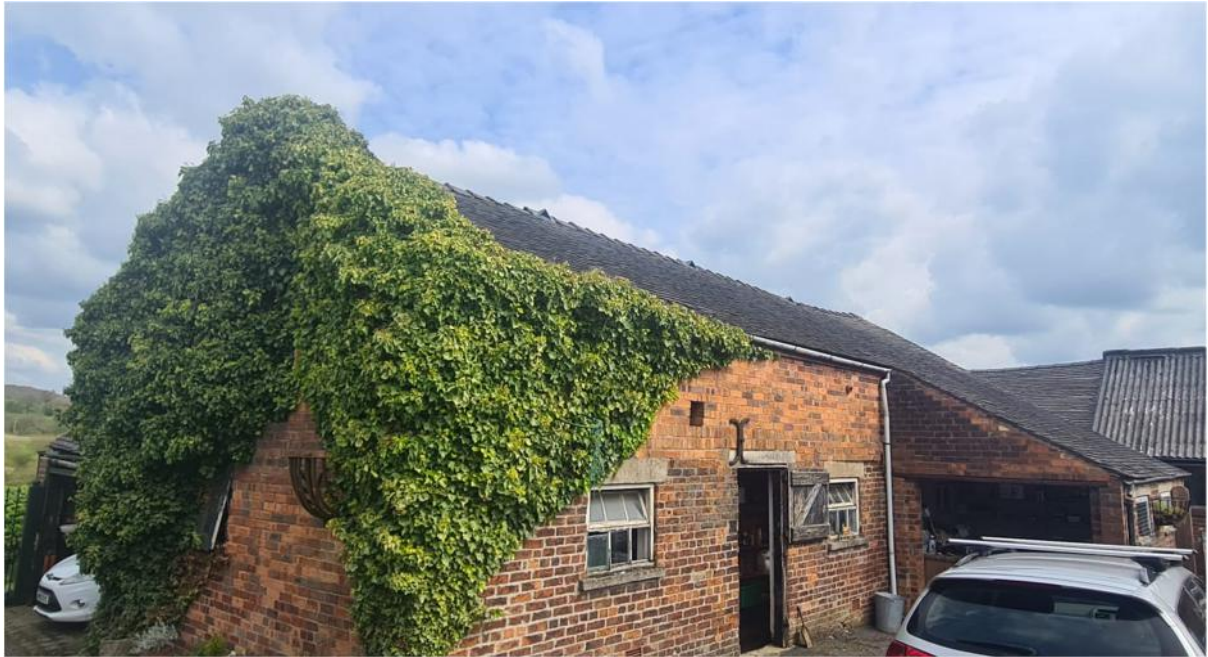
The front elevation is covered by a substantial amount of common ivy (*Hedera Helix*) which has limited the extent of the inspection to this elevation. The exposed areas however, do not show any signs of severe or significant structural defects. However, I would recommend that the vegetation is removed as part of the refurbishment works as there is a risk of deterioration to the fabric of the building façade and roof should it remain. The lintel over the garage door should also be replaced for a galvanised steel lintel.

Fig 1. Common ivy growth to front and righthand elevation.

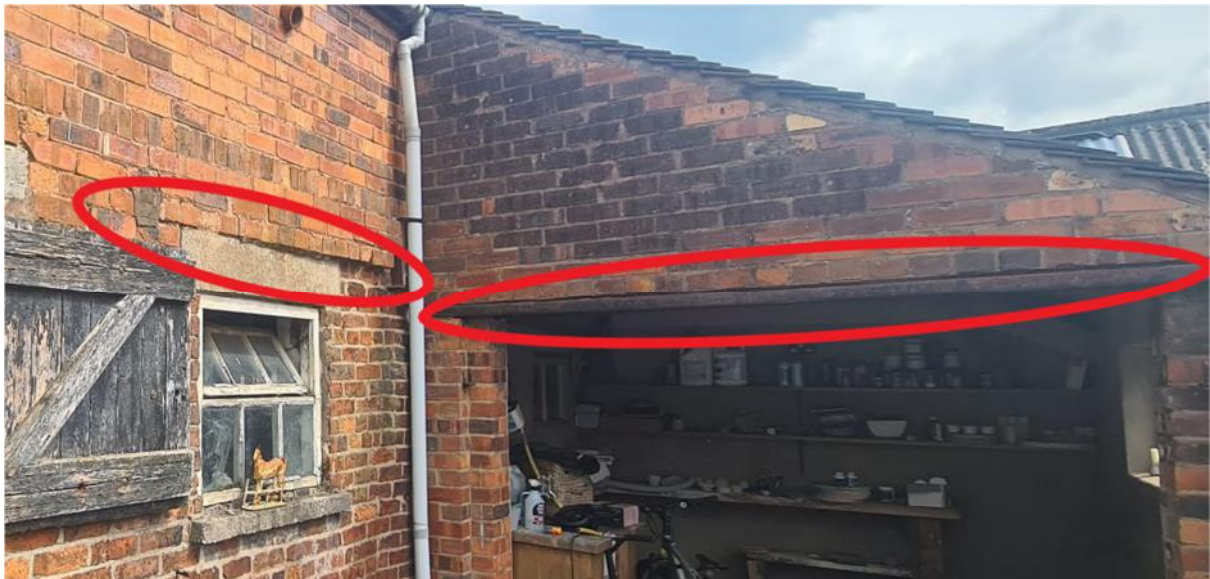
There is a store room opening which has a section of steel railway track used as a lintel to support a panel of masonry. The beam is suffering from corrosion and has begun to laminate. This should be replaced as part of any refurbishment works.

Fig 2. Corbelled brickwork over concrete lintel and steel railway track section over store room entrance.

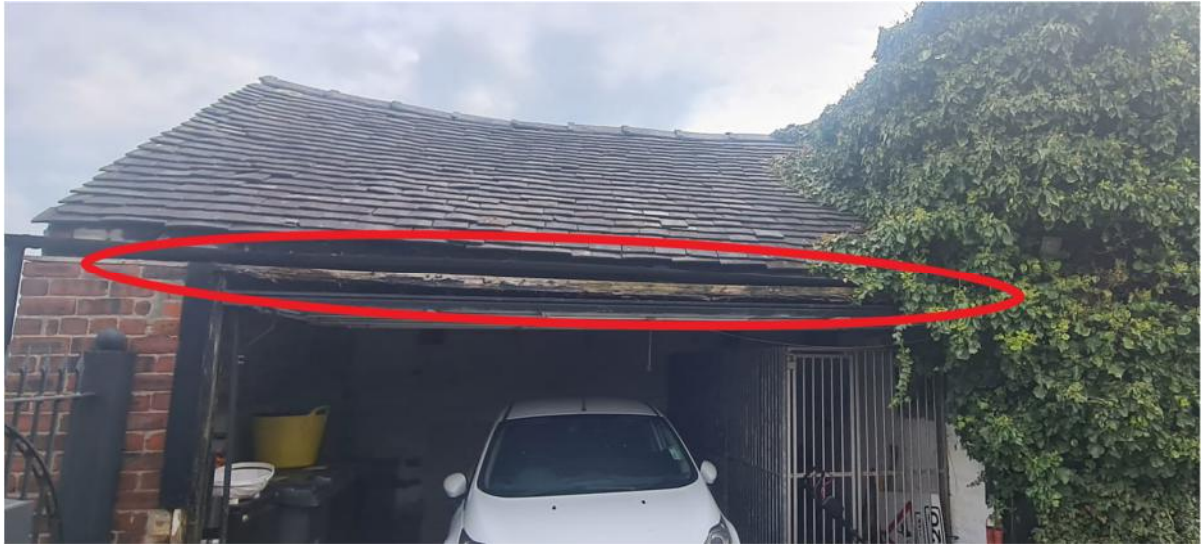
Fig 3. Front elevation where lintel has deflected and should be replaced (By CATNIC or similar approved).

1. Install crack stitching to damaged masonry sections using a Helifix Helibar and Dryfix system (See Appendix B).
2. Rake out and repoint cracked and weathered mortar joints once remedial works are completed where required in a mortar mix to match existing.
3. The steel railway track section that has been installed over the garage door opening should be removed and replaced for a galvanised steel lintel (By CATNIC CN81B or similar approved).
4. Where lintels are absent above doorways, a steel lintel (By CATNIC CN71A or similar approved) should be used.

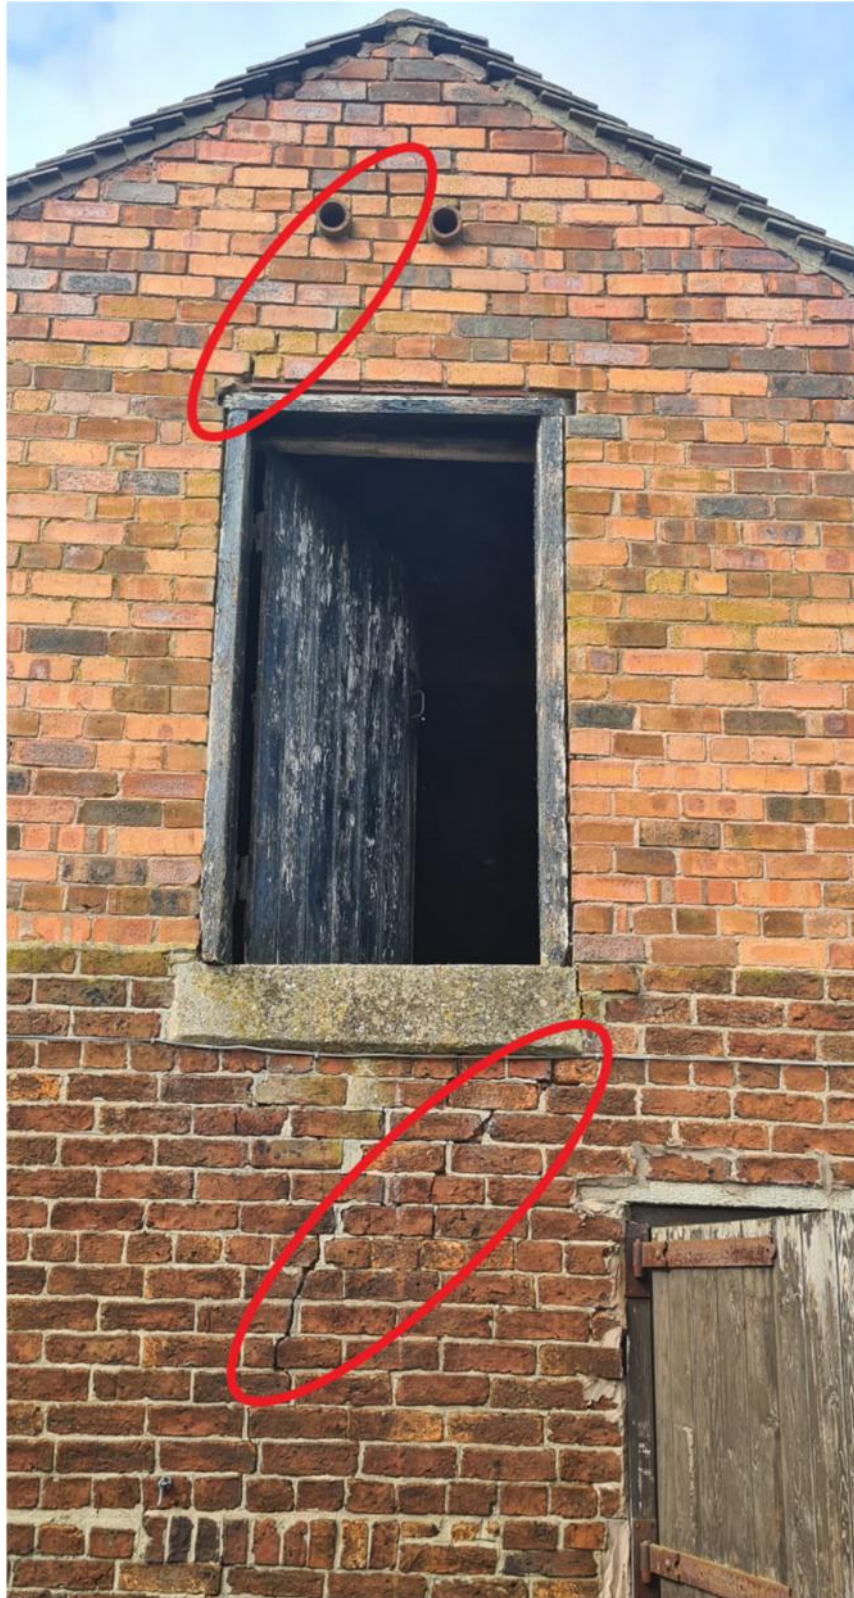
The rear elevation wall has a fine stepped diagonal crack running from the corner of a doorway formed at 1<sup>st</sup> floor level downwards and is approximately 900mm long. There is another stepped diagonal crack from the top of the doorway running up to the ridge of the roof. There is no apparent lintel installed where this doorway has been formed so would be recommended that an appropriate lintel for a solid external wall is fitted as part of the refurbishment works. The cracks appear to be historic and are not deemed to be structurally severe or significant defects.

Fig 5. Fine stepped diagonal cracks above and below doorway to rear elevation.

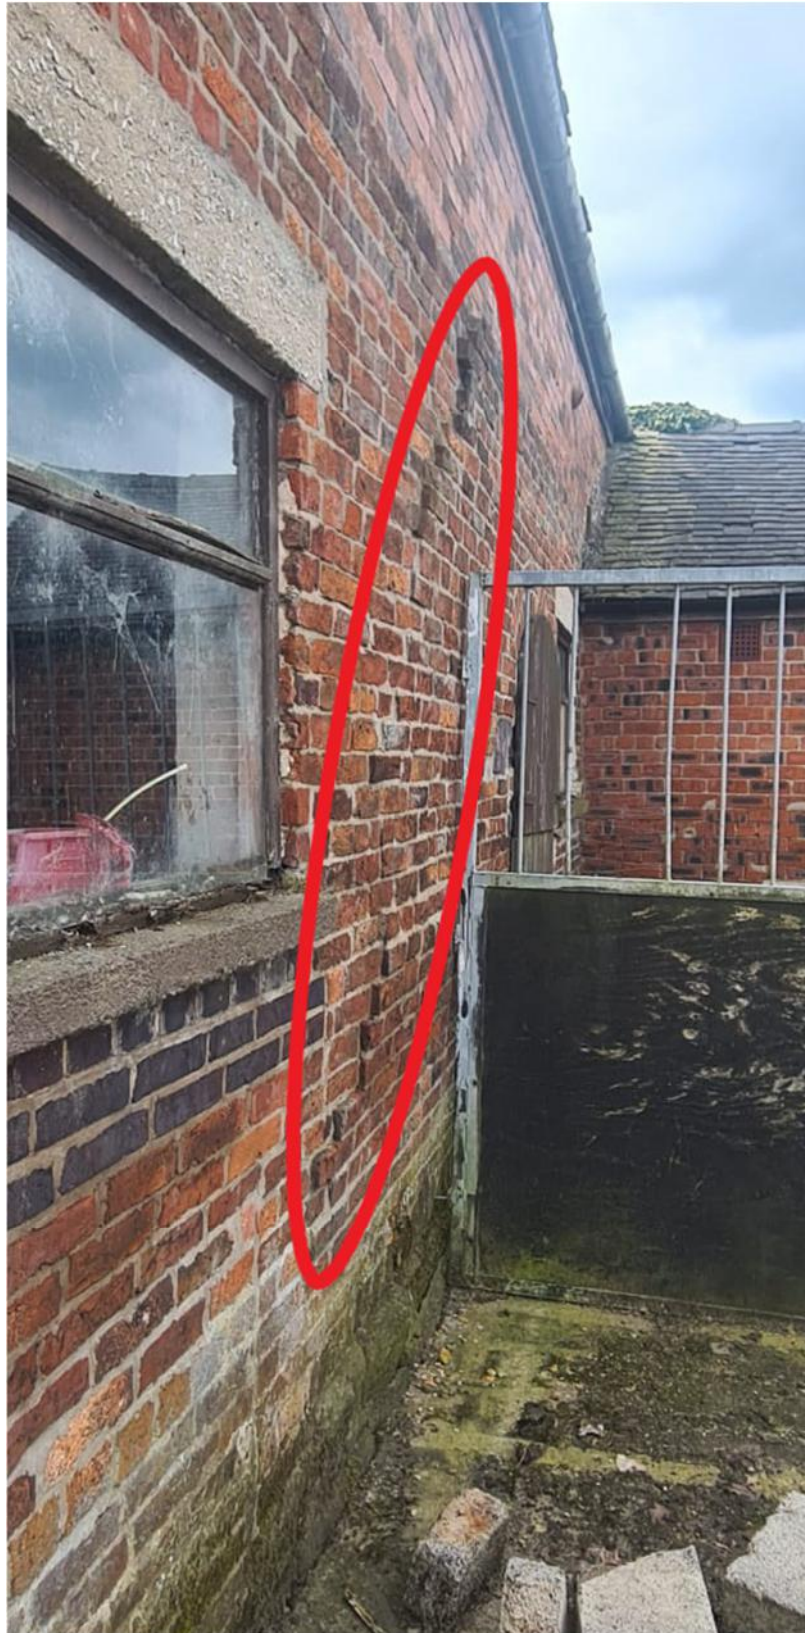
The left hand elevation runs parallel to Marshfield lane shows visible signs of lateral movement to the original ground floor level masonry. The mortar to the middle of the wall panel has allowed the right side to lean outwards creating a step in the wall panel by 25mm up to 2.4m in height. However, this does not continue above into the later era of construction (circa 1900s) which suggests that this movement is historic and is not considered to be a structurally significant defect.

Fig 6. Step in wall panel due to historic lateral movement.

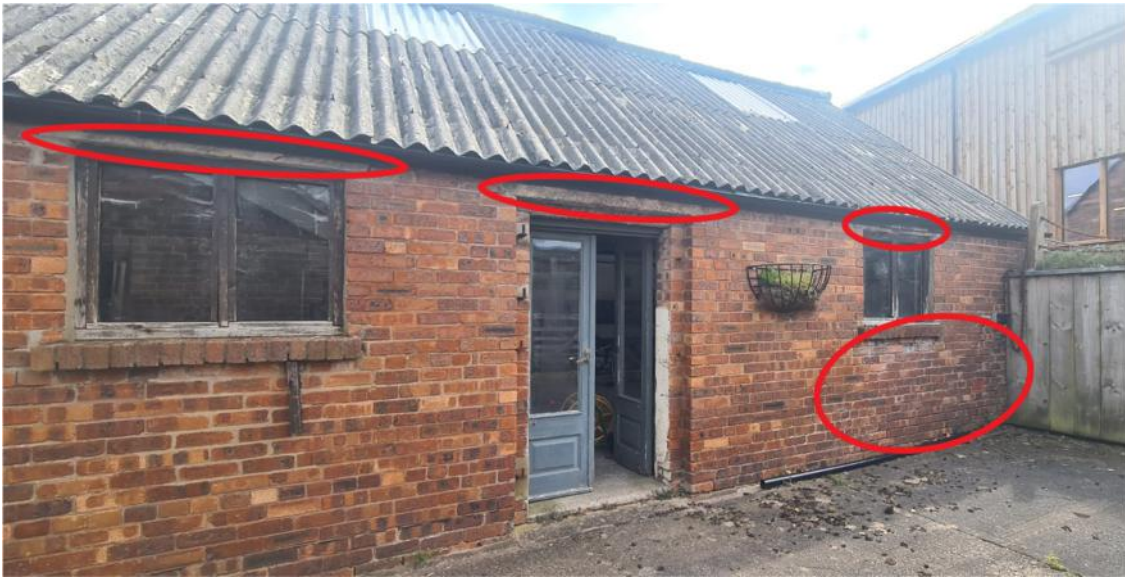
The front elevation has a series of windows and entrance door. The openings are formed with precast concrete lintels above and the windowsills have a brick on edge corbel detail. The concrete lintels have spalled in parts exposing the steel reinforcement. It is recommended that these are replaced as part of the refurbishment works.

There are areas below windowsill level where the mortar has eroded. The condition of the mortar joints should be examined further and raked out and repointed where required.

Fig 10. Front elevation. Eroded mortar joints low level and damaged concrete lintels.

1. Install crack stitching to damaged masonry sections using a Helifix Helibar and Dryfix system (See Appendix B).
2. Rake out and repoint cracked and weathered mortar joints once remedial works are completed where required in a mortar mix to match existing.
3. Damaged concrete lintels where steel reinforcement is exposed should be replaced for a new steel or concrete lintel (By CATNIC or Naylor or similar approved).
4. Where lintels are absent above doorways, a steel lintel (By CATNIC CN71A or similar approved) should be used.

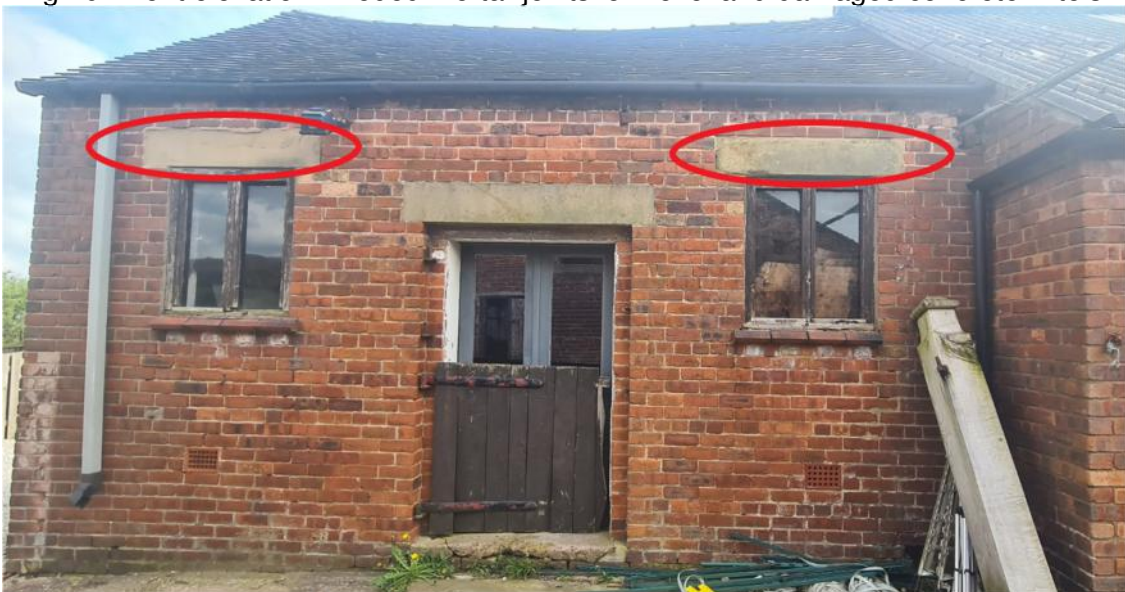
Fig 11. Left hand side of front elevation. Weathered face to stone lintels.

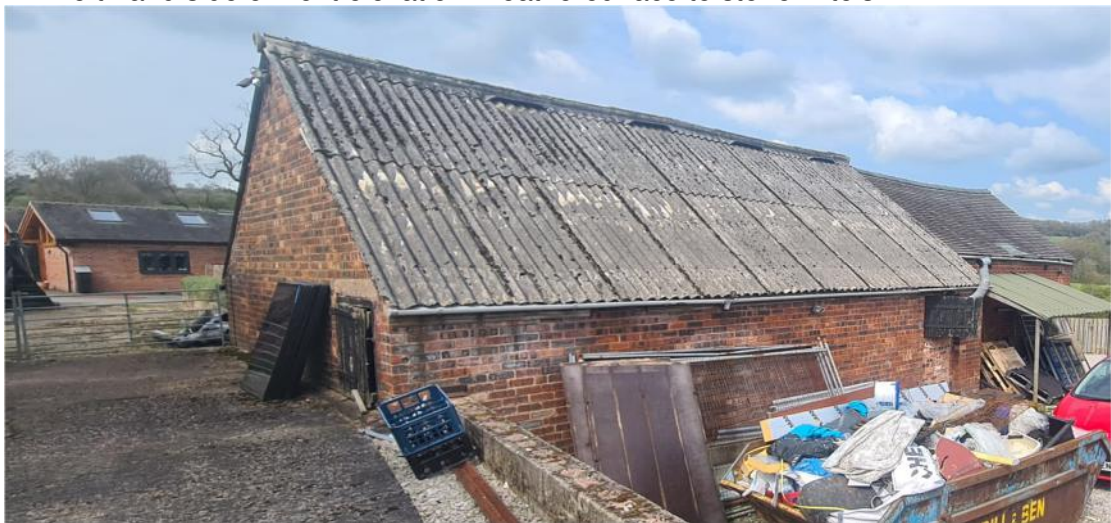
The righthand elevation wall acts as a retaining wall to approximately 1m high along its length where an access road runs parallel. There are some fine horizontal cracks at approximately the level of the road internally close to where a window opening has been formed. This area should be locally rebuilt and made good.

Fig 12. Rear and righthand elevation showing raised level access road.

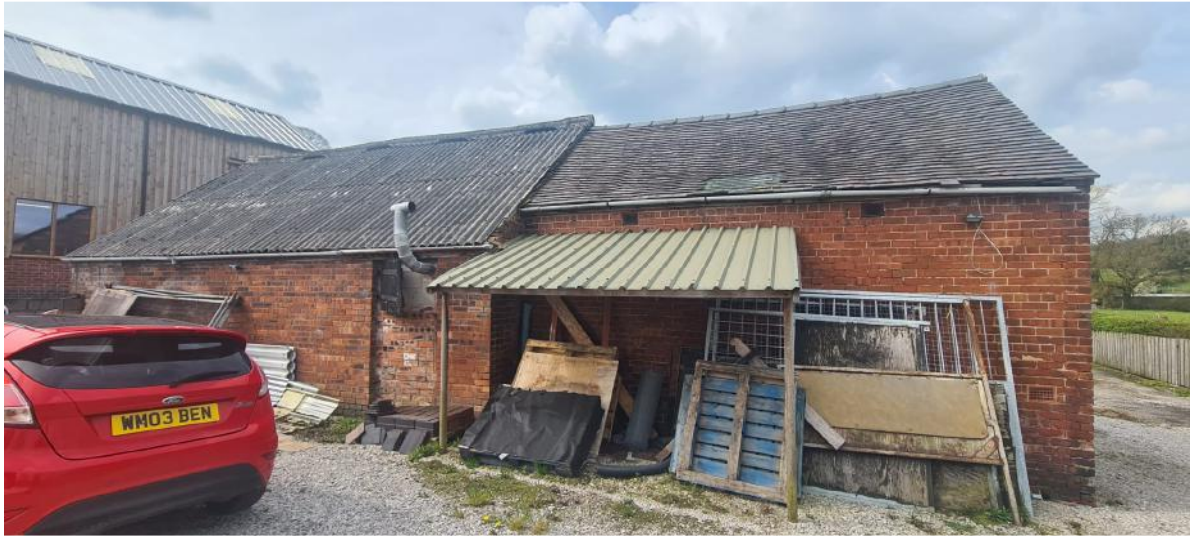
The rear elevation has a temporary lean-to timber structure fixed to the perimeter wall. A doorway has been poorly infilled with brickwork and should be made good to match. The rear right side wall has bowed outwards by approximately 40mm. This is believed to be as a result of deflection in the roof applying lateral force to the top of the wall. As part of the remedial repairs to the roof, an allowance to take down and rebuild this section of wall to straighten and level it should be considered.

Fig 13. Rear elevation. Doorway partly blocked up with bowed wall panel where lean to is.

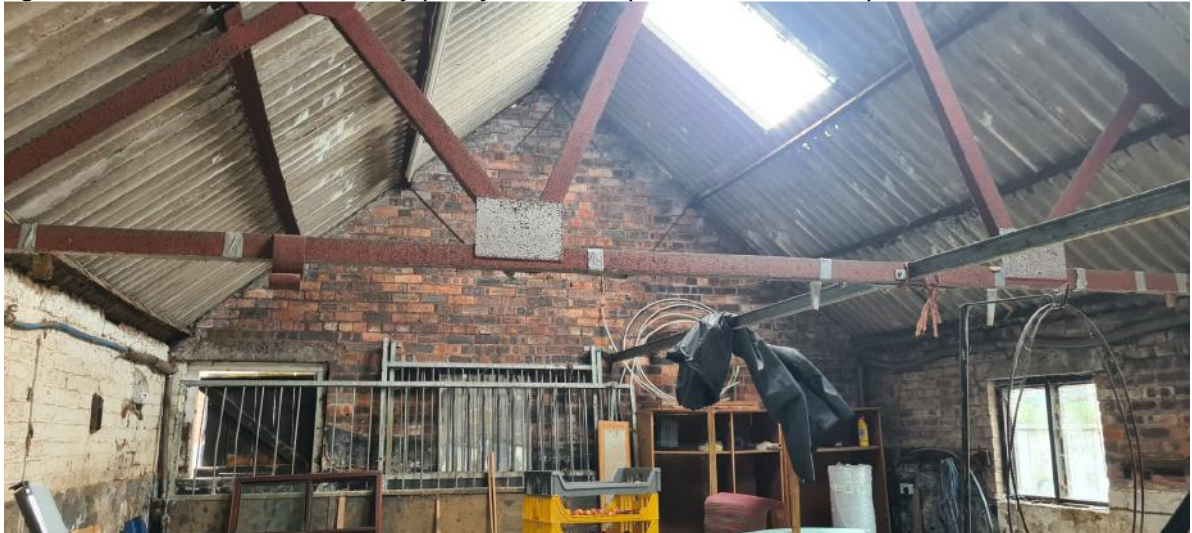
The right side has a corrugated cement/asbestos sheets covering which are supported by steel angle purlins. The purlins span onto loadbearing masonry and supported midspan by a steel fink truss formed using similar sized angle sections. The roof structure overall appears to be in good order. There is some slight surface corrosion to some of the steel members but nothing visible suggests there are significant defects.

Fig 14. Internal view of steel fink roof truss and steel purlins.

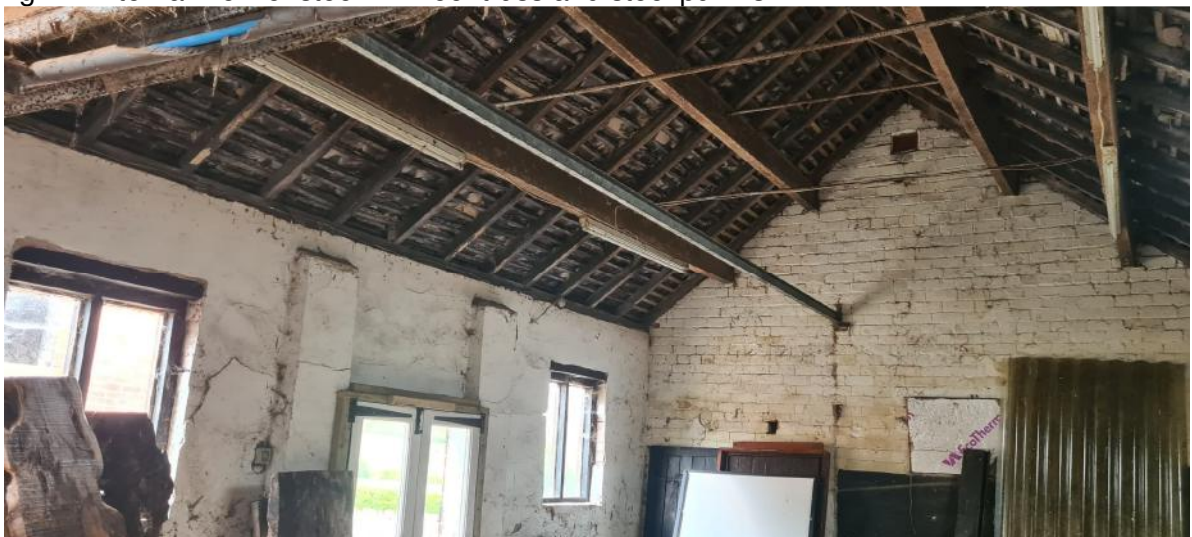
The left side of the building is constructed using softwood rafters with a series of purlins that span onto the left gable and an internal panel of loadbearing masonry. This is covered with rosemary clay tiles with no sarking membrane present. Other than some minor areas where daylight is coming through the roof due to the occasional slipped/broken tile, there are no obvious issues with the fabric of the roof. However, There appears to have been noticeable deflection of the roof structure across the rear. Some of the rafters appear to have failed with longitudinal splits. The damaged timbers should be replaced like for like as required.

Fig 15. Internal view of timber purlins with steel rod ties.

1. Access to be provided to carry out a closer inspection of the apparent lateral roof spread within timber structure to the left side. Damaged or decayed timber sections to be replaced for matching section sizes.
2. A roof condition survey should be carried out to inspect the fabric of the roof and rainwater goods by an accredited NRFC member.
3. The rainwater goods and external fascia boards will likely need to be replaced at the same time.

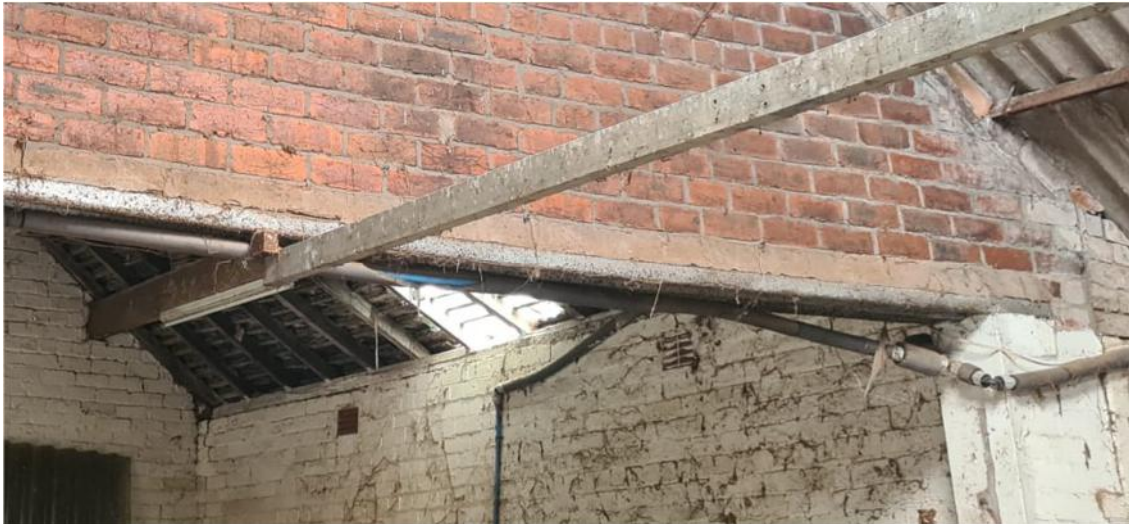
Fig 16. Internal view of bowed rear external wall.
