| Drawing Title<br><b>TOPOGRAPHICAL SURVEY</b> | | | |

# CCTV Survey Report

**The Royal Oak  
High Street  
Dilhorne  
Stoke-on-Trent  
ST10 2PE**

## Royal Oak - CCTV Survey Report : 15/05/24

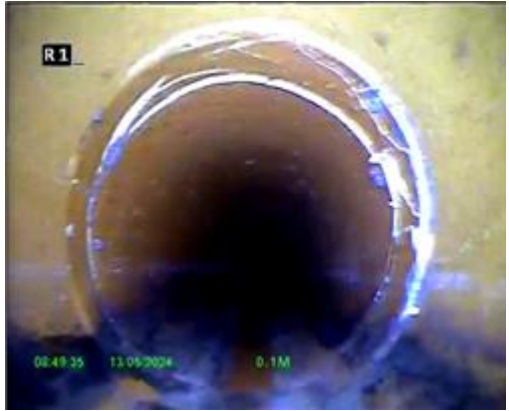
| Pos | Video Ref | Code | Description | Image |
|---|---|---|---|---|
| 00.10m | 0:00:01 | CM | Cracks, multiple - Severity 2 | Image Provided - Ref: 0_2<br> |

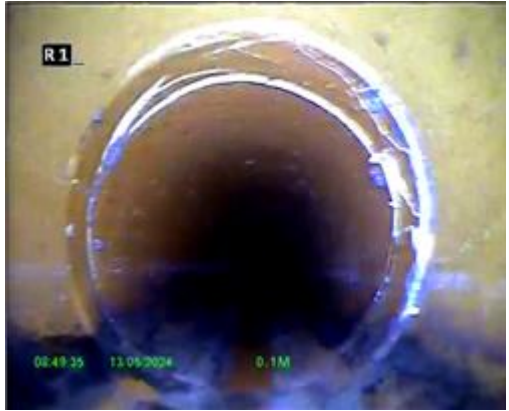
| Pos | Video Ref | Code | Description | Image |
|---|---|---|---|---|
| 00.10m | 0:00:01 | JDM | Joint displaced medium - Severity 3 | Image Provided - Ref: 0_3<br> |

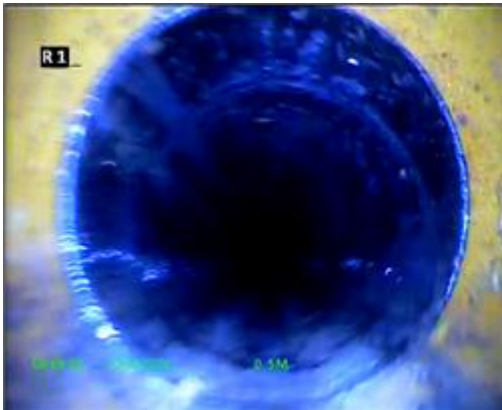
| Pos | Video Ref | Code | Description | Image |
|---|---|---|---|---|
| 00.50m | 0:00:04 | MCPF | Material of pipe changes to Pitch fibre | <p>Image Provided - Ref: 0_4</p> |

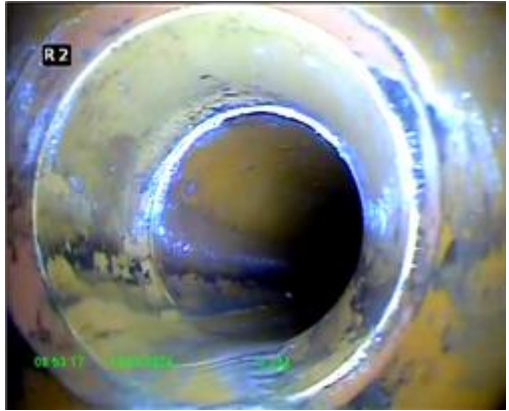
| Pos | Video Ref | Code | Description | Image |
|---|---|---|---|---|
| 00.30m | 0:00:01 | LRQ | Line of drain/sewer deviates right [quarter] | Image Provided - Ref: 1_2<br> |

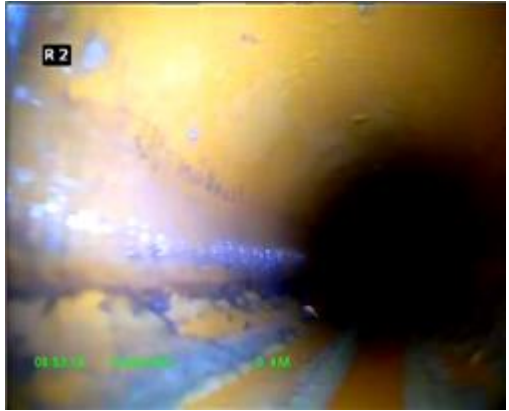
| Pos | Video Ref | Code | Description | Image |
|---|---|---|---|---|
| 00.40m | 0:00:03 | S1 DEG | Attached deposits, grease 0.4m - 12.2m from 05 o'clock to 07 o'clock: 5% Cross sectional area loss - Severity 3 | Image Provided - Ref: 1_3<br> |

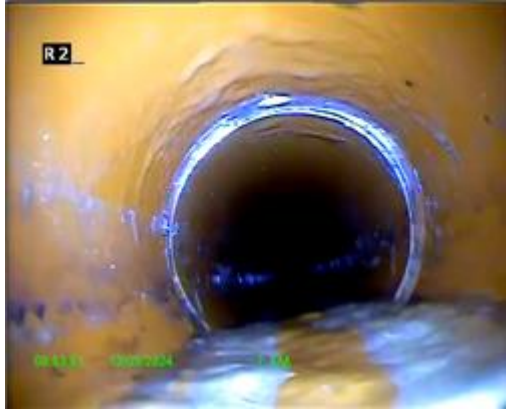
| Pos | Video Ref | Code | Description | Image |
|---|---|---|---|---|
| 07.80m | 0:00:35 | JDM | Joint displaced medium - Severity 3 | <p>Image Provided - Ref: 1_7</p> |

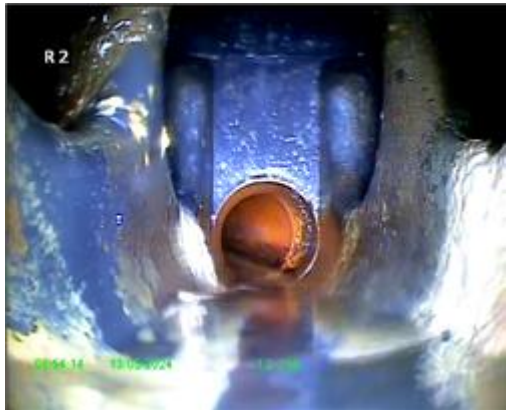
| Pos | Video Ref | Code | Description | Image |
|---|---|---|---|---|
| 12.20m | 0:00:03 | F1 DEG | Attached deposits, grease<br>Defect End from 05 o'clock to 07 o'clock: 5% Cross sectional area loss - Severity 3 | <p>Image Provided - Ref: 1_-3</p> |

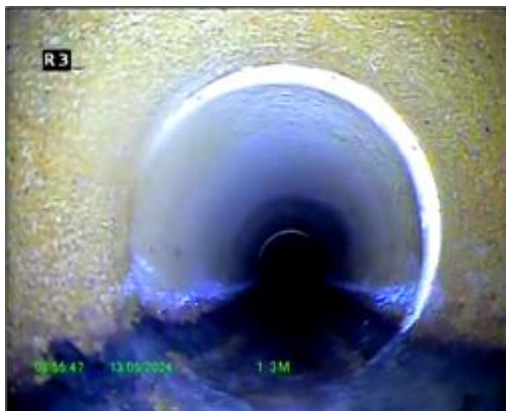
| Pos | Video Ref | Code | Description | Image |
|---|---|---|---|---|
| 01.30m | 0:00:11 | JDM | Joint displaced medium - Severity 3 | Image Provided - Ref: 2_2<br> |

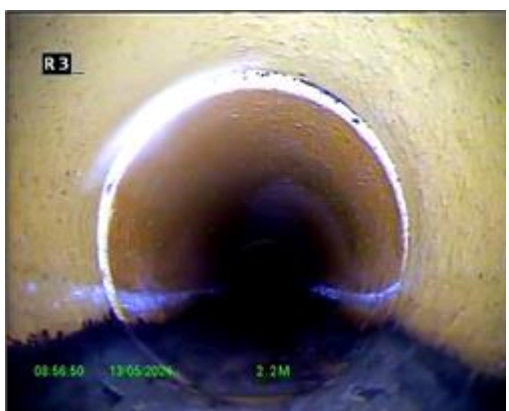
| Pos | Video Ref | Code | Description | Image |
|---|---|---|---|---|
| 02.20m | 0:00:14 | JDM | Joint displaced medium - Severity 3 | Image Provided - Ref: 2_3<br> |
